Date: 15 June 2024

ERA23FA174 Tamarack Aerospace Party Submission

Cessna 525B Structural Departure Near KTPA

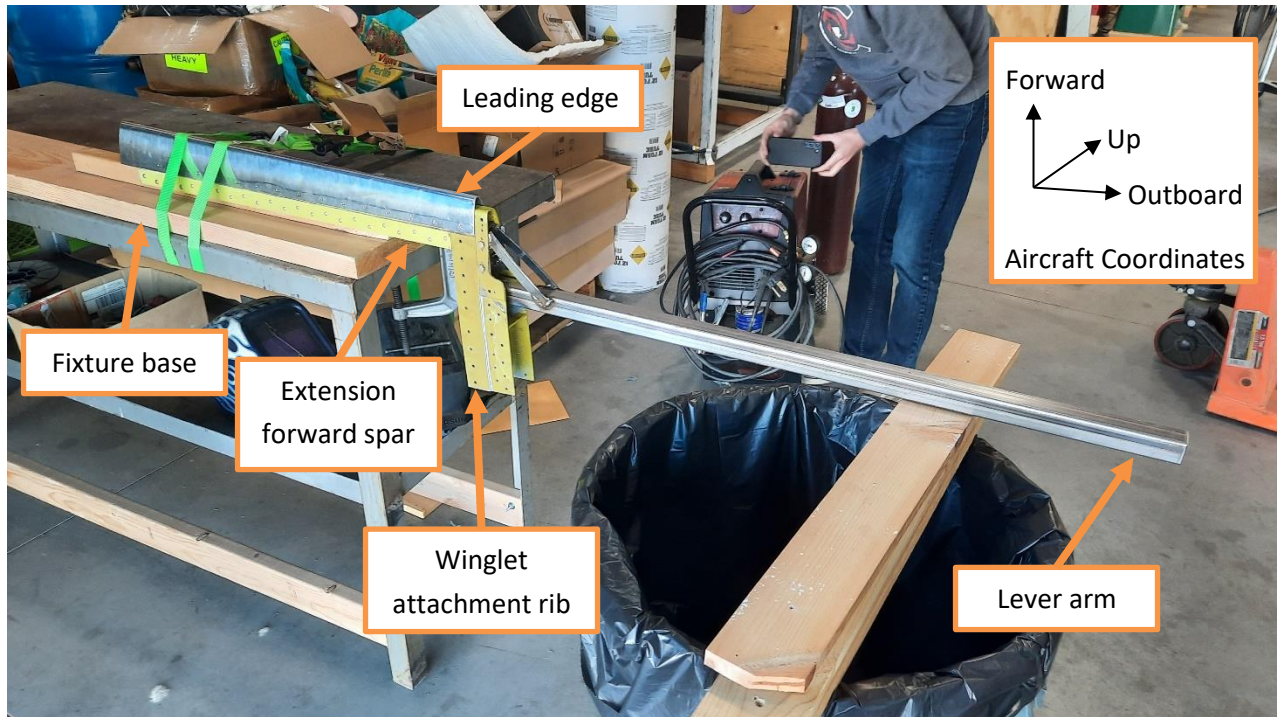
Figure 3-1 Company winglet rib tear-out test setup

The test setup was a simple wooden fixture base with a scrap extension forward spar and leading edge assembly fixed to it. A winglet attachment rib was installed as it would be in an airplane installation, with a riveted angle bracket and two screws in the leading edge. The rest of the leading edge screws were installed in the forward spar caps as they would be in the airplane. A steel lever arm was fabricated and bolted into existing fastener holes in the winglet attachment rib, providing a place to apply a moment on the assembly. An image of the test setup is presented below.

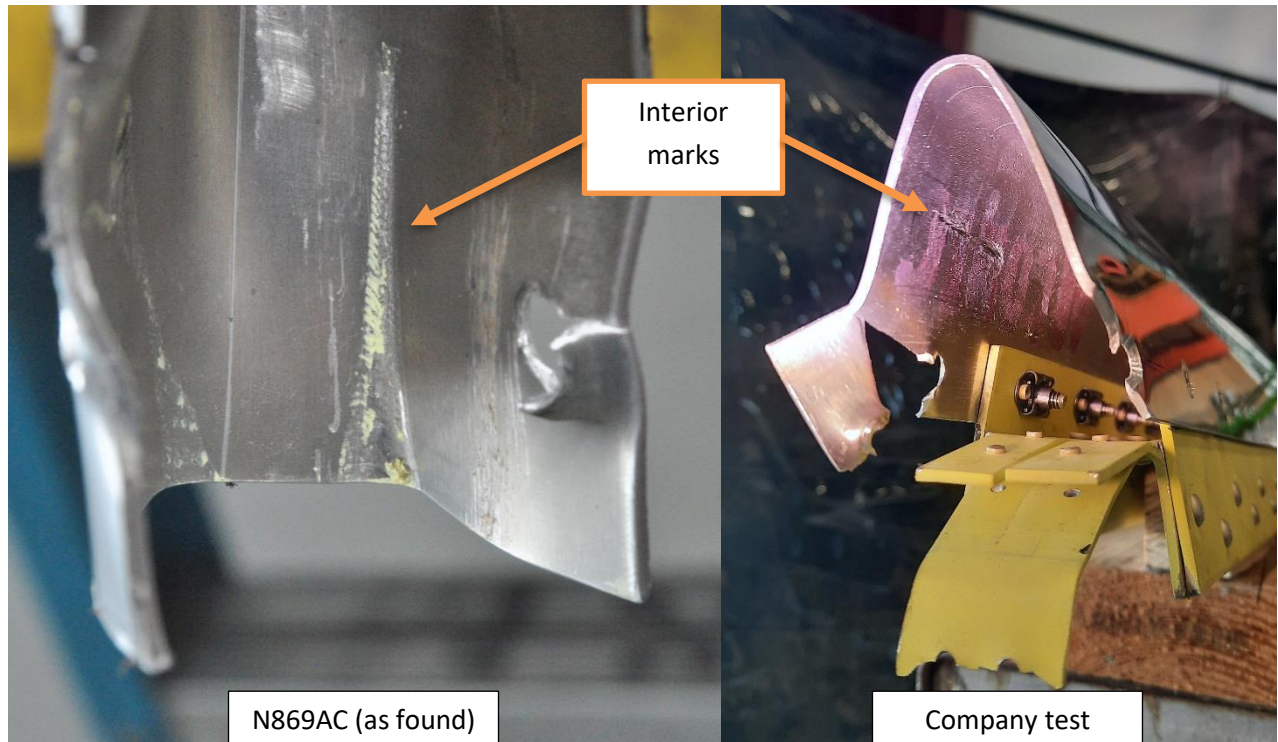
Figure 3-2 Aircraft damage vs. test damage - leading edge interior marks

During the company test, the forward edge of the rib dragging along the interior of the leading edge skin caused deformations similar to those found on the accident airplane. Notably, the company test was less dynamic and destructive than the accident sequence appears to have been, and the deformation is therefore less pronounced than the flattening of the leading edge discovered on the accident airplane. However, the company test article deformation is of a similar type and in a similar location. A reflection of

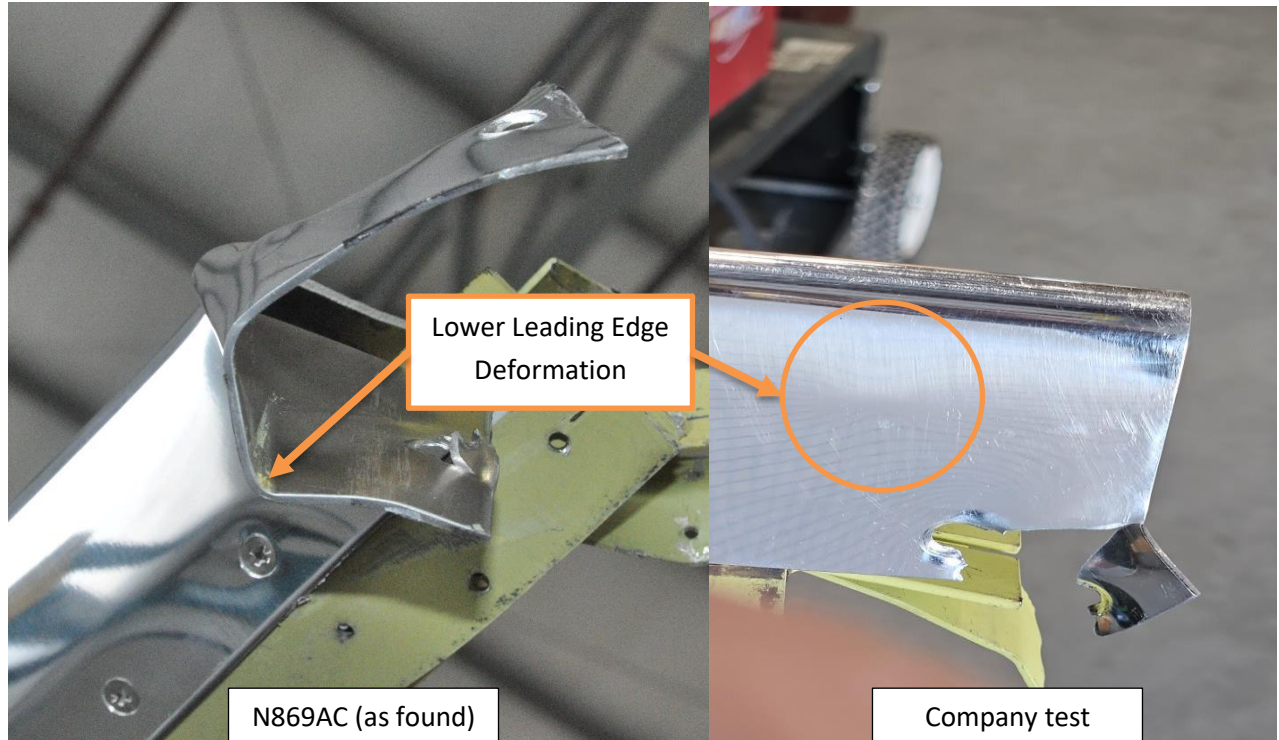
Figure 3-3 Aircraft damage vs. test damage - leading edge deformation

graph paper is used to demonstrate the location of deformation of the company test article leading edge in the following comparison image.

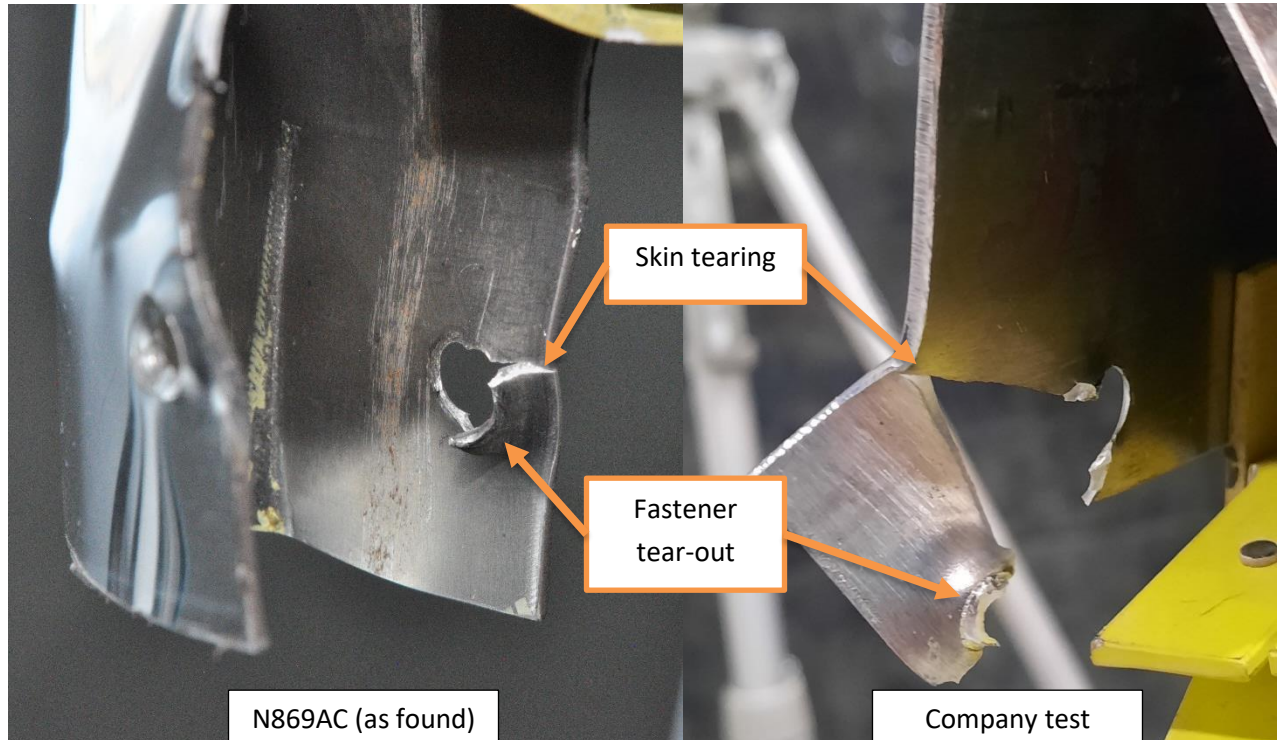
Figure 3-4 Aircraft damage vs. test damage – fastener damage and skin tearing

Tearing of the leading edge skin around the fasteners in the winglet attachment rib was similar in both the accident airplane and the company test article following the test, as shown below.

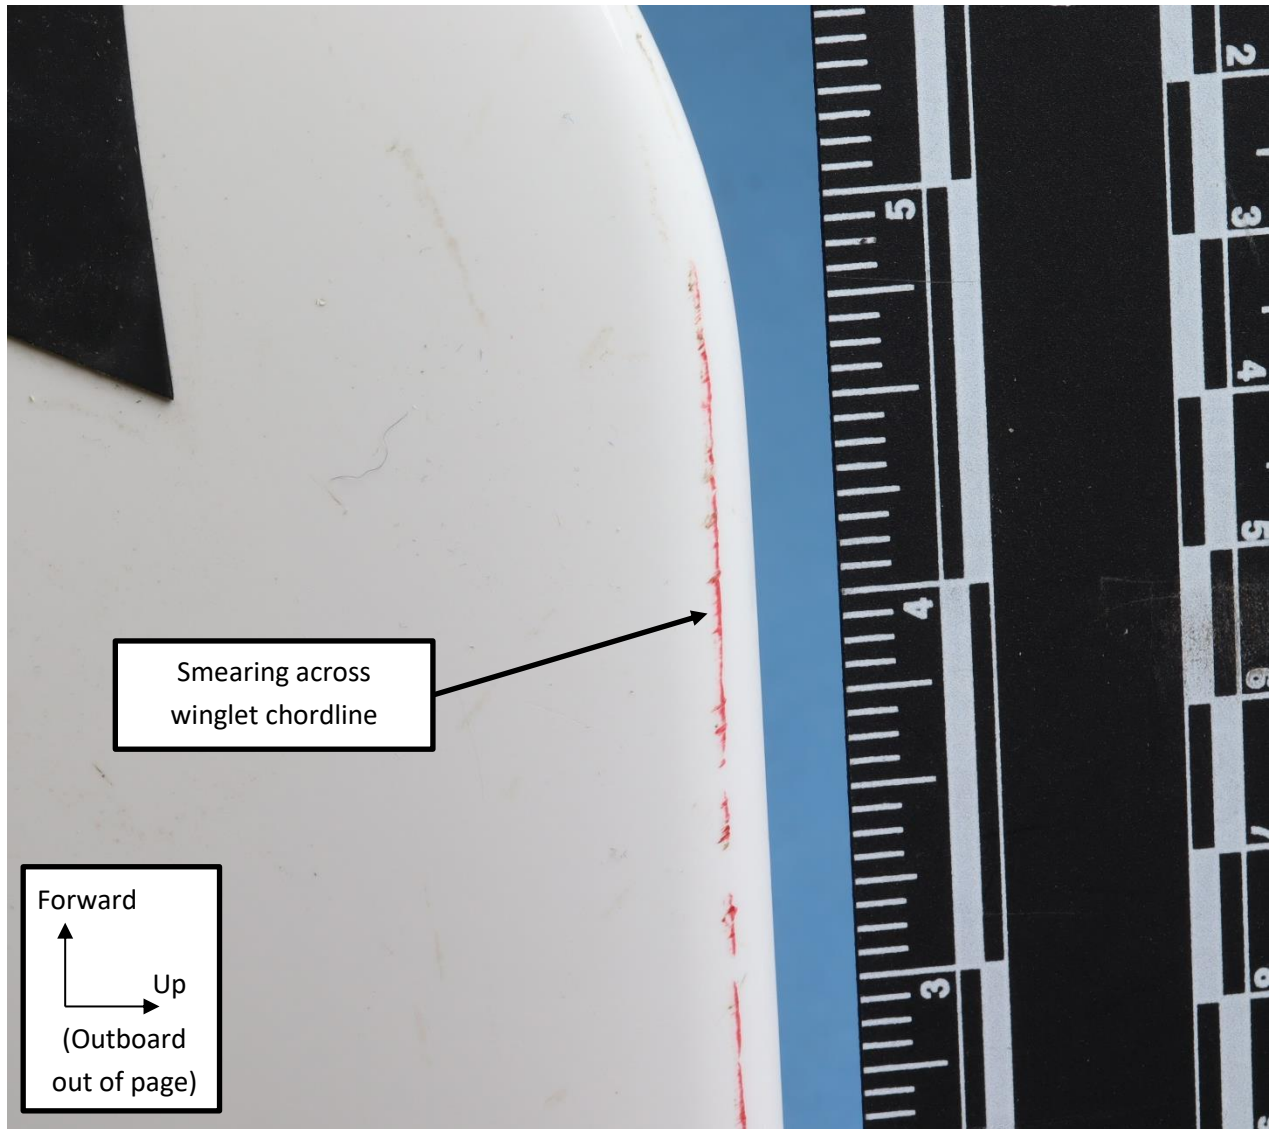
Figure 3-5 Winglet tip cap red mark

The winglet was recovered by a fishing boat shortly after the initial inspection of the airplane was conducted in Tampa, and was found with a red mark on the winglet tip cap. The red mark is of particular interest, because the airplane paint scheme does not include red, the primer used on the winglet is not red, and the structure of the winglet itself is not made of any red material. The red mark therefore could only have been caused by contact with some other object.

It is improbable that this contact occurred in flight, specifically that the airplane would have passed close enough to another aircraft or UAS at that altitude for the winglet to make contact and transfer paint without the other aircraft or UAS being visible either to radar or the pilot. It is also improbable that contact would be limited solely to a single red paint transfer on the winglet tip and not involve any other obvious damage to the structure of the winglet, especially considering the speeds involved during the accident event.

Testing conducted at the NTSB materials lab concluded that the red mark chemical composition was consistent with automotive and industrial paints in common use and was similar to the aircraft topcoat. That color is not used anywhere on the airplane, and therefore must have transferred from a different object. The shape of the marks indicates dragging or scratching across the chordline of the winglet.

A mark of this type is improbable in flight, but can occur during hangar rash and ground handling mishaps. Tamarack customer service personnel have responded to at least ten reported incidents of ground contact with other airplanes, hangars, and vehicles since ATLAS certification. Of the reported incidents, seven have involved varying degrees of confirmed structural damage. An example of damage on a different airplane involved in a confirmed ground collision is presented below for reference.

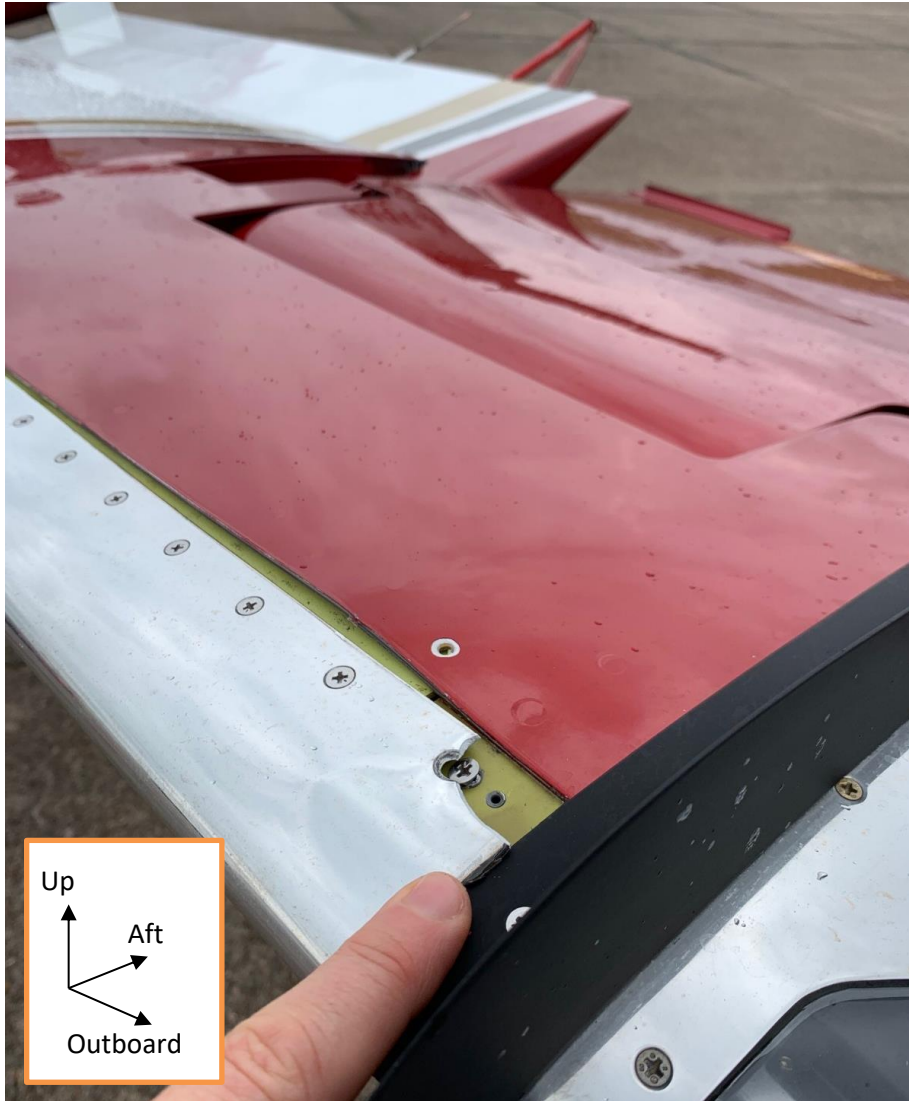
Figure 3-6 Example of confirmed ground damage (separate incident)

Note that the damage shown above is clearly visible on a standard walkaround inspection. The leading edge of the winglet collided directly and forcefully with a parked airplane, causing obvious structural damage. Also note that the damage caused failures of the wing extension forward spar fasteners and deformation of the leading edge skin around the area of the winglet attachment rib, similar to failure modes observed on the accident airplane, though more obvious and severe.

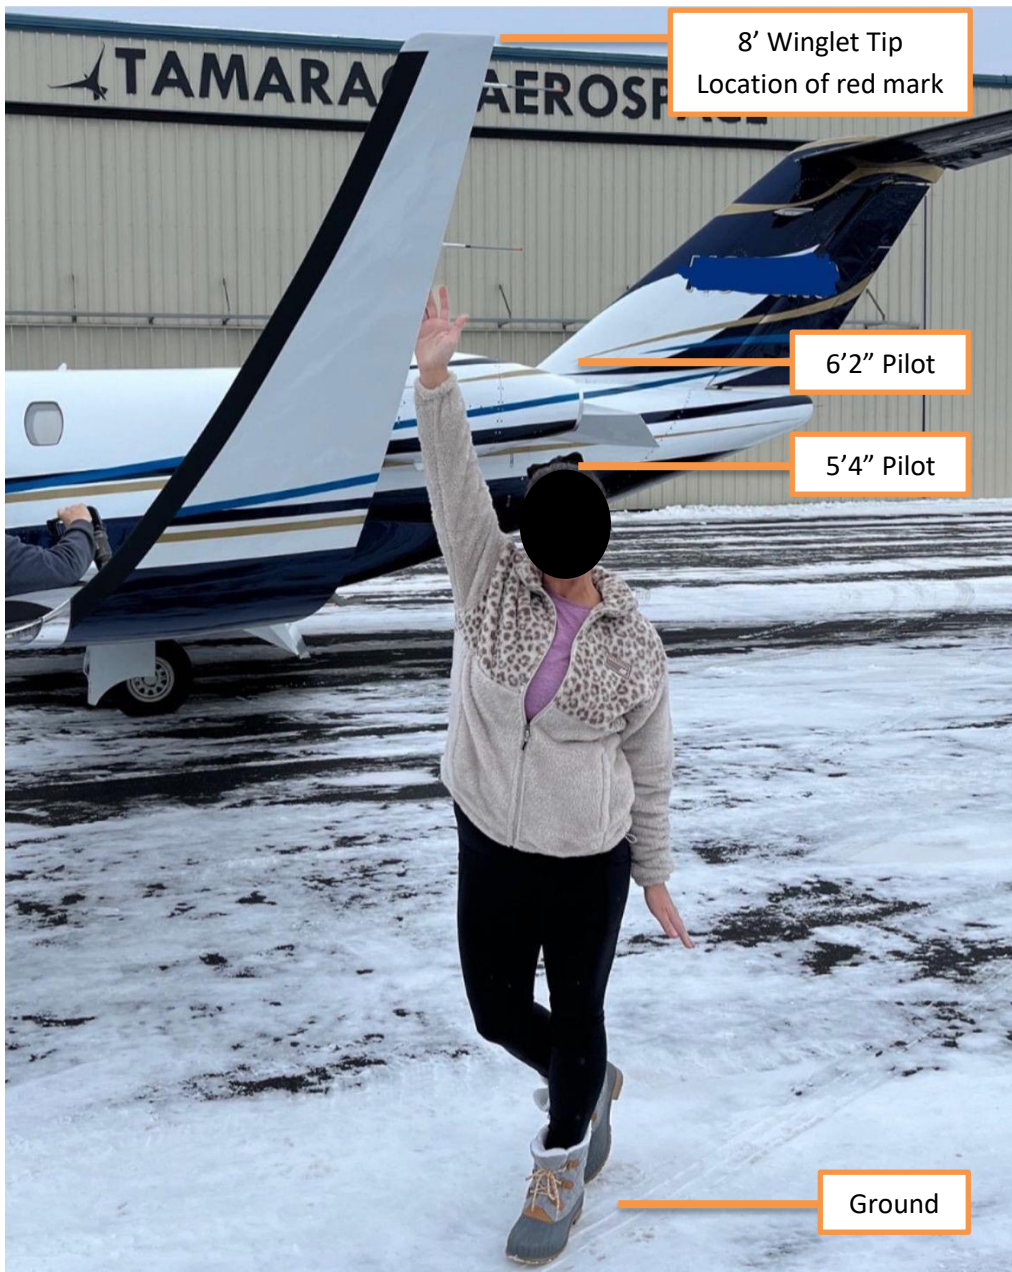
Figure 3-7 Winglet tip height reference image

The red mark on the accident airplane is located on the curve of the winglet tip cap, a location on the winglet that nominally sits approximately eight feet above ground level. This area is difficult for pilots to inspect during preflight . An image of an exemplar aircraft and exemplar pilot is presented below to illustrate.

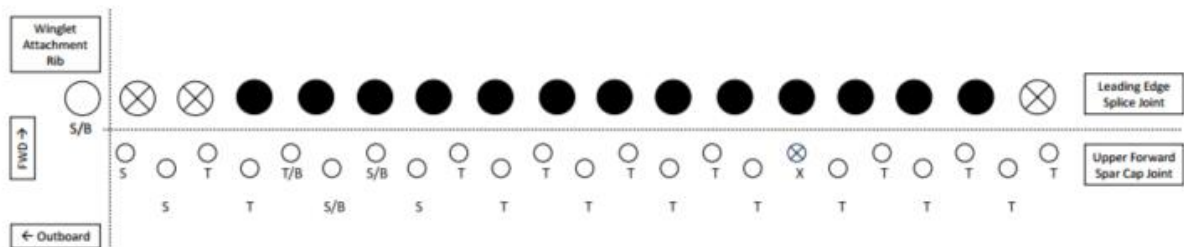
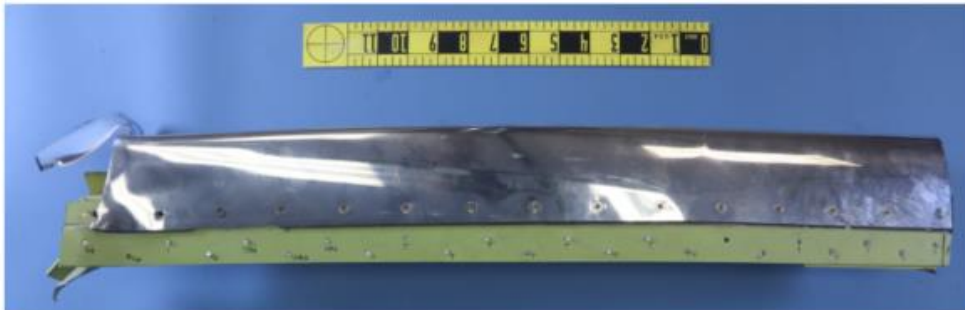
Figure 3-8 Figure 25 from NTSB materials lab report - forward spar upper surface fasteners

Figure 25. Schematic of the upper leading edge splice joint and upper skin-to-forward spar fastener conditions along the wing extension. Fractured fasteners are identified by an open circle, missing fasteners by a circle with an "X" and intact fasteners by a filled circle. Fracture designations are T = tensile fracture mode, S = shear fracture mode, B = mixed mode bending fracture used in conjunction with T or S as applicable.

The upper surface rivet failures were largely tensile, consistent with a lifting or peeling action of the upper skin of the wing extension. The outboard fasteners, particularly the most outboard pair of rivets,

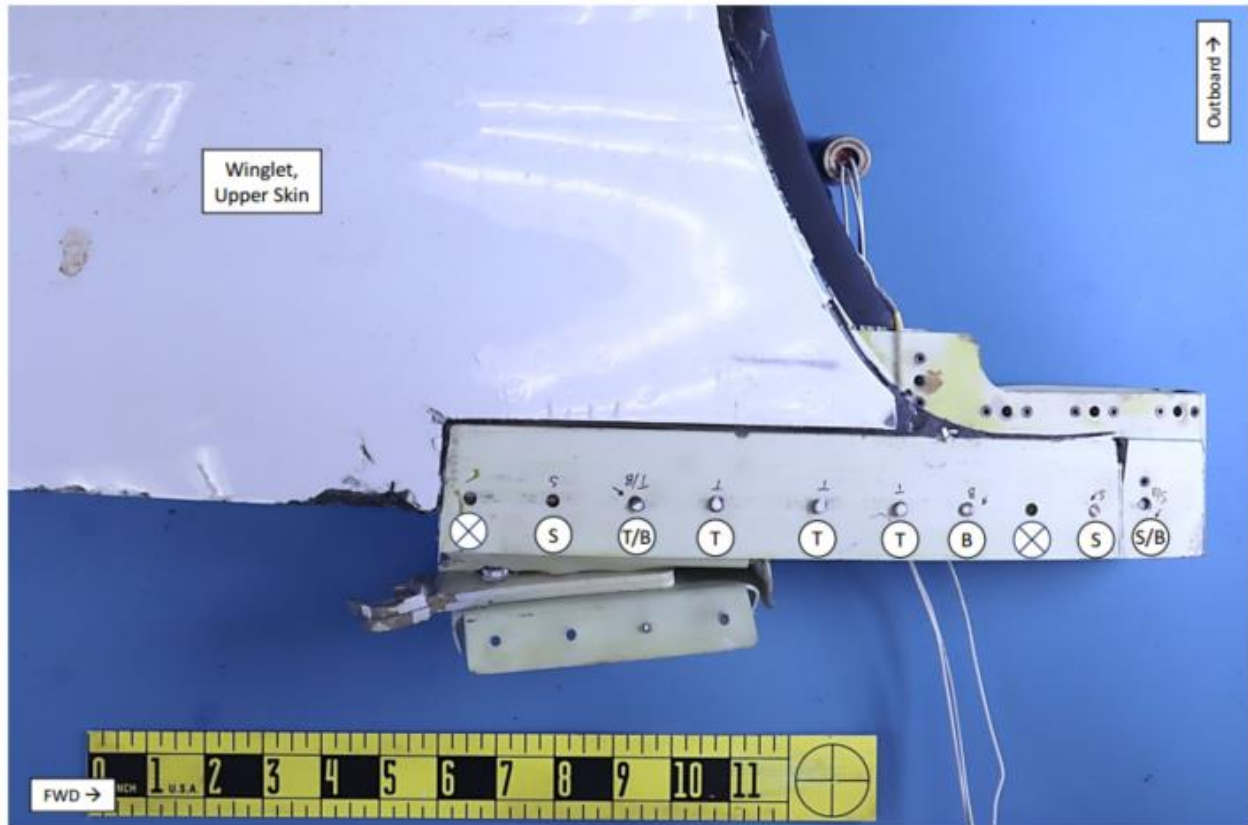
Figure 3-9 Figure 27 from NTSB materials lab report – winglet attachment rib upper surface fasteners

Figure 27. Schematic of the wing extension upper skin-to-winglet attachment rib fastener conditions. Fractured fasteners are identified by an open circle, missing fasteners by a circle with an “X” and intact fasteners by a filled circle. Fracture designations are T = tensile fracture mode, S = shear fracture mode, B = mixed mode bending fracture used in conjunction with T or S as applicable.

Note that in the figure above, three of the four forward fasteners of the winglet attachment rib were determined to be shear or bending failures. These fasteners are installed on the wing extension side, attaching the wing extension upper surface to the inboard edge of the winglet attachment rib. This indicates that a group of fasteners in proximity to each other failed in shear or shear/bending, rather than the tensile failures consistent across the rest of the wing extension forward spar.

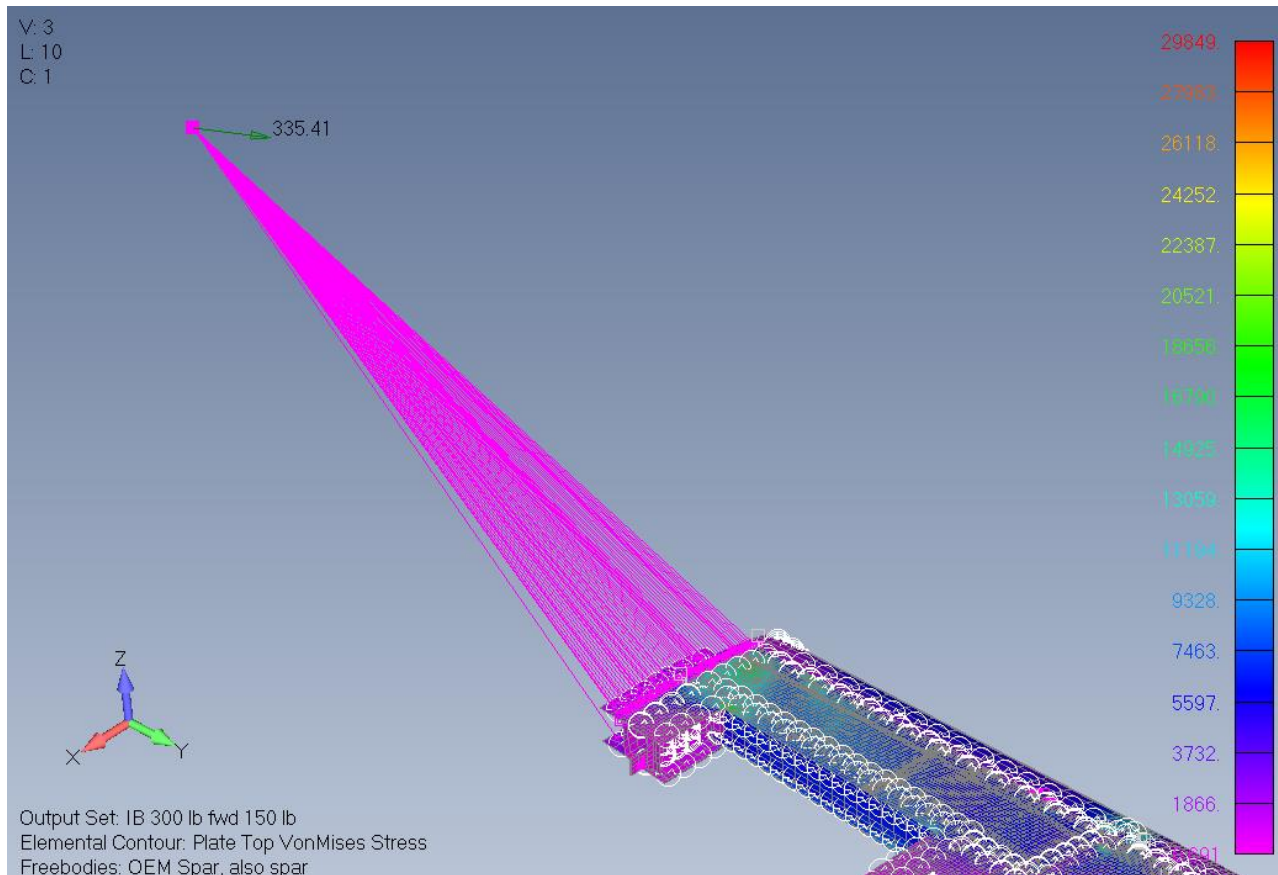
Figure 3-10 Winglet tip cap point load analysis results

Examining the fasteners common to the forward upper spar cap and upper skin revealed that they were primarily loaded in shear. The fasteners farther outboard experienced significantly higher loads than the fasteners further inboard. Under the loading conditions described above, the two farthest outboard fasteners were subject to loads higher than their prescribed shear allowable, meaning they would likely fail in shear.

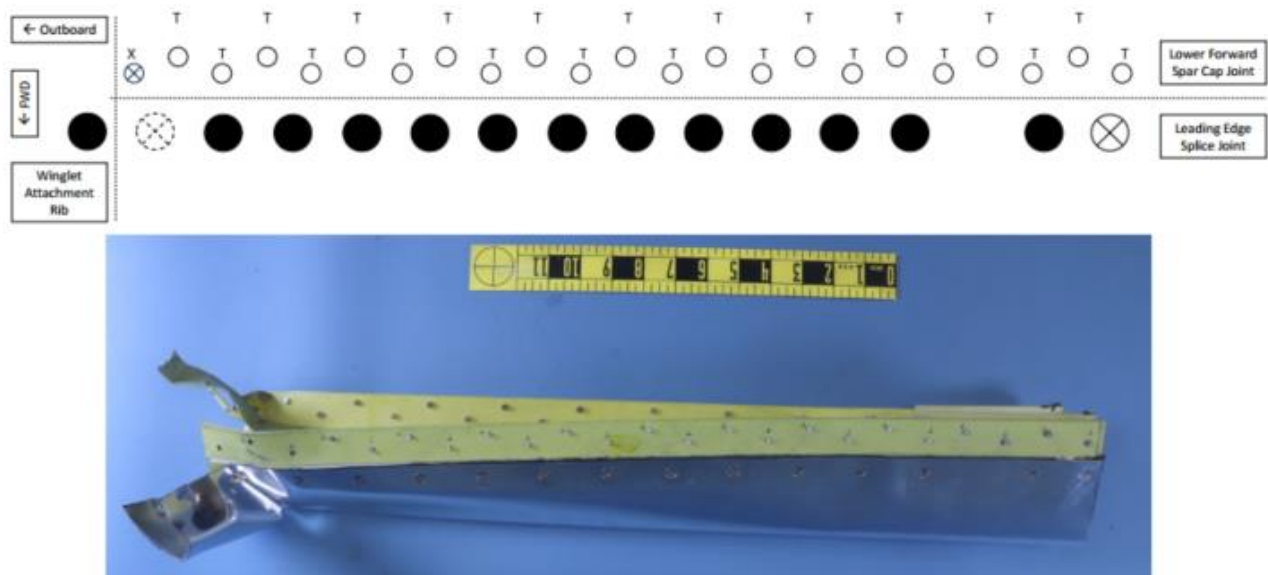
Figure 3-11 Figure 27 from NTSB materials lab report –extension forward spar lower fasteners

Figure 26. Schematic of the lower leading edge splice joint and lower skin-to-forward spar fastener conditions along the wing extension. Fractured fasteners are identified by an open circle, missing fasteners by a circle with an “X” and intact fasteners by a filled circle. Fracture designations are T = tensile fracture mode, S = shear fracture mode, B = mixed mode bending fracture used in conjunction with T or S as applicable. The fastener represented by a dashed “X” circle was drilled out to aid with disassembly.

This type of failure would be consistent with a lifting or peeling of the lower wing extension skin. A small portion of the wing extension lower skin was found still attached to the lower portion of the winglet

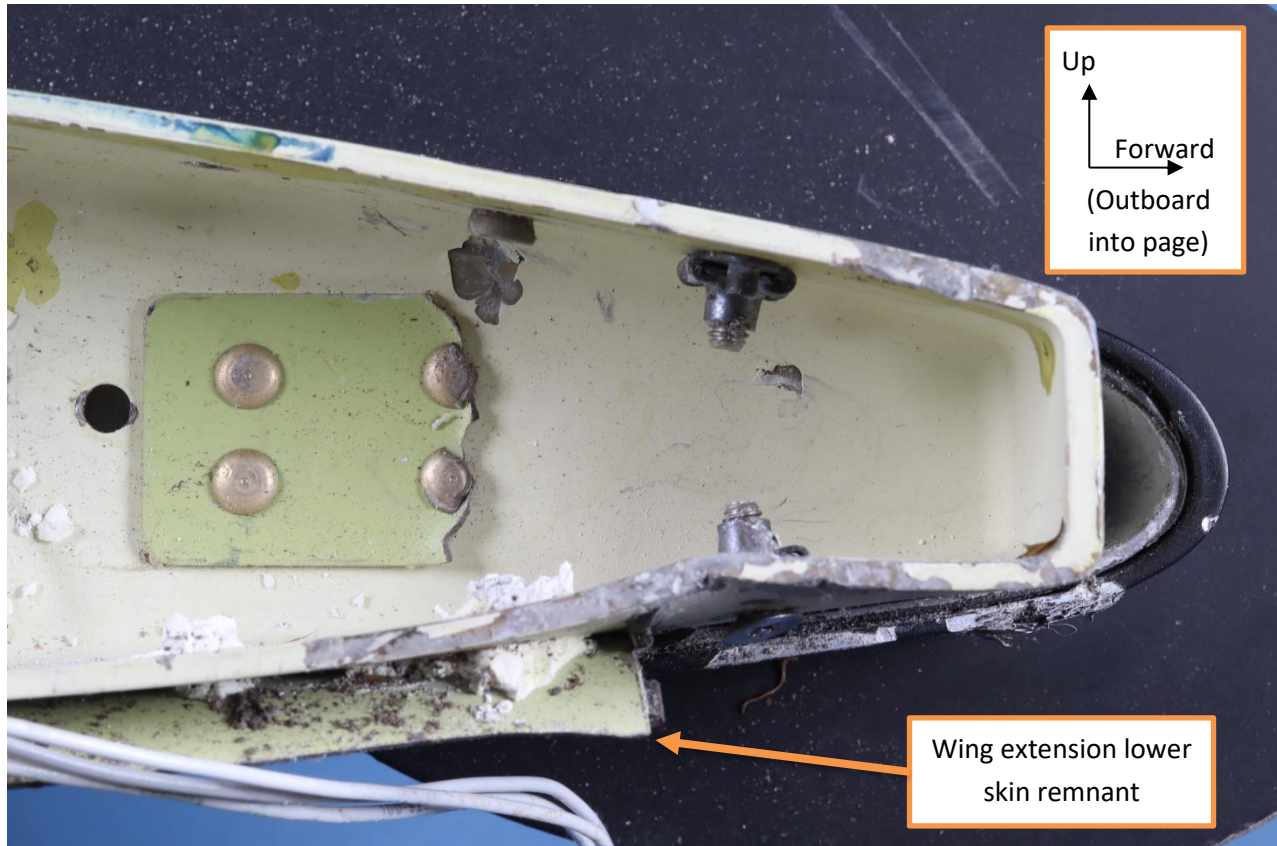
Figure 3-12 Detail view of the winglet attachment rib

The remnant lower wing extension skin is bent downward and torn, which is consistent with the winglet rotating outward around the axis of the wing extension chordline and departing the aircraft downward.

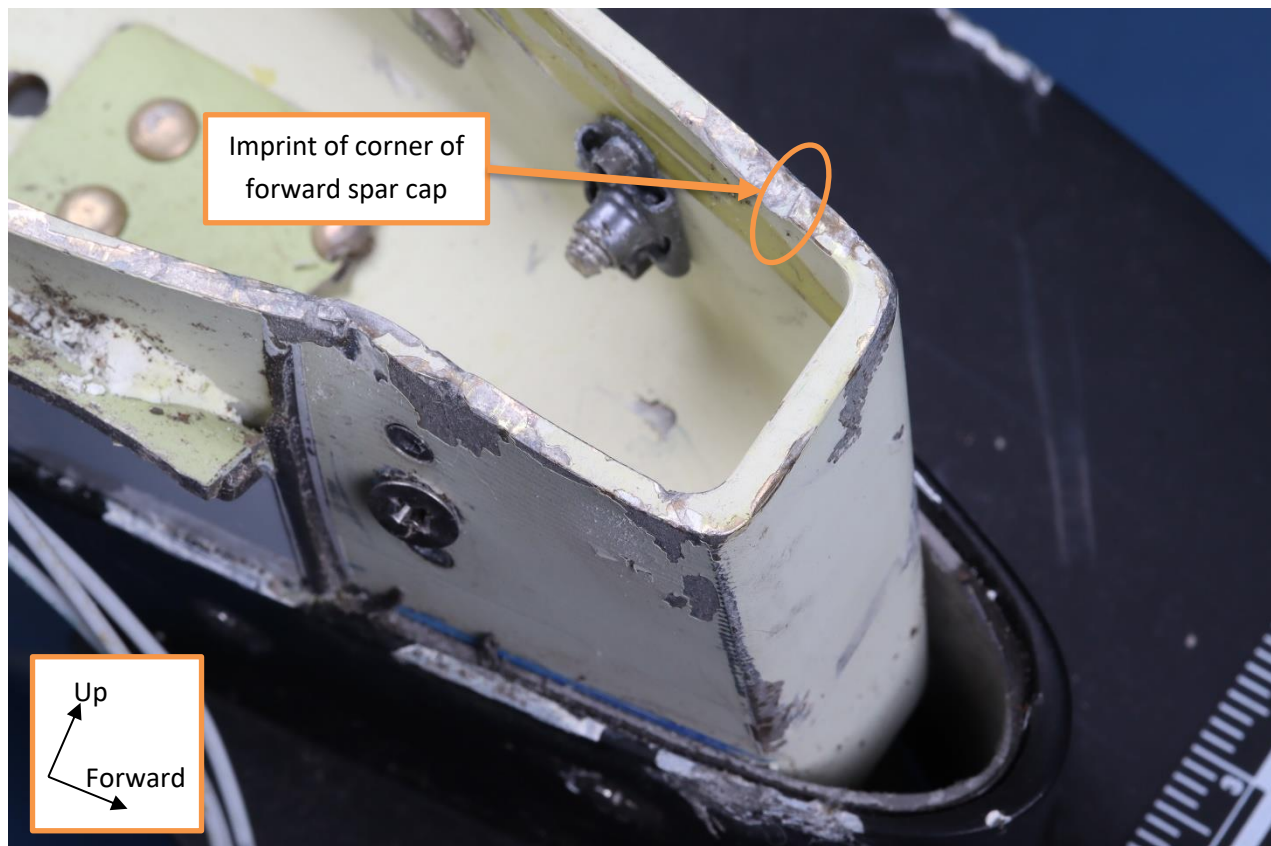
The failure of the outboard forward upper skin fasteners may have allowed the winglet to twist upward or bend inward and deform the upper wing extension skin, peeling the upper skin from the forward spar. It is unknown what may have caused this twisting, but normal flight operations involve a variety of changing aerodynamic loads and perturbations, particularly at higher dynamic pressures, any of which may have caused minor flexing of the structure. This could lead the upper surface to deform upward, with aerodynamic loads catching the skin and causing it to peel from the forward spar. This would cause the remaining upper surface forward spar rivets to fail in tension (consistent with fastener states observed during the investigation). A witness mark on the upper flange of the winglet attachment rib indicates contact between the winglet attachment rib and the corner of the forward spar cap, to which the leading edge is fastened, consistent with inboard rotation of the winglet and relative movement of the two components. The mark is illustrated in the figure below.

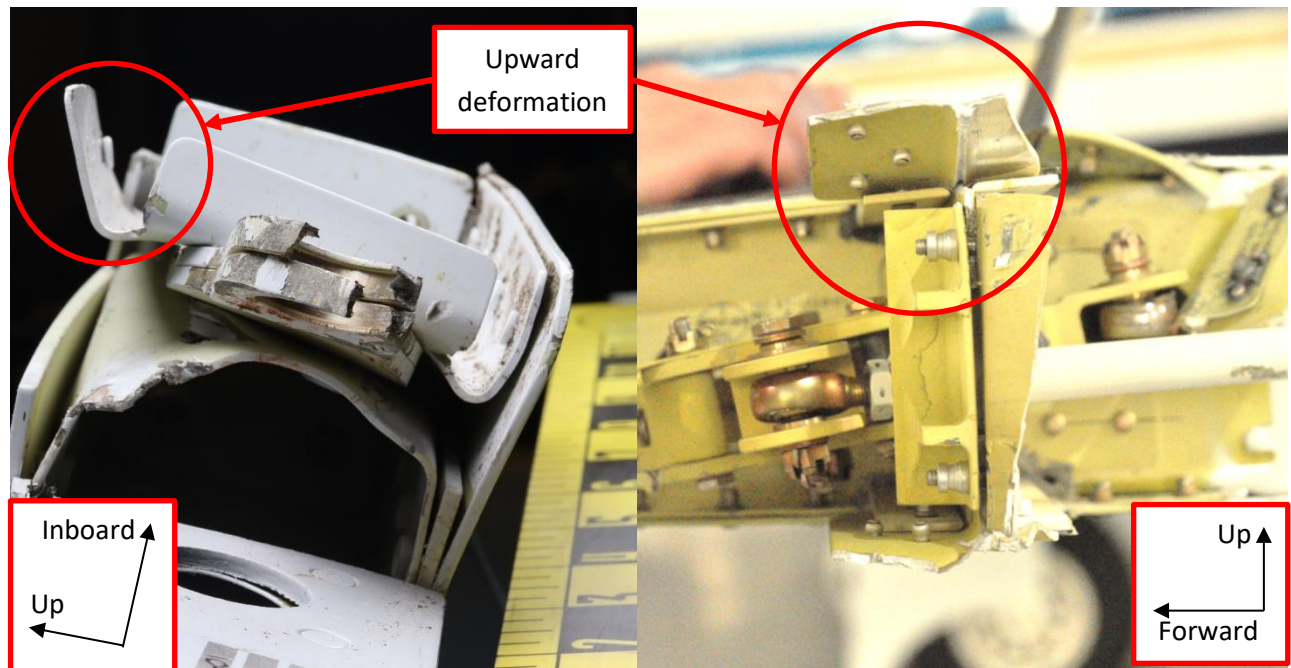
Figure 3-13 Winglet attachment rib forward view (left), wing extension main inboard view (right)

If the upper wing extension skin continued to peel upward and aft, it would likely depart the airplane aft and slightly inboard. This would cause the upper flange of the outboard TACS hinge bracket to deform upward as the skin pulled it up, then cause a portion of the inboard rib upper cap at the attachment to the OEM wing to deform upward as well. This is consistent with the states of these two components as found in the investigation (see below).

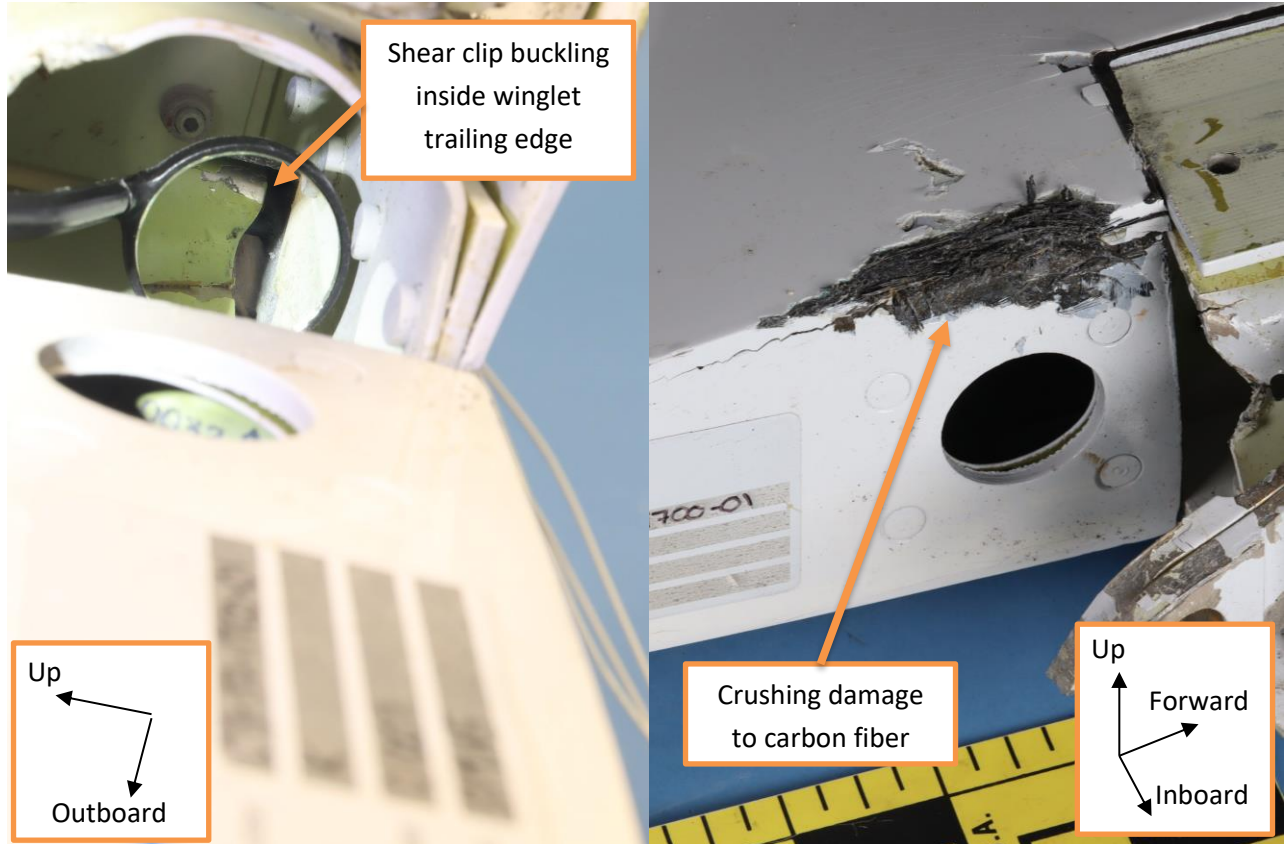
Figure 3-14 Winglet trailing edge damage due to contact with adjacent structures

The departure of the upper skin would further reduce the stiffness of the winglet, allowing the winglet to twist outboard about the winglet spar and contact the TACS, causing crushing damage to the trailing edge portion of the winglet. This is consistent with damage found during the investigation, specifically in the

form of buckling of a shear clip within the aft portion of the winglet attachment rib and crushing of the carbon fiber of the aft section of the winglet itself.

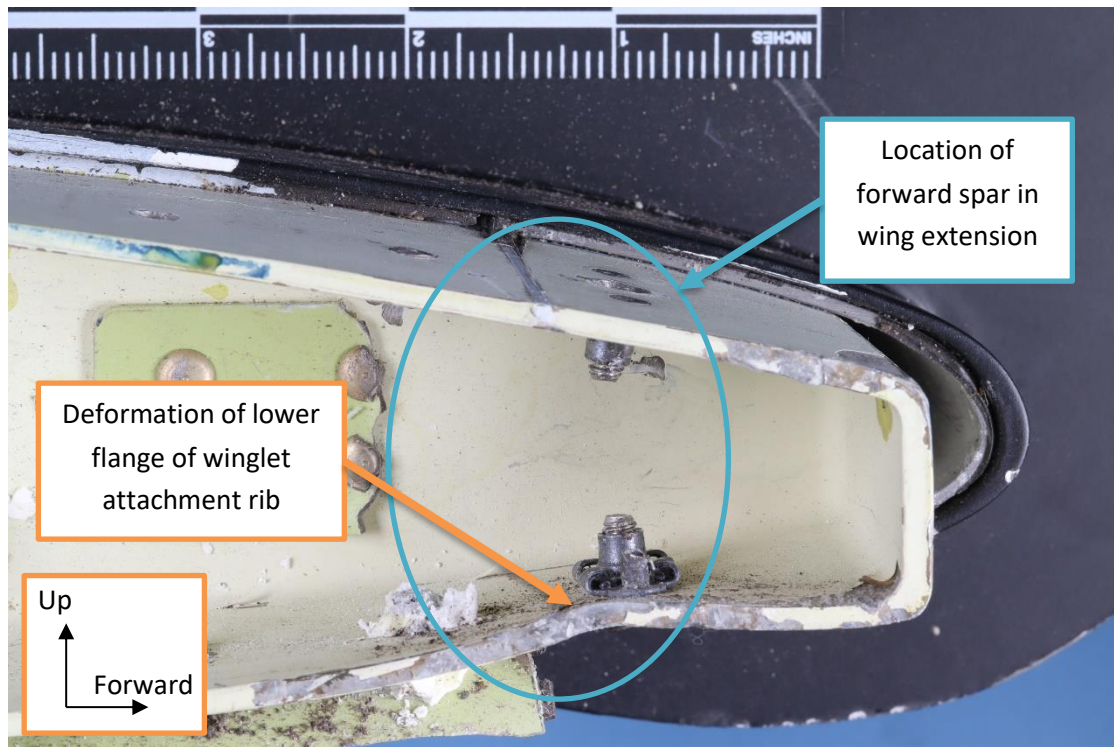
Figure 3-15 Winglet attachment rib lower flange dent (view looking outboard)

The winglet could also rotate outward about the chordline of the winglet attachment rib in this state, causing buckling deformation to the winglet attachment rib at the location of the forward spar as the two components contact each other under high load.

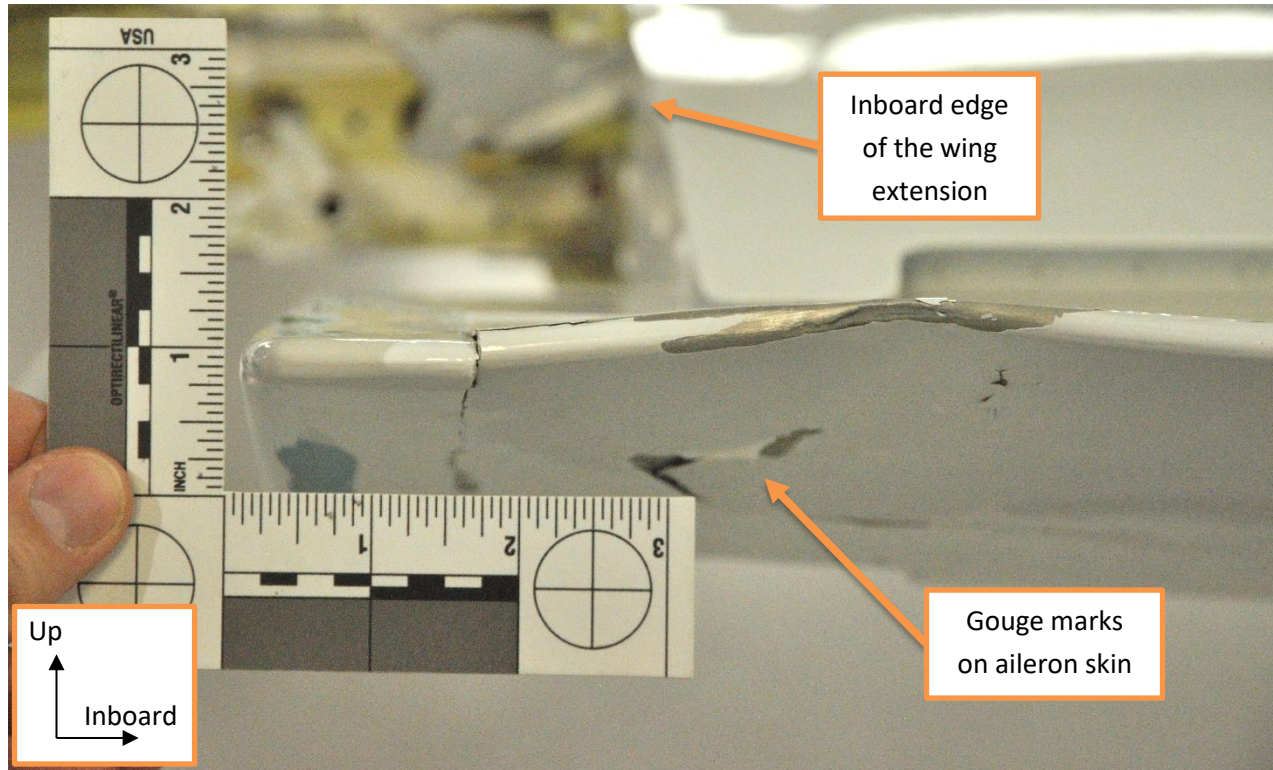
Figure 3-16 Aileron trailing edge damage as found (view looking forward)

If the lower skin departed the airplane aft, the skin debris could contact the aileron trailing edge almost directly behind the inboard edge of the wing extension as it departed the airplane, scratching and denting

the aileron trailing edge. See below for a view of the aileron trailing edge as found on the accident airplane.

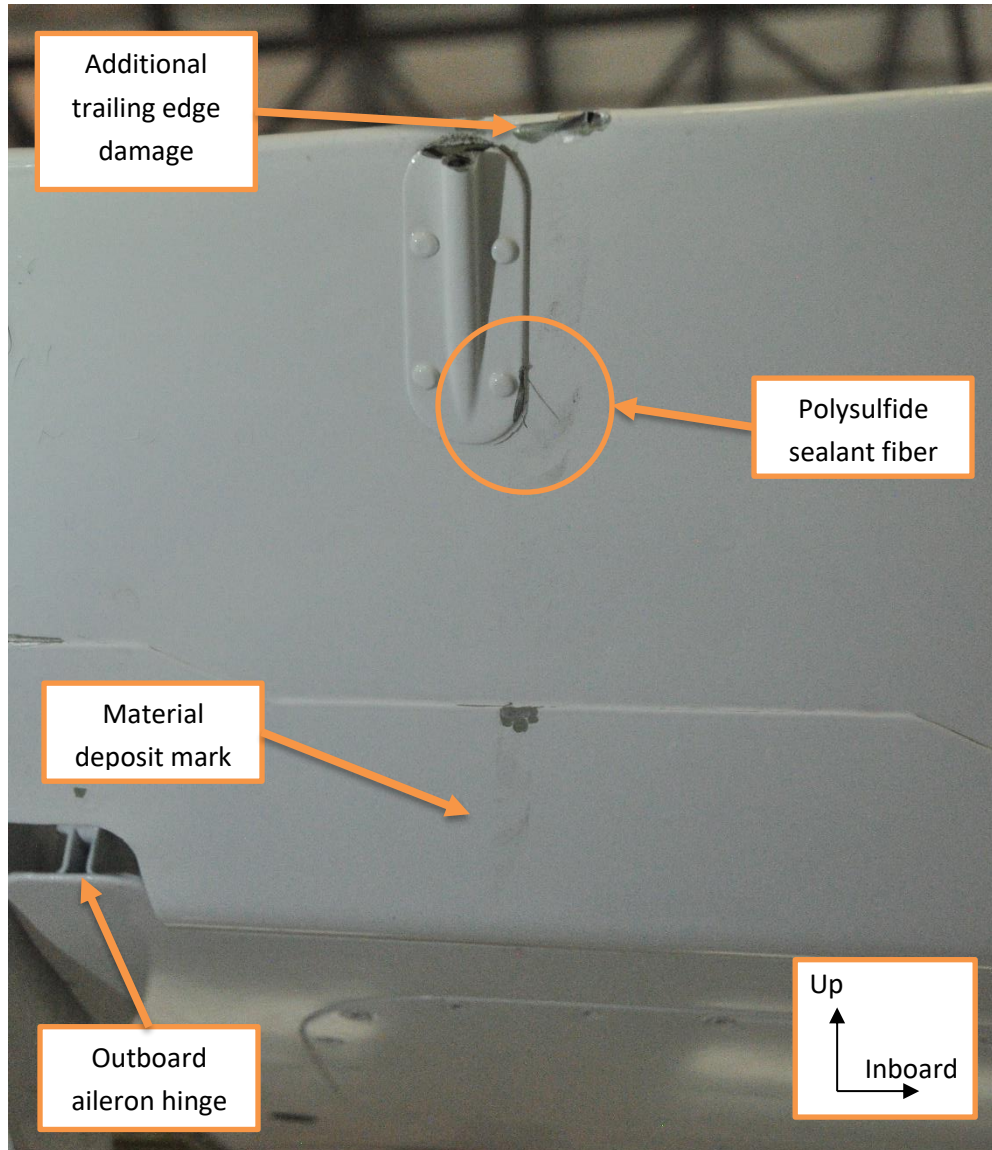
Figure 3-17 Aileron static wick fiber and aileron skin marks (view looking forward, aileron deflected up)

The departing lower skin could also leave the small fiber of the aviation sealant on the aileron static wick as found in the process. The wing extension uses a similar type of sealant throughout the assembly, notably around the edges of the wing extension skin as a gap-filler. The sealant fiber was accompanied by material transfer oriented aft on the lower aileron skin and additional physical damage to the trailing edge. The material was collected and tested, but no conclusive determination could be made regarding its

composition. It is possible that the material was polysulfide sealant of the same type that was deposited on the aileron static wick. See below for illustration.

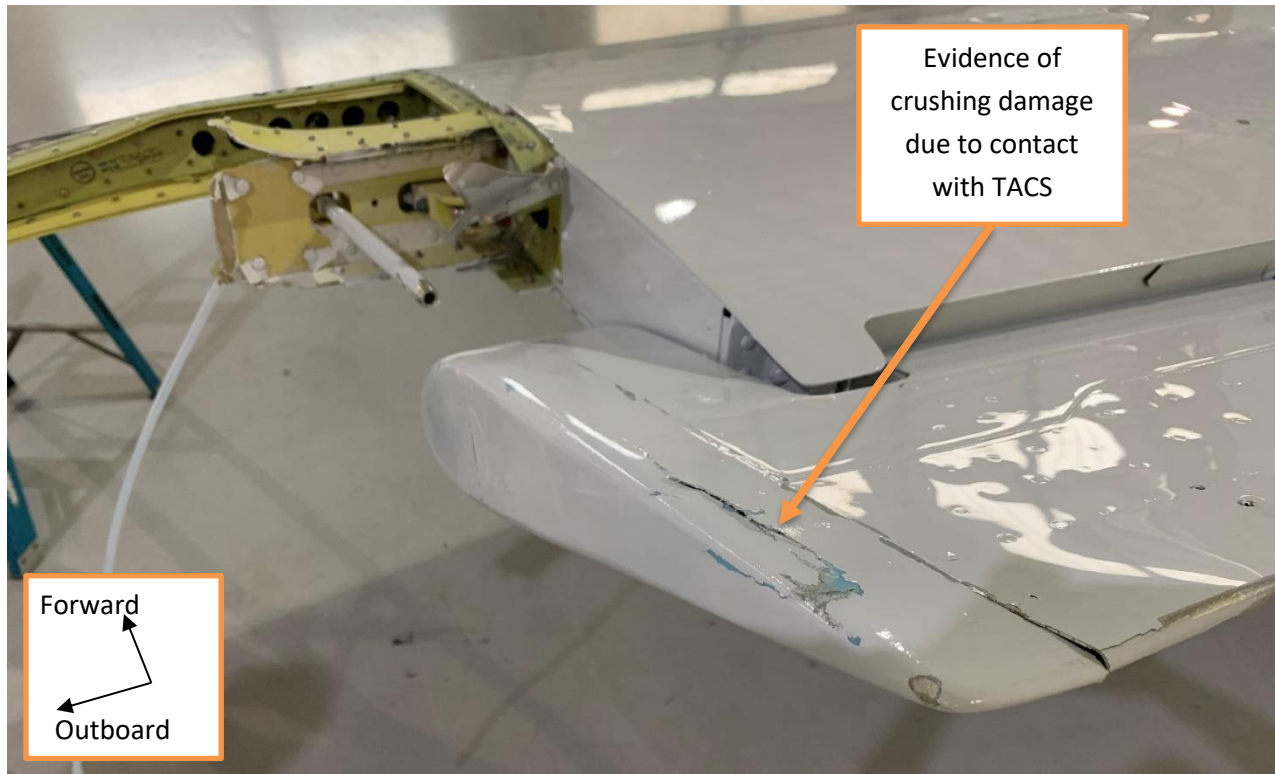
Figure 3-18 Aileron tip cap crushing damage (view looking forward and inboard)

The aileron tip cap was also discovered with evidence of hard contact oriented inboard, most likely from the TACS rotating about the inboard hinge as the winglet separated from the wing extension and pulled the outboard TACS hinge aft.
