Date: 15 June 2024

ERA23FA174 Tamarack Aerospace Party Submission

Cessna 525B Structural Departure Near KTPA

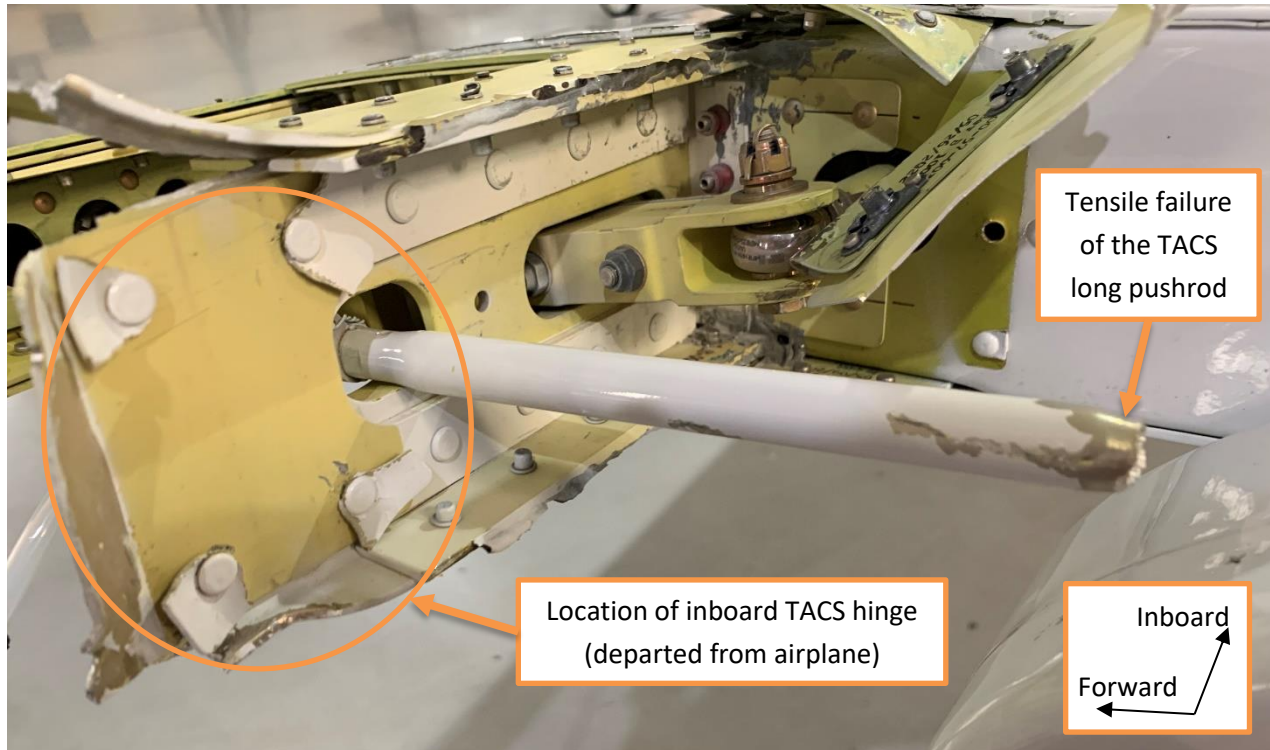
Figure 3-19 Inboard wing extension main spar and TACS kinematics remnants

After the departure of the upper and lower skins of the wing extension and the winglet, the only structure available to support the TACS was the main spar, which was not designed to carry the extremely abnormal load exerted on it by the half-unsupported TACS and high dynamic pressure against the main spar web. The airplane was found with the TACS inboard hinge bracket completely separated from the remnants of

the main spar still attached to the airplane. See below for a view from the initial inspection of the accident airplane illustrating this.

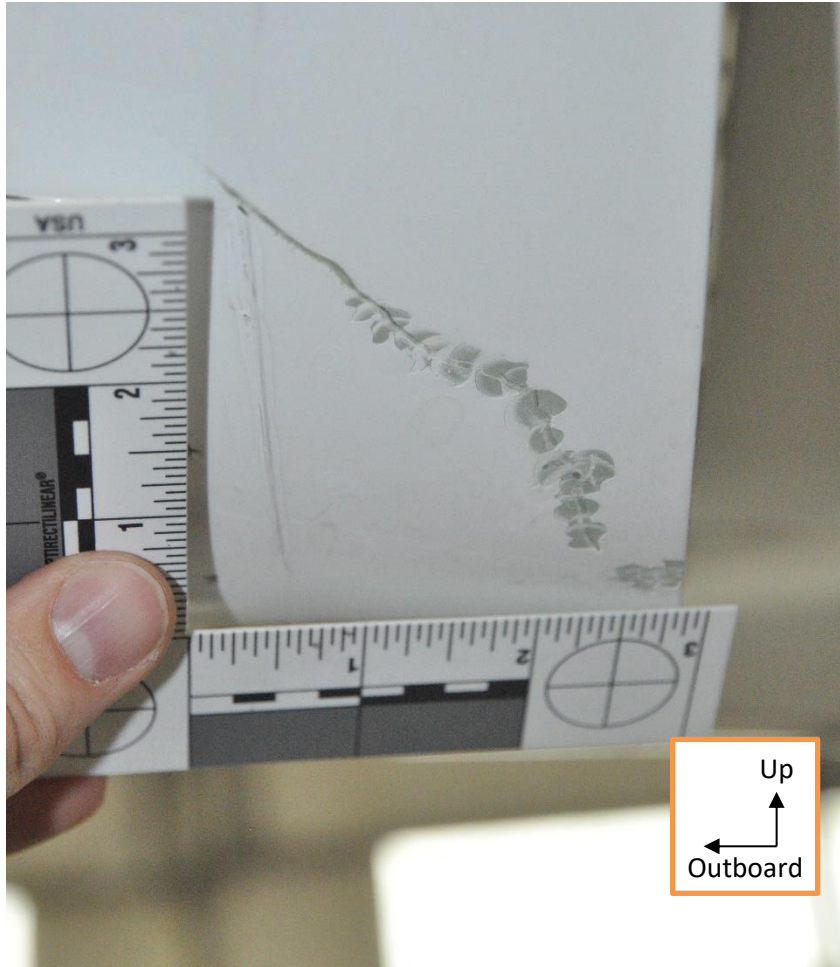
Figure 3-20 Aileron control horn gouging (view looking forward)

during flight and landing, which could not be replicated during inspection of the accident aircraft after moving the long pushrod out of position. See below for an image of this damage.
