# National Transportation Safety Board

ERA23FA188

## **AIRWORTHINESS FACTUAL REPORT**

Location: Climax, North Carolina  
Date: April 11, 2023  
Time: 1132 local  
1532 UTC  
Airplane: Experimental Amateur Built, Van's RV-12, N543GM

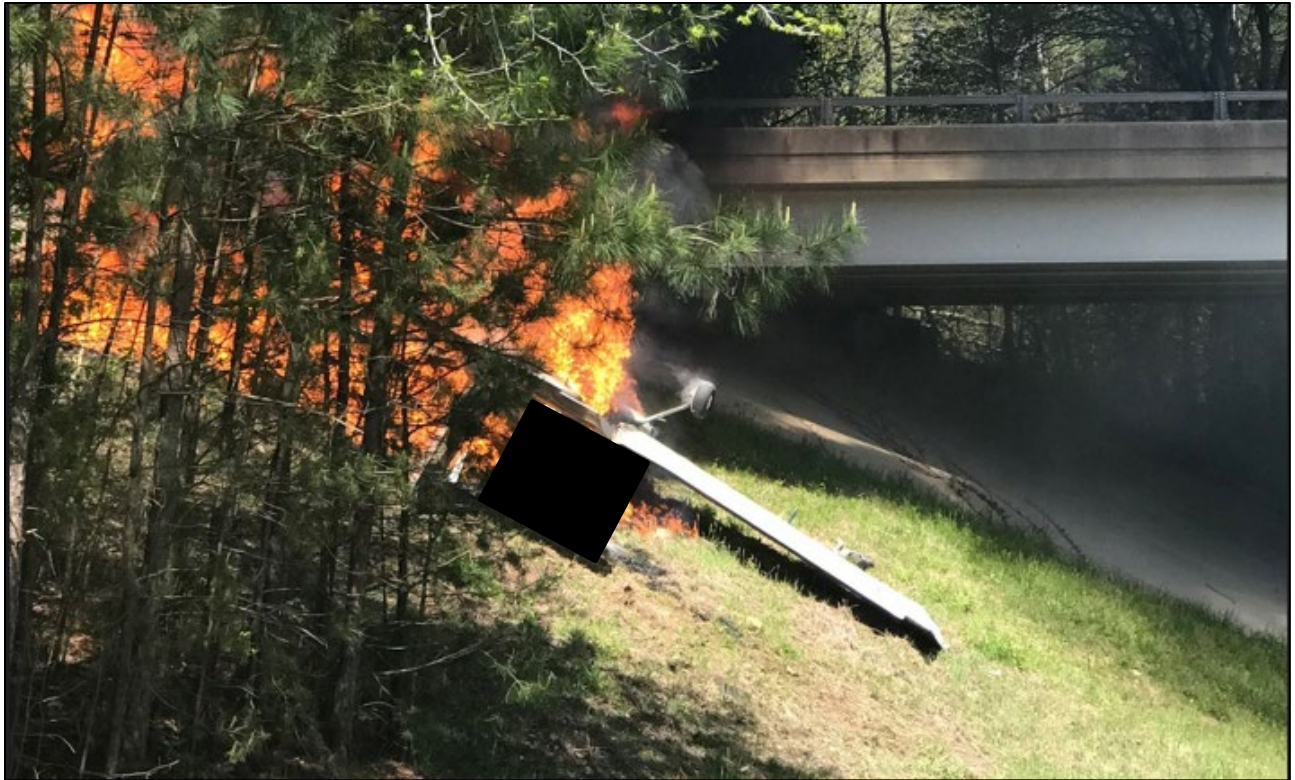
**Figure 12: A motorist provided a photo of the airplane observed shortly after impact. A post-crash fire ignited and consumed the cockpit and eventually major portions of the airplane.**

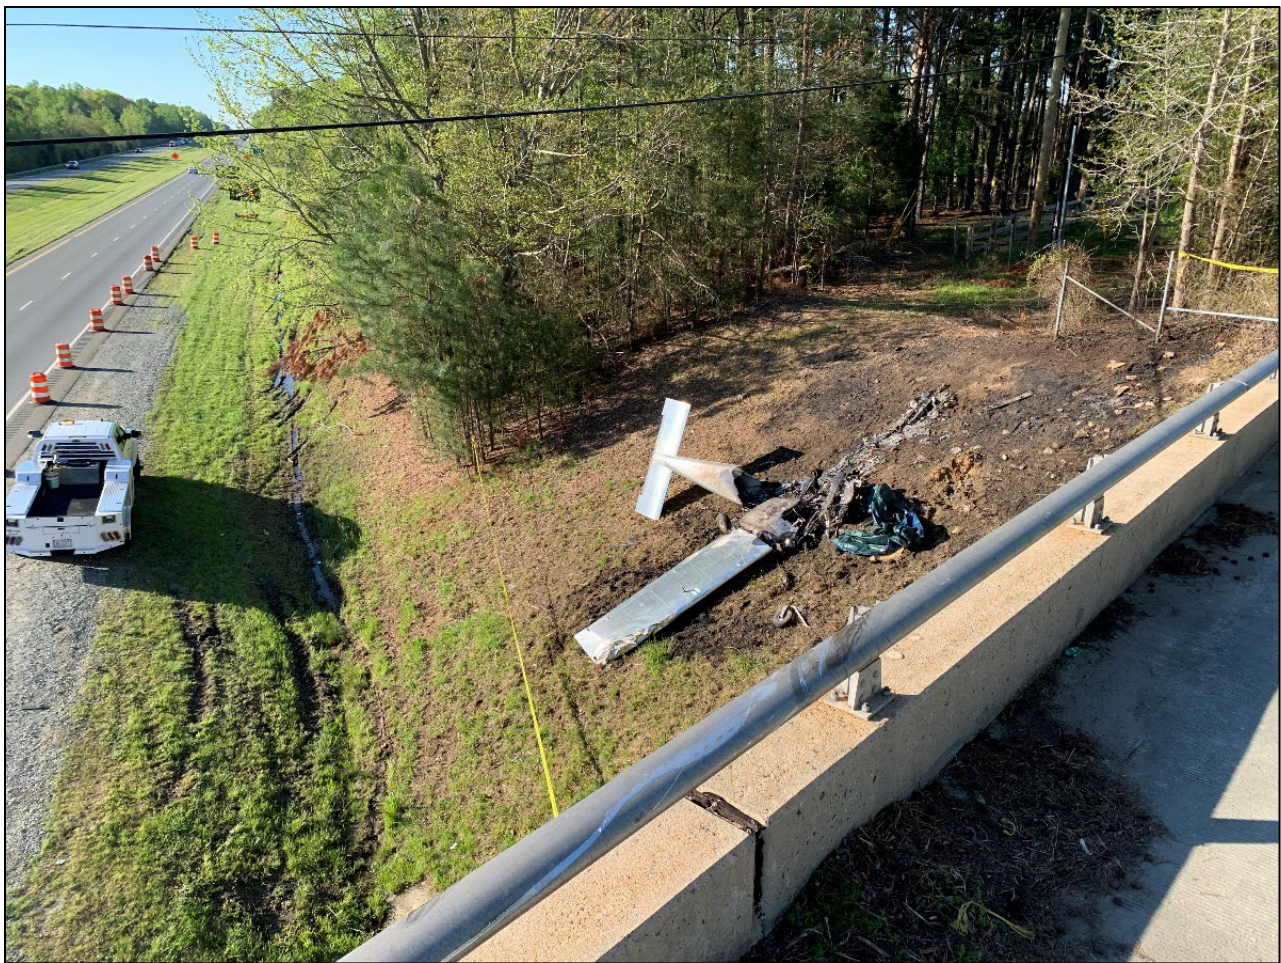
The airplane's initial impact point coincided with an overpass bridge railing that traveled over US Highway 421. The airplane subsequently impacted terrain shortly beyond the bridge on a hill next to the highway. The airplane came to rest inverted, the wreckage was fragmented, and was located in one compact area.

**Figure 14: Overview of the accident site as viewed from the bridge the airplane impacted. Note the powerlines above the bridge, which spanned across the entire highway from east to west.**

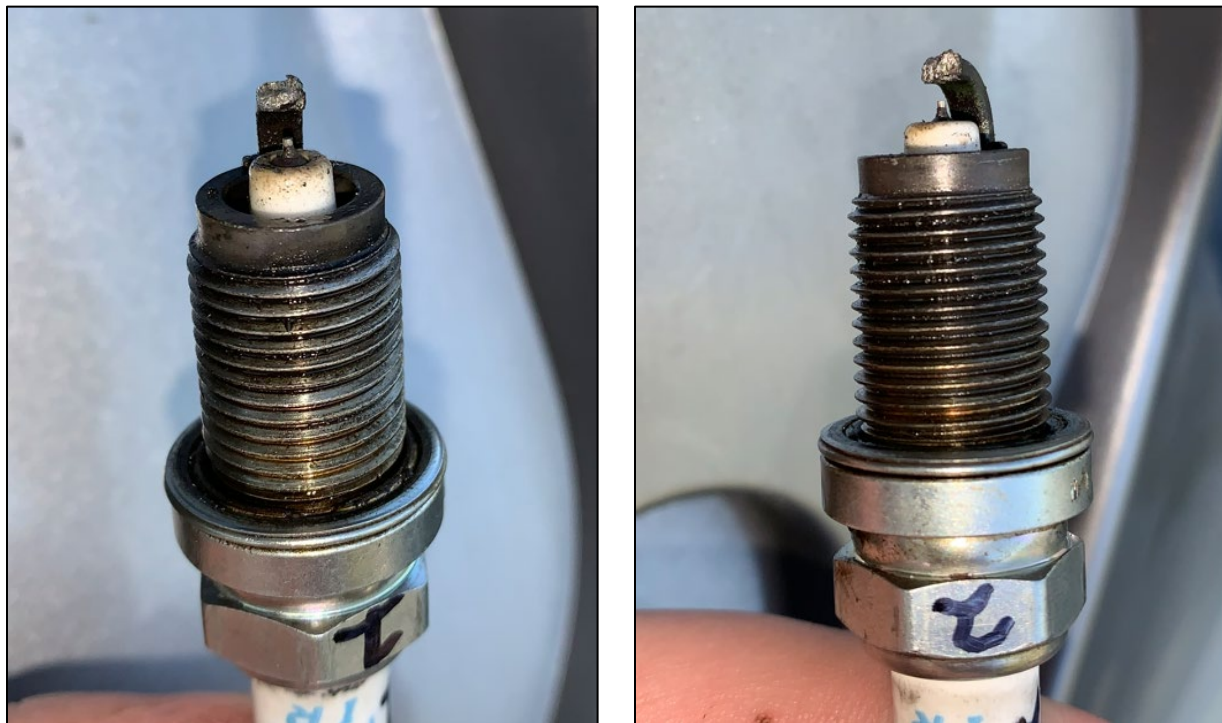
The NGK IR spark plugs (IZFR6K - 13 - NGK-IR) were found securely installed. When the spark plugs were removed and examined, the Nos. 1 and 2 cylinder spark plug ground electrode tips were found obliterated and the remainder of the electrodes on both spark plugs exhibited blackening. The Nos. 3 and 4 cylinder spark

The Nos. 1 and 2 spark plugs exhibited a spark around 60-70psi, but with compression at 70-80psi, both spark plugs would immediately lose their continuous spark and would extinguish.<sup>6</sup>

**Figure 15: View of the Nos. 1 and 2 cylinder spark plugs as viewed left to right.**

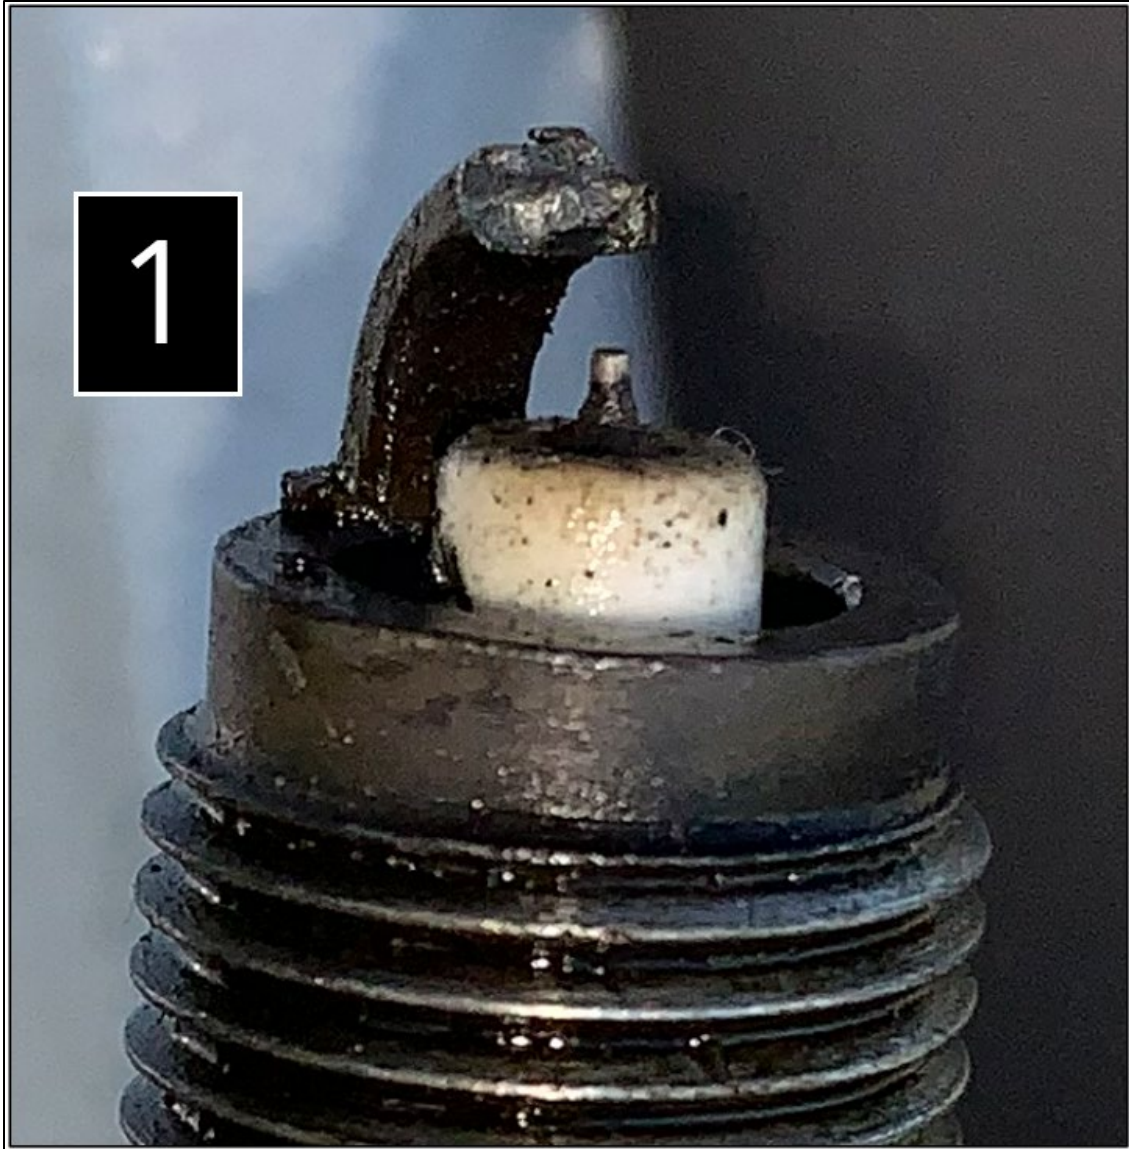
**Figure 16: Closer view of the No. 1 cylinder spark plug. Note the tip of the electrode was observed to be obliterated.**

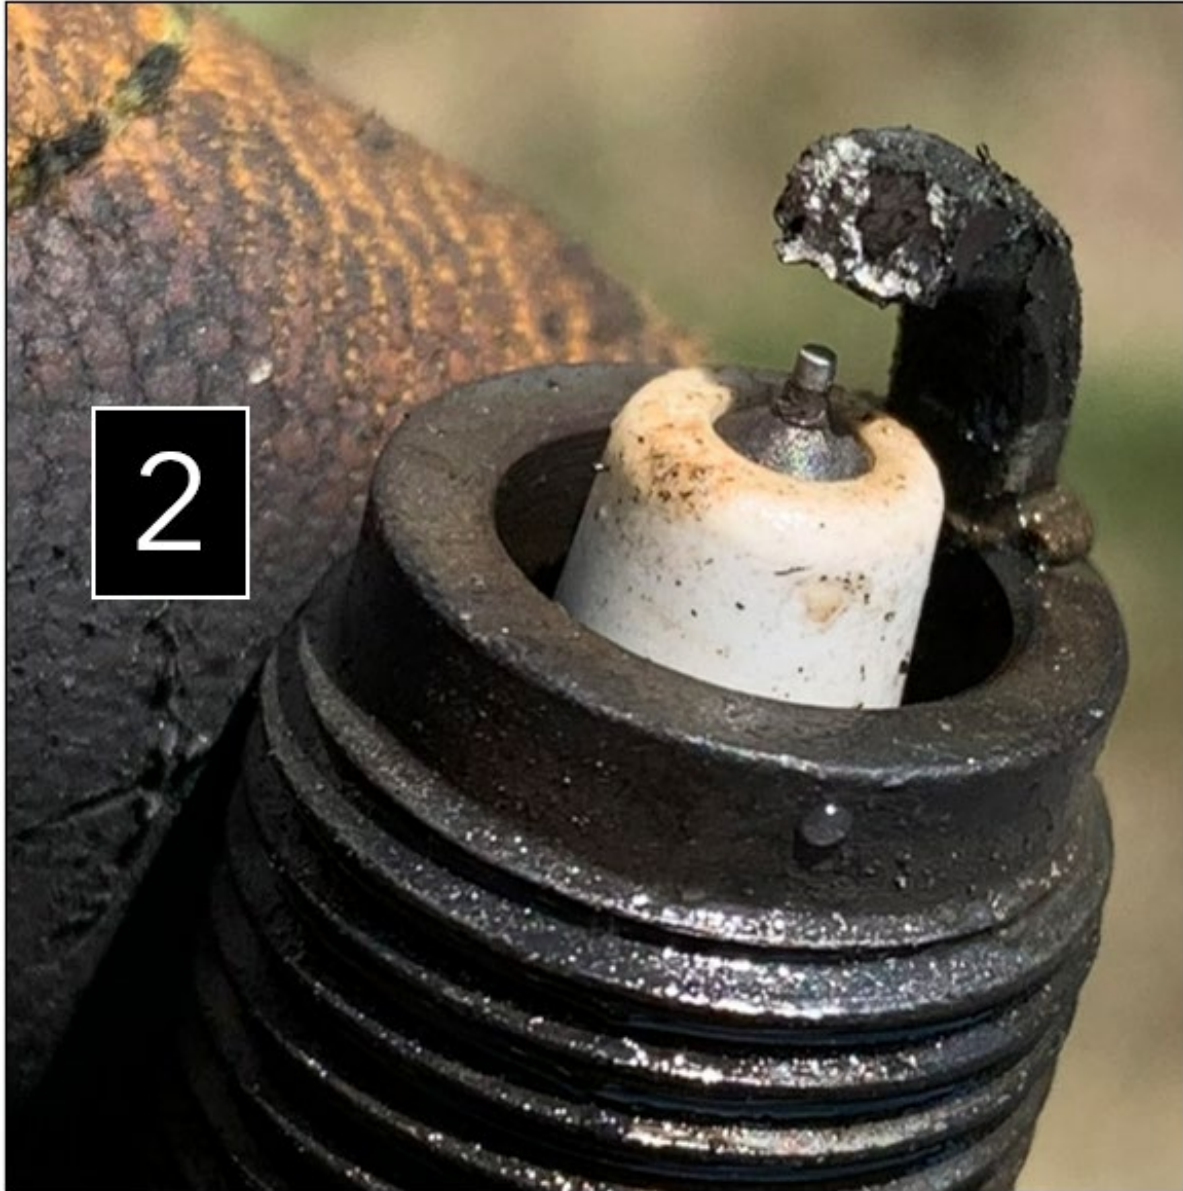
**Figure 17: Closer view of the No. 2 cylinder spark plug. Note the tip of the electrode was observed to be obliterated.**

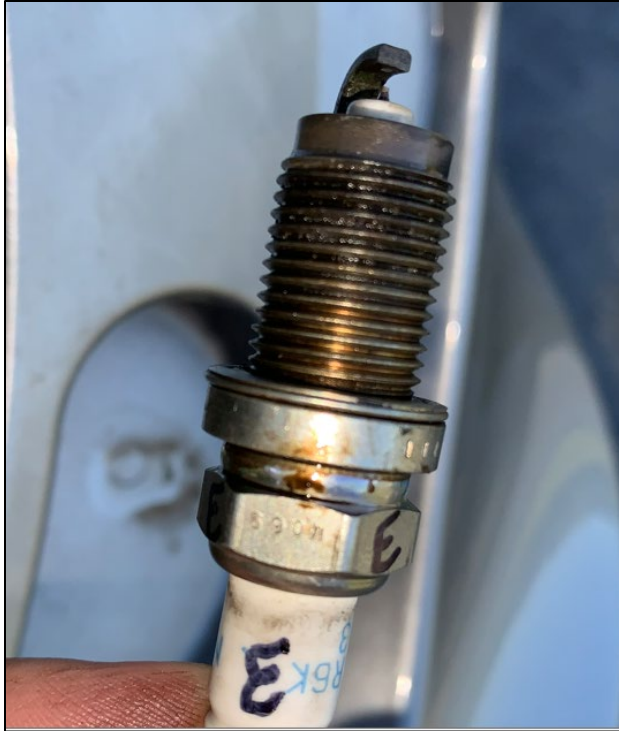
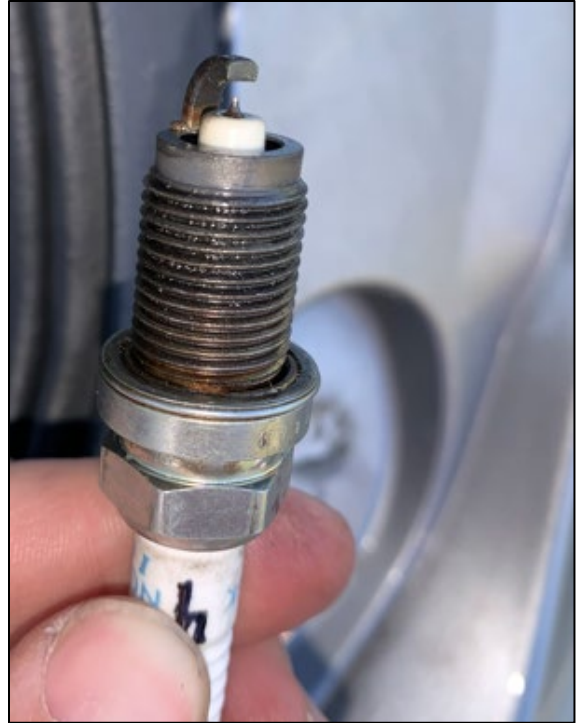
plugs were blackened, however; their electrode tips remained intact. There was no evidence of impact related damage to any spark plug.

The Nos. 3 and 4 spark plugs operated normally throughout a range of low pressure up to 80psi.

**Figure 18: View of the Nos. 3 and 4 cylinder spark plugs as viewed left to right.**

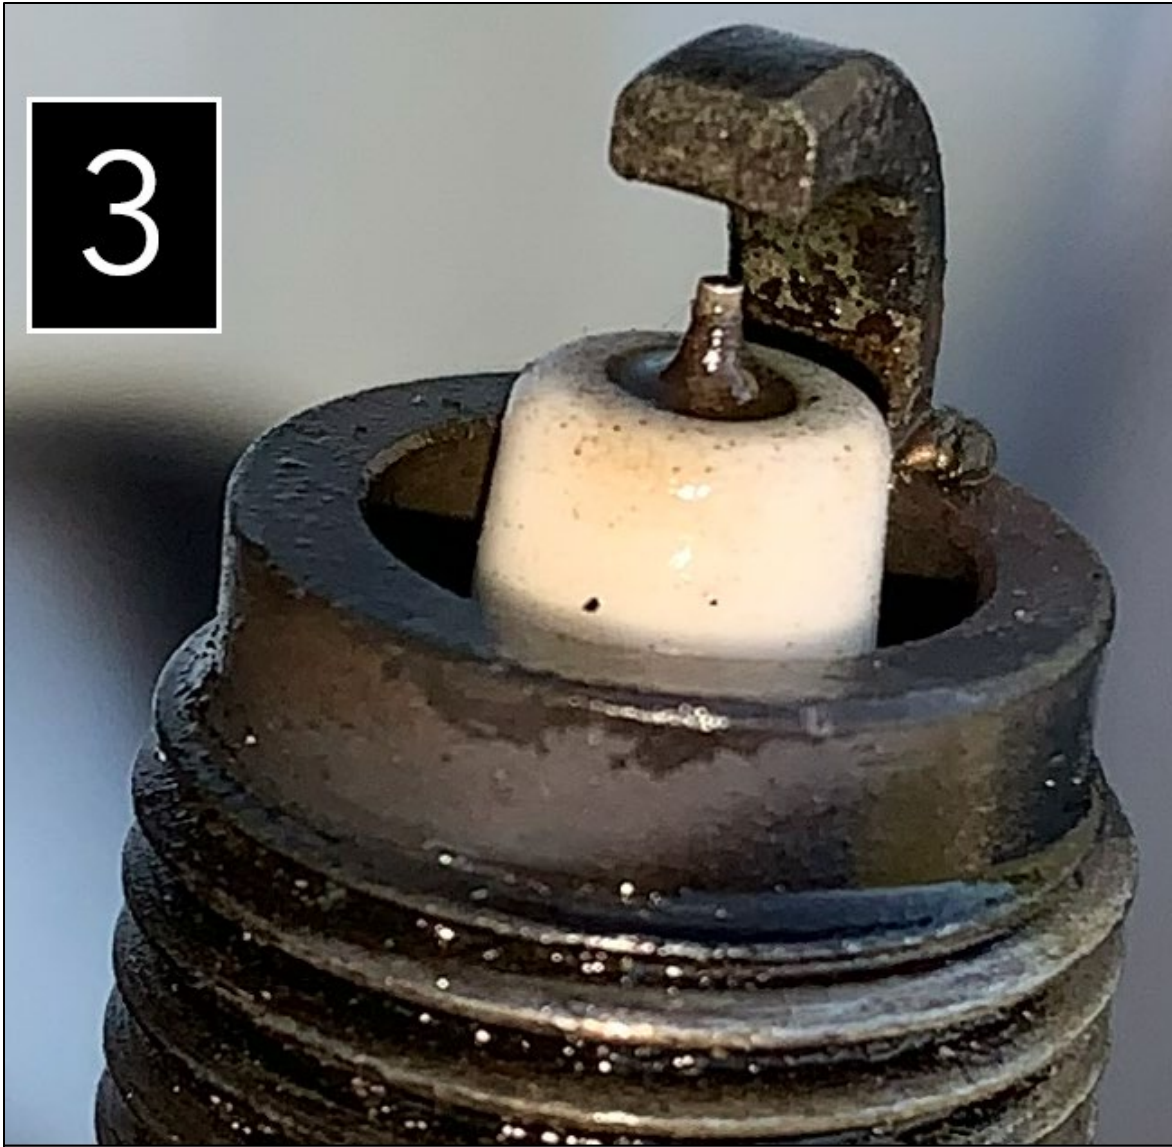
**Figure 19: Closer view of the No. 3 cylinder spark plug. Note the tip of the electrode remained intact.**

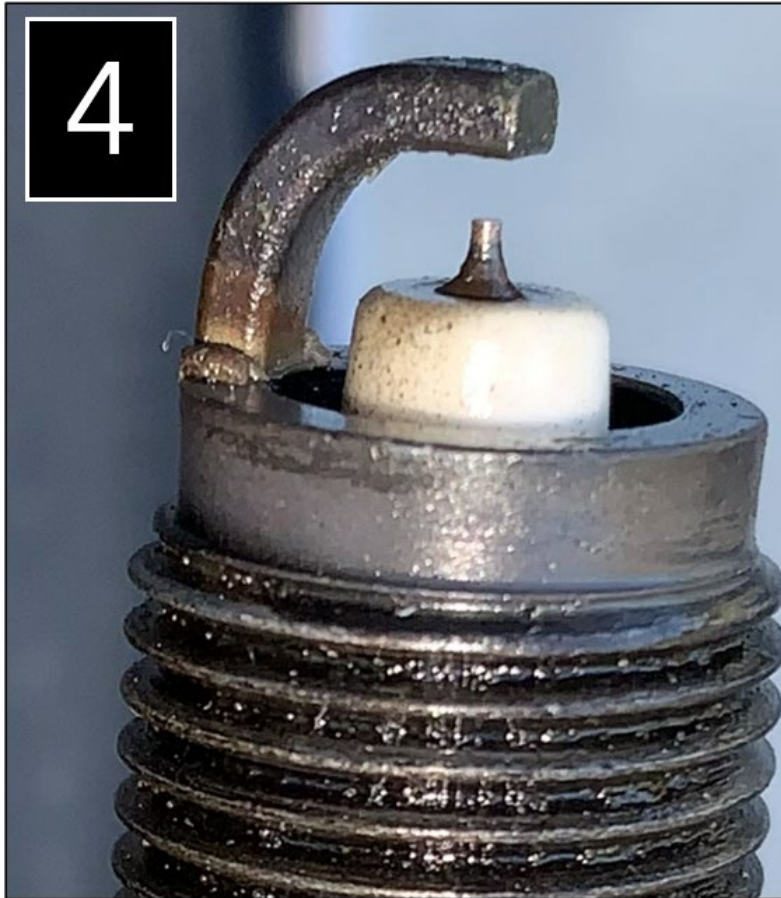
**Figure 20: Closer view of the No. 4 cylinder spark plug. Note the tip of the electrode remained intact.**

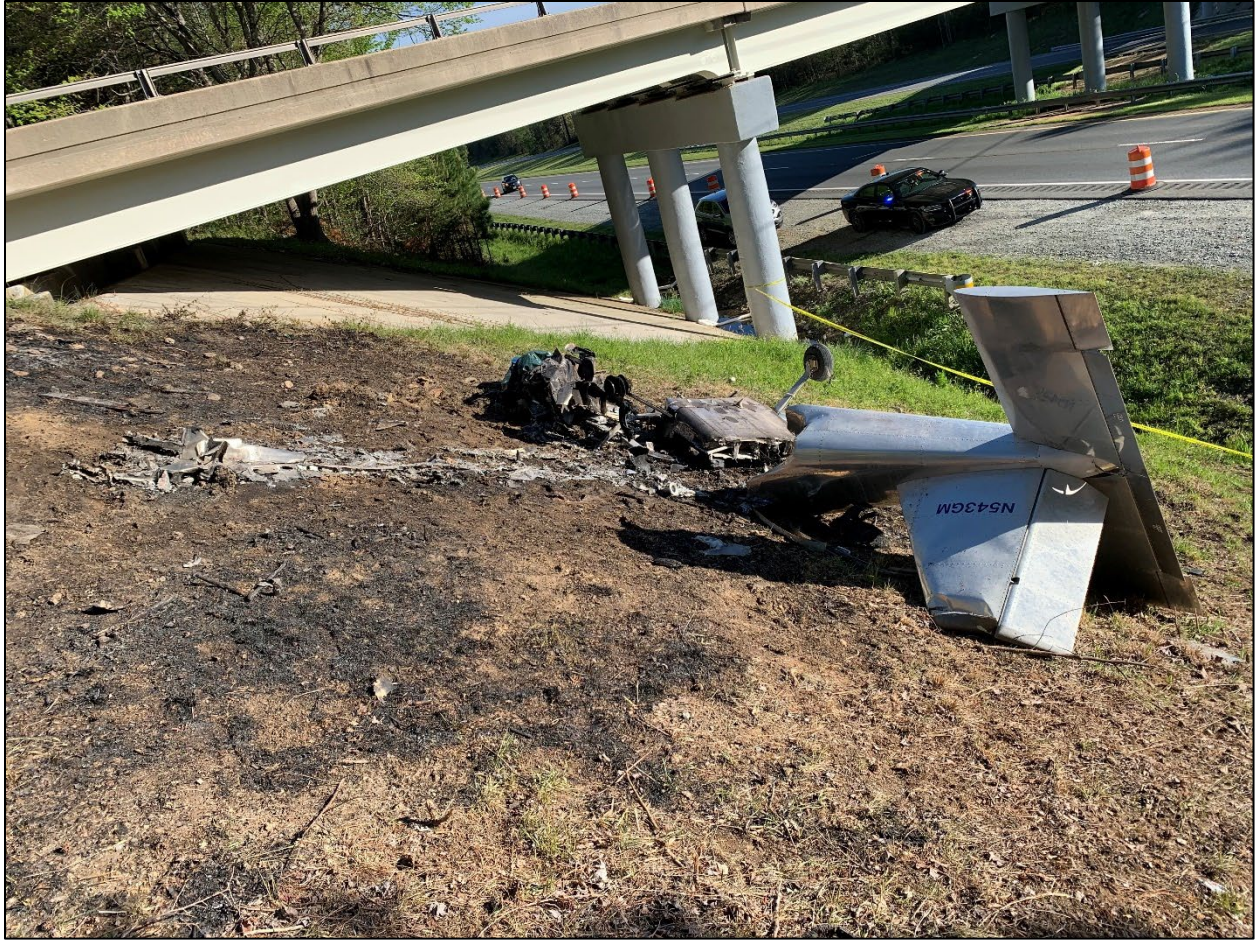
**Figure 23: Overview of the accident site. The bridge in the background exhibited impact marks consistent with a portion of the airplane colliding with it.**

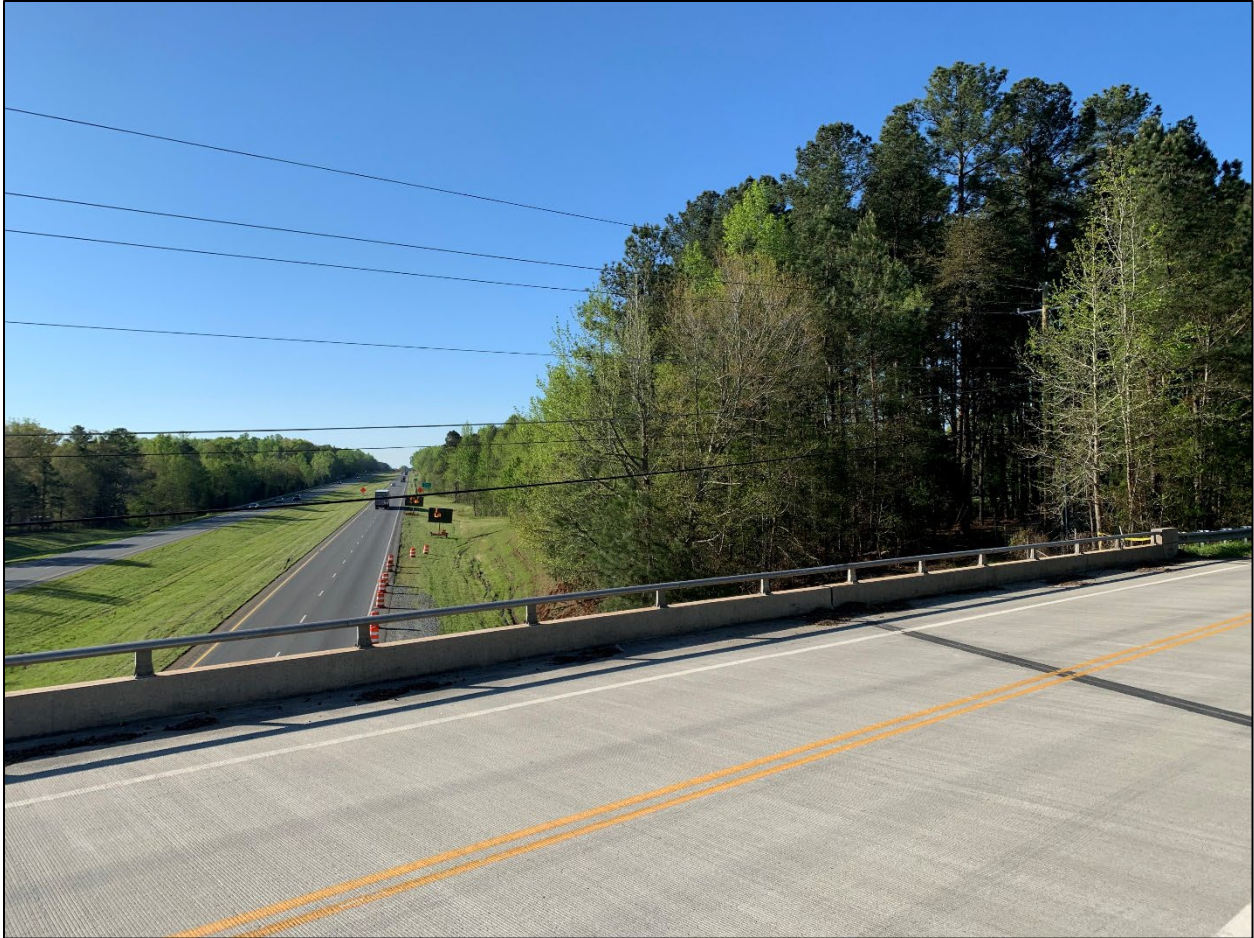
**Figure 25: View of the bridge impacted and the powerlines that spanned across the entire length of the bridge across the highway. The camera is facing the direction of airplane travel and the accident site is forward and below the bridge, as referenced for this photograph.**

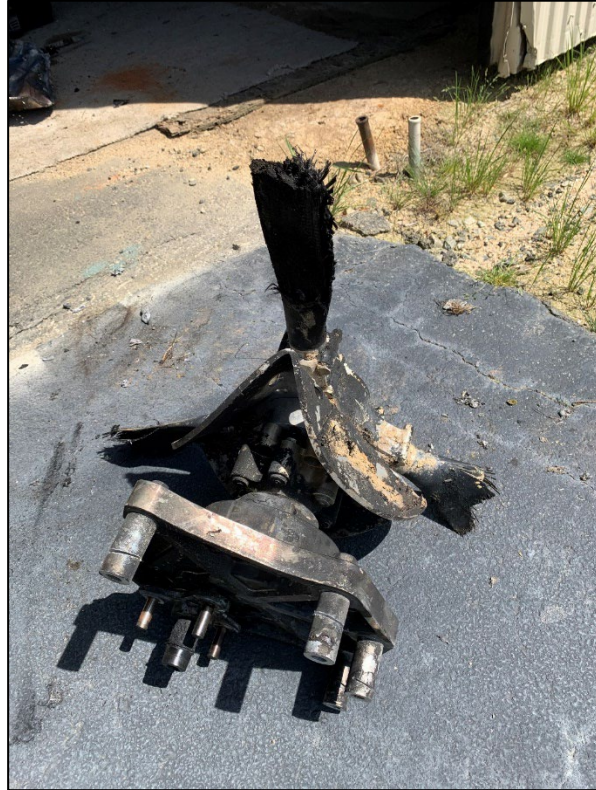
The propeller was a composite three-bladed Warp Drive. All three blades splintered from the propeller hub. Two of the blades were located in the debris. One blade exhibited a leading edge gouge.

**Figure 26: View of the propeller and hub.**

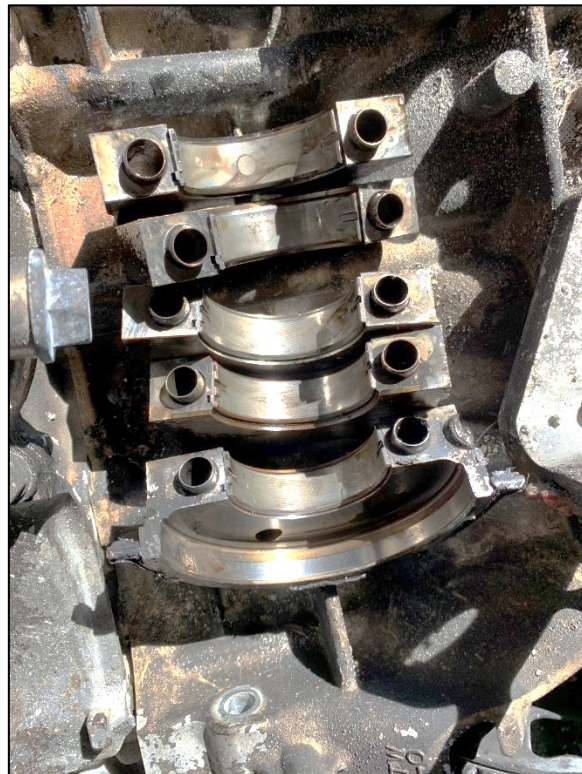
The main crankshaft bearings were intact and displayed clean oil signatures. There was no evidence of thermal damage on any of the crankshaft bearings. The internals of the cylinders appeared normal. The pistons and valves were intact and displayed normal combustion signatures. The throttle body remained attached to the engine and its control arm operated the butterfly valve normally.

**Figure 27: View of engine bearings as observed during the engine teardown.**
