National Transportation Safety Board

ERA23FA200

SURVIVAL FACTORS

Specialist's Factual Report

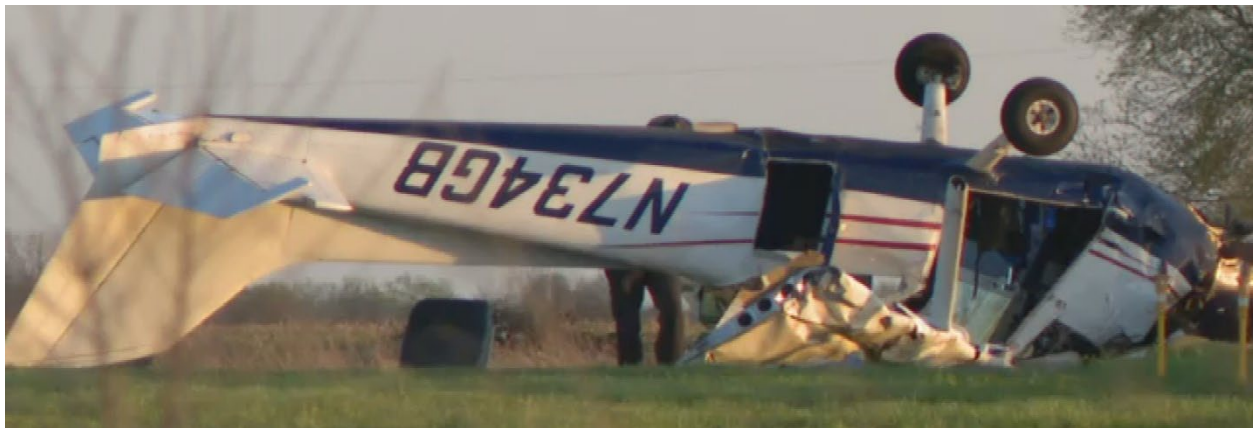
The airplane was found in an inverted position in a field by first responders. The engine compartment was crumpled rearward toward the cabin (see figure 3).

Figure 3. Post-crash photo of N734GB.

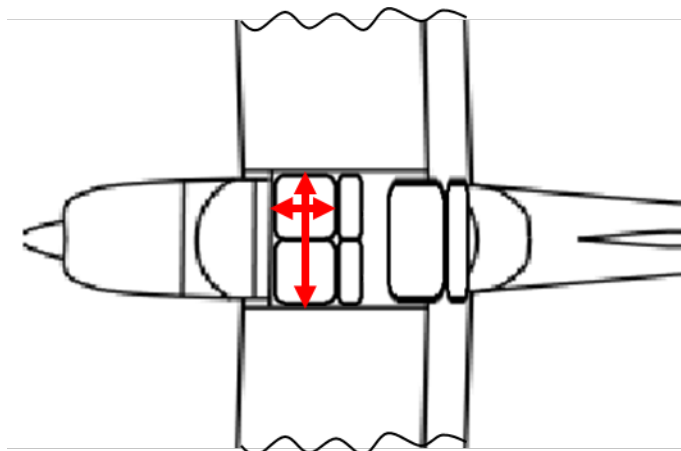
Measurements were taken at multiple locations in the cabin to document any loss of occupiable volume. The cabin interior measured about 36 inches across at the front seats. The distance from the seat back cushion to the instrument panel was 18 inches for the front, right seat (see figure 4). A similar measurement for the front, left seat could not be obtained because it had been removed by the medical examiner after the accident. The measured distance from top of the front, left seat to the ceiling was about 33 inches.

Figure 4. Line drawing showing measurements taken for the front right seat place.

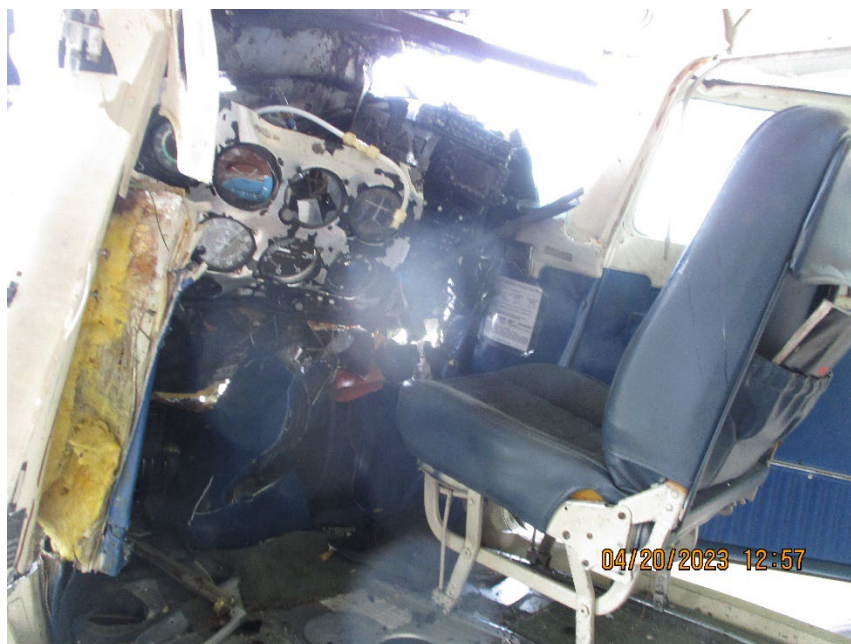
The seats were adjustable forward or aft on the seat rails to accommodate the occupant (see figure 5). According to first responders the pilot and copilot seats remained attached to the seat rails which were attached to the floor.

Figure 5. Right hand pilot seat.

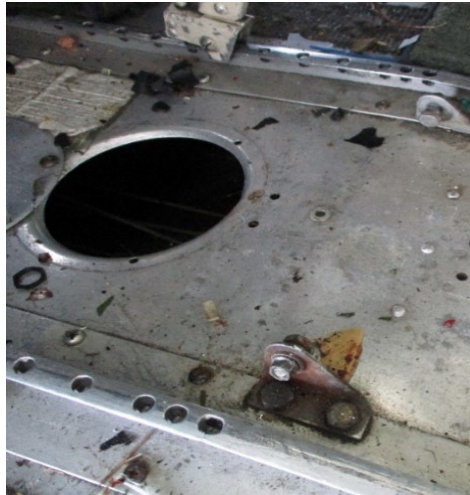
The restraint system consisted of an adjustable lift latch-style lap belt that was secured to attachment points anchored directly to the floor (see figure 6). The shoulder belt was adjustable and routed over the occupant’s outboard shoulder to an attachment anchored to structure above, and slightly behind the occupant (see figure 7). The

Figure 6. Lap belt inboard anchor points.

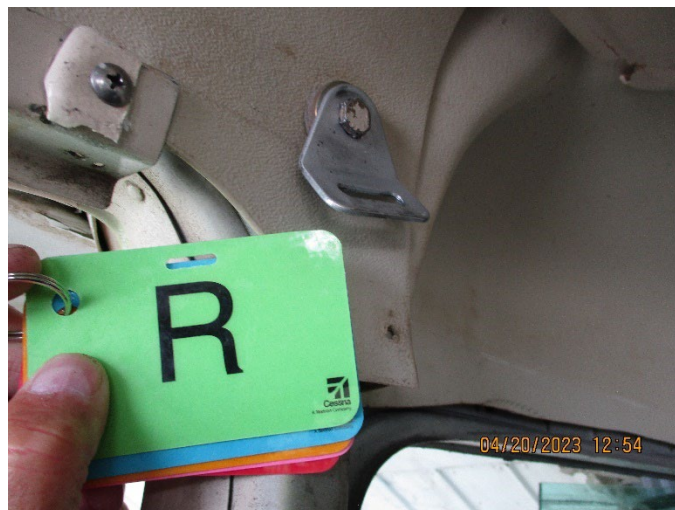
shoulder belt webbing was routed through the anchor point then stitched back on itself to secure it.

Figure 7. Right shoulder belt anchor point.

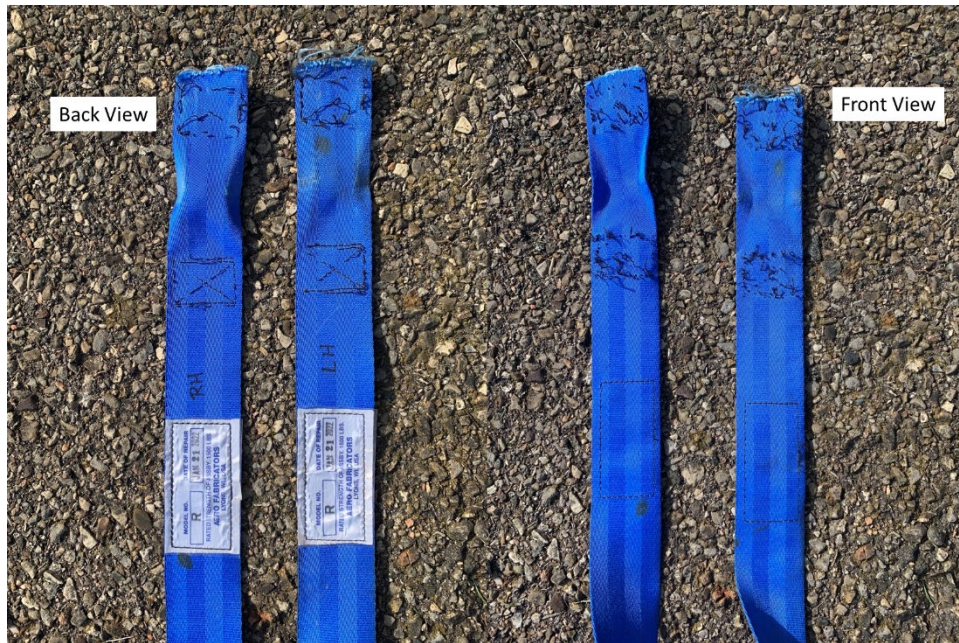
According to first responders, the lap belts did not become detached from their anchor points and were buckled when emergency responders arrived; however, both shoulder belt webbing had come unstitched (see figure 8). The buckles were latched and released normally when examined by investigators postaccident. Both belt webbings were lost during transport to the NTSB, preventing further examination.

Figure 8. Left and right shoulder belts stitching.
