National Transportation Safety Board

ERA23LA121

AIRWORTHINESS FACTUAL REPORT

Location: Hartford, Connecticut
Date: January 28, 2023
Time: 1542 local
2042 UTC
Airplane: Experimental Lancair 4P, N550LX

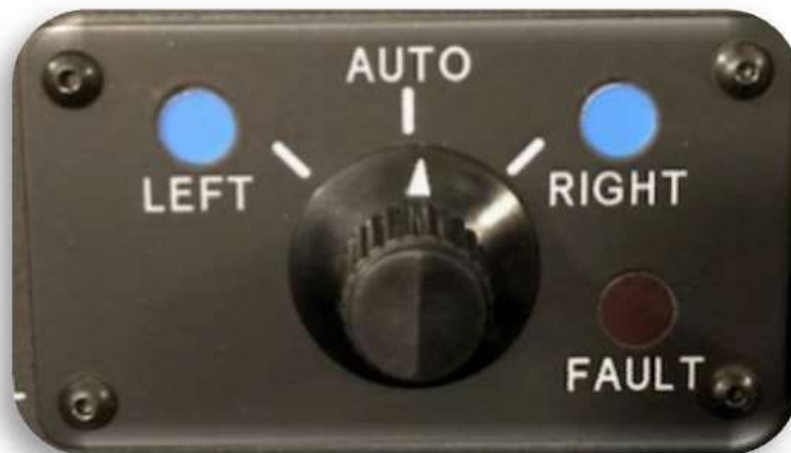
The majority of the cockpit controls and switches were thermally destroyed or displayed heavy impact related damage. The fuel controller (as seen in the exemplar figure 6) was thermally damaged, and the face of the unit and switch position were no longer readable.

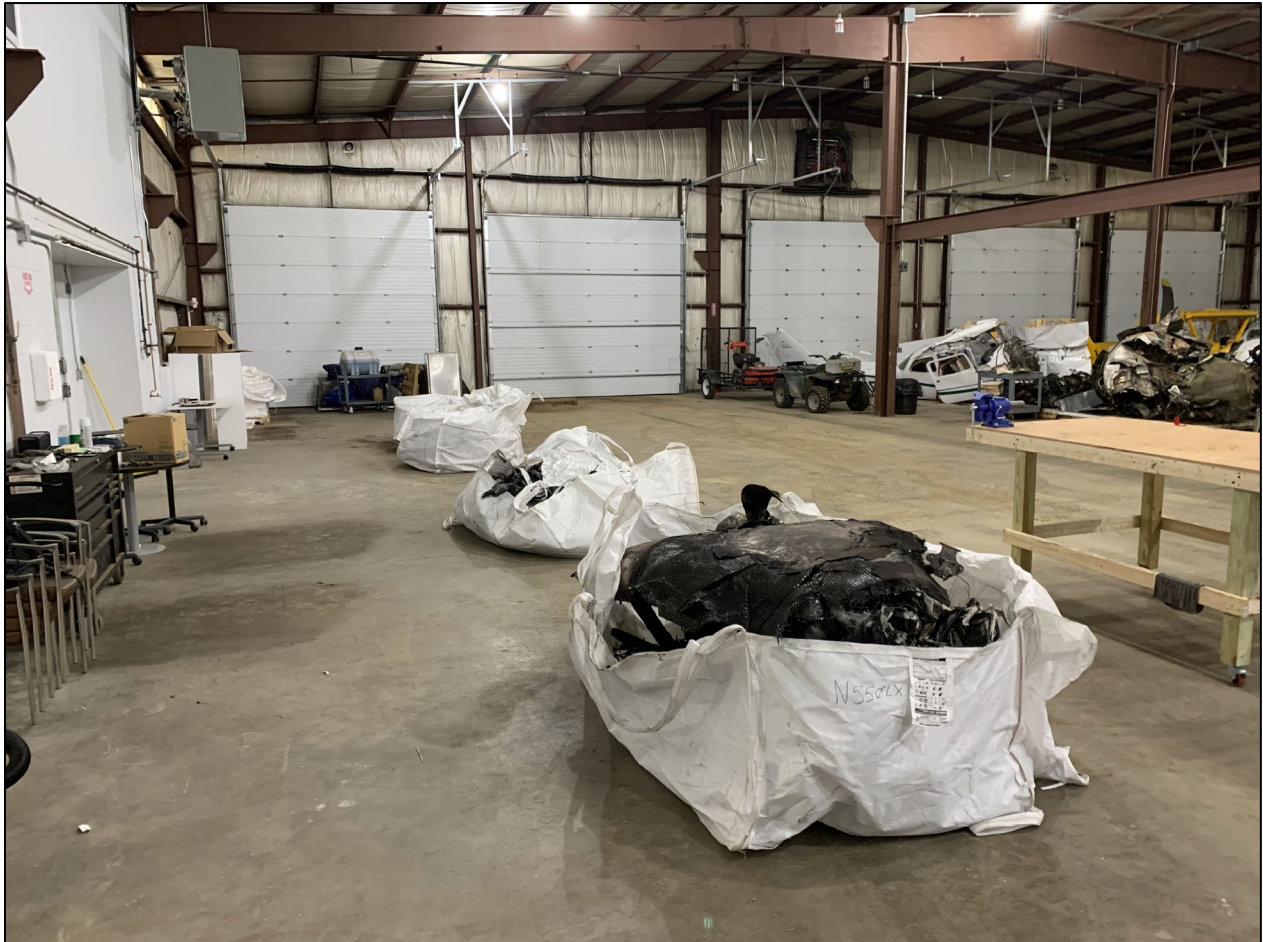
The NTSB investigator-in-charge traveled to the recovery facility on March 13, 2023. The NTSB did not travel to the accident site, however, the FAA did so, and documented the site. The wreckage was located in multiple recovery bags. The wreckage was examined on March 13, 14, 2023. One party member from RDD Enterprises LLC. participated in the examination. This report contains the factual findings related to the examination. Additional relevant airplane systems and maintenance information is also included in this report.

Photo 1: View of the wreckage as found in recovery bags at the recovery facility.

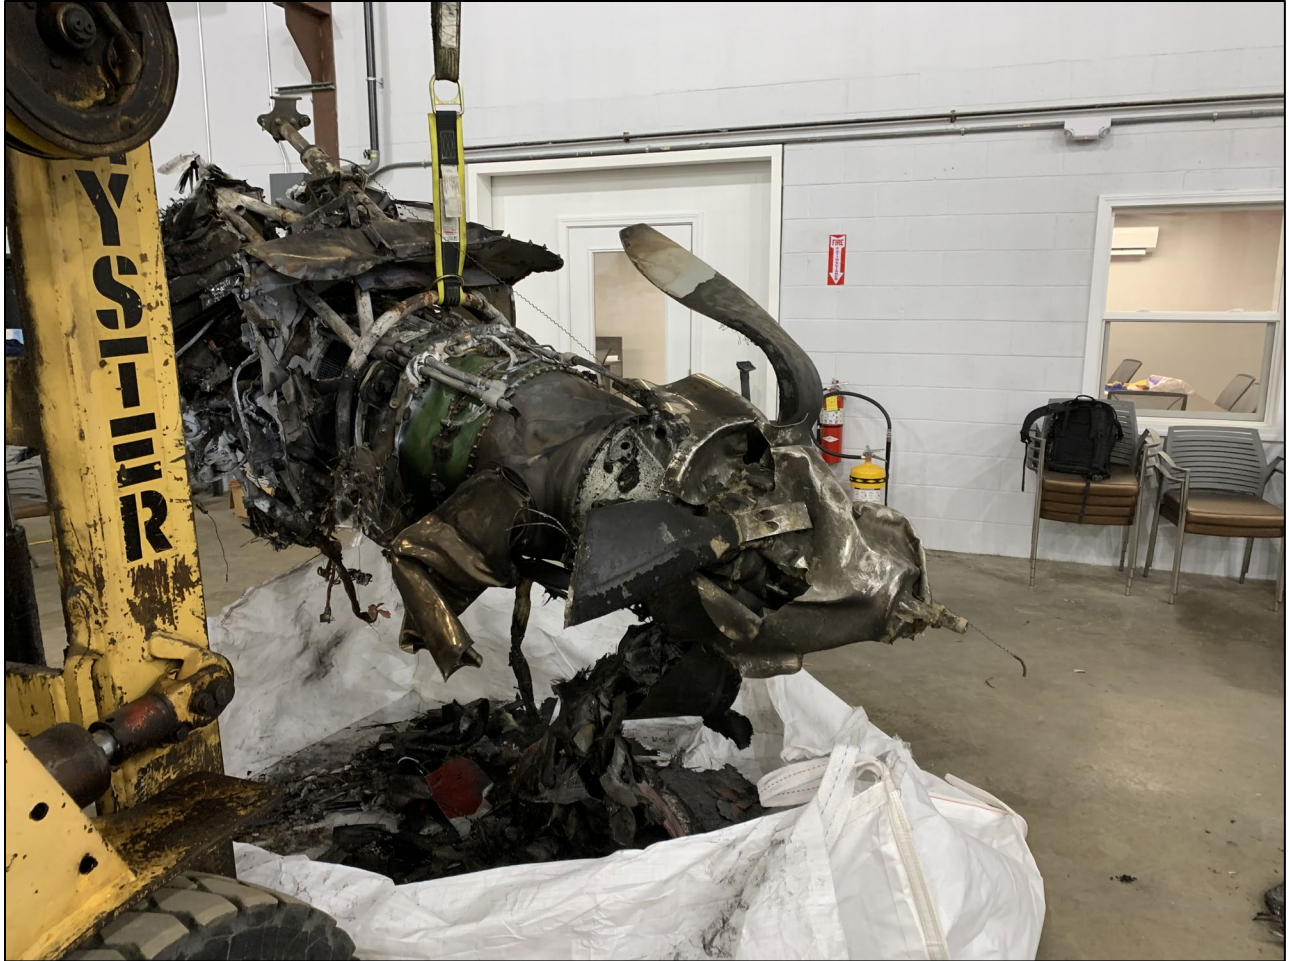
The engine remained partially attached to its engine mounts but had separated from the fuselage. It sustained significant thermal and impact damage. The exhausts were removed. When the forward area air compressor was observed, evidence of leading edge turbine blade damage was observed. The propellers

exhibited s-bending, torsional twisting, and chordwise scratches. One propeller blade had fragmented.

Photo 2: View of the engine and propellers

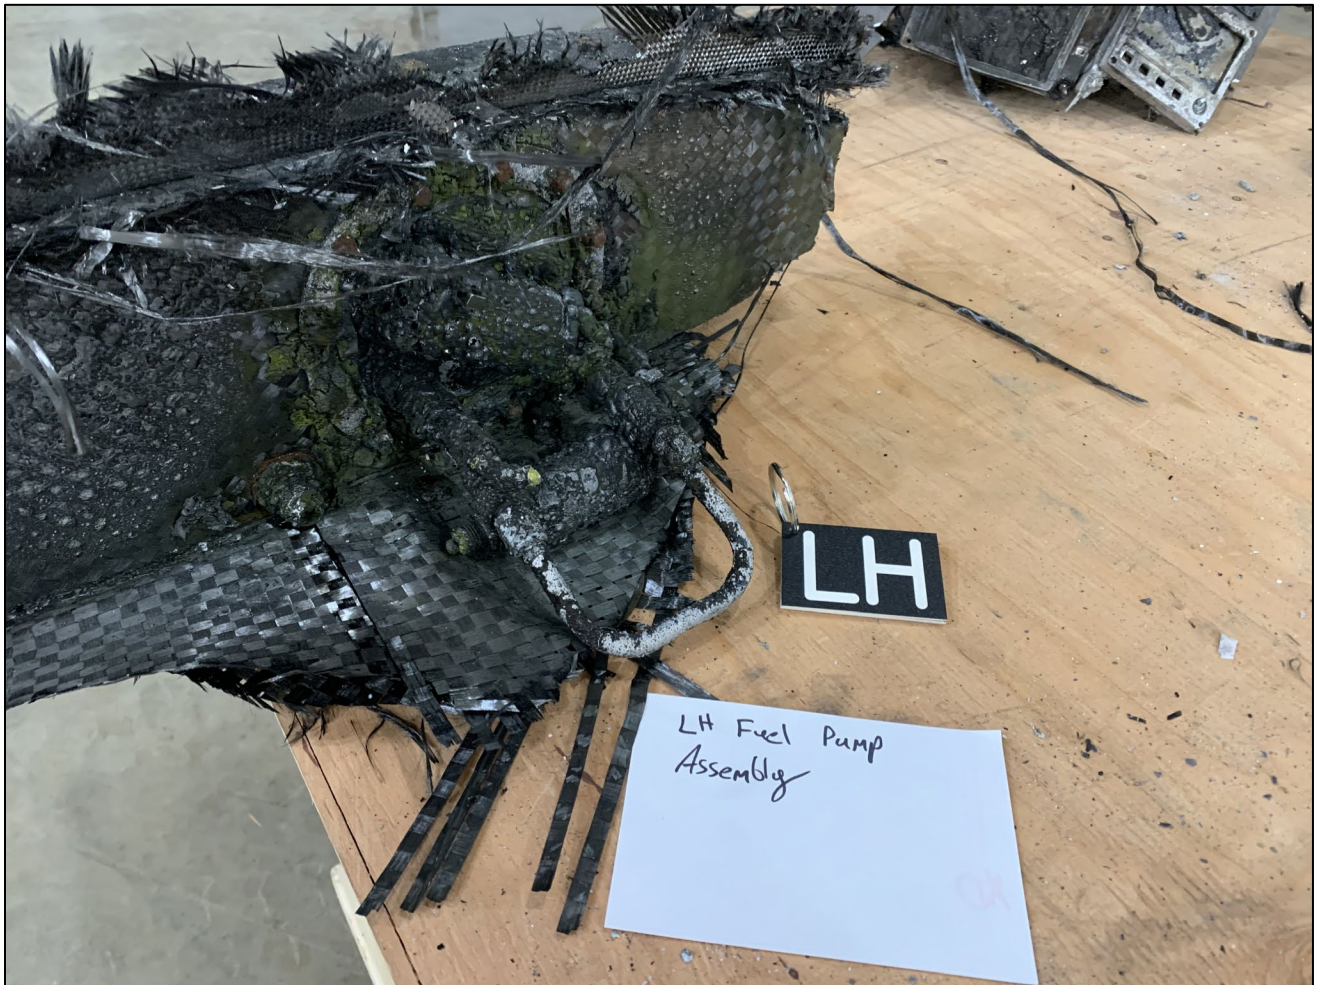
The left fuel pump assembly, cross flow prevention valve, was found in a closed position, with the valve was seized. The unit sustained thermal damage. The actuator arm and motor were not present with the system. The control board and brackets were present. After applying force to the valve, it would move. As found, the distance from the actuator to the valve arm as found was 5" inches, 13/16th. This position corresponded to a closed position. When moved to an open valve position, the measurement from the actuator was 3" 13/16ths.

Photo 3: View of the left fuel pump assembly.

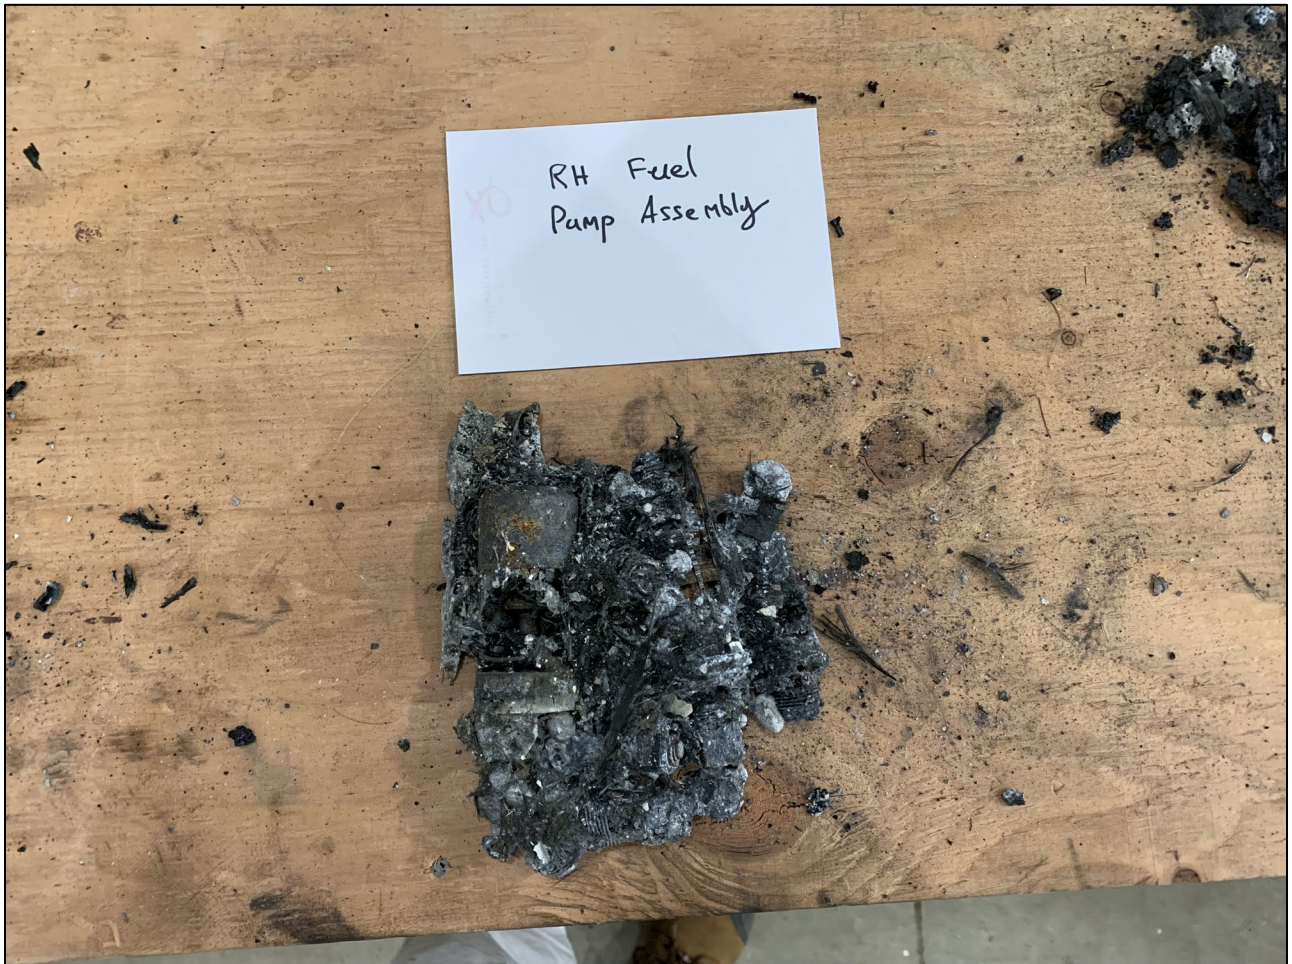
The right fuel pump assembly was found partially separated from its attach point and was thermally damaged and severely deformed.

Photo 4: View of the right fuel pump assembly

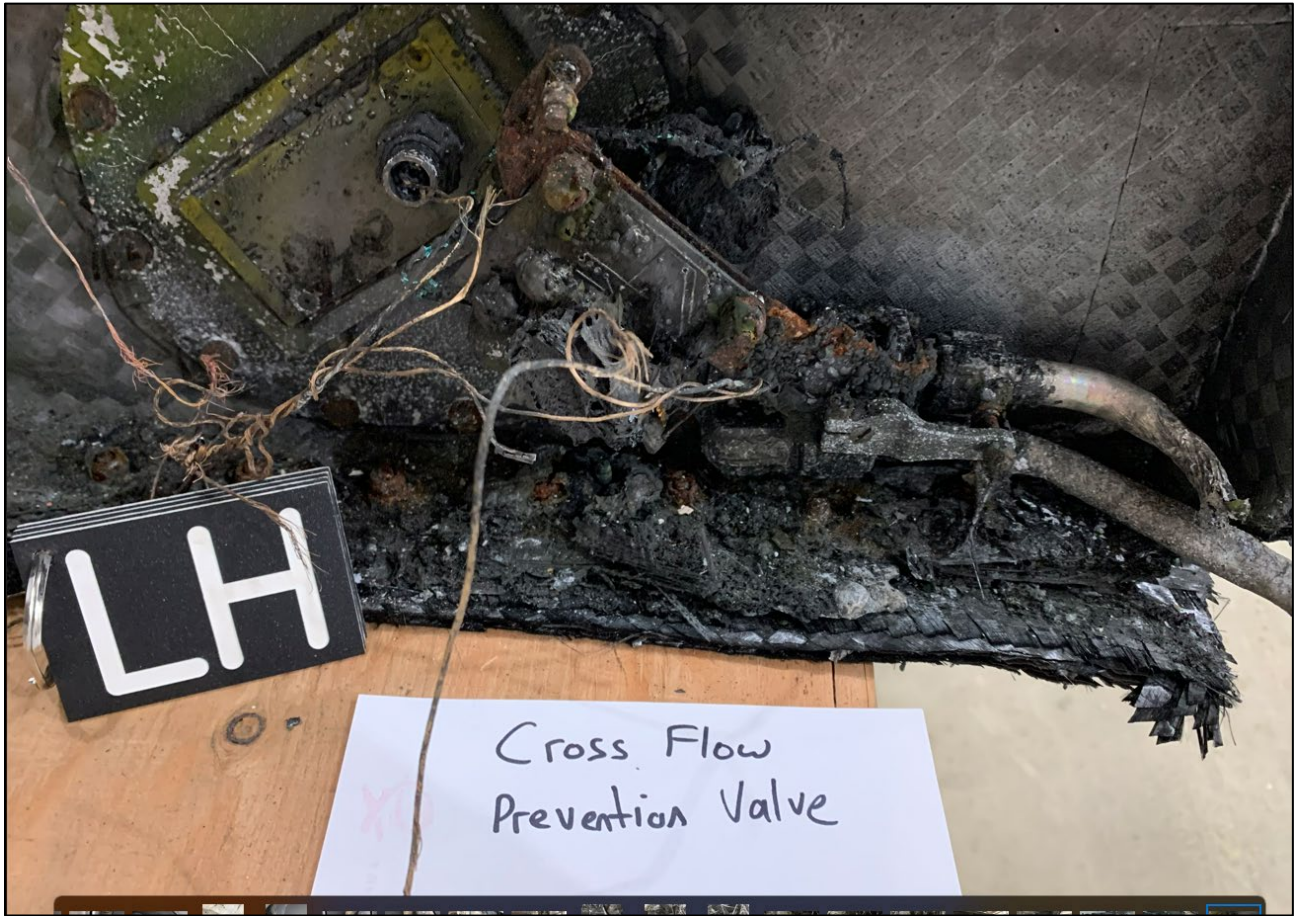
Photo 5: View of the cross flow prevention valve installed to a fragment of left wing.

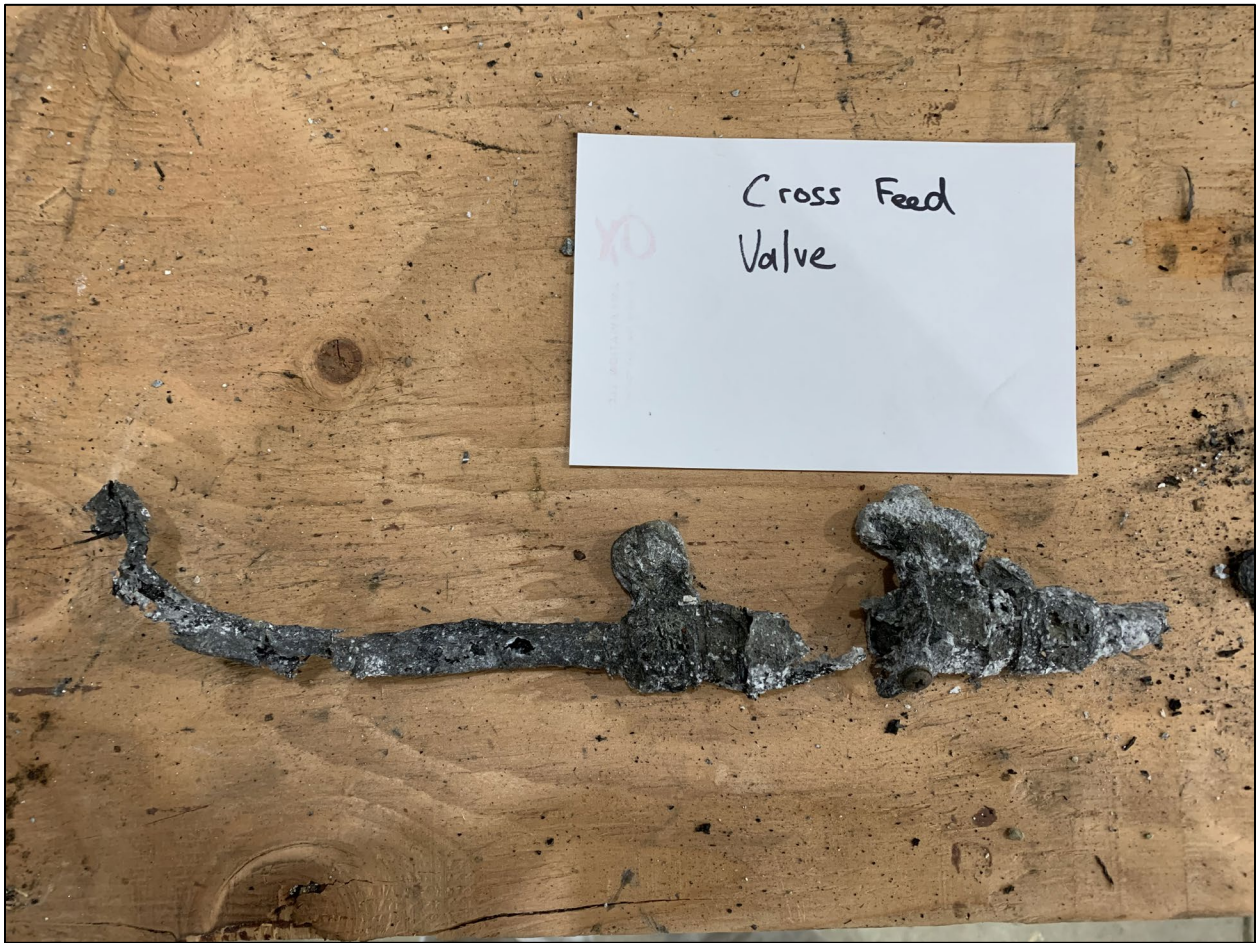
The on/off cross feed valve was found in its normal installation area and displayed thermal damage and melting. The valve was found mostly closed and it had seized, however, it displayed a slight angle towards the open position.

Photo 6: View of the cross feed valve recovered in the wreckage.

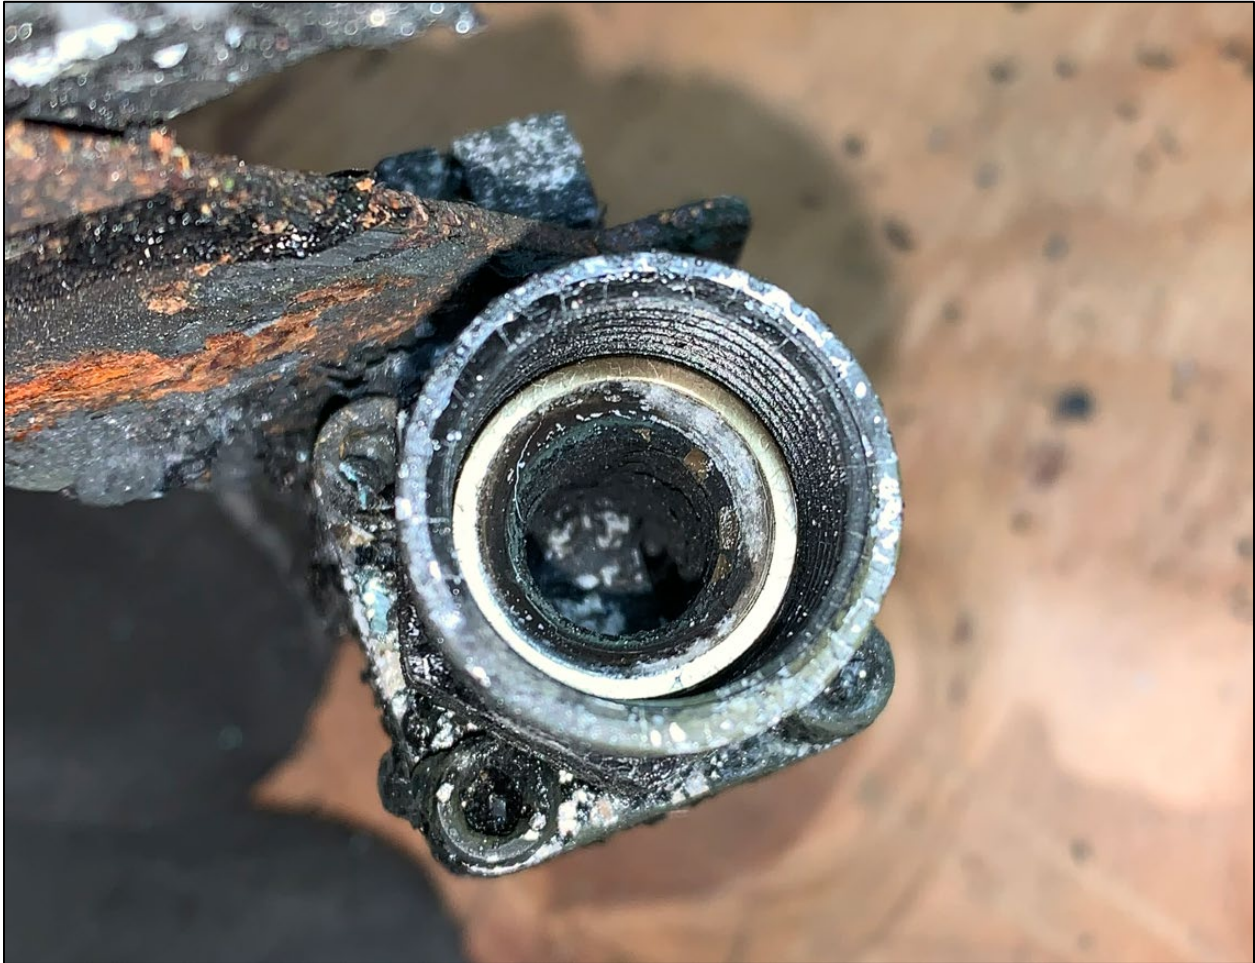
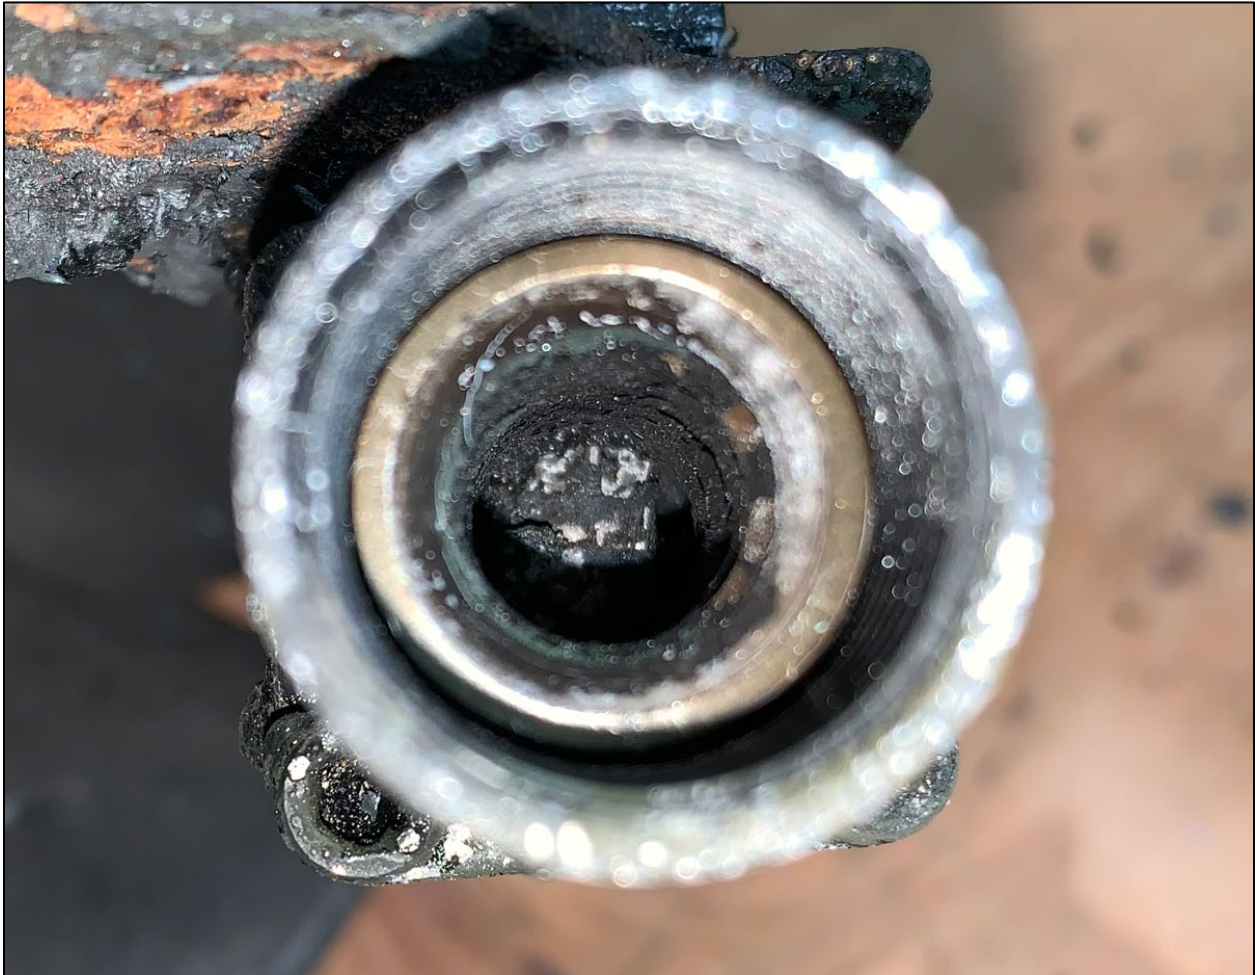
According to RDD, the fuel system design incorporates check valves to prevent the migration of fuel from one wing to another, even in temperature changes as well as sloped parking conditions. However, if a check valve develops a seep or the cross-feed on/off valve is cracked open (or develops a leak) it is possible for fuel to migrate on the ground from one wing tank, to the other.

Photo 7: View of the cross feed valve as found mostly closed and seized, but with a partial opening.

Photo 8: Additional view of the cross feed valve as found mostly closed and seized, but with a partial opening.

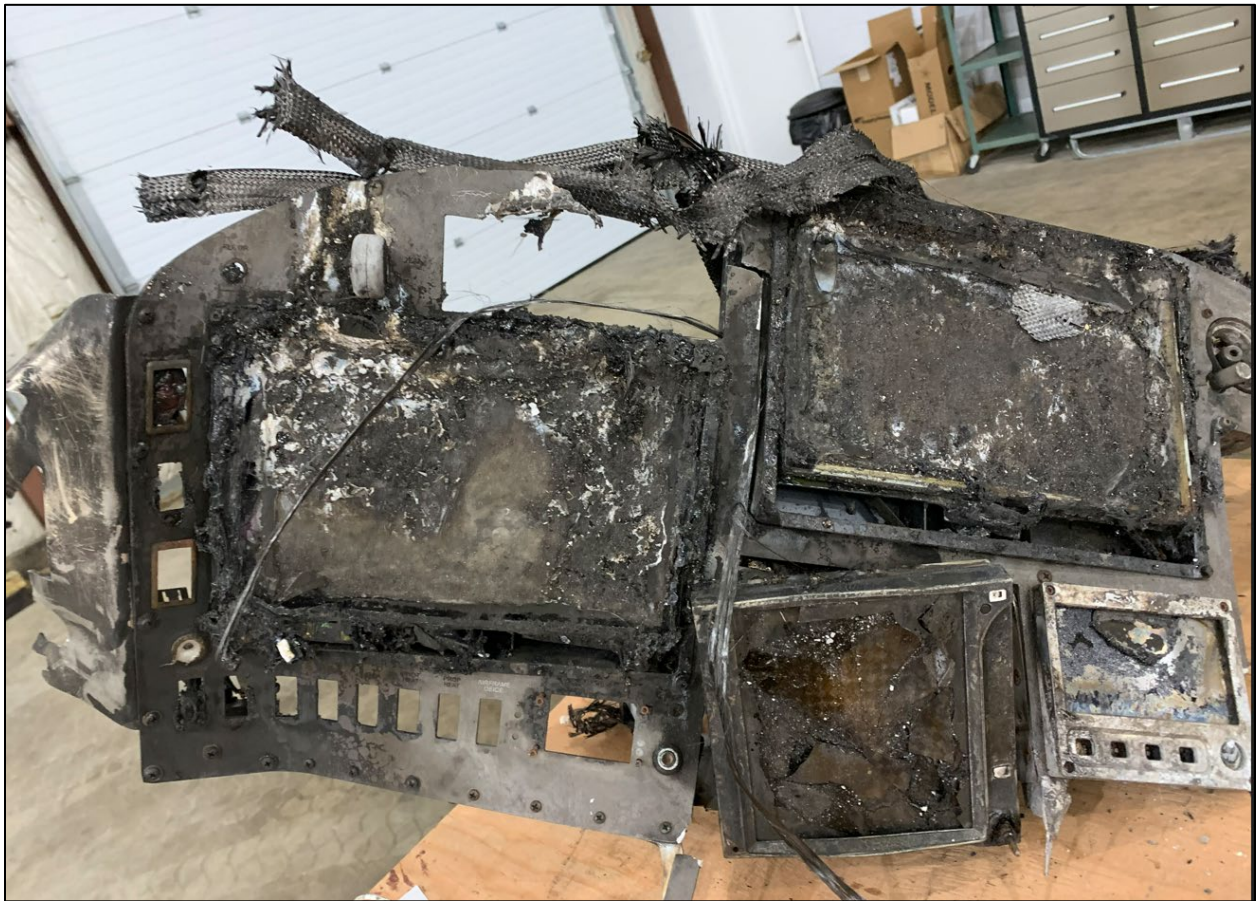
The Garmin G3X Touch (GDU 460) left PFD, and MFD remained partially in position. The right PFD was no longer in its installation area. They all sustained significant thermal damage. The right MFD was located in a recovery bag. It sustained significant impact and thermal damage and fragmented into several pieces. A Garmin GTN 750 was also located partially in its normal installation area. It displayed thermal damage. Refer to the Cockpit Displays - Specialist's Factual Report in the public docket for an overview of the data extracted from the units.

Photo 9: View of the recovered cockpit panel.
