National Transportation Safety Board

ERA23LA135

FLIGHT TESTING

Location: Windsor Locks, Connecticut
Date: March 3, 2023
Time: 1600 Local
2100UTC
Airplane: BOMBARDIER INC, BD-100-1A10 (Challenger 300)

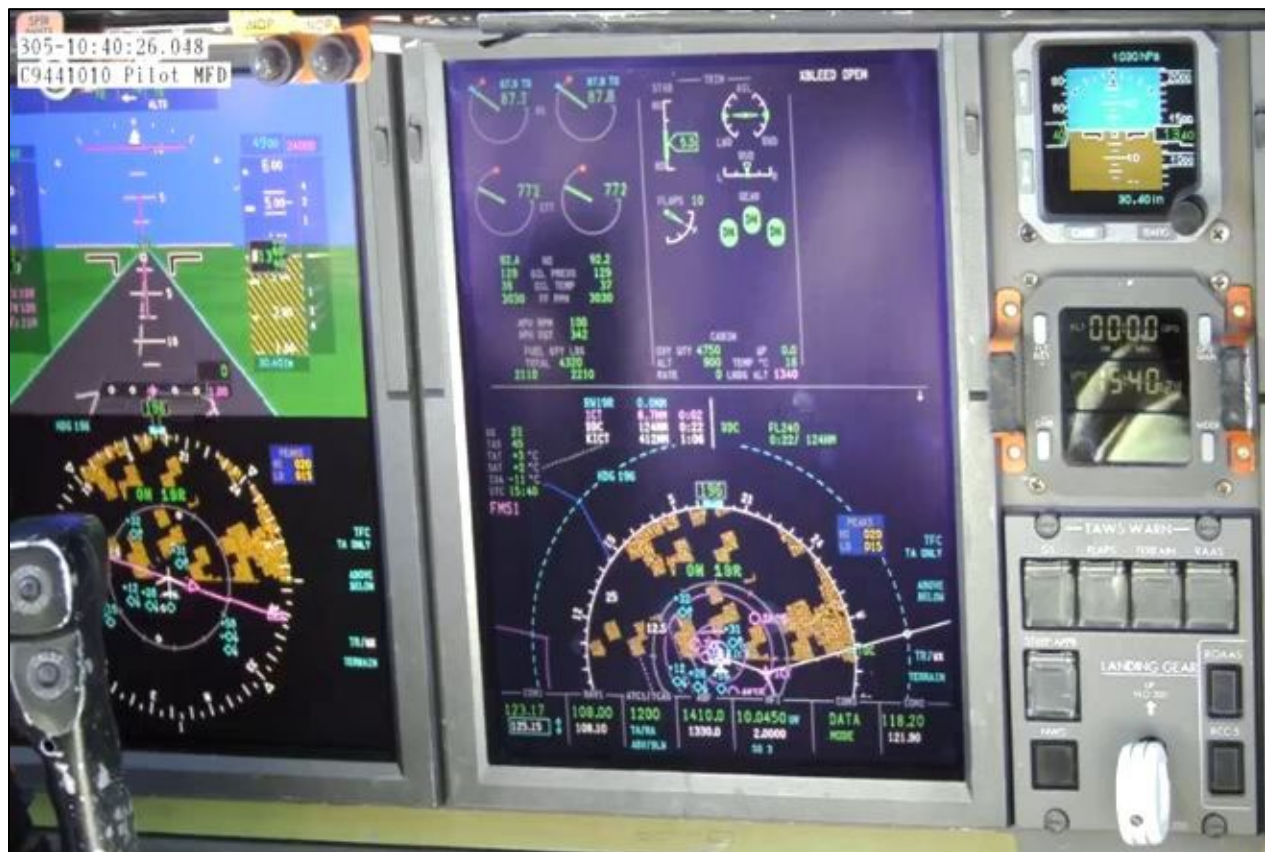
At 10:40:26¹, the first takeoff was initiated and at 90 kts a rejected takeoff (RTO) was performed. During the RTO, the pilots observed an IAS PFD flag indication (Yellow Boxed IAS) as expected. This flag displays on the PFD when there is a greater than 10 kts discrepancy between L/R displayed airspeed.

Figure 1: Screenshot from the RTO as thrust was applied².

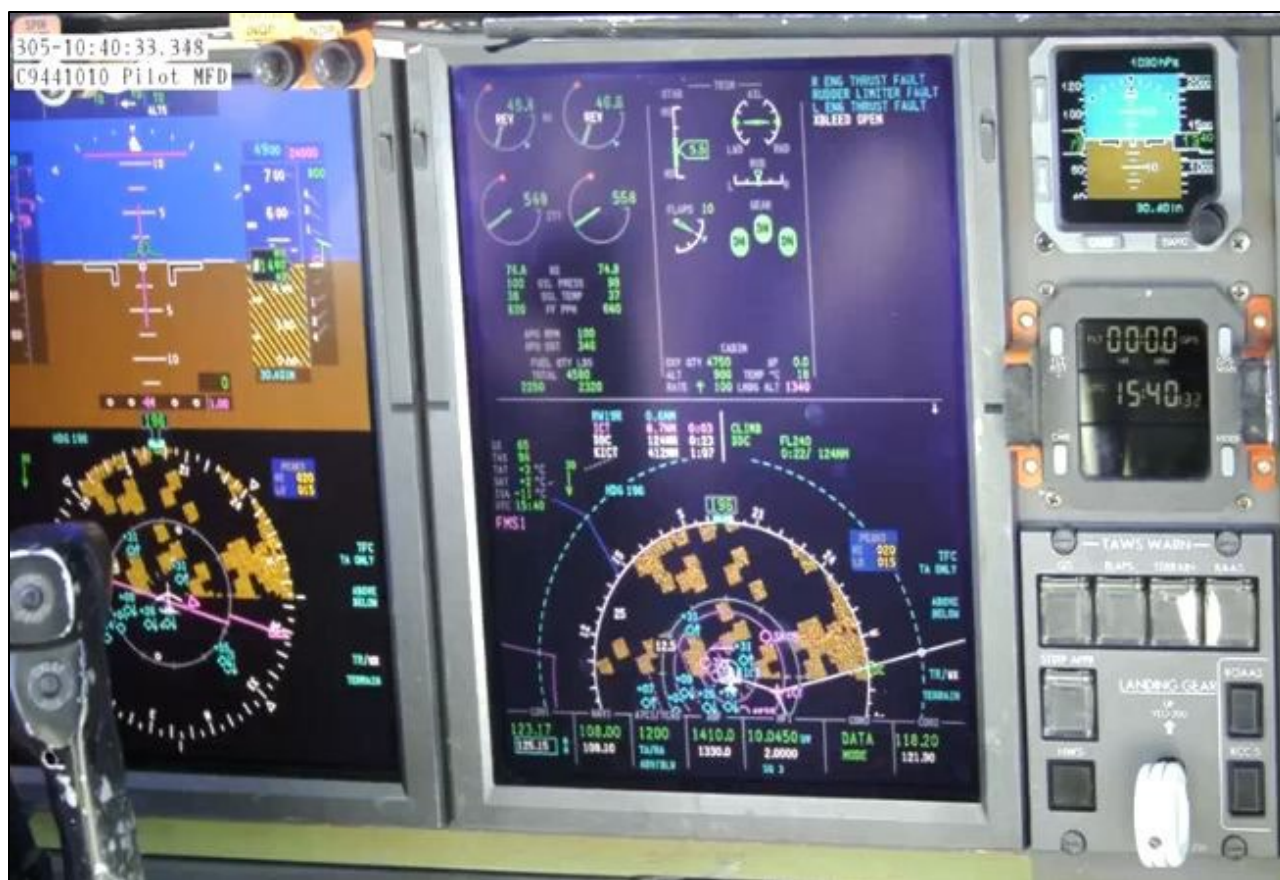
During the deceleration in the RTO, the RUDDER LIMITER FAULT Advisory CAS was displayed. The L/R Eng Thrust Fault advisory messages also displayed during the deceleration, however, the thrust fault messages cleared within a few seconds after they were first annunciated. The V-Speeds no longer displayed on the PFD. Shortly after the RTO, the pitot probe heat was turned off and the L/R Probe Heat Off caution CAS message was displayed.

Figure 2: Screenshot taken as the crew announced 90 kts and at the moment thrust was reduced in the RTO.

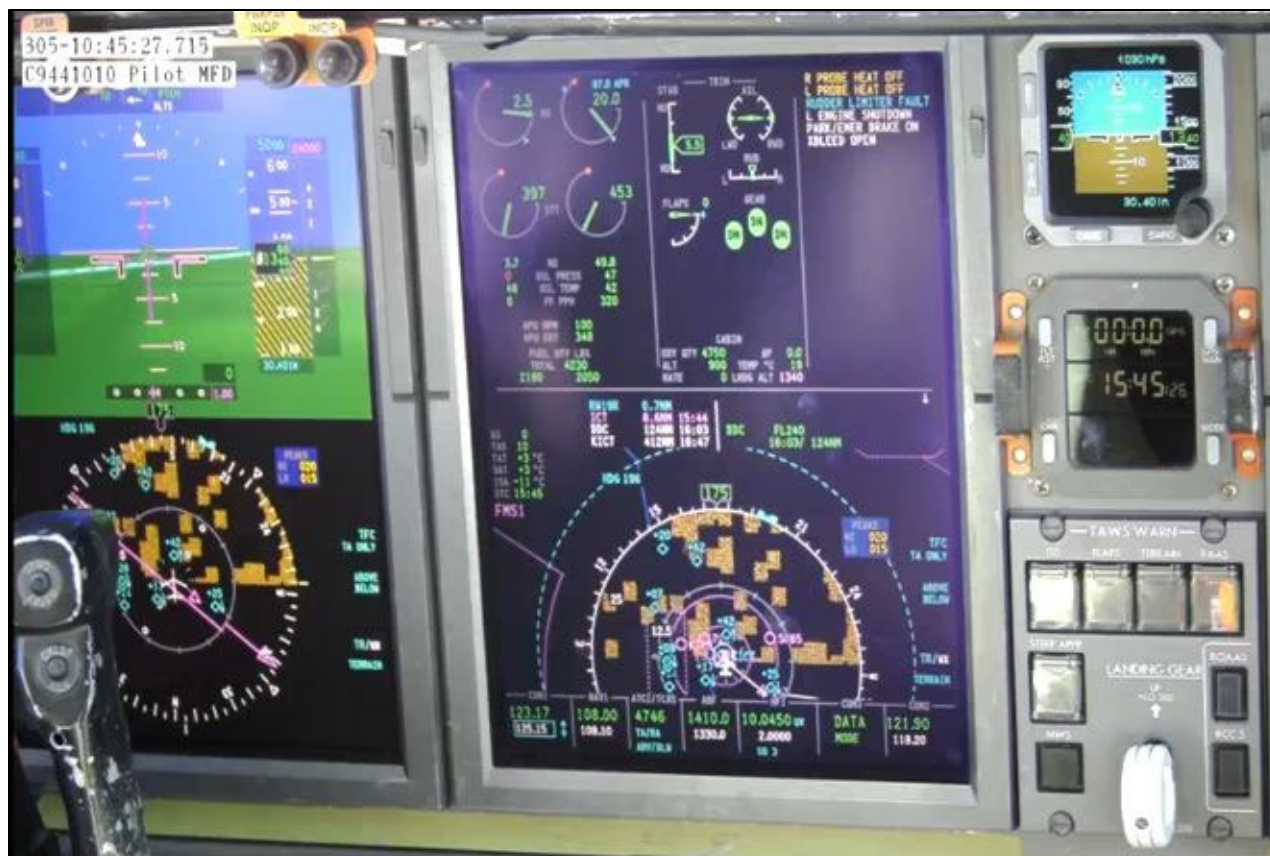
At 10:45:00 the crew taxied to the ramp area, shut down the left engine, and ground crew removed the RH pitot-static probe cover. The cabin door was not opened. At 10:46:11, the crew remarked that the Control Display Unit (CDU)³ displayed a message of 'VSPEEDS DESELECTED' as expected.

Figure 3: Left Engine Shutdown.

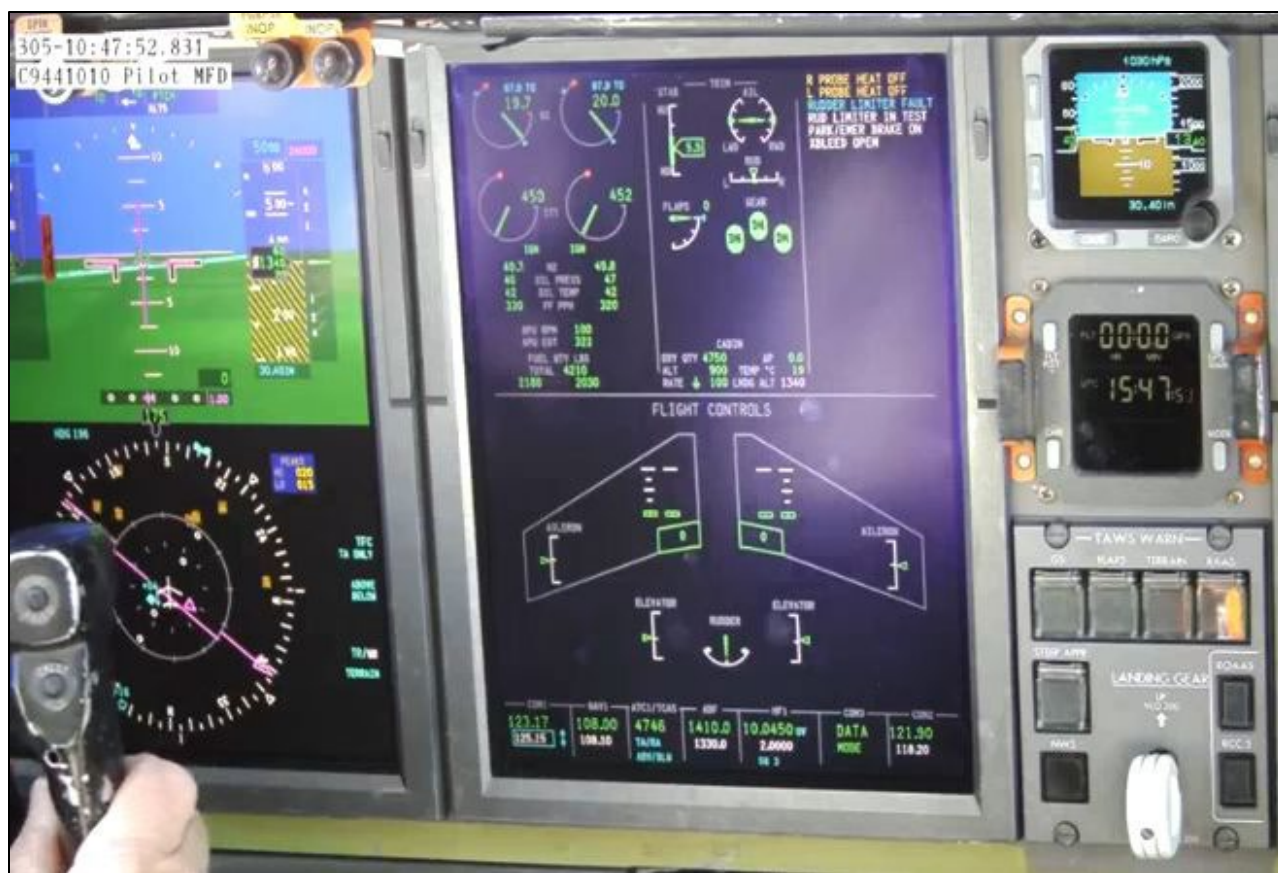
At 10:46:50, the crew restarted the left engine. At 10:47:50, the STALL/ RUD LIM test was performed two times. The second test was completed at 10:48:27. During the test, the RUD LIMITER IN TEST status message displayed. The RUDDER LIMITER FAULT Advisory CAS remained posted following the completion of the two tests. The flight crew taxied to the runway for the next phase of the test flight.

Figure 4: Screenshot taken during the STALL/ RUD LIM test.

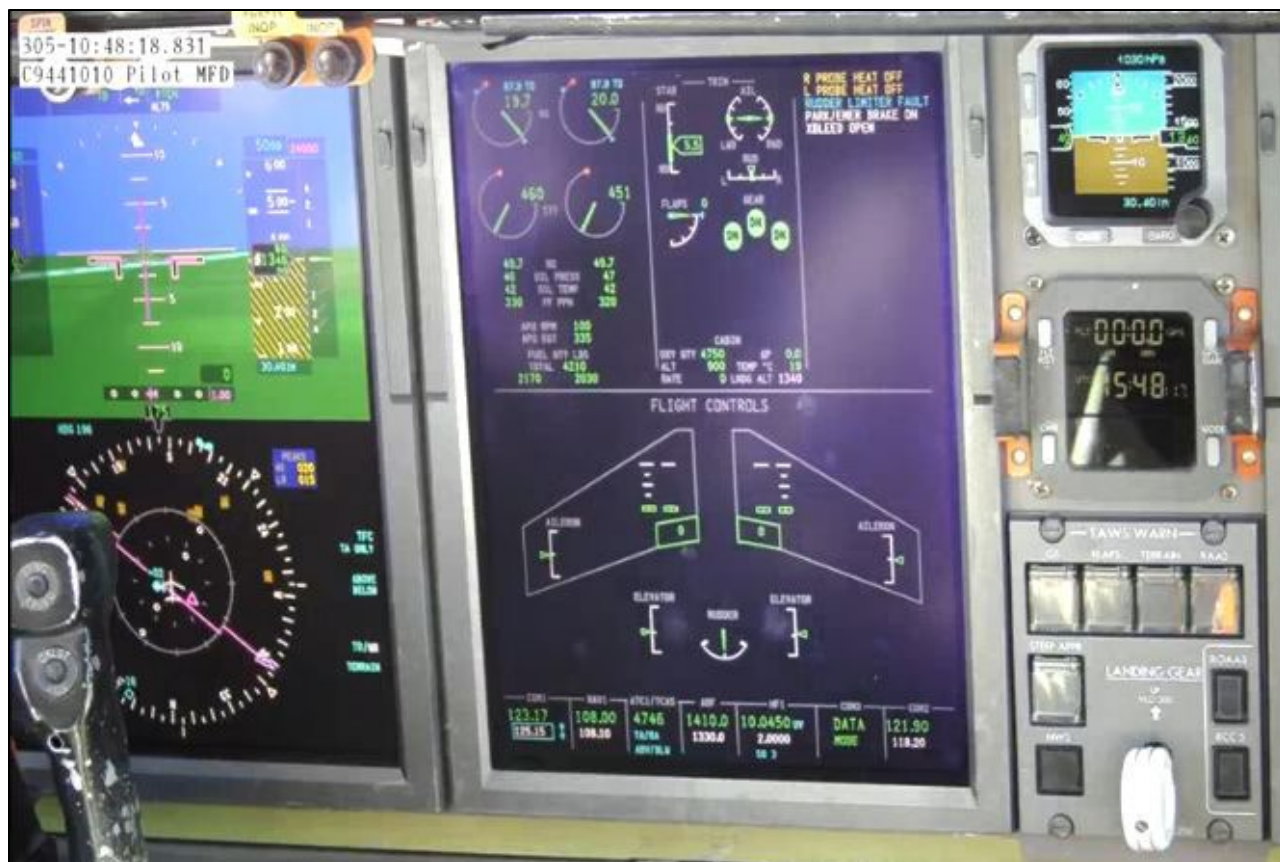
Figure 5: Screenshot taken following the conclusion of the two STALL/ RUD LIM tests, with the RUDDER LIMITER FAULT advisory CAS remaining posted.

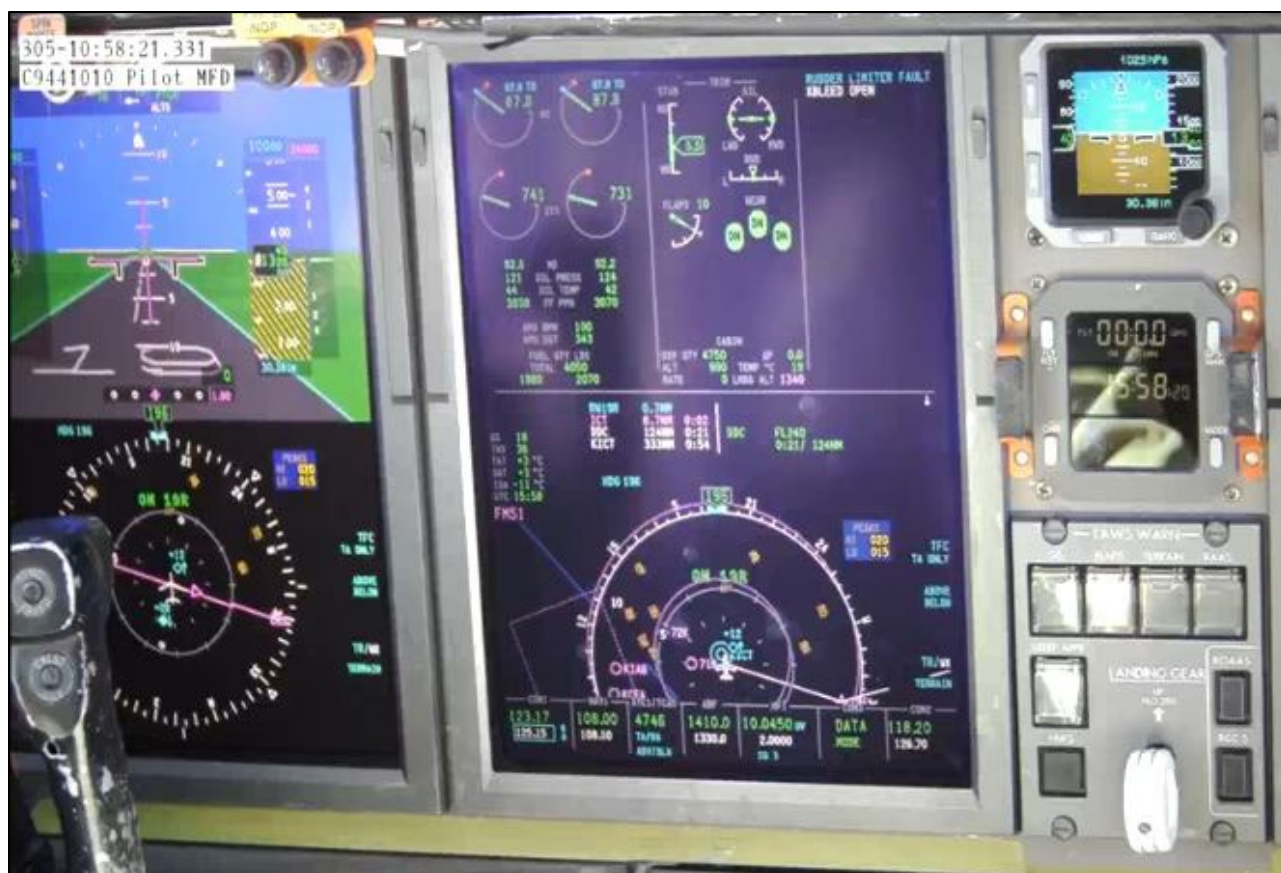
At 10:58:20, the takeoff was initiated without the V-speeds displayed on the PFD and the RUDDER LIMITER FAULT advisory CAS still posted. No other additional CAS messages were posted.

Figure 6: Screenshot taken following the application of thrust during the second takeoff.

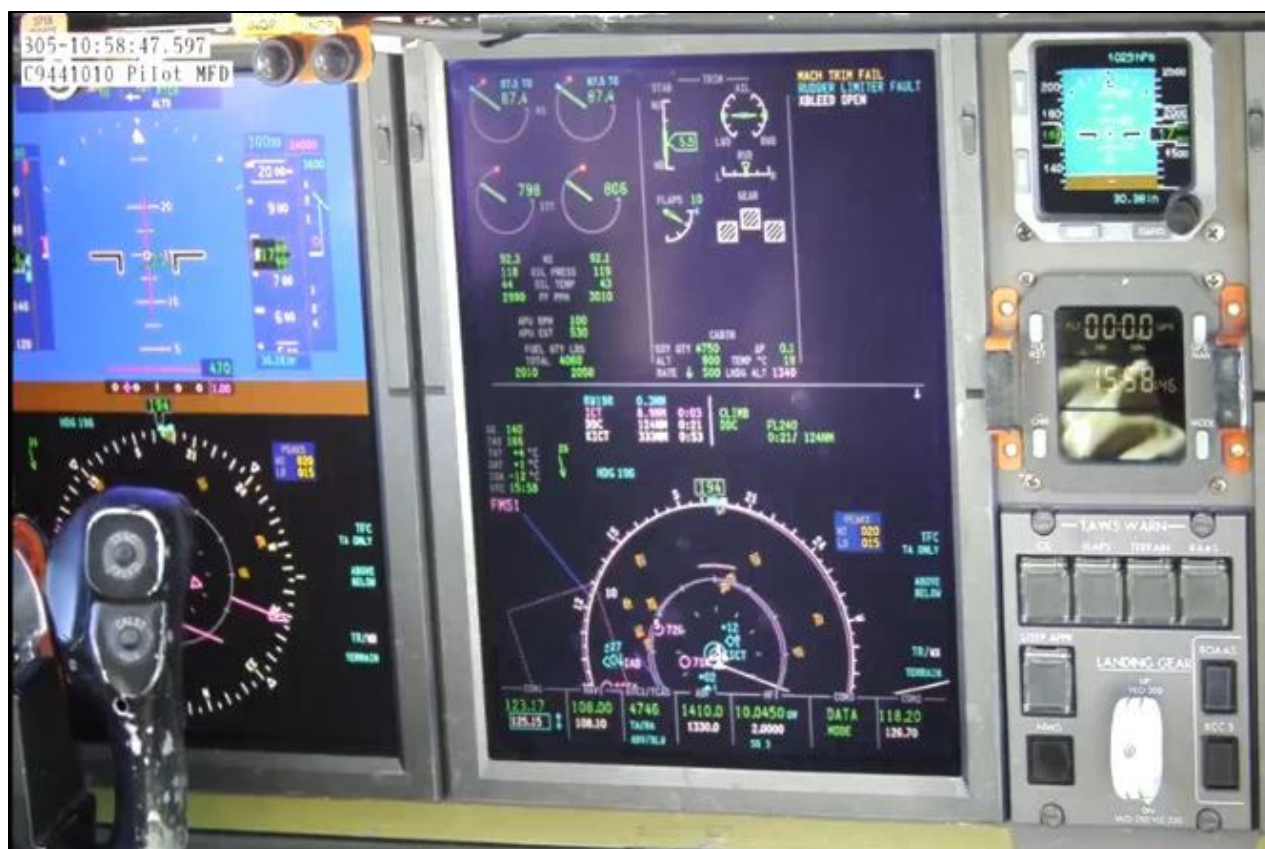
At 10:58:47, about 1,780 indicated altitude⁴ (about 400 ft radio altitude), the MACH TRIM FAIL caution CAS message posted. It was accompanied by a master caution light and a master caution aural alert (single chime)⁵. The message persisted for the remainder of the flight.

Figure 7: Screenshot of MACH TRIM FAIL posting.

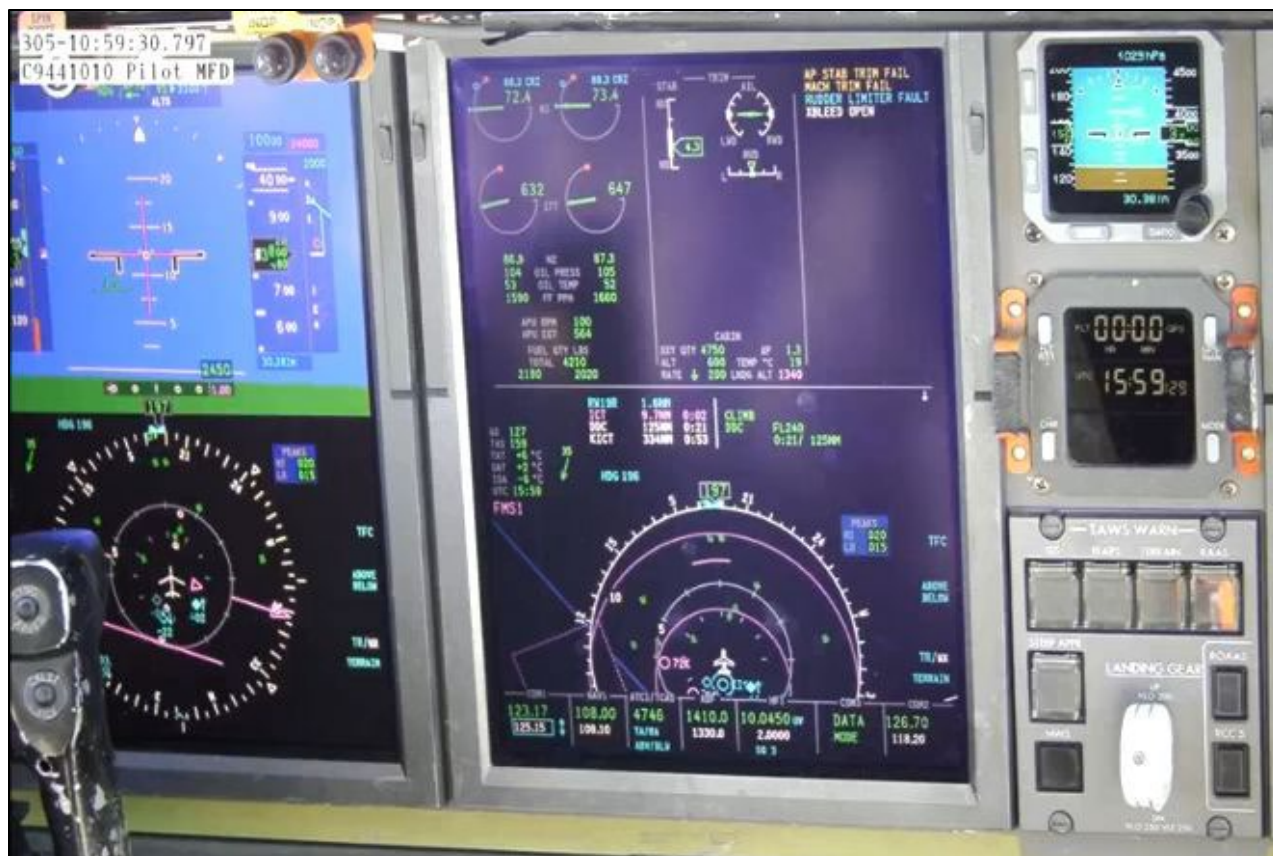
At 10:59:30, about 153 kts and 3750 ft, the autopilot was turned on. Immediately following the AP engagement, the AP STAB TRIM FAIL caution CAS message posted. It was accompanied by a master caution light and a master caution aural alert (single chime).

Figure 8: Screenshot at first AP engagement.

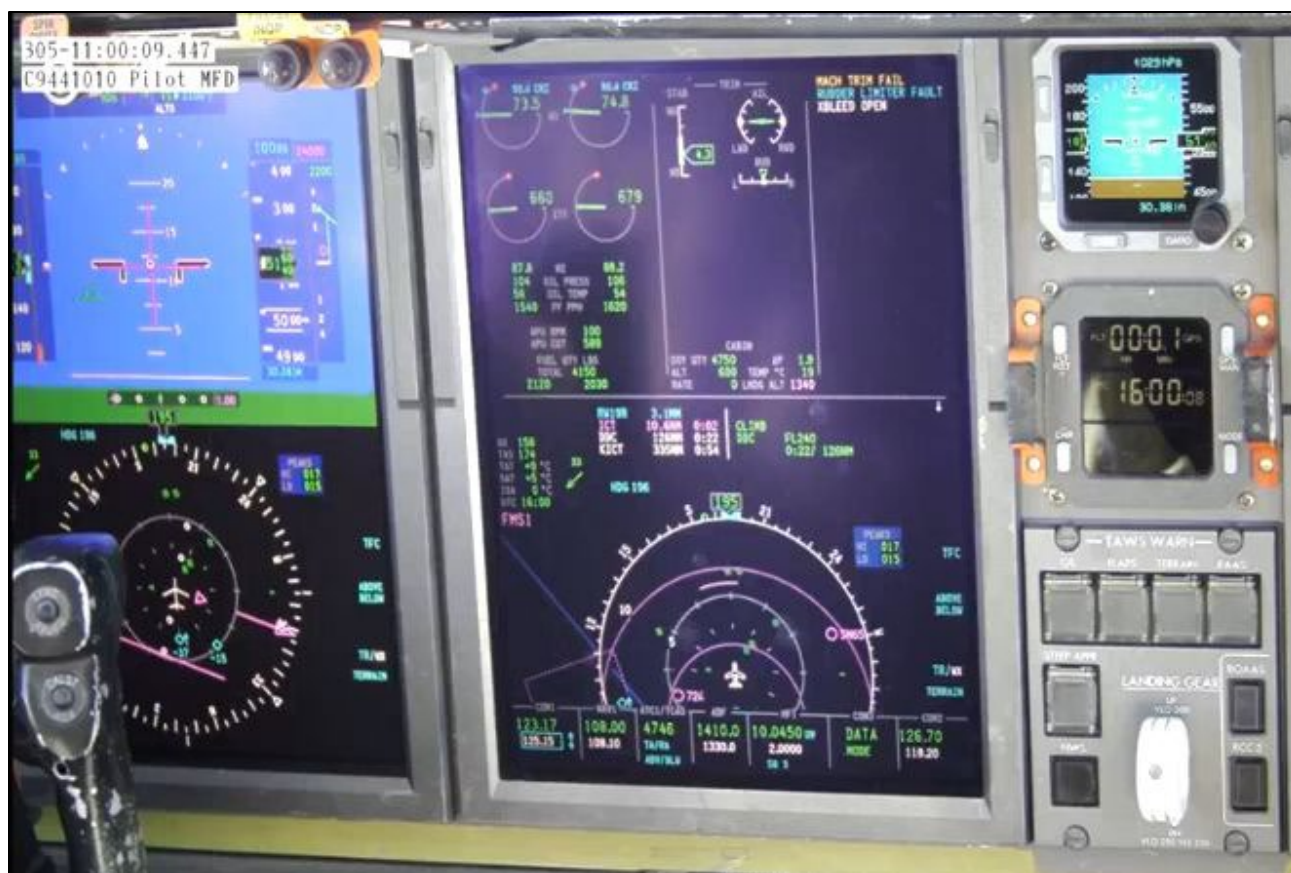
At 11:00:09, about 159 kts and 5,140 ft, the AP was disconnected with the left seat yoke mounted pitch trim switch. When the AP was disengaged, the AP STAB TRIM FAIL caution CAS message was cleared.

Figure 9: Screenshot following first AP disengagement.

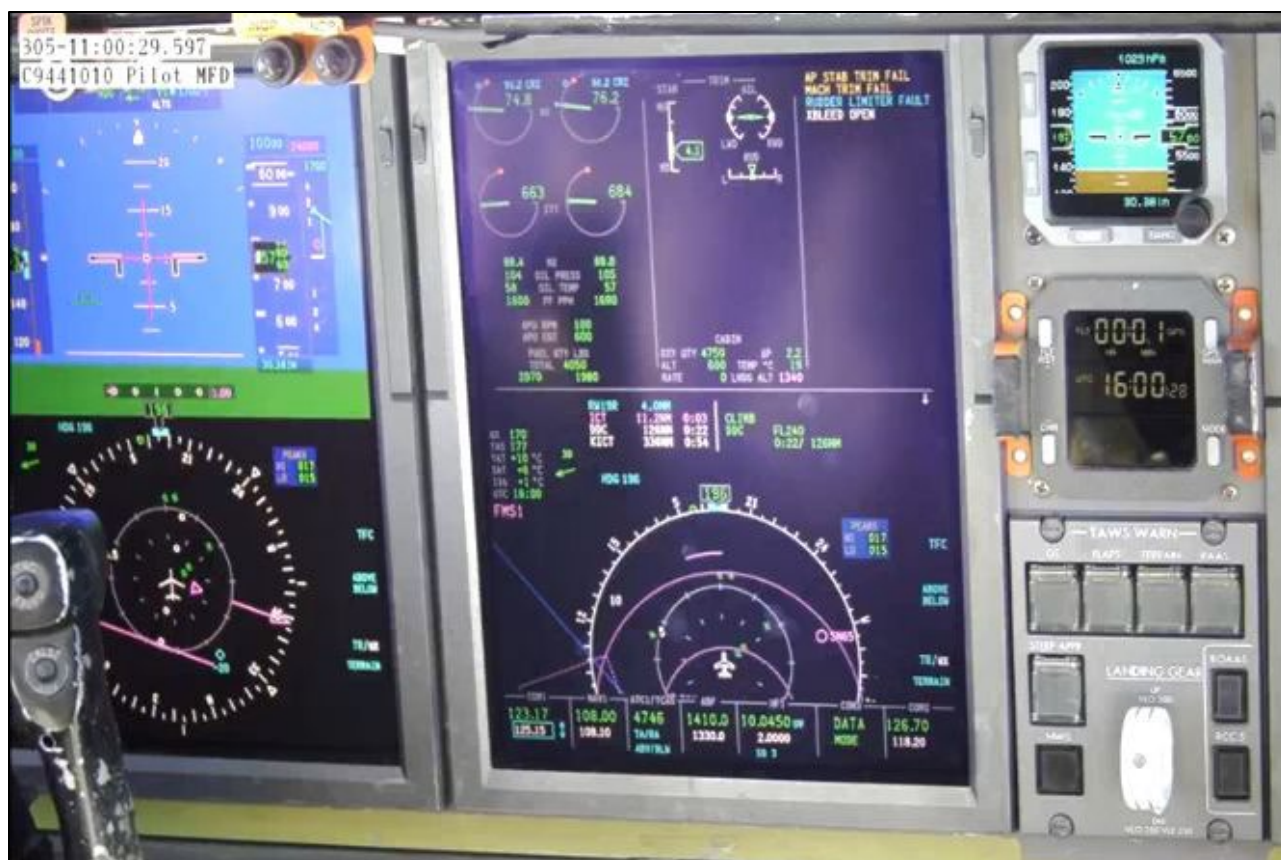
At 11:00:29, the AP was reengaged a second time at 162 kts, at 5,750 ft. Immediately following the AP engagement, the AP STAB TRIM FAIL caution CAS message posted. It was accompanied by a master caution light and a master caution aural alert (single chime).

Figure 10: Screenshot at second AP engagement.

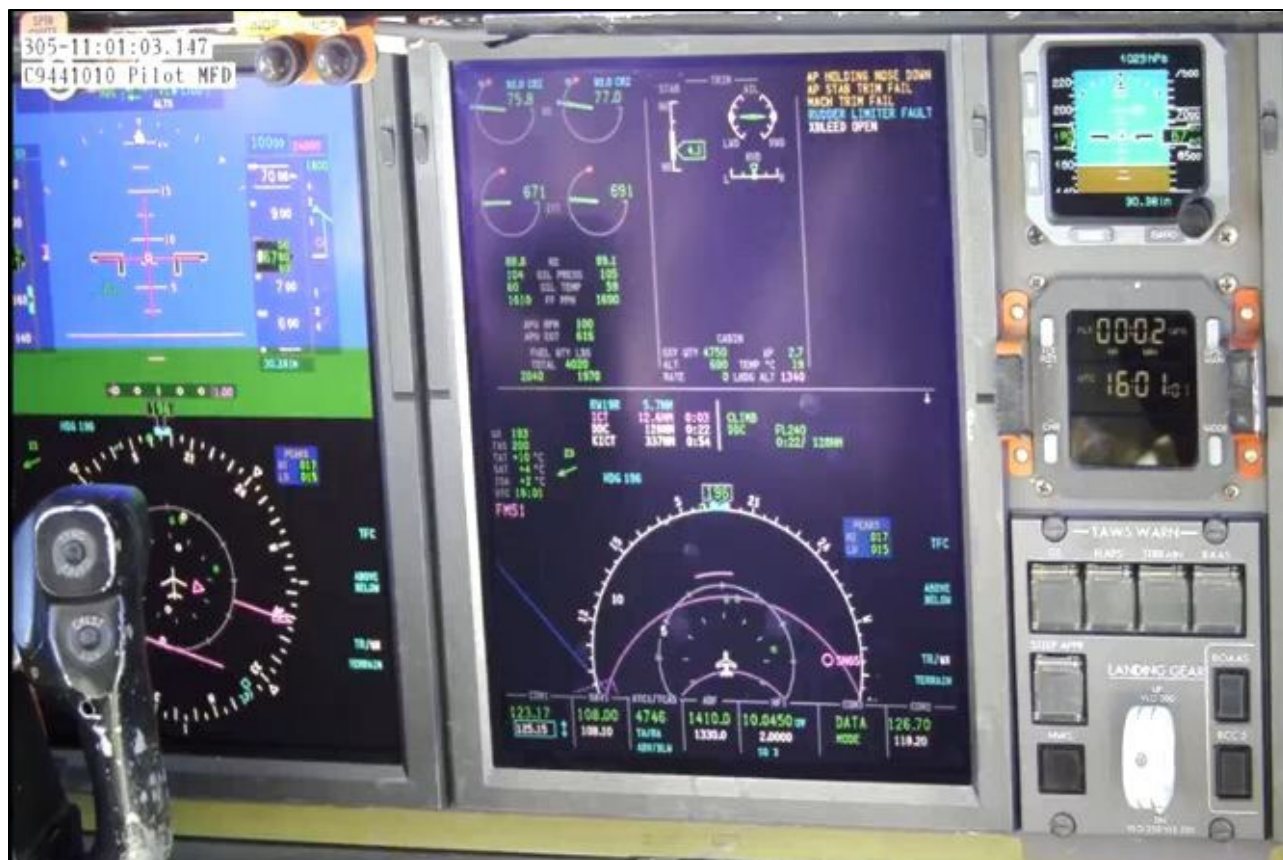
The airplane continued to accelerate at a rate of one knot per second in the climb. At 11:01:02, at 182 kts the AP HOLDING NOSE DOWN caution CAS message was posted. At 11:01:07, the message cleared when the speed dropped below 182 kts⁶.

⁶ The AP HOLDING NOSE DOWN caution CAS message displays when forces on the pitch servo exceed mis-trim threshold limits.

Figure 11: Screenshot taken when AP HOLDING NOSE DOWN posted.

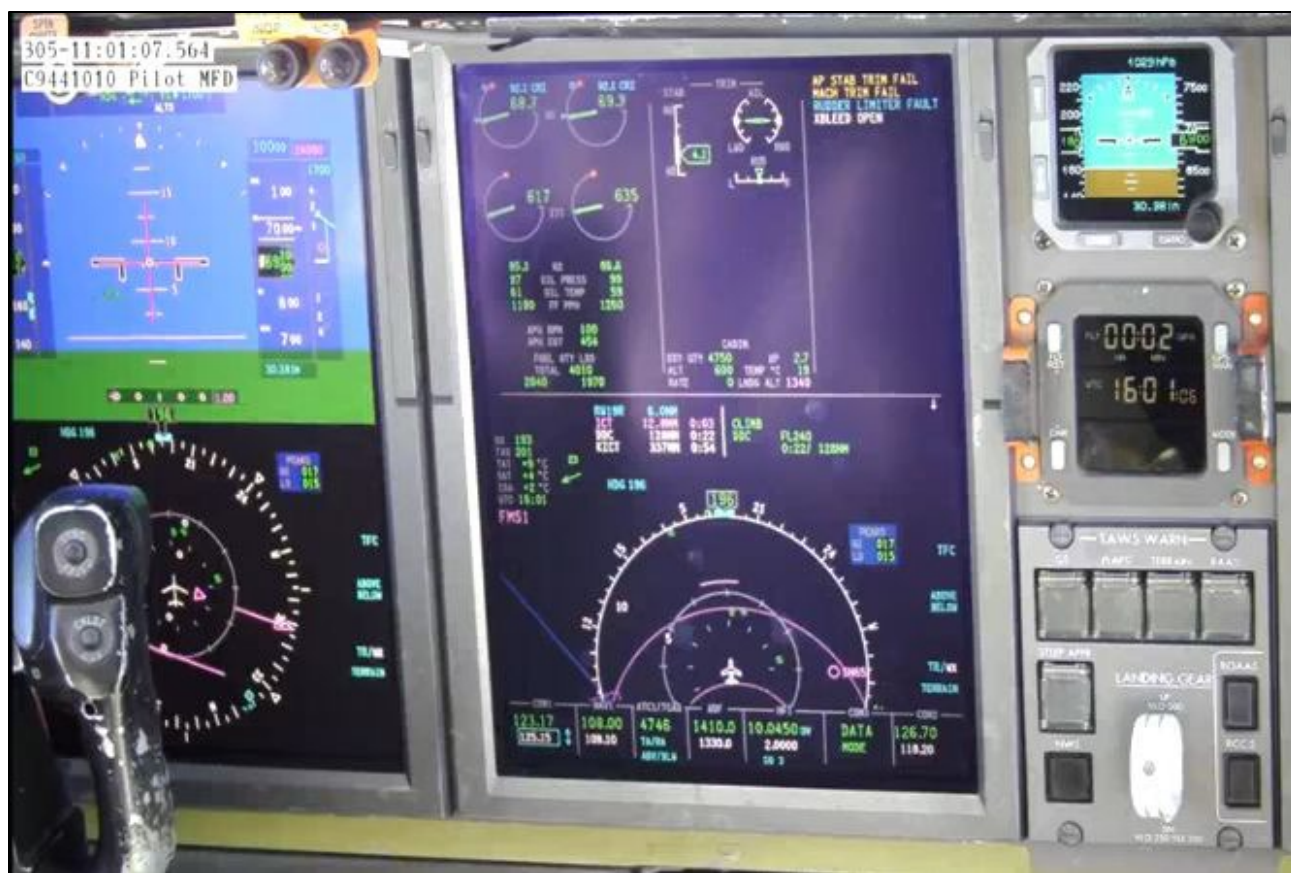
Figure 12: Screenshot taken when AP HOLDING NOSE DOWN cleared.

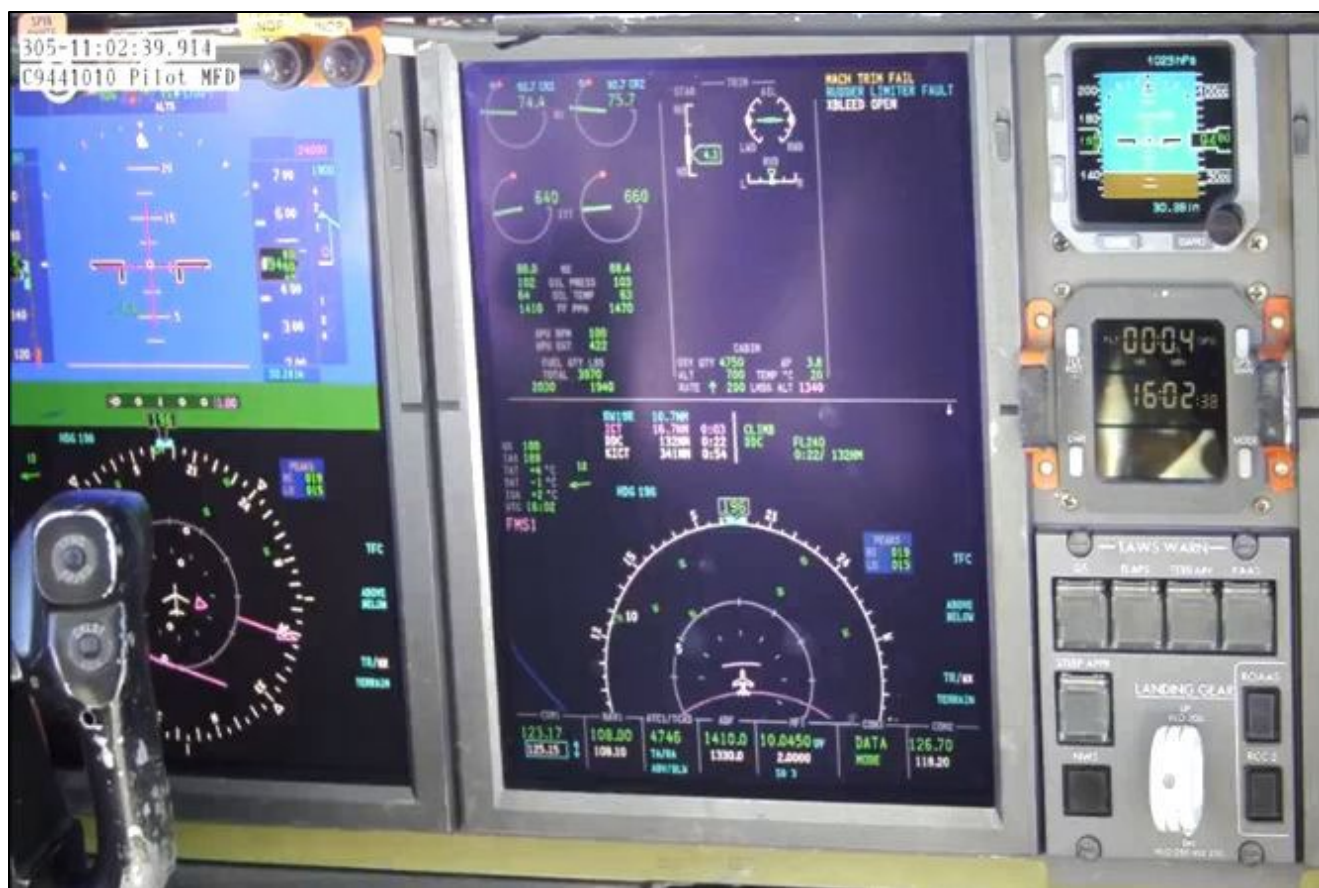
The airplane was slowed to 165 kts about 9,000 ft. At 11:02:39, the flight crew executed the AP STAB TRIM FAIL checklist and at the conclusion of the checklist, the master AP disconnect switch was pressed and the AP disconnected. The calvary charge AP disconnect was heard. In addition, when the AP was disengaged, the AP STAB TRIM FAIL caution CAS message was cleared. The airplane returned for landing.

Figure 13: Screenshot at the time the AP was disconnected for the second and final time.
