National Transportation Safety Board

ERA23LA135

SYSTEMS

Group Chair's Factual Report

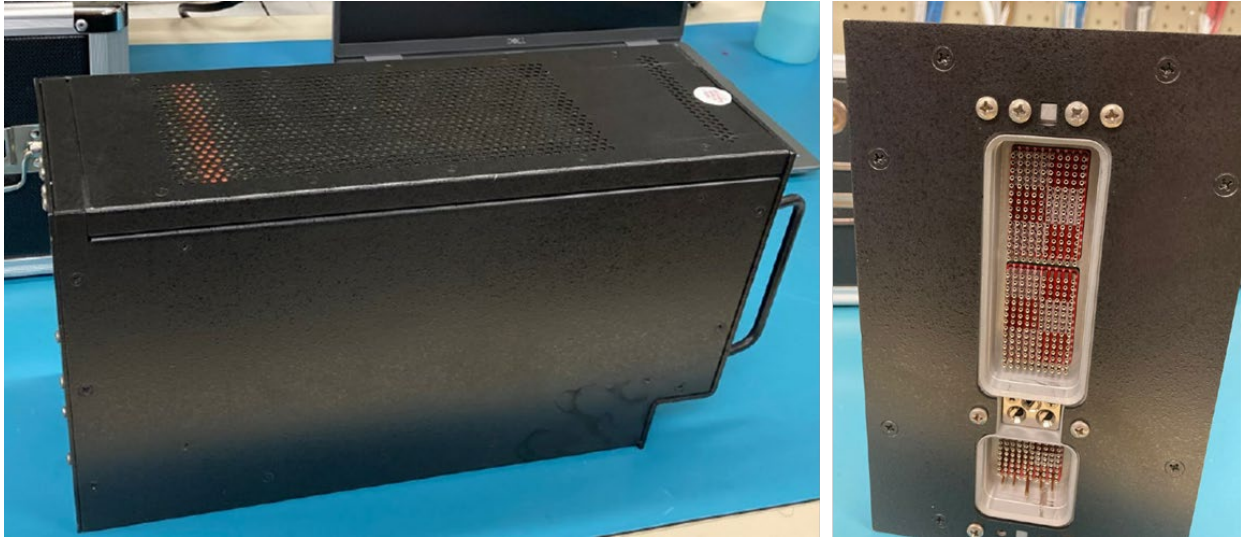
Figure 4. Photos of the HSTECU. (Courtesy of Moog)

A visual inspection of the HSTECU was completed and no anomalies were noted. All HSTECU electrical connector pins appeared normal.
