National Transportation Safety Board

ERA24FA003

AIRWORTHINESS FACTUAL REPORT

Location: Croydon, New Hampshire
Date: October 8, 2023
Time: 1932 Eastern Daylight Time (EDT)
2332 Coordinated Universal Time (UTC)
Aircraft: Bell 407, N802JR

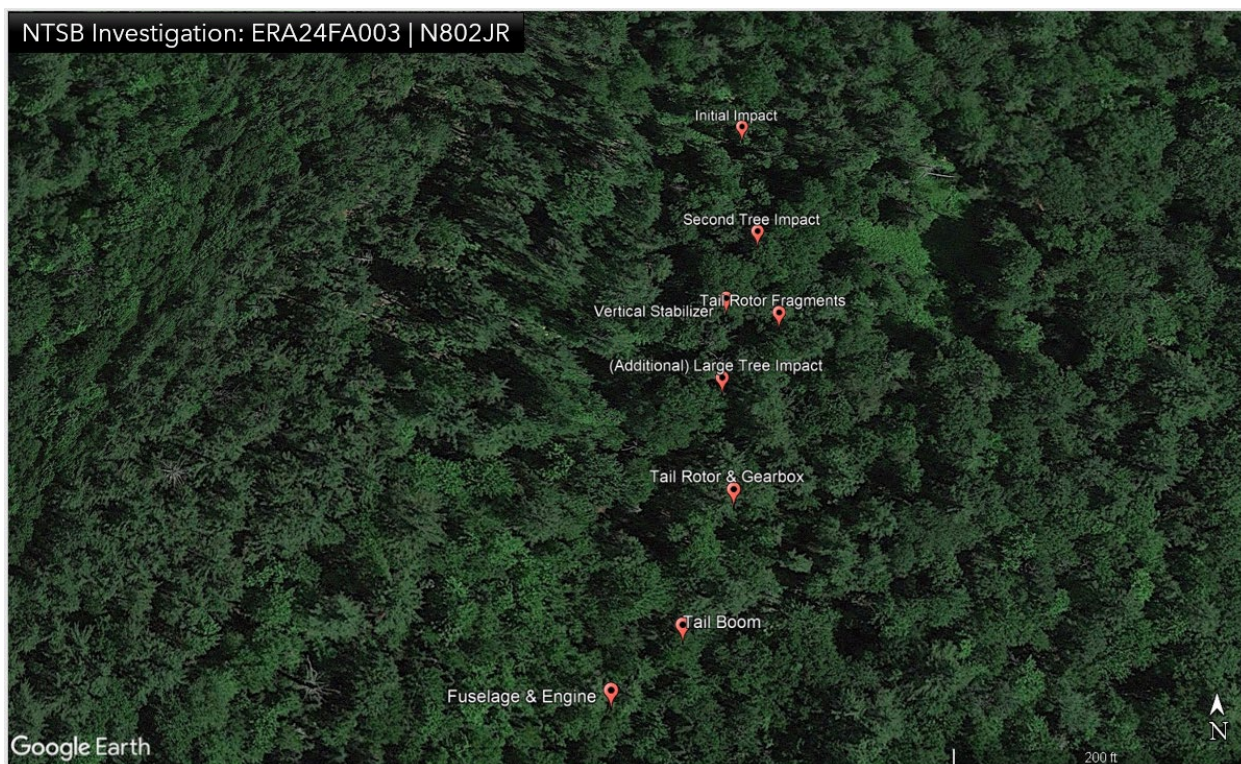
The wreckage was oriented on a southerly heading of about 193° and spanned about 485 ft from the initial impact point to the fuselage and engine. The initial impact point coincided with a tall pine tree about 100 ft tall. Evidence of broken tree branches and plexiglass were located at this point. Several additional broken tree branches were located along the wreckage path. All major components of the helicopter were located in the debris field and portions of the helicopter were heavily fragmented along the debris area.

Figure 1: Major components located in the debris field.

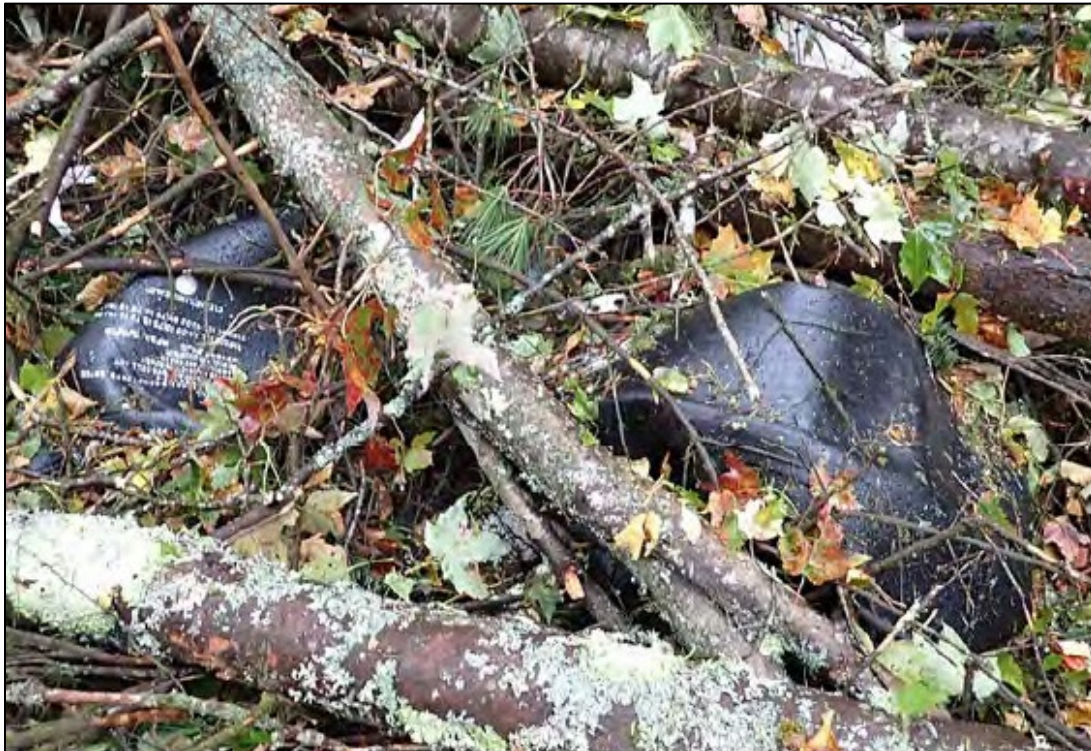
The components of the fuel system, including the two fuel cells (forward and main), one electrically operated fuel boost pump, one electrically operated fuel transfer pump, fuel cell interconnect tubes, forward/aft quantity probes, fuel/vent lines, fuel shutoff valve, and the airframe fuel filter were substantially damaged by impact forces. A strong odor of fuel was present at the accident site. The components of the fuel system had separated from the airframe and were located in the debris path. The airframe fuel filter was present but could not be examined due to the damage to the fuselage.

Figure 2: Fuel system component (Bell Photo).

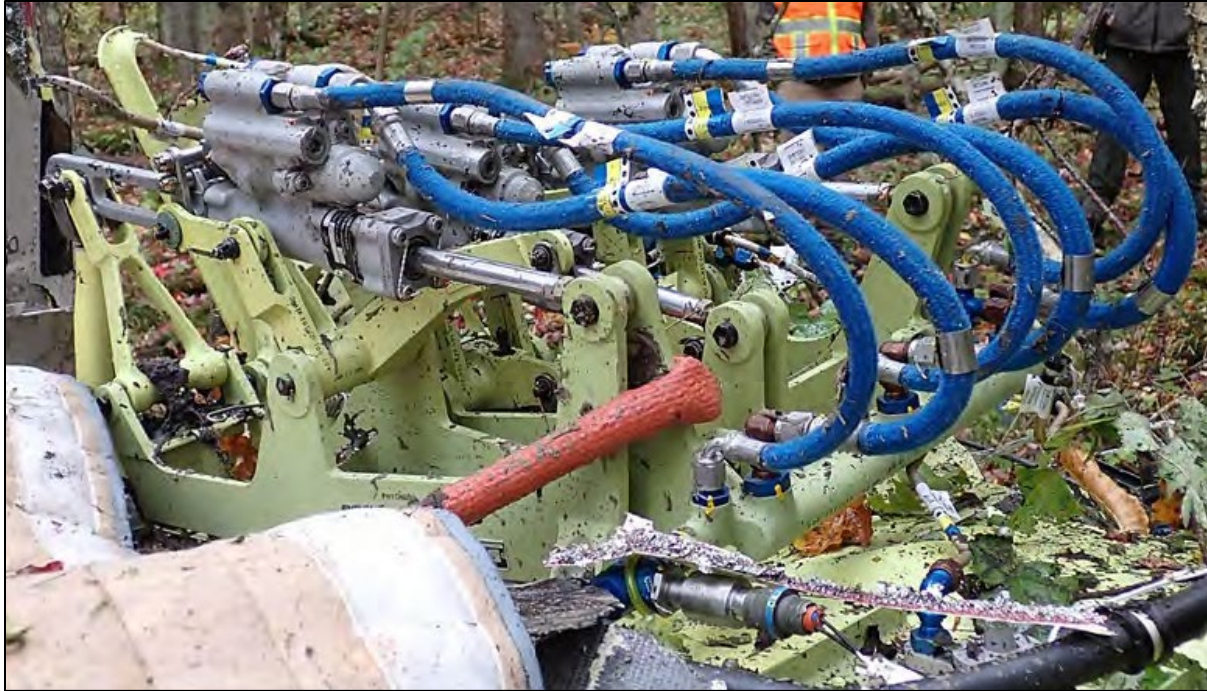
The components of the hydraulic system, including the hydraulic pump and reservoir, 3 collective/cyclic servo actuators, 1 tail rotor servo actuator, hydraulic manifold, solenoid and relief valves, hose assemblies, and hydraulic filters were substantially damaged or destroyed by impact forces. All three main rotor servos remained installed on the roof structure and all hydraulic lines were connected.

Figure 3: Servo Actuators (Bell Photo).

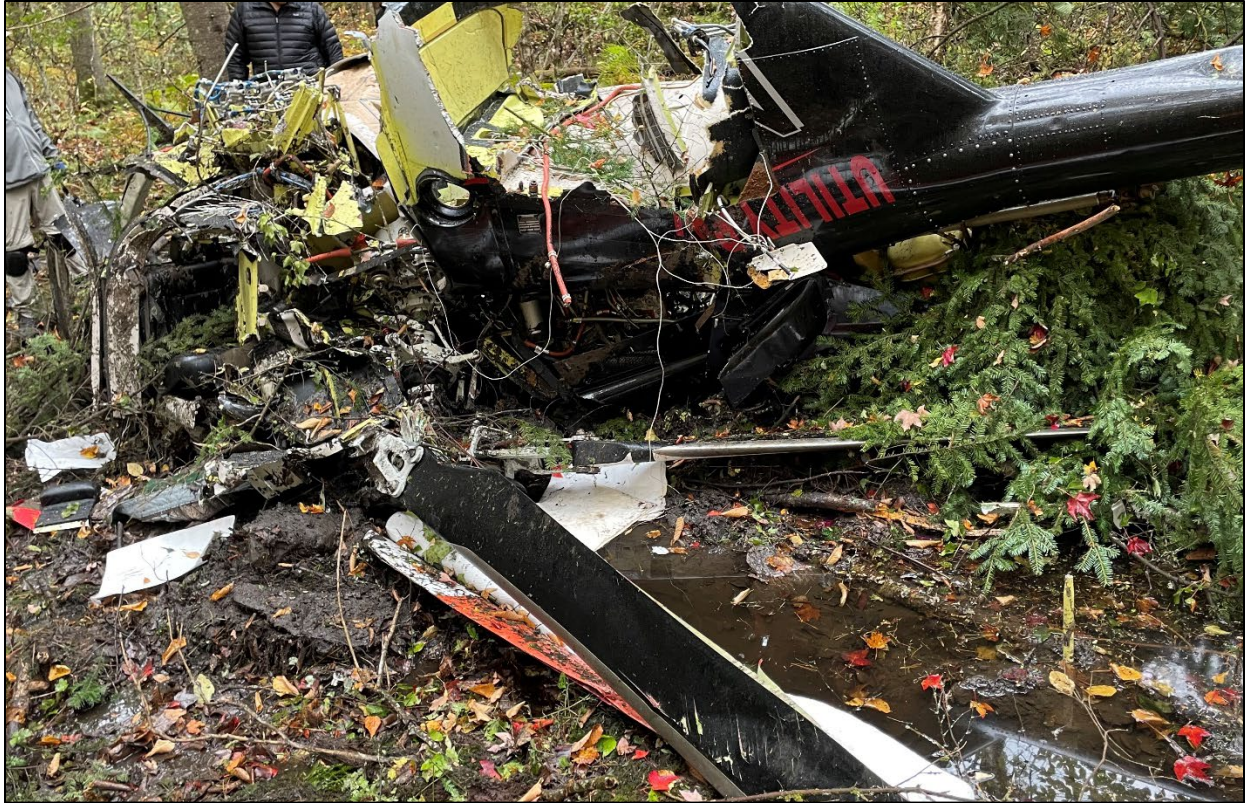
The vertical fin separated from the tailboom followed by the tail rotor gearbox. The vertical fin showed an impact mark on the lower section of the fin. The stinger was found separated from the tailboom. The components of the forward airframe (cockpit area) were substantially damaged by impact forces. The cockpit area of the forward fuselage section remained in an upright position. However, the intermediate section along with sections of the roof beam assembly/shell were found to be "upside down," rotated 180° from the normal position. The tail boom separated just aft of the intercoastal support. The left horizontal stabilizer and finlet had separated from the tailboom. The right elevator remained in place but missing the finlet.

Figure 4: View of the fuselage and tail boom.

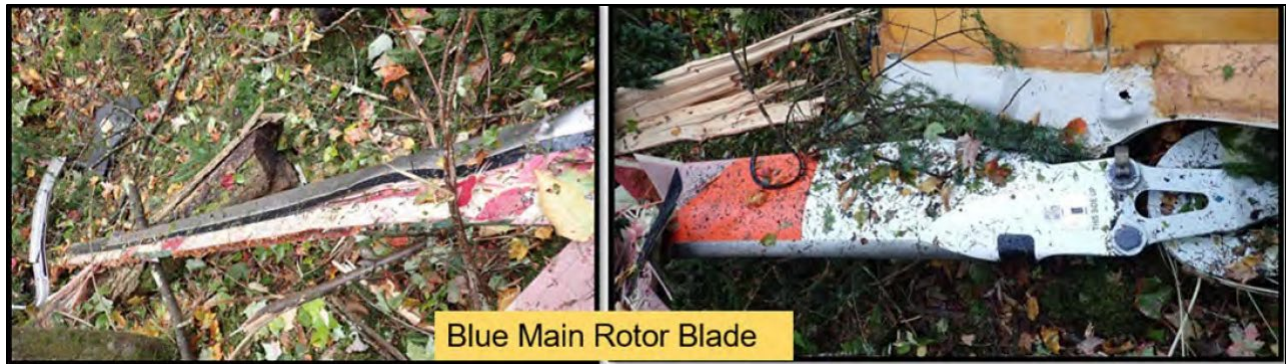
The "Blue Blade" (P/N 407-015-001-137, S/N A-4617) remained attached to the blade grip and the yoke flexure separated from the yoke. The blade exhibited fracturing outside of the aft root closure where the spar was bent 90 degrees. The fracturing appeared to be consistent with a sudden stoppage due to contact with trees. Most of the blade after-body was missing. The tip weight remained attached. The remaining three main rotor blades were found attached to the yoke/mast where the fuselage was located. The remaining blades exhibited various degrees of damage, but the damage appeared to be decreasing by blade order (Orange, Red, and Green).

Figure 5: "Blue" Main Rotor Blades (Bell Photo).

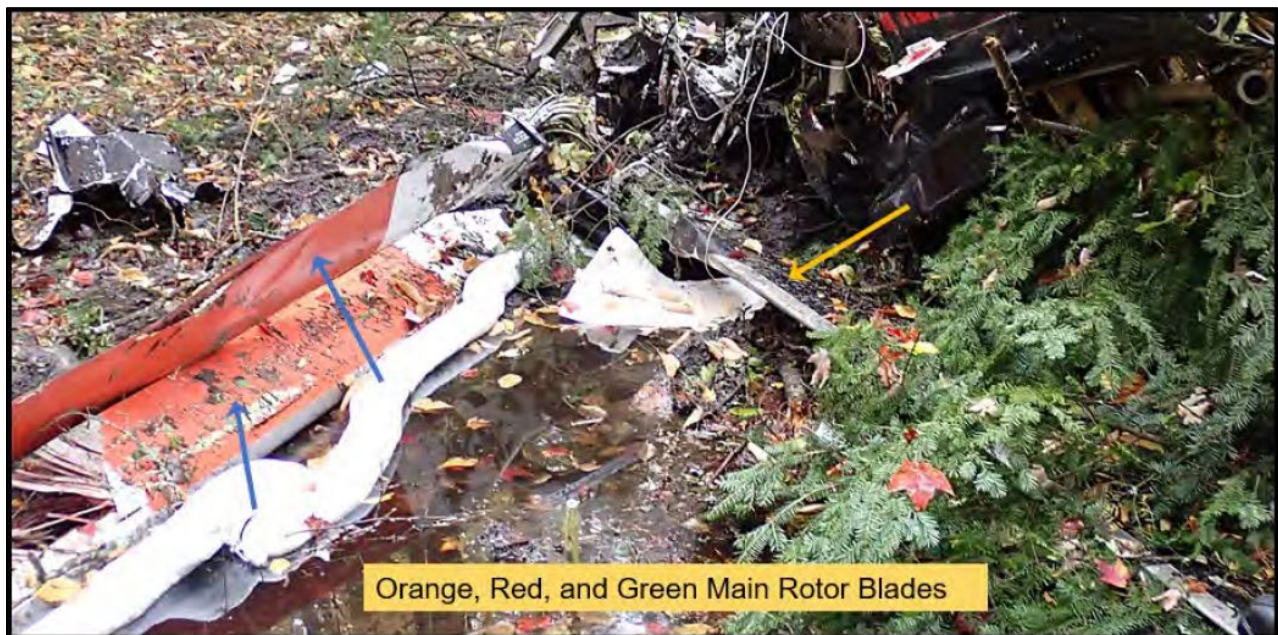
Figure 6: "Orange, Red, and Green" Main Rotor Blades (Bell Photo).

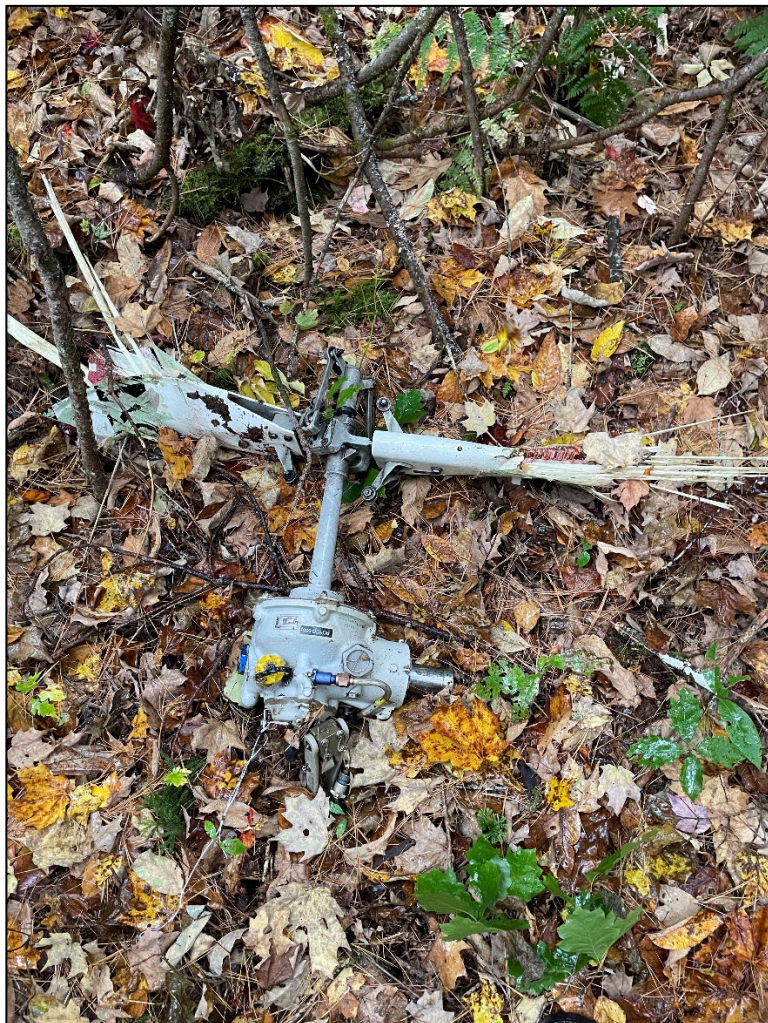
The two tail rotor blades had fractured approximately 12 inches from the blade root. The tail rotor flap stops exhibited evidence of contact with the yoke assembly. The tail rotor pitch change links remained installed, were slightly deformed, and did

not exhibit fractures. The tail rotor hub was unremarkable. The pitch of the tail rotor blades was manipulated by hand with appropriate control movement to the fractured control mechanism on the tail rotor gearbox.

Figure 7: Tail Rotor.

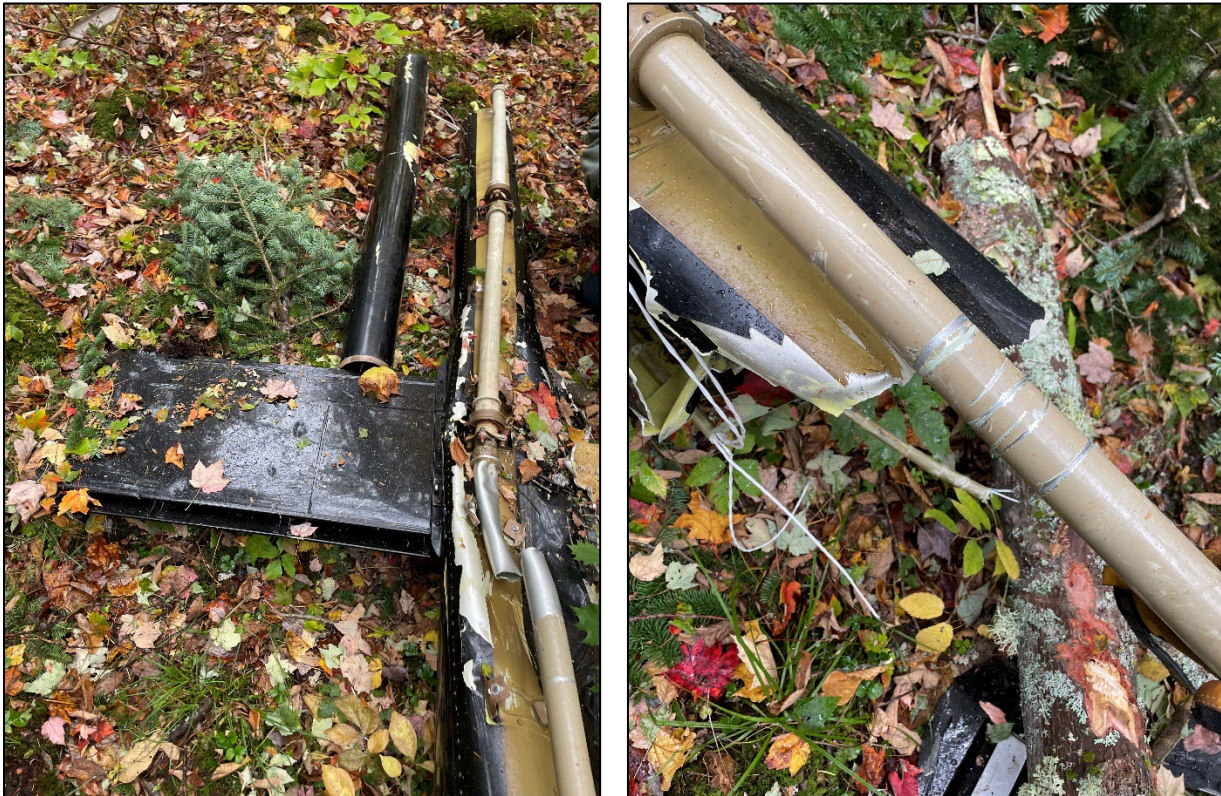
No pre-impact anomalies were observed with the tail rotor drive system. The aluminum tail rotor drive shafts were present. The #4 and #5 drive shaft segments remained attached to the tailboom. The #5 drive shaft segment had been pulled from the tail rotor gearbox. The #3 drive shaft segment had fractured in overload approximately 8 inches forward of the #2 segment. The #2 segment was present, but the forward end was pulled out and was attached to the #1 segment hangar bearing. The #1 segment was present, and the forward end remained attached to the oil cooler blower shaft.

Along the tail rotor drive shaft, multiple areas of rotational scoring were observed. The oil cooler blower shaft was rotated by hand. The tail rotor gearbox and tail rotor had separated from the tailboom support during the accident sequence. Rotation of the tail rotor gearbox was accomplished by turning the tail rotor yoke by hand. The rotation was smooth and exhibited no evidence of binding or restrictions. Oil was present within the tail rotor gearbox. The oil was of normal color with no abnormal smell. The tail rotor gearbox chip detector was removed and contained no magnetic particles.

Figure 8: Views of the tail rotor drive shaft.
