# National Transportation Safety Board

ERA24FA003

Factual Report

Location: Croydon, New Hampshire  
Date: October 8, 2023  
Time: 1932 eastern daylight time (local)  
2332 UTC  
Aircraft: Bell Helicopter Textron Canada, 407

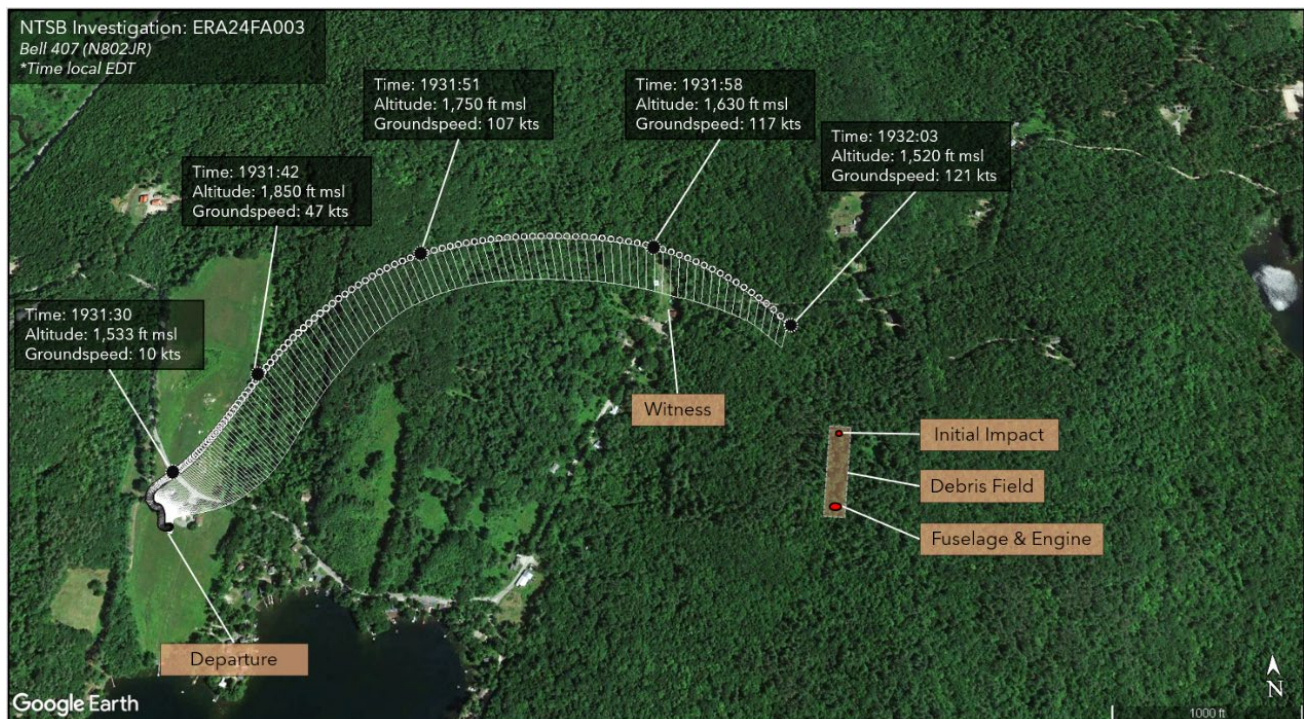
The helicopter then turned east and eventually southeast, and as the helicopter turned, it began descending while its ground speed gradually increased. The helicopter subsequently impacted trees and terrain about 600 feet southeast of the helicopter's last recorded position. Figure 1 provides an overview of the flight track, select callouts for time, altitude, and speed, as well as the wreckage location.

**Figure 1: Overview of the flight track (white dots); callouts of the helicopter's position, speed and altitude (black dots); and wreckage location (red dots and shaded box).**

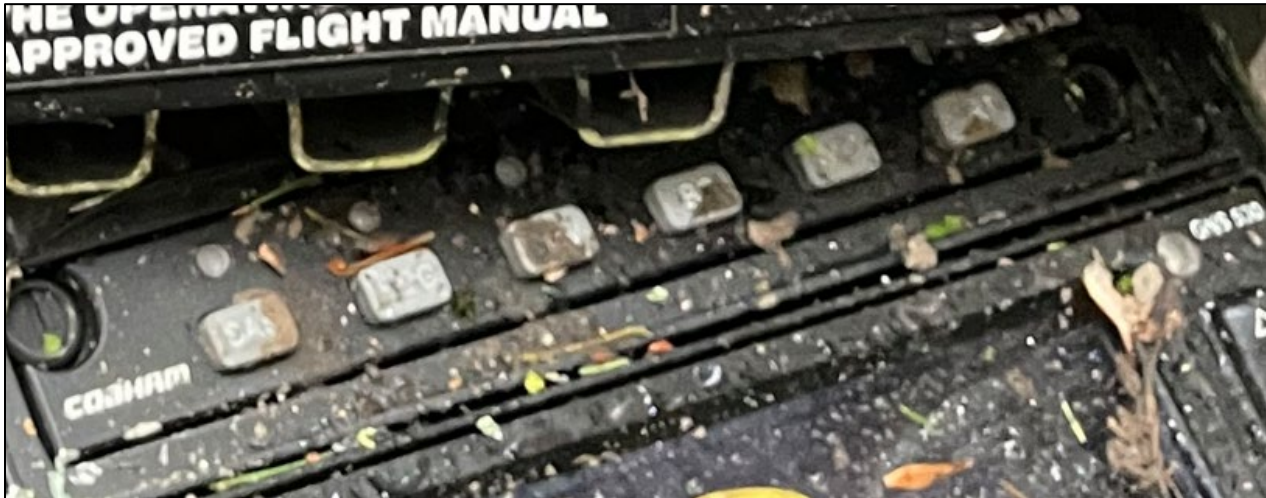
**Figure 4: View of the accident helicopter HCP.**

Review of the onboard image recorder found that during the takeoff and initial climb, the SAS system was not activated and remained in a white standby mode throughout the flight.
