ERA24LA279

INVESTIGATION PHOTOGRAPHS

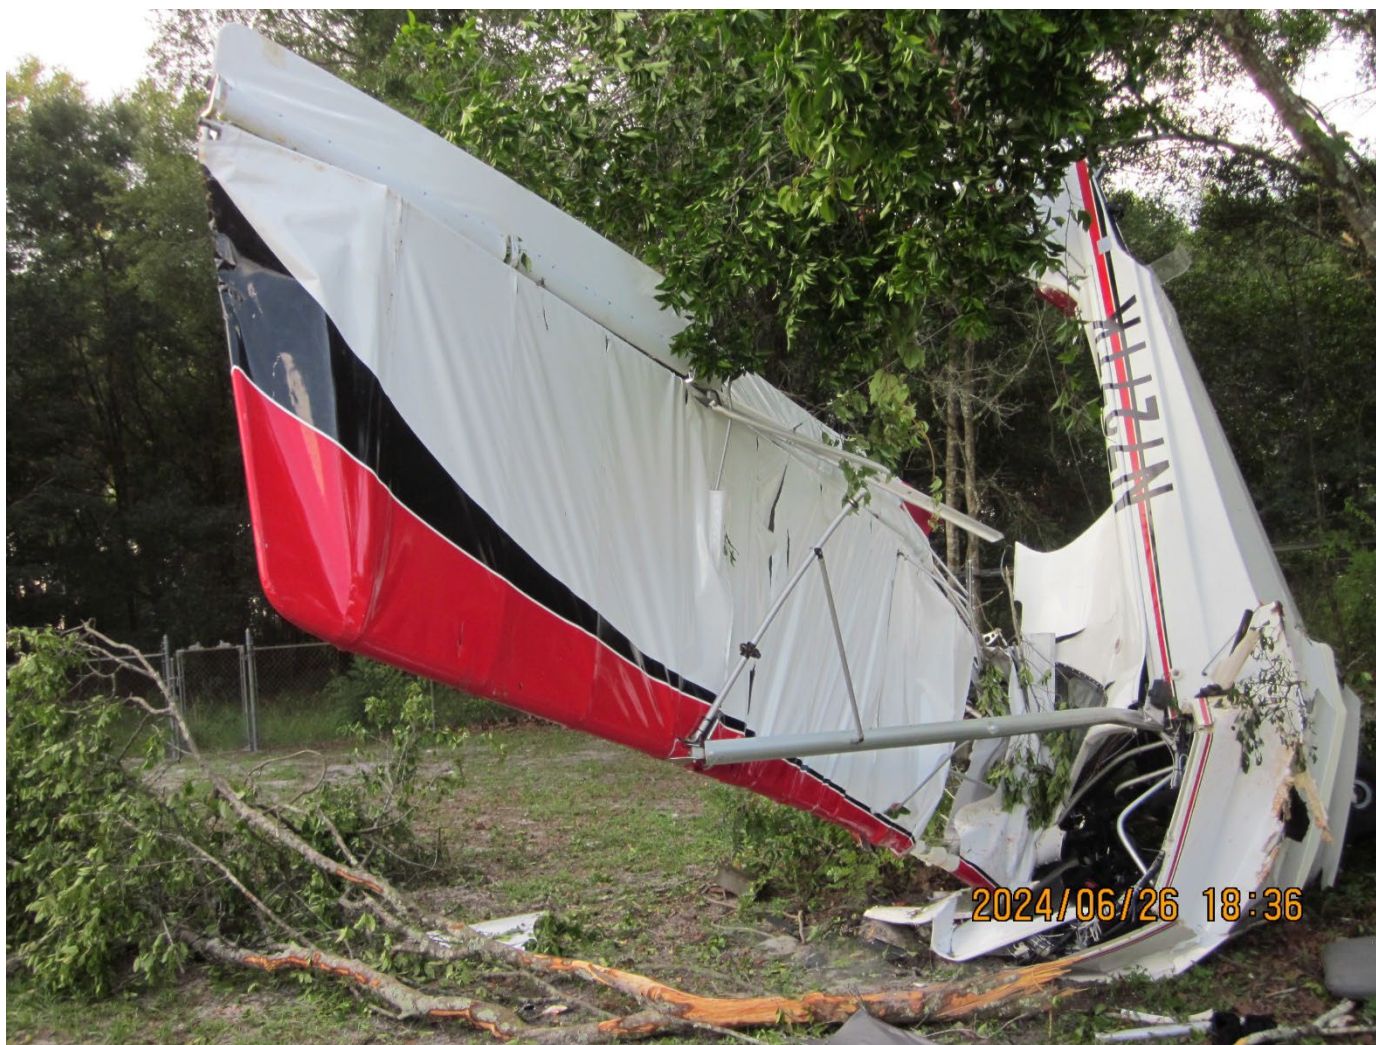
Photograph 1 - Postaccident view of wreckage (Courtesy of FAA)

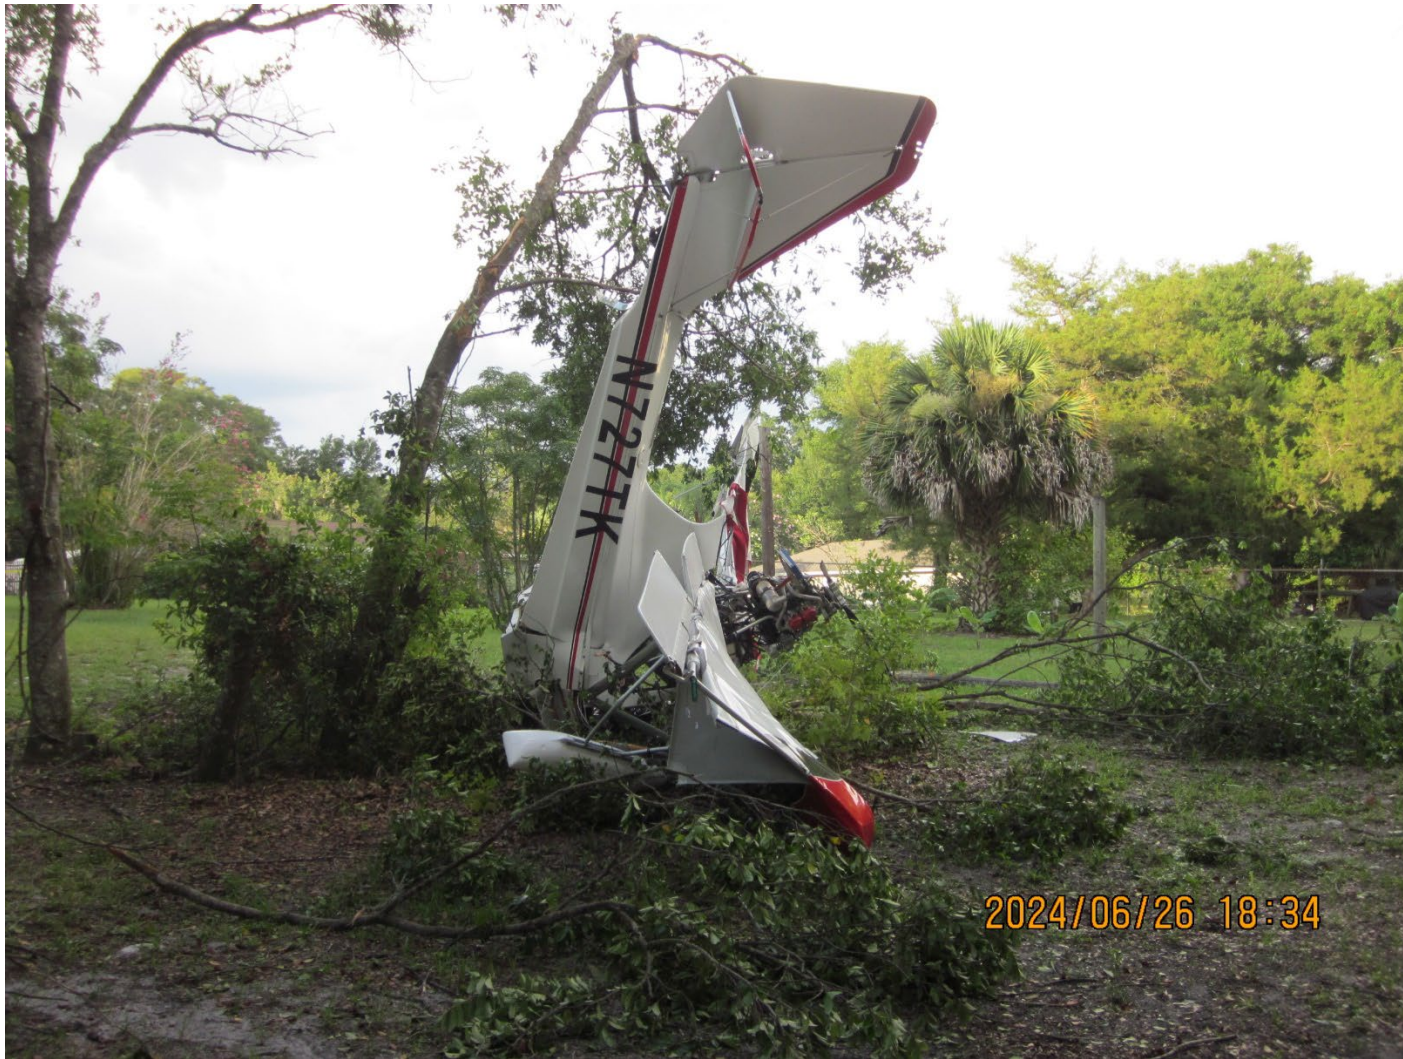
Photograph 2 - Postaccident view of wreckage (Courtesy of FAA)

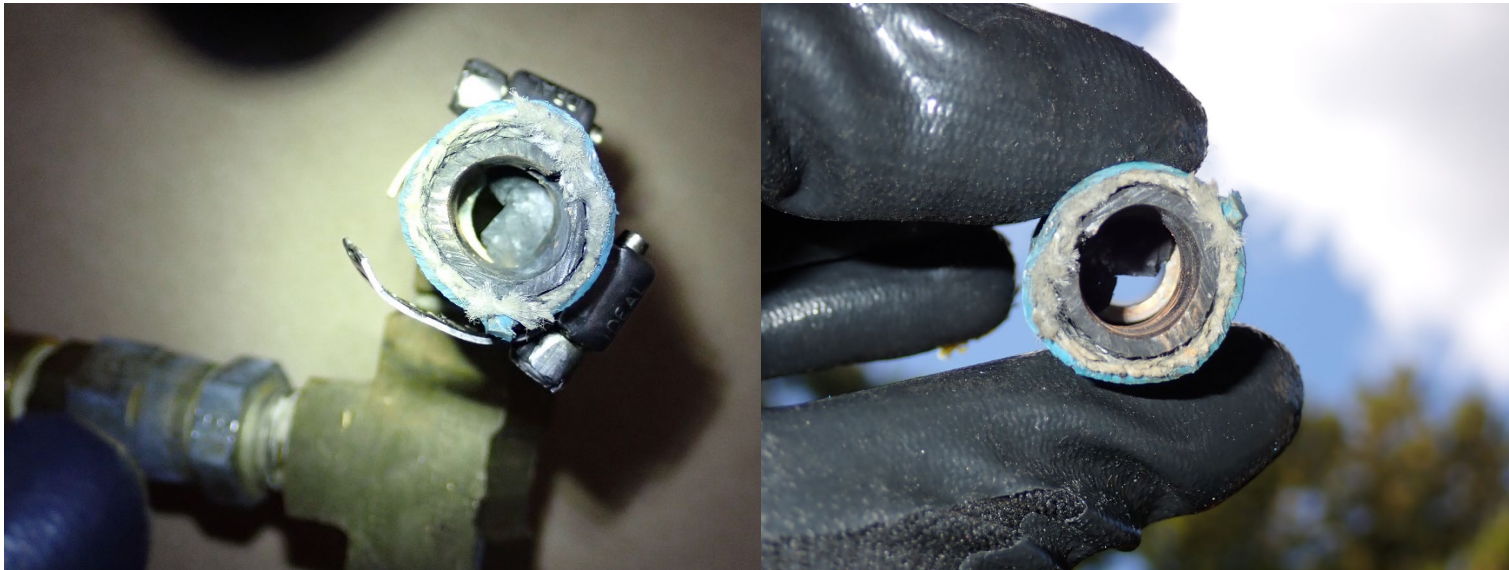
Photograph 3 & 4 - Two views of partially occluded fuel line from fuel pump inlet manifold

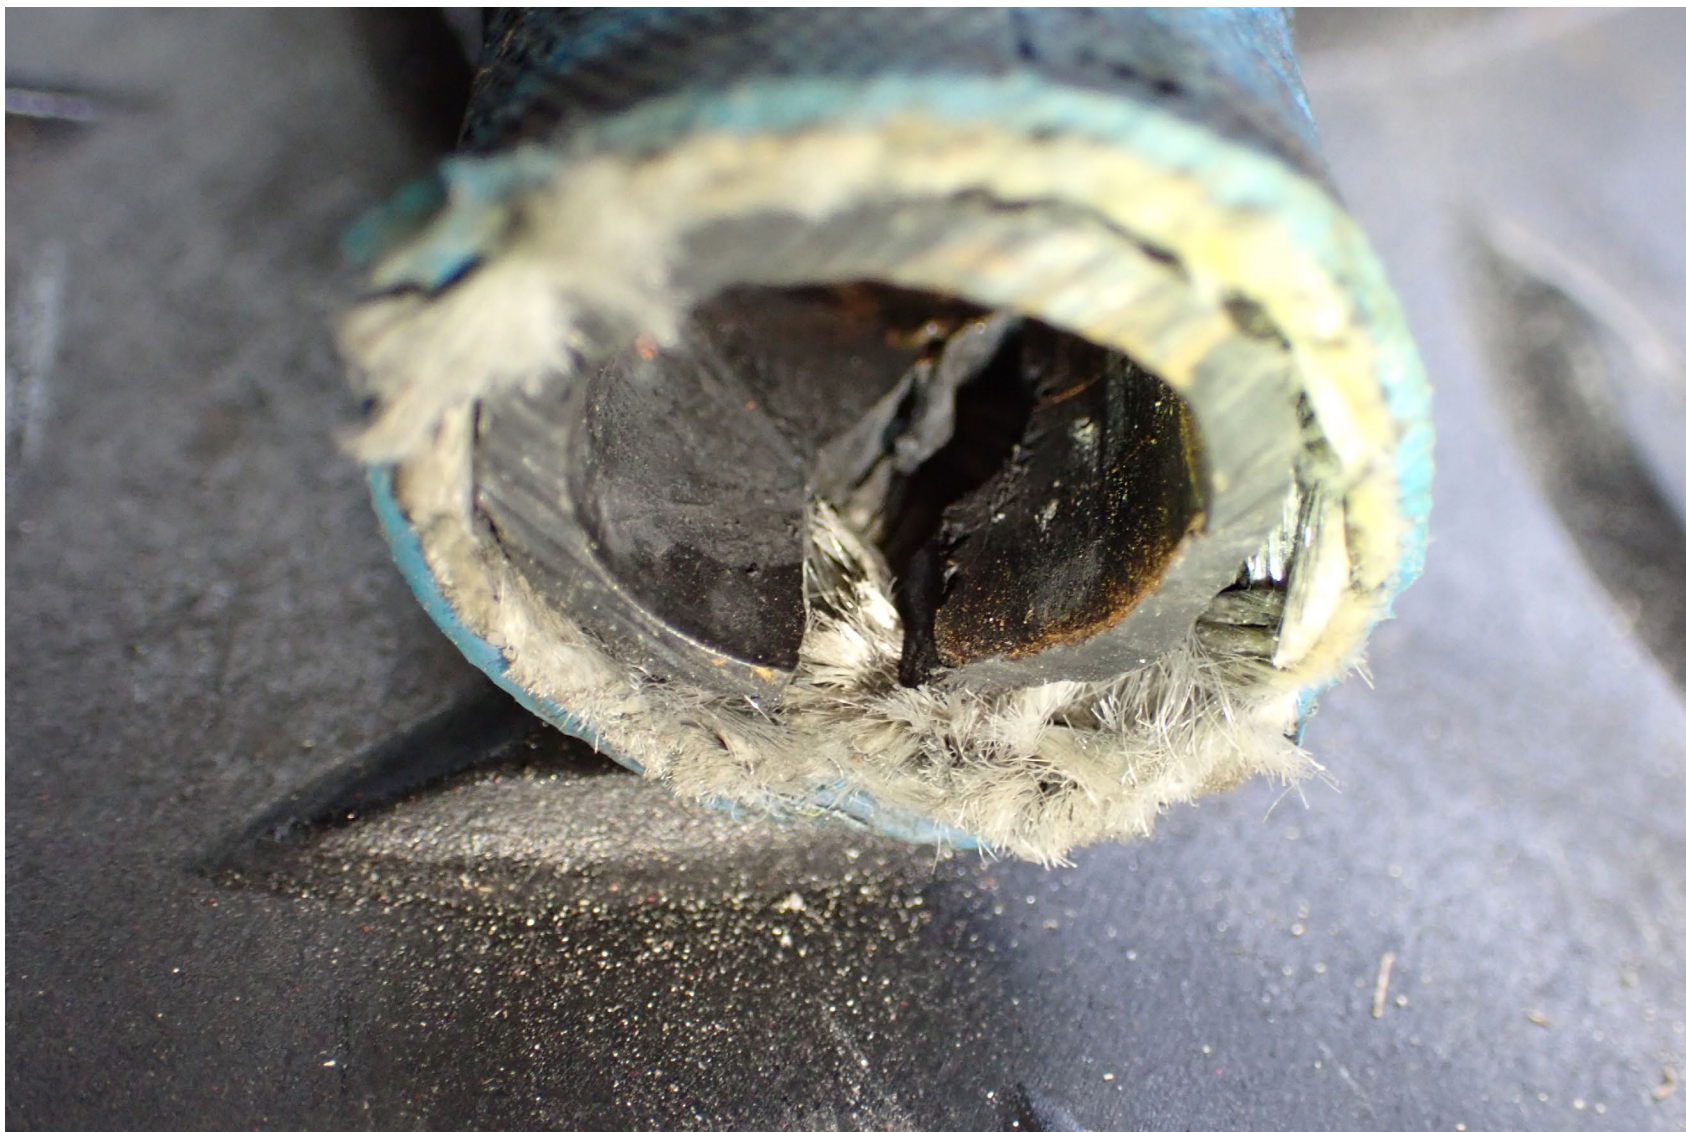
Photograph 4 - Cracked fuel hose from fuel pump inlet manifold

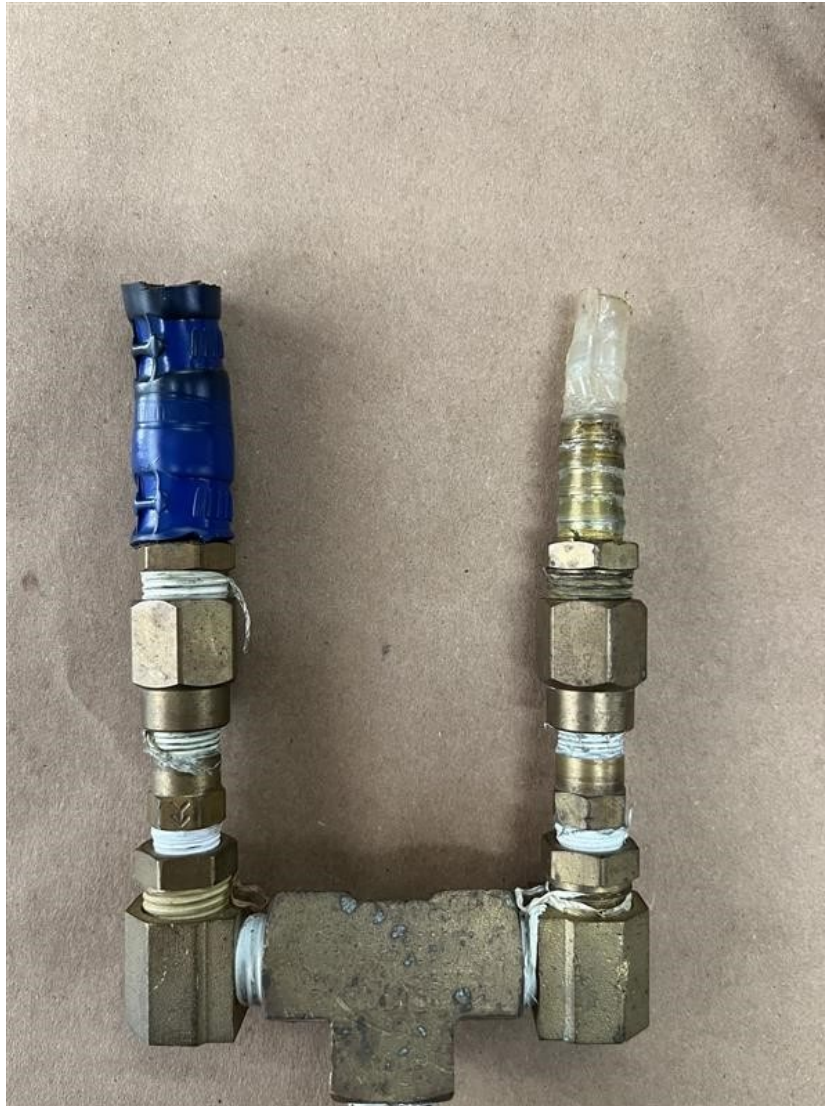
Photograph 5 - Fuel pump outlet manifold hose and fitting installation

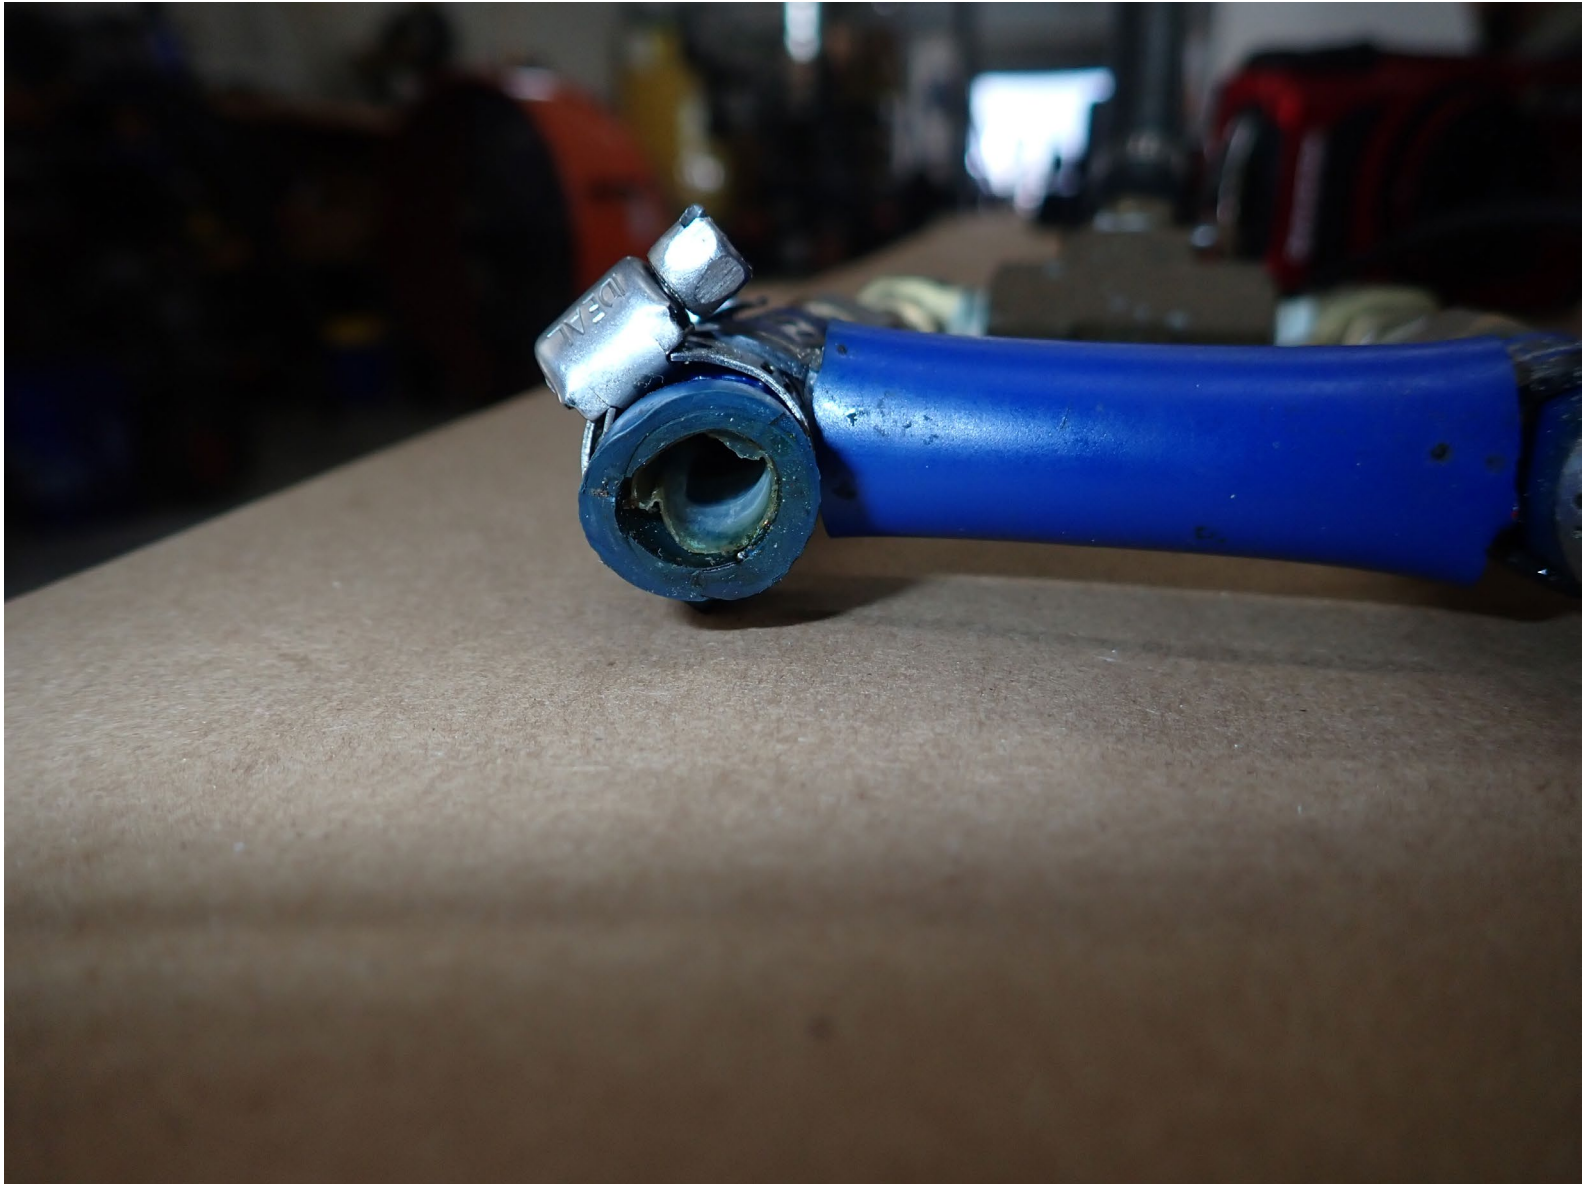
Photograph 6 - Partially occluded fuel hose from fuel pump outlet manifold
