Early Warning  
December 14, 2018  
EW-5331

File Number: BSC 480.12

**Subject: Repair of Trainline Arrangements on Box Cars**

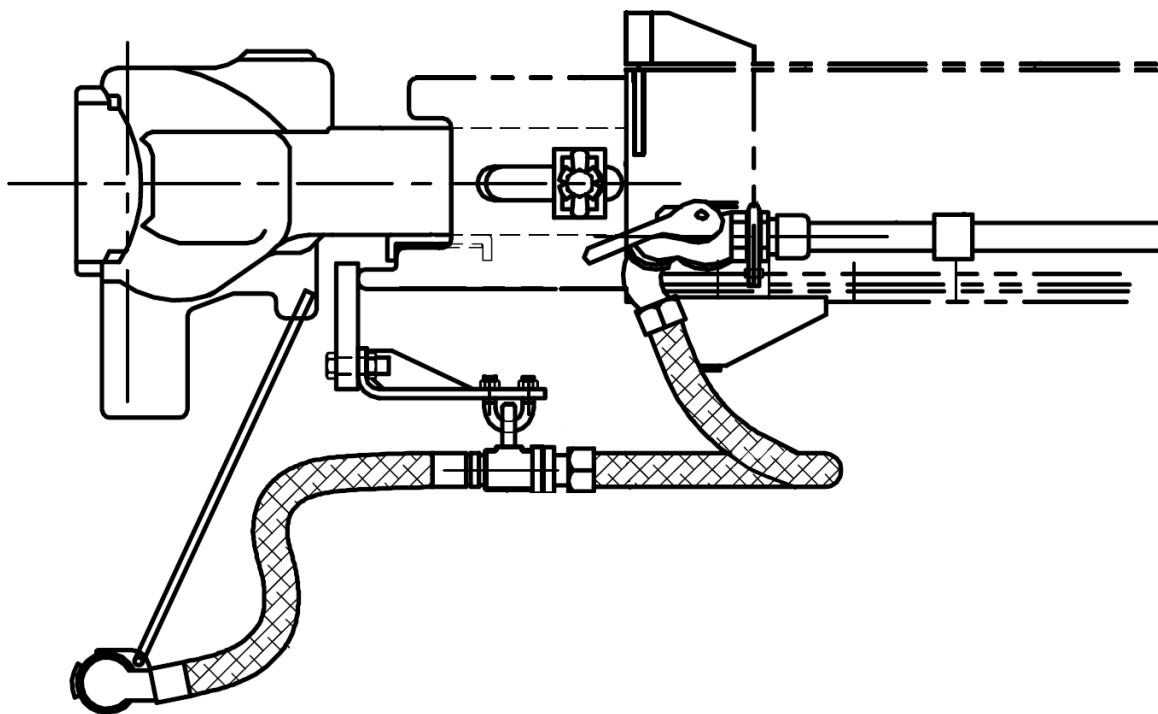
**Figure 1(a): Trainline Arrangement on Suspect Cars**

The AAR has been notified of a specific trainline arrangement/brake rigging configuration that has caused limited cases of kinked intermediate air hoses and a loss of continuity through the trainline. The arrangement had proven itself reliable based on time in service but bent components and variations in repairs led to conditions that caused the kinks.

Since the cars involved were built circa 1995, the trainline arrangement is fairly unique and predates current standards. Twenty-eight (28) suspect cars have been identified that were originally configured with both the trainline arrangement shown in Figure 1(a) and with “Hook and Eye” Brake Rigging identified in Figure 1(b). The trainline arrangement was originally configured with the following components:

- Floating Yoke with attached Trainline Support Bracket
- 39" Intermediate Air Hose
- Long Sweeping Elbow
- Trainline Support Casting with clevis connected to the Trainline Support Bracket by a U-Bolt

The correct repair is to replace trainline arrangement components, as needed, and reconfigure to a Coupler Attached Bracket based arrangement as shown in Figure 2.

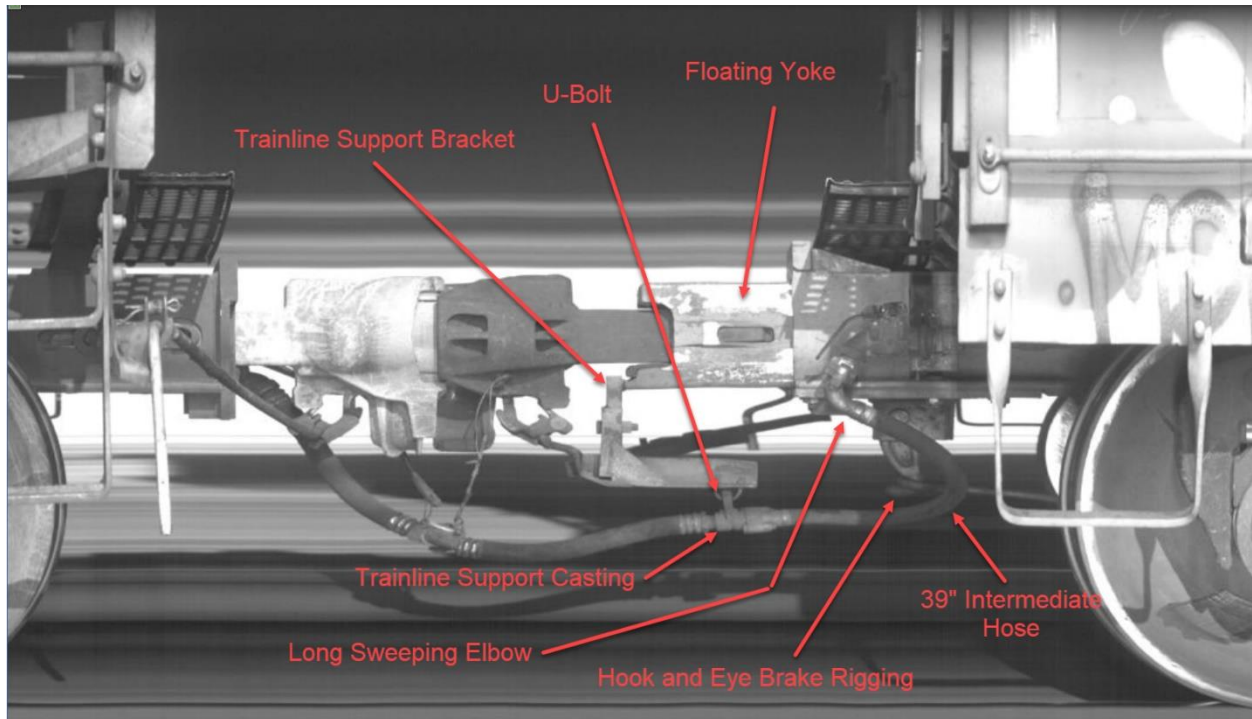
**Figure 1(b): Wayside Image of Trainline Arrangement with Components Identified**

In accordance with AAR Interchange Rule 125, this Early Warning is assigned Severity Code: 06 - AAR Defined. The twenty-eight (28) cars included on this EW shall be stopped only when empty and both ends should be inspected for presence of the Hook and Eye Brake Rigging shown in Figure 1(b). If the Hook and Eye rigging is present, the car should be addressed as follows:
