**USCG MARINE SAFETY CENTER**  
**POST-SINKING STABILITY ANALYSIS OF F/V EMMY ROSE**

**EXPLANATION OF ANALYSIS AND ASSUMPTIONS**

**March 2, 2022**

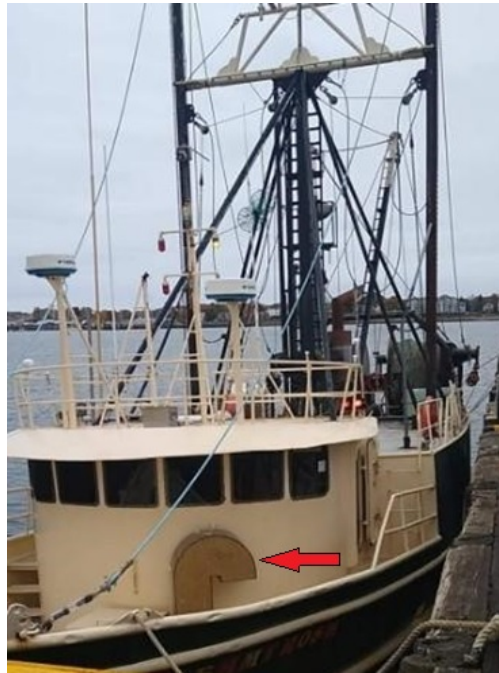
Figure 4.1: Engine Room Vent downflooding point

Downflooding points are typically identified during the stability test and described in the field notes or analysis with pertinent information such as location and watertight integrity properties. There was a lack of information to properly identify possible downflooding points for this analysis. In reference (b) the only downflooding point noted is the engine room vent located 50 inches off the bulkhead deck, however, the longitudinal and transverse location of the vent are omitted. The location of the engine room vent was assumed to be the vent located on the

forward portside of the pilot house, see Figure 4.1. The location of this downflooding point was estimated by using scaled measurements from pictures and reference (c).

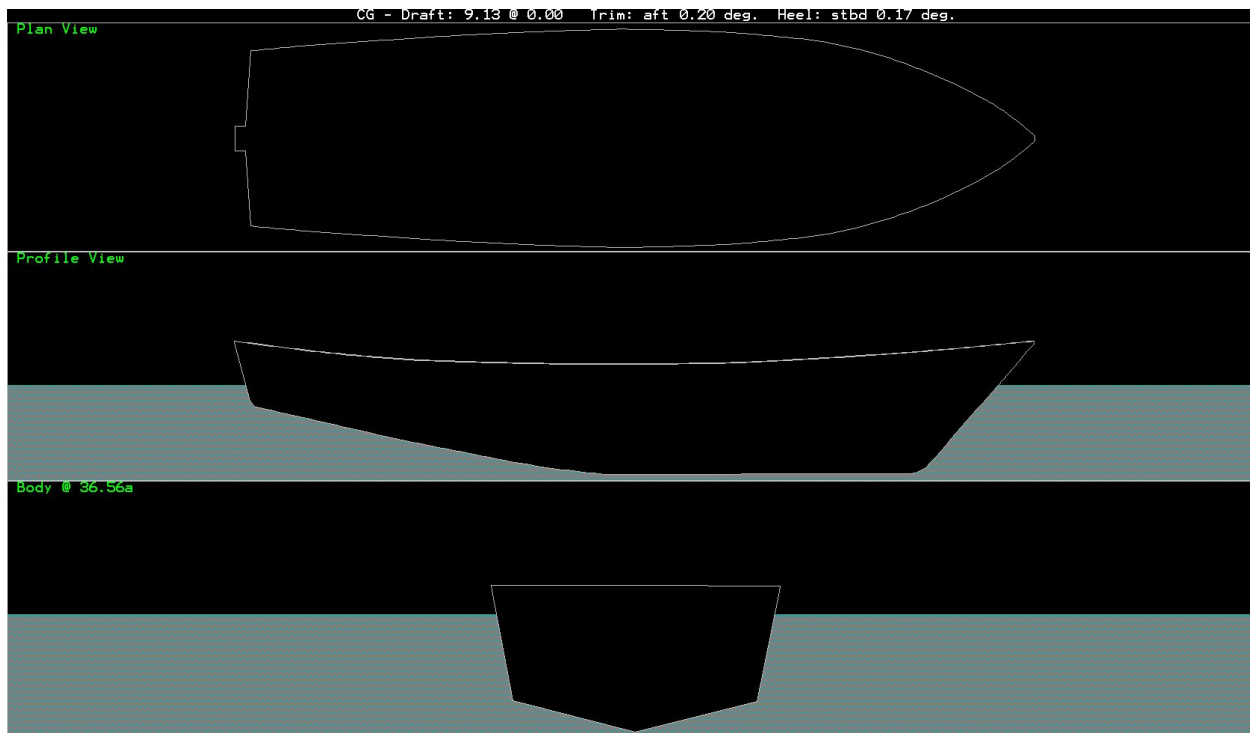
Figure 5.1: Equilibrium Condition at Time of Incident (Load Condition 9)

Load condition 8 represents the vessel in transit with no catch onboard. Load condition 9 represents the estimated condition of the vessel at the time of the incident based on the reported catch onboard and typical liquid load for that point in the voyage. The additional weight of the known larger trawler door modification was added in load condition 9. The equilibrium condition of the vessel at load condition 9 can be seen in Figure 5.1.

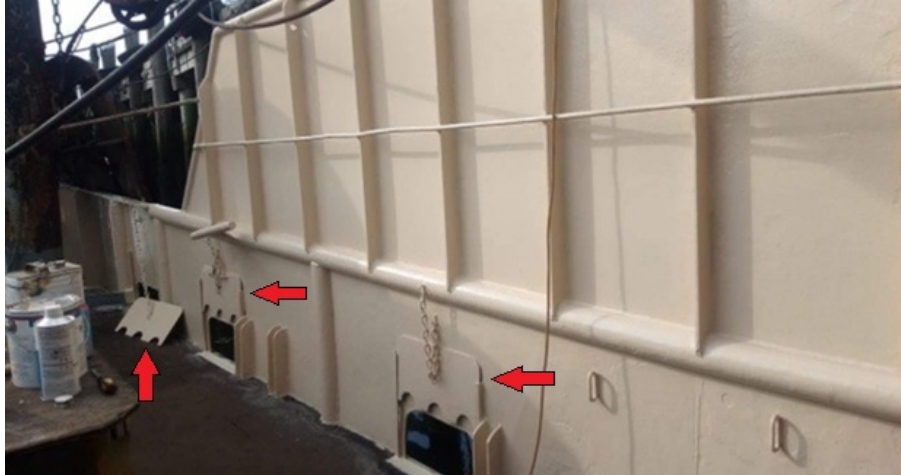
Figure 7.1: Freeing Port Restrictor Plates

In addition to Subchapter C intact stability, fishing industry vessels must meet the drainage requirements of 46 CFR 28.555 Freeing Ports. The vessel was equipped with six freeing ports on each side of the vessel. The main deck was separated by a transverse bulkhead just aft of the pilot house. Two of the twelve freeing ports were located in the bow section to provide drainage of the forward bulwarks while the remaining ten freeing ports service the aft deck. The required freeing port area is a function of bulwark length with the required freeing port area calculated to be 48.94 square feet in enclosure (10).

Measurements were taken from photos to approximate the dimensions of the freeing ports. Due to the skew of the photograph, MSC approximated dimensions conservatively high. The dimensions of an individual freeing port was estimated to be 1.75 feet long by 1.25 feet high and all freeing ports were assumed to be identical. Using this estimate, the total freeing port area of the vessel was estimated to be 26.25 square feet, much less than the required 48.94 square feet. Additionally, the vessel had restrictor plates installed that could cover the freeing ports (see Figure 7.1), and drastically restrict deck drainage. Each restrictor plate has three semicircular openings that measure approximately 4 inches in diameter. If all twelve restrictor plates were installed and in the closed position, the total freeing port area would have been reduced to only 1.57 square feet. The vessel was also fitted with removable “storm gates” in the bulwark under the aft net reels, see Figure 7.2. With the “storm gates” removed additional drainage would be gained, but this area was not included in the freeing port calculation since the gates are typically in place during inclement weather.

Table 7.1 is a summary of the required and actual freeing port areas. Insufficient deck drainage has the potential to retain water on deck, increasing the vessel’s displacement, reducing its freeboards and righting arms, and reducing the effective height of downflooding points. Off-center pocketing and shifting of water on deck also reduces the vessel’s stability.

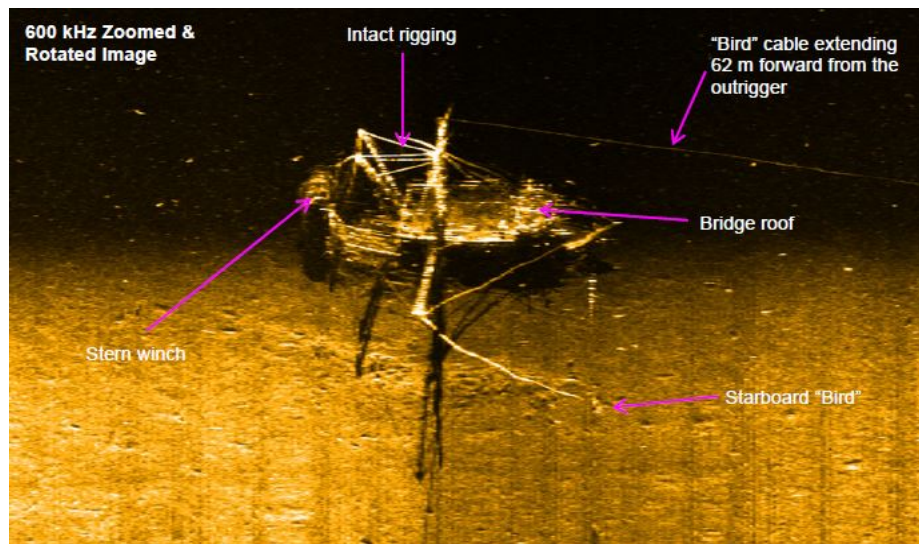
Figure 9.1: Sonar image of F/V EMMY ROSE from MIND Technology

A side scan sonar search was conducted by MIND Technology on May 17-21, 2021 to locate the F/V EMMY ROSE. The vessel was found in the vicinity of the last known EPIRB transmission and can be seen in Figure 9.1 resting on the seabed in an upright position with the outriggers

deployed. The sonar image shows the paravanes, also known as “birds,” are paid out forward of the vessel, indicating the vessel possibly sank stern first through the water column. There is also a difference in cable length for the paravanes with the port side paid out four times further at 62 meters. A possible cause for this could be winch failure from water intrusion during the sinking. It was also explored that the paravane snagged bottom, but this is not possible since the vessel is in over 200 meters of water. The sonar scan does not indicate any damage from an allision or collision.
