National Transportation Safety Board

ERA23FA006

ENGINE EXAMINATION

Location: Arundel, Maine
Date: October 5, 2022
Time: 1356 EST
1856 UTC N906AT,
Airplane: Beech A36

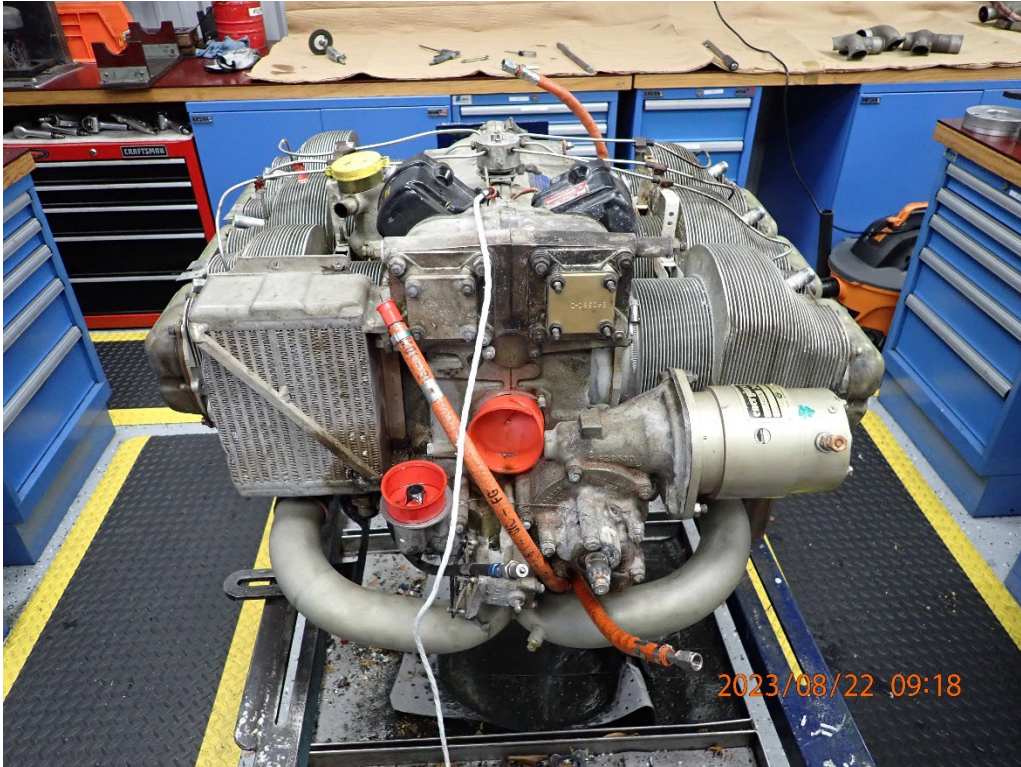
The engine was separated from the airframe. The propeller was rotated by hand and continuity was established through the powertrain to the valvetrain and the accessory section. Compression was attained using the thumb method. The magnetos were secure in their mounts and produced spark at all terminal leads when the crankshaft was rotated. The engine was retained for further examination.

Photo 1: Engine as first viewed at the facility.

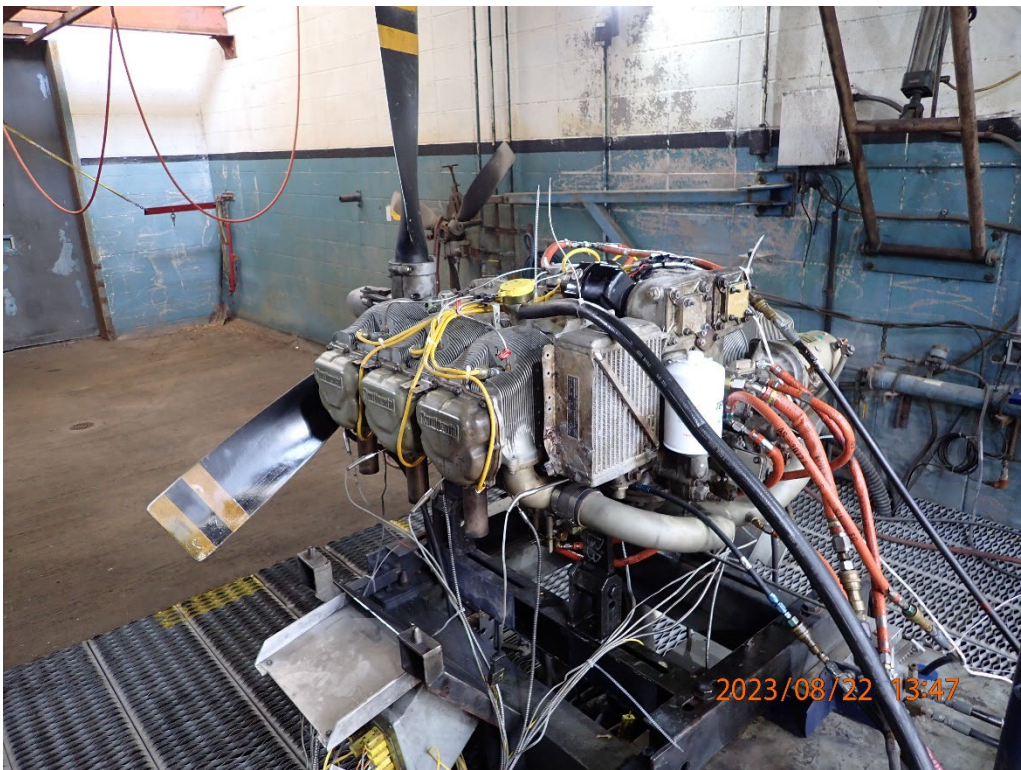
An engine test run was then performed, and the engine accelerated smoothly from idle to a maximum of about 2550 RPM (Maximum-rated 2700 rpm) with the throttle fully open. During the engine test run the engine idled at about 500 RPM. The engine was then accelerated to 1800 RPM and ran smoothly at that power setting for about 3 minutes. It was then advanced to about 2100 RPM which would be consistent with a power setting used for an instrument approach procedure. The engine ran smoothly at that power setting for about 4 minutes. The engine ran at maximum RPM for about 3 minutes. A magneto check was performed at 2100 RPM when switched to only the left magneto the RPM dropped 124 RPM and when switched to only the right magneto the RPM dropped 135 RPM.

Photo 2: The engine fitted to the stand for test run.

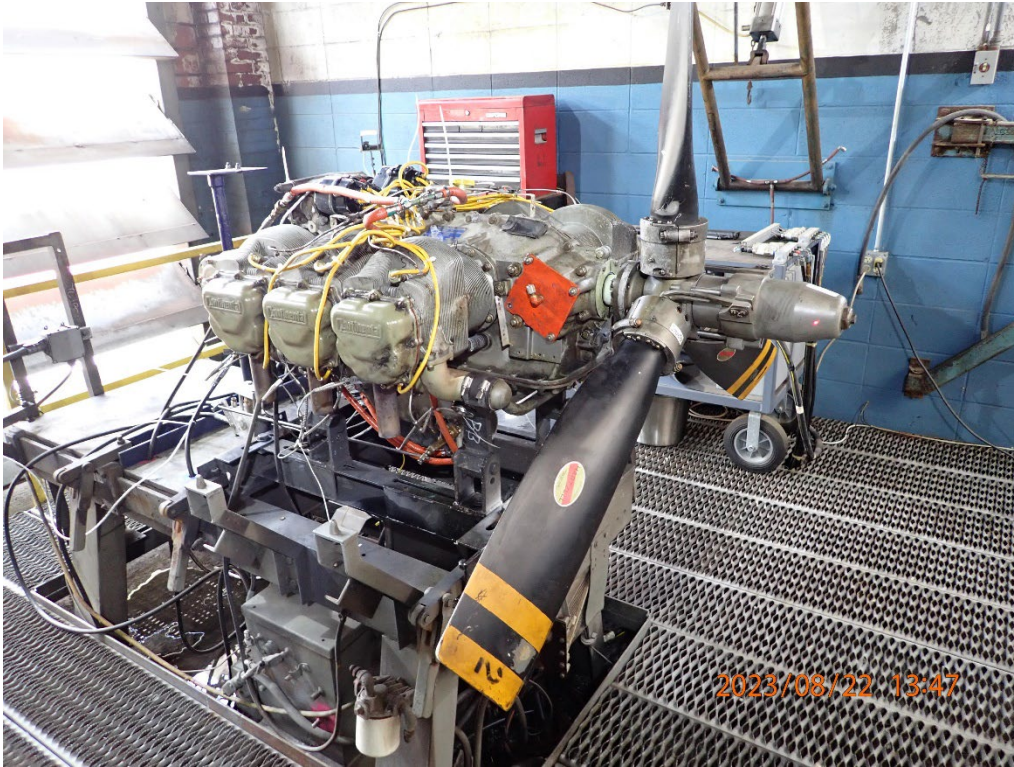
Photo 3: The engine fitted to the stand for test run.

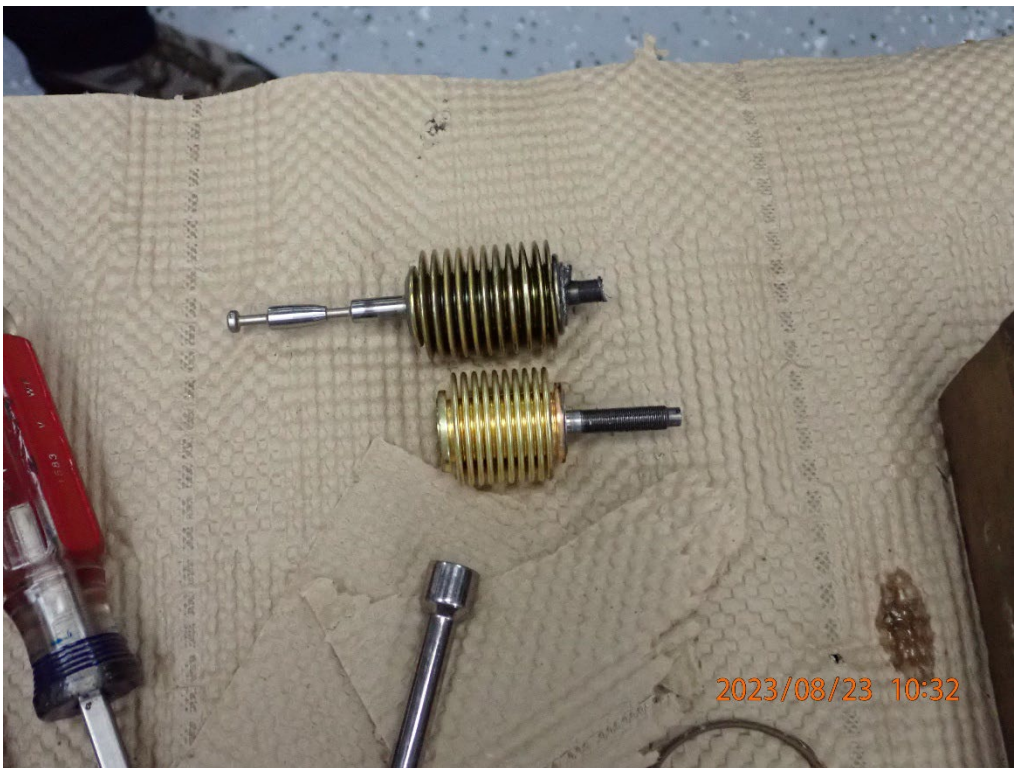
The No. 6 cylinder exhaust gas temperature (EGT) was "low," likely due to an inoperative test cell EGT probe. The cylinder head temperature was on the "low side" of the normal operating range. The fuel flow was lower than expected which likely resulted in the lower than expected RPM during full throttle application. The altitude compensating engine driven fuel pump was disassembled, the impact damage to the fuel pump punctured the aneroid bellows and resulted in the bellows being fully expanded. The bellows being expanded would result in a lower than normal fuel flow.

Photo 4: Exemplar aneroid bellows (lower) vs aneroid bellows from accident engine (upper).
