National Transportation Safety Board

WPR22FA331

ENGINE EXAMINATION

Location: Shafter, California
Date: September 2, 2022
Time: 1100 Pacific daylight time
Airplane: N5943, Yakovlev Yak-11

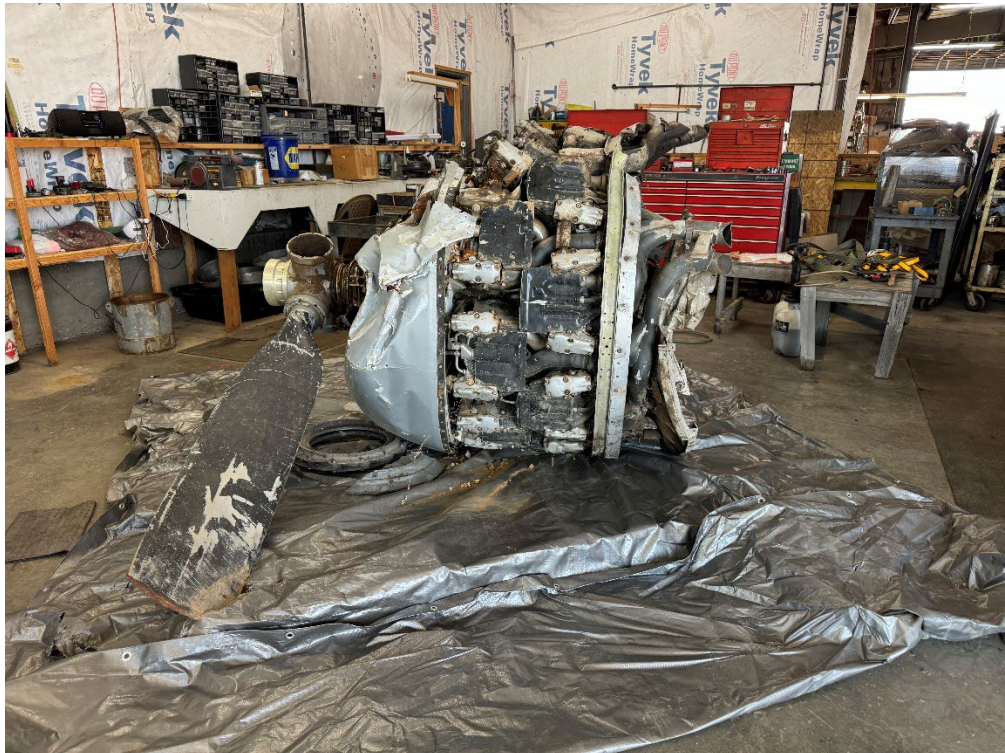
Examination of the engine revealed that the engine was separated into 2 sections, between the main case and the collector case. The collector case was impact damaged. A separated section remained attached to the main case.

Figure 1: Forward section of the engine.

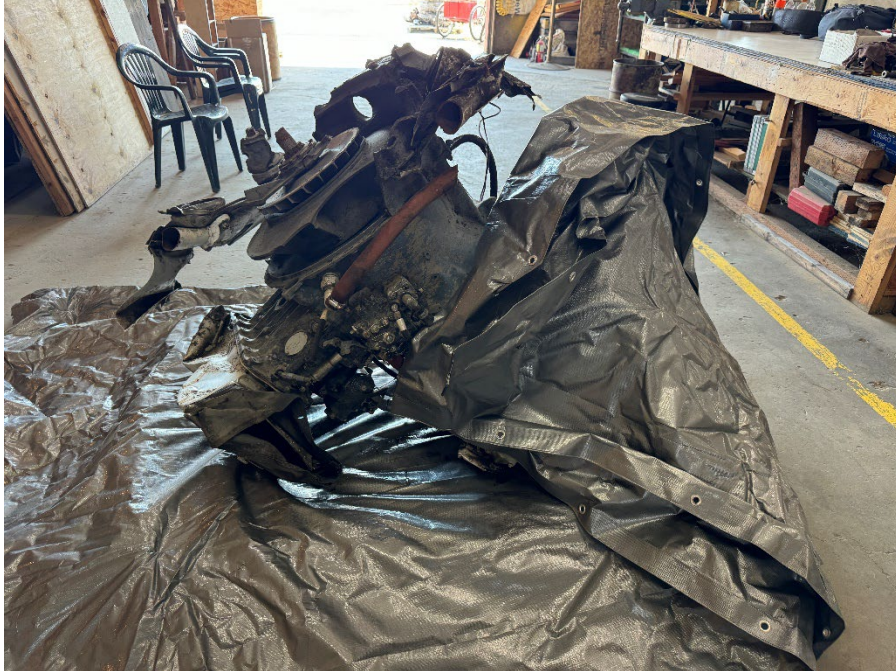
Figure 2: Collector case, intermediate rear case, and rear case assemblies.

Internal examination of the collector case, intermediate rear case, and rear case sections revealed no evidence of any thermal discoloration. A slight amount of metallic debris was observed in the internal areas of the collector case and intermediate rear case sections.

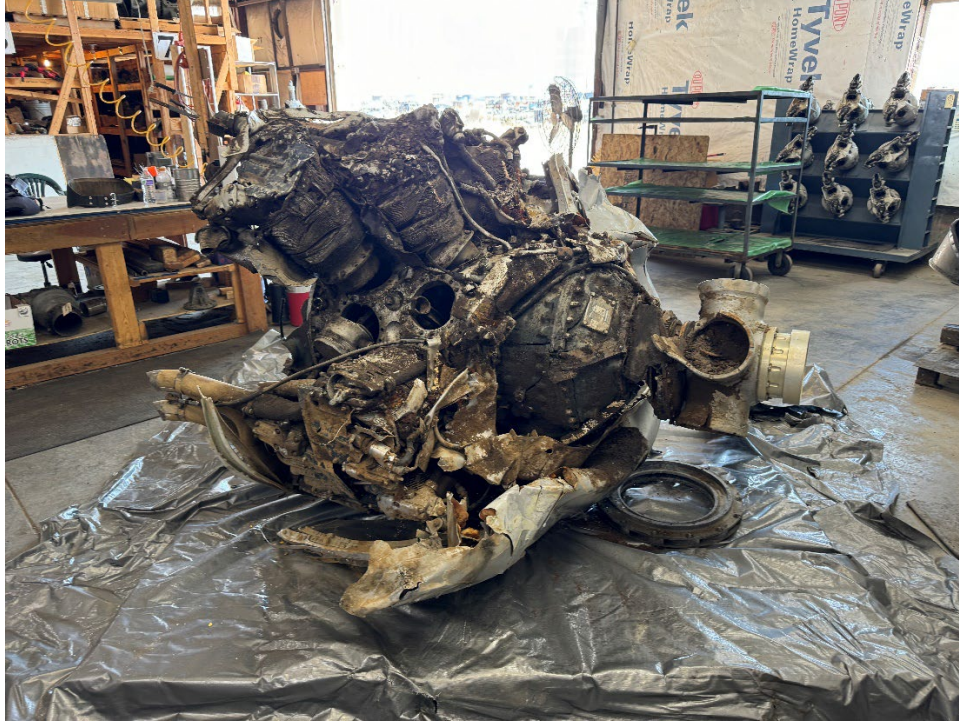
The induction system and exhaust exhibited varying degrees of impact damage. Cylinders nos. 8 and 9 were impact damaged. Cylinders nos. 12 and 13 were separated. Cylinder nos. 10, 11, and 14 were partially attached. The front case and front accessory case was cracked in various locations, consistent with impact damage.

Figure 3: Forward section of the engine with the area of impact damage and displaced cylinders.

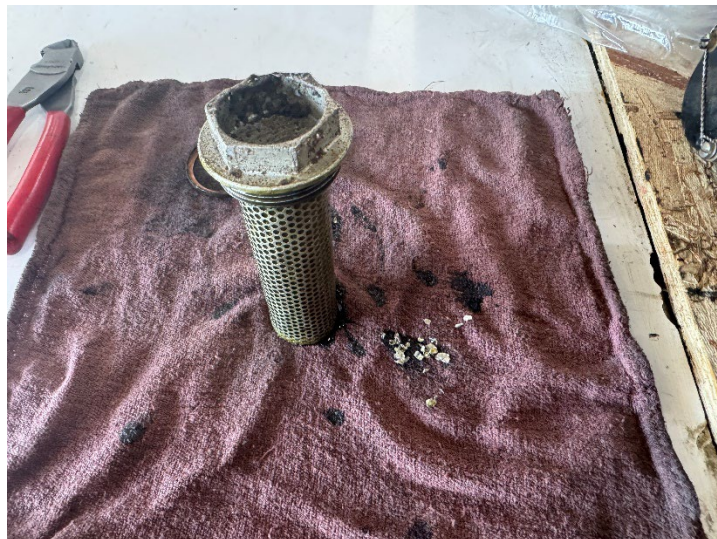
The intermediate rear case scavenge oil screen was removed and contained several metallic flakes. The main sump drain plug was removed and contained a small amount of metallic debris and dirt. The main oil screen was removed and contained a significant amount of metal particles/debris.

Figure 4: Intermediate rear case scavenge oil screen and metallic flakes.

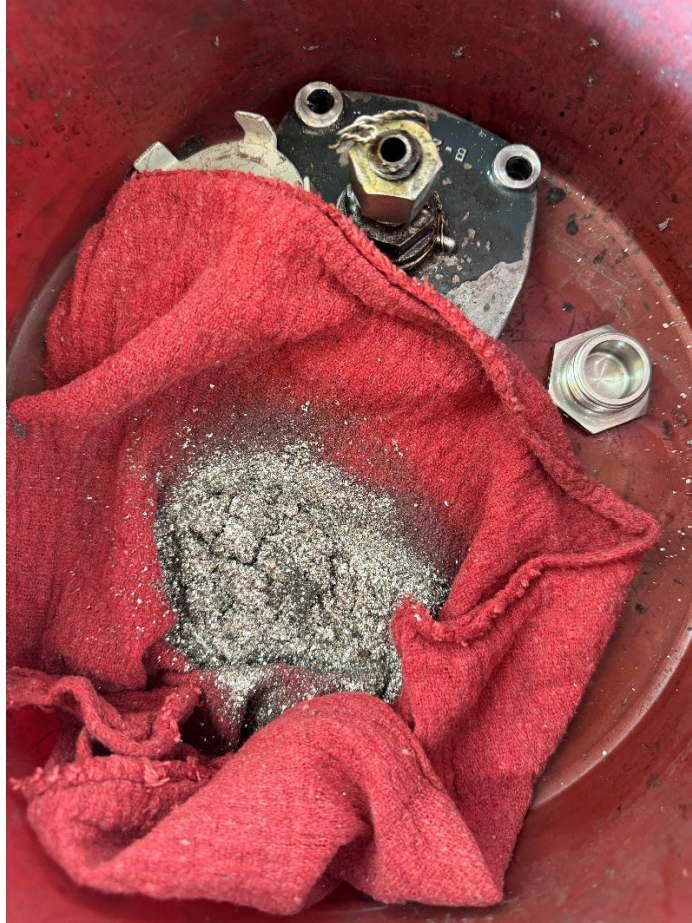
Figure 5: Main oil screen metallic debris.

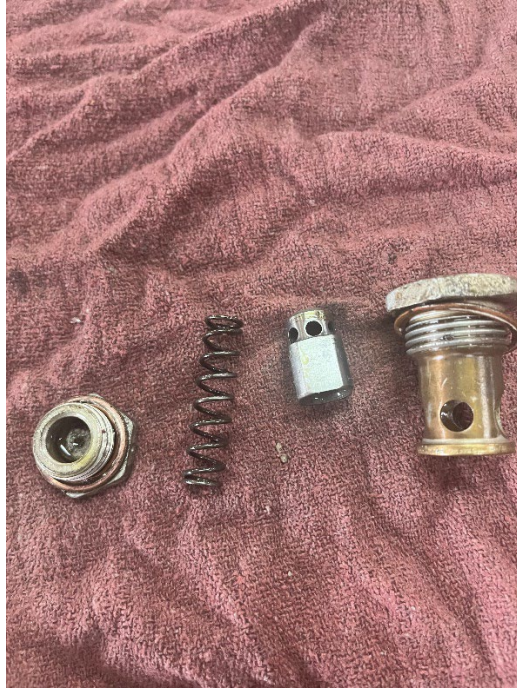
The oil pressure relief bypass valve was removed and disassembled. A small amount of metallic debris was observed within the relief valve.

Figure 6: Disassembled oil pressure relief bypass valve. Photo courtesy of Anderson Aeromotive Inc.

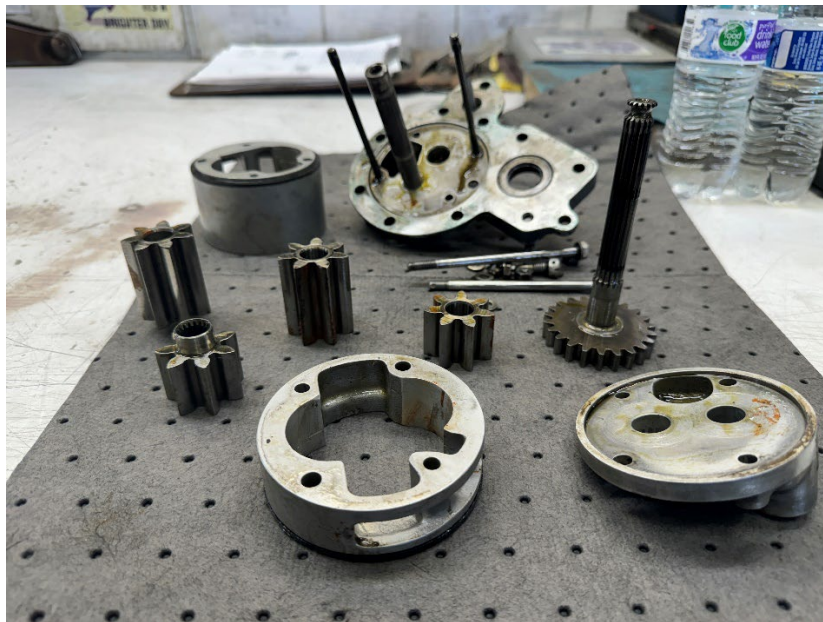
The scavenge pump removed and disassembled. A small amount of corrosion was observed on the scavenge pump gears. Scoring was observed on the inner walls of the scavenge pump body.

Figure 7: Disassembled scavenge pump.

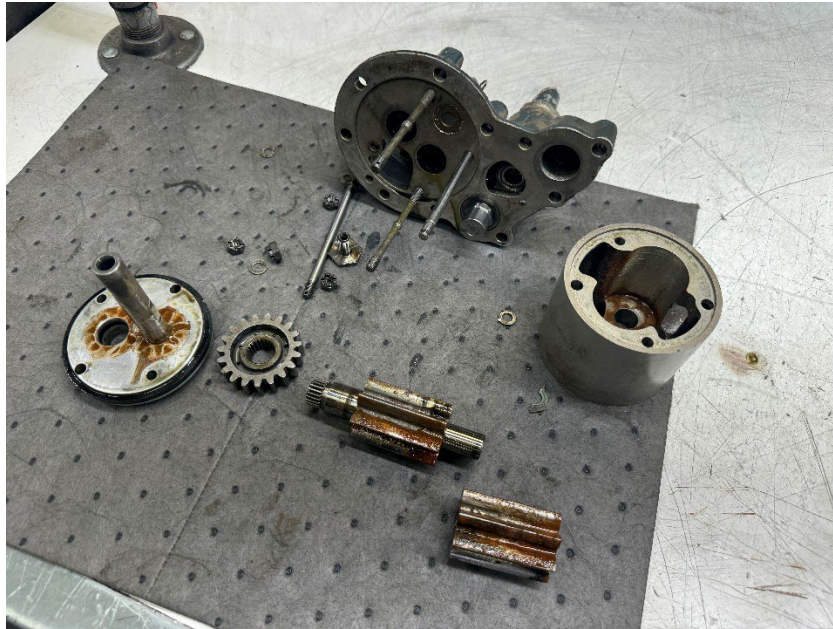
The oil pump was removed and disassembled. Scoring was observed on the inner walls of the oil pump body. The internal gears exhibited varying degrees of corrosion.

Figure 8: Disassembled oil pump.

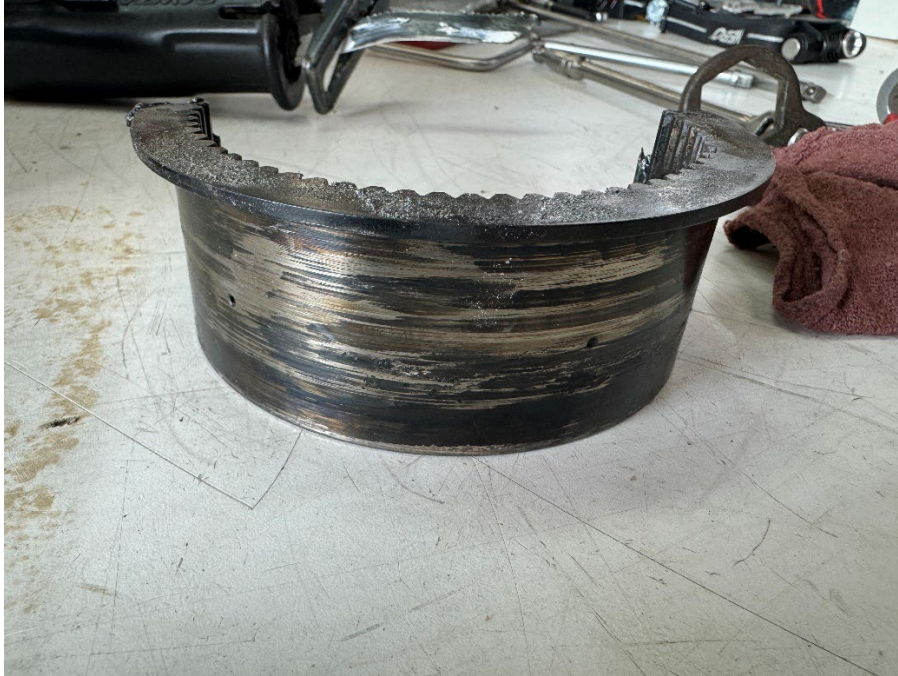
The front case and propeller shaft were removed from the main case. Metallic fragments were observed throughout the front case. Fragments of the front secondary counterbalance bearing was observed on the front case side of the main case. Thermal discoloration of the front secondary counterbalance assembly was observed. The front secondary counterbalance bearing was fused to the crankshaft. The bearing was cut off using a cutting torch. Portions of the removed bearing exhibited thermal discoloration and scoring along the outer area of the bearing.

Figure 9: Portion of the front secondary counterbalance bearing.

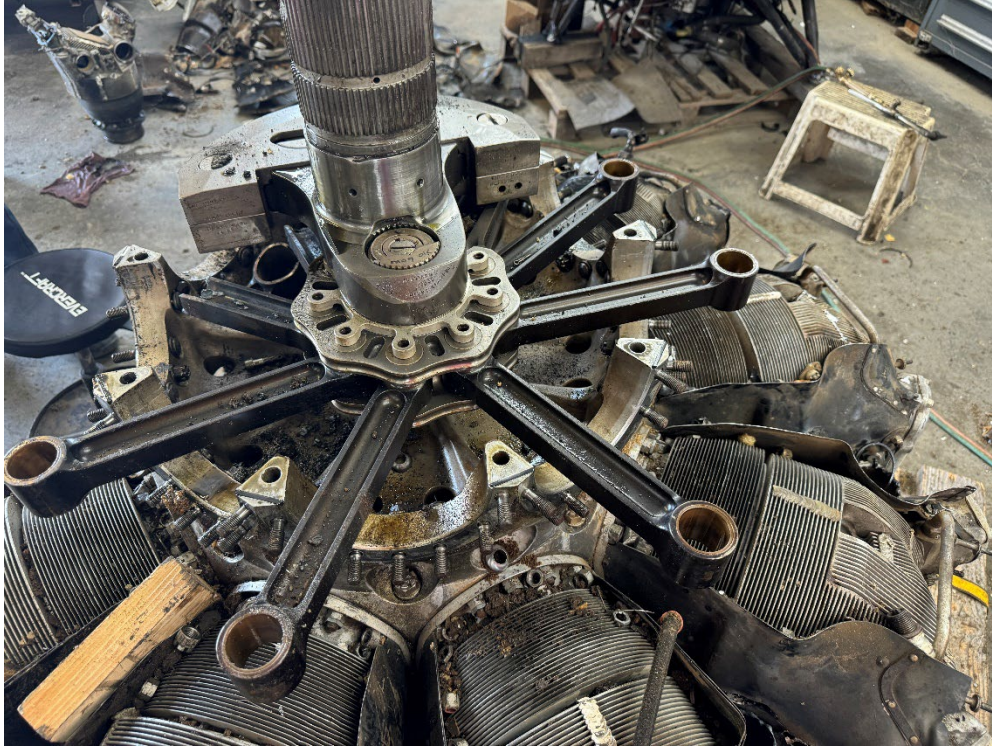
The front cylinders (cylinder nos. 1, 3, 5, 7, 9, 11, 15, 17) were removed along with the forward section of the main case. The pistons on cylinders no. 1, 3, 5, 7, 9, 11, 15, and 17, exhibited slight scoring on the piston skirts, however, were otherwise unremarkable. The front link rods and master rod moved freely once the cylinders and pistons were removed. No thermal discoloration was observed on the master rod or link rods. No visible areas of thermal discoloration were observed on any of the rear cylinder link rods, or master rod. The front crankshaft bearing was unremarkable. The counterweight was unremarkable.

Figure 10: View of the front link rods, master rod, and crankshaft bearing assemblies.

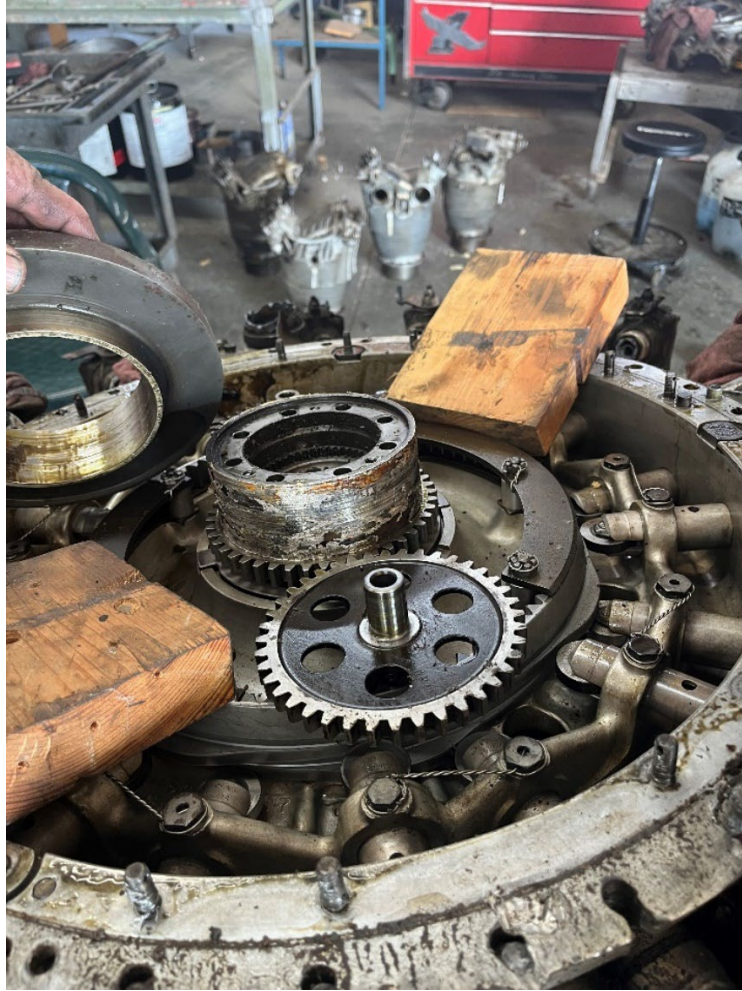
The rear support assembly was removed, which exposed the rear counterbalance and counterbalance bearing. The rear counterbalance exhibited thermal discoloration, with scoring within the inner part. The rear counterbalance bearing exhibited severe scoring and displaced bearing material.

Figure 11: Rear counterbalance, rear counterbalance bearing, and rear cam. Photo courtesy of Anderson Aeromotive Inc.

The rear cam was intact. The cam rollers were all intact and undamaged.
