National Transportation Safety Board

WPR22FA210

AIRFRAME AND ENGINE EXAMINATION

Location: Camarillo, California
Date: June 10, 2022
Time: 0803 Pacific daylight time
Airplane: Mooney M20K, N305L

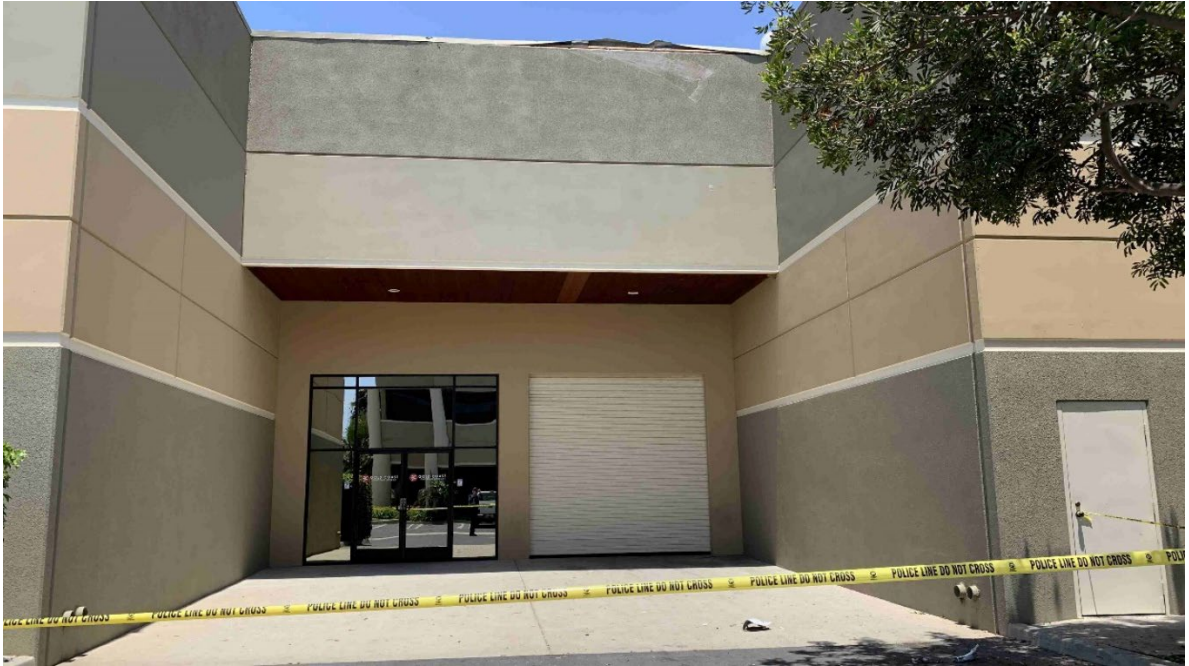
Figure 1 - First impact point

The first point of impact was identified by a wing-shaped imprint at the top wall of a building located south of the freeway, and one mile west-northwest of the departure end of runway 26 (figure 1). The imprint was about 50 ft above the ground, and its shape corresponded to a 15° right-wing-down impact attitude. The outboard section of the right wing and aileron were located on top of the building (figure 2). A trail of debris consisting of wing skin fragments and the right flap continued on a heading of 035° magnetic, across the freeway to a secondary impact point in a strawberry field, 750 feet beyond (figure 3).

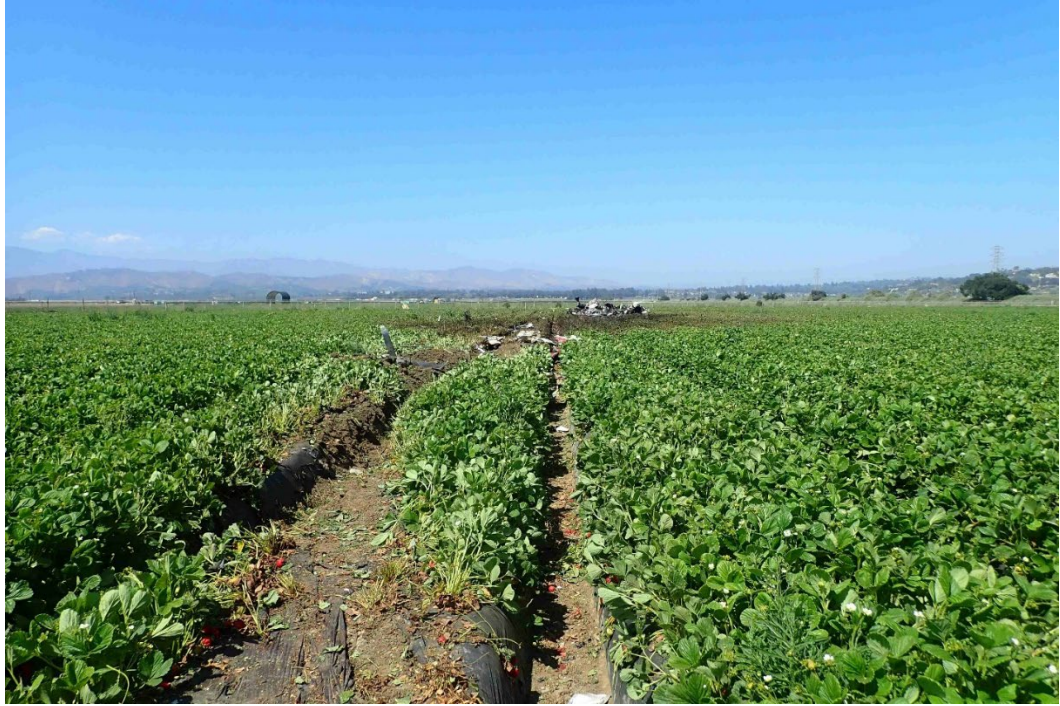
Figure 3 - Debris field

The debris beyond the secondary impact point consisted of the propeller, cabin skin fragments, and flight instruments, all leading to the main wreckage, which was on the same heading, a further 250 ft downrange (figure 3). The airframe sustained extensive impact and thermal damage through to the leading edge of the tail assembly. Impact and thermally damaged remnants of the left wing, along with the inboard section of the right wing remained attached to the center of the cabin (figure 4).

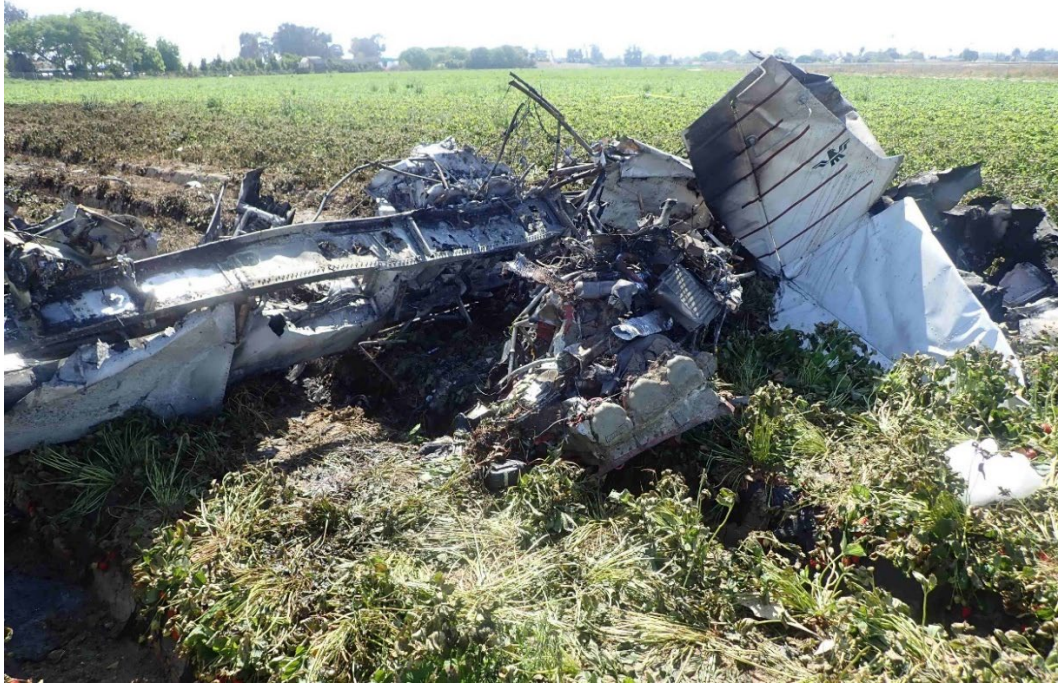
Figure 5 - Main wreckage

The fuselage sustained extensive fragmentation and thermal damage through to the leading edge of the moving tail assembly (figure 5). The flight controls, seats, and instrument panel were crushed and thermally damaged. Most of the flight instruments and avionics components were found distributed in the center of the debris field, and each had sustained varying degrees of impact damage. The vacuum driven attitude indicator and horizontal situation indicator were crushed such that their functionality at the time of the accident could not be determined. The circuit breaker panel was bent and sustained thermal damage, and most of the breakers were in the "open" position (figure 6). The throttle control was set about 1.5 inches aft from full forward, the propellor control was full aft, and the mixture control was full forward (figure 7).

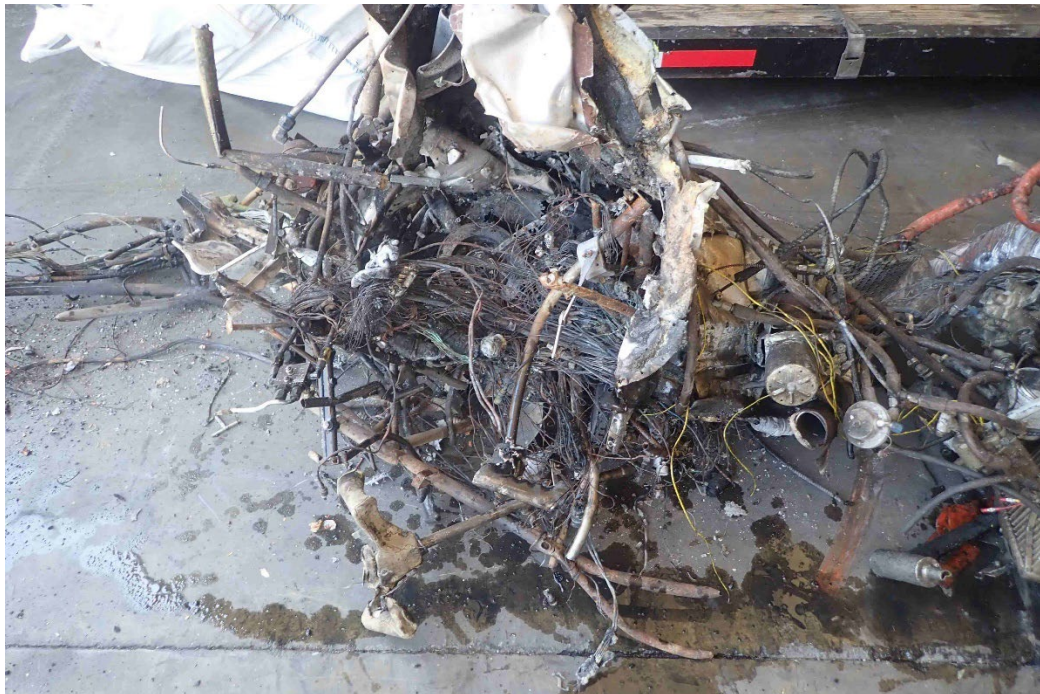
Figure 8 - Cabin flight controls

The flight control yoke, push-pull tube, and bellcrank assemblies within the forward cabin sustained extensive crush and fragmentation damage (figure 8). Examination of all separations revealed bending, tear, and other damage signatures consistent with overload. A section of the right seat rail and lower seat was located and appeared to be set in the middle of its travel range, damage and fragmentation of the remaining seat assemblies prevented a determination of their positions. Two rear and one forward-left seatbelt latch assembly were located, all were found locked (figure 9).

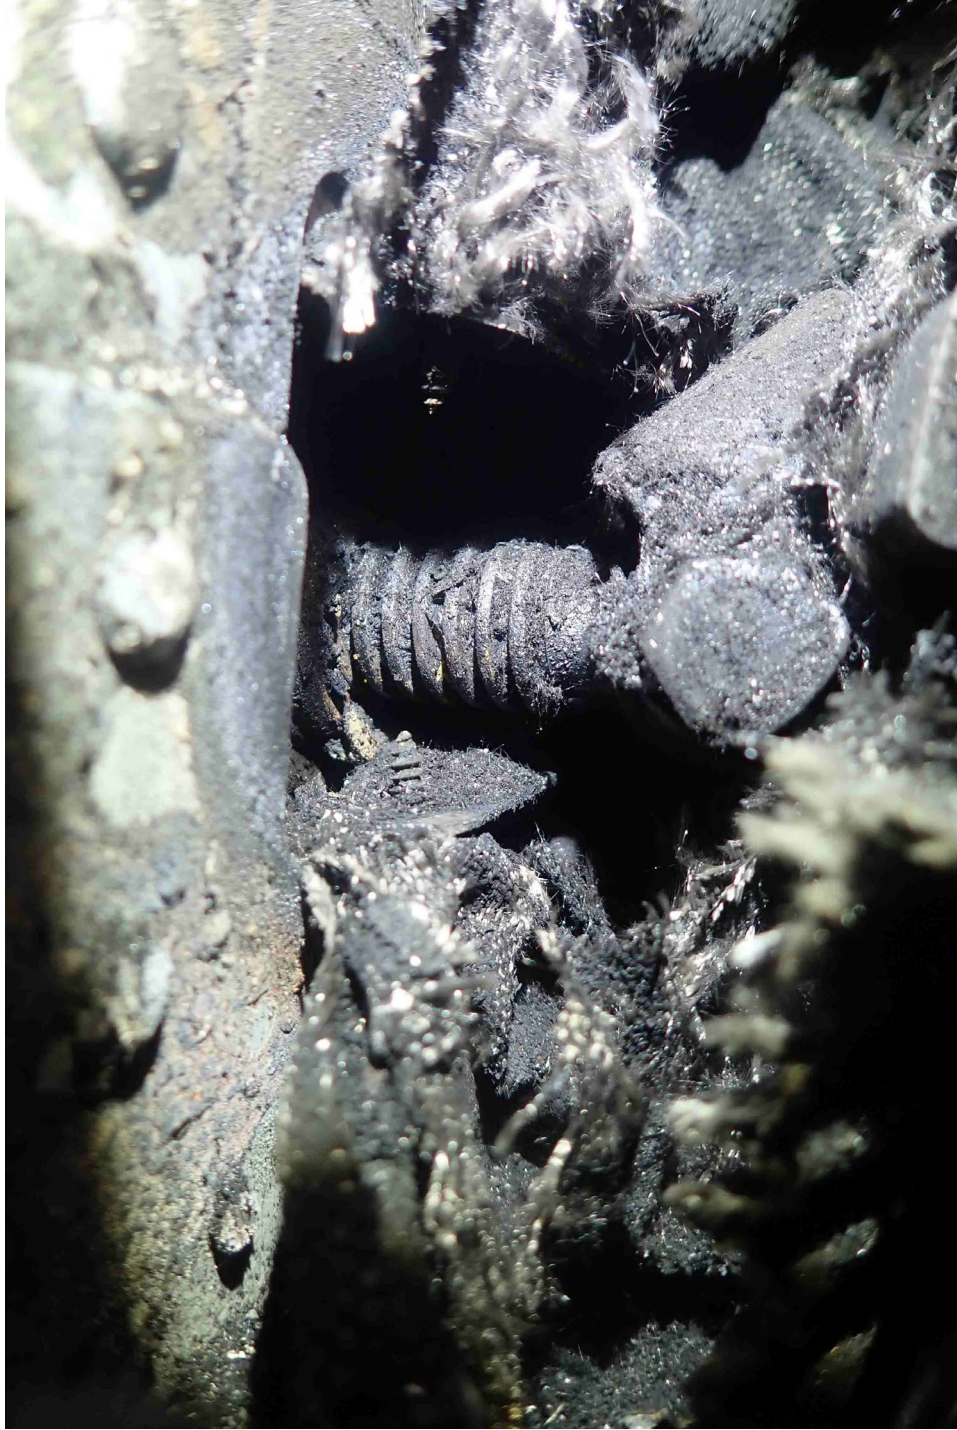
Figure 10 - Elevator trim actuator

The entire moving tail assembly structure had detached from the airframe and remained partially attached by electrical cables and wires. The vertical stabilizer was intact, and the rudder remained attached by all its hinges. The elevator trim jack located in the lower moving tail assembly exhibited 7 exposed threads, which was consistent with the takeoff trim setting (figure 10).

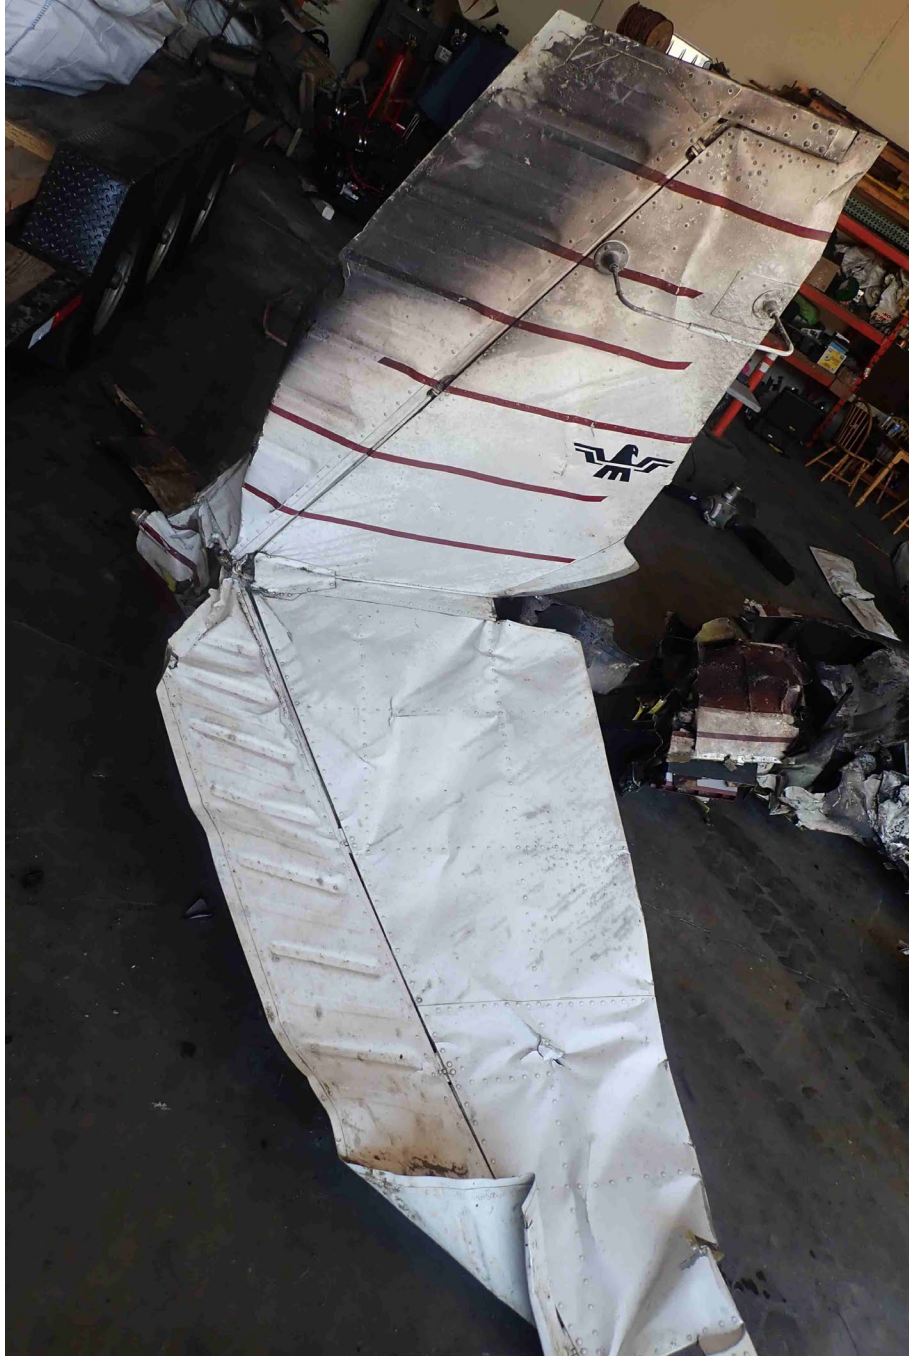
Figure 11 - Empenage

The lower portion of the rudder skin was bent left (figure 11) along with its rudder control arm, which remained attached and connected to its push-pull tube. The right horizontal stabilizer remained attached and sustained crumpling damage outboard; the elevator remained attached to the horizontal stabilizer at all of its hinges and the

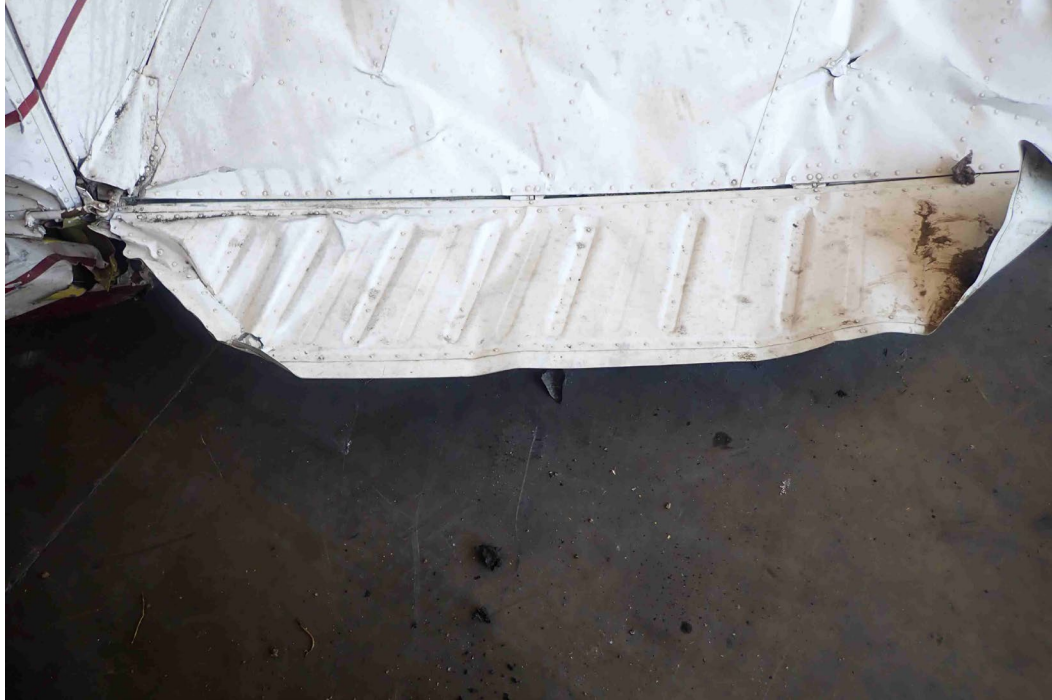
Figure 12 - Right Elevator

control horn (figure 12). The left horizontal stabilizer remained attached and sustained upward bending damage along its outboard side. The elevator had detached from the horizontal stabilizer but remained attached to the tail by its control horn.

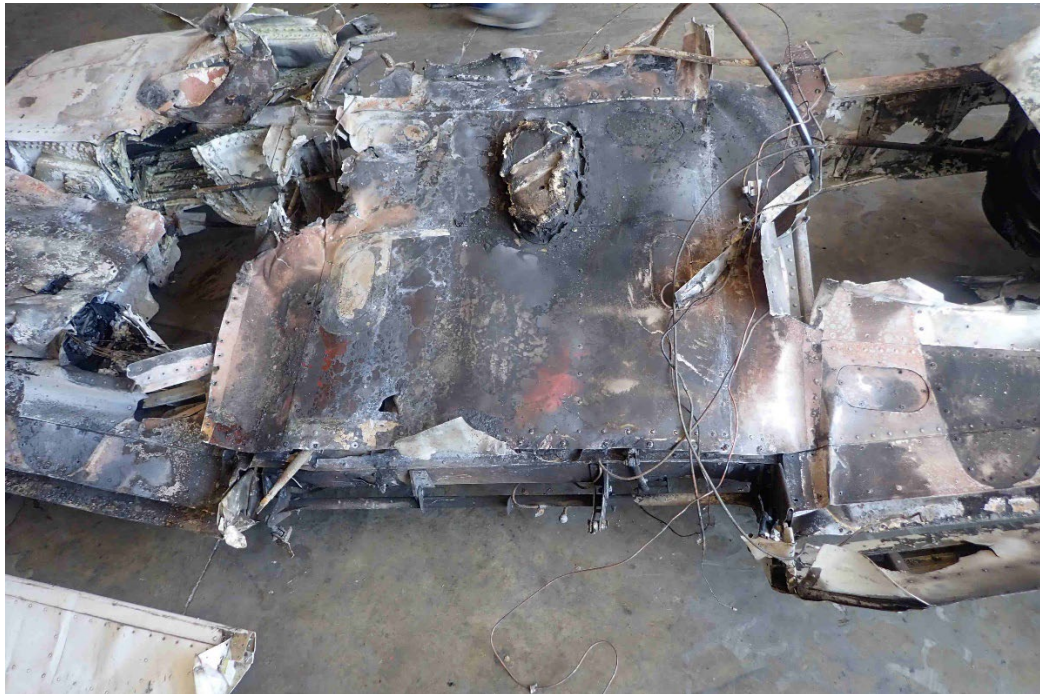
Figure 13 - Wing center section

The left and right wings remained attached to each other at the cabin floor, which was burnt and separated from the cabin structure. The flap torque tube control assembly remained attached to the aft center spar (figure 13). The flap actuator motor assembly was not located.

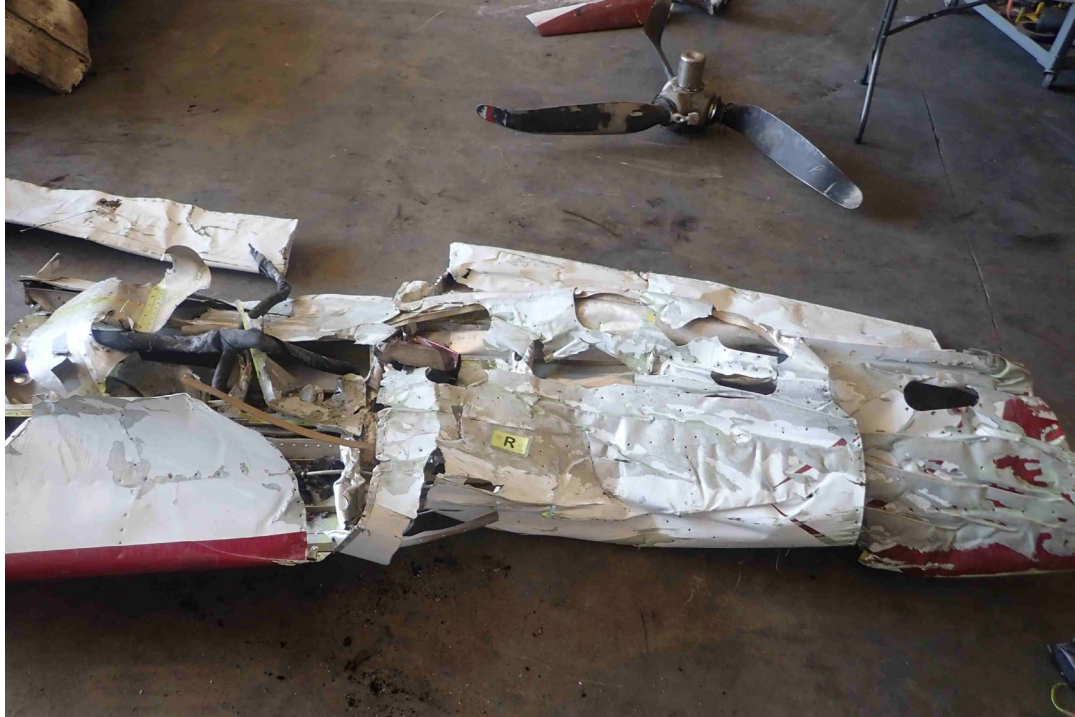
Figure 14 - Outboard right wing

The outboard section of the right wing, along with the aileron, had detached and was located on the roof of the building at the initial impact point. This wing section sustained crush damage through to the aft spar (figure 14). The aileron had detached, and was spilt in two, midspan (figure 15). The outboard aileron hinge remained attached and had pulled away from the aft spar. The inboard hinge remained attached to the aft wing spar and had pulled away from the aileron (figure 16). The push-pull tube remained attached to the aileron horn, and the wing bellcrank, which remained attached to the wing structure. The lateral push-pull tube had pulled away from the bellcrank, and was folded and buckled, but remained within the leading edge of the inboard wing section (figure 17).

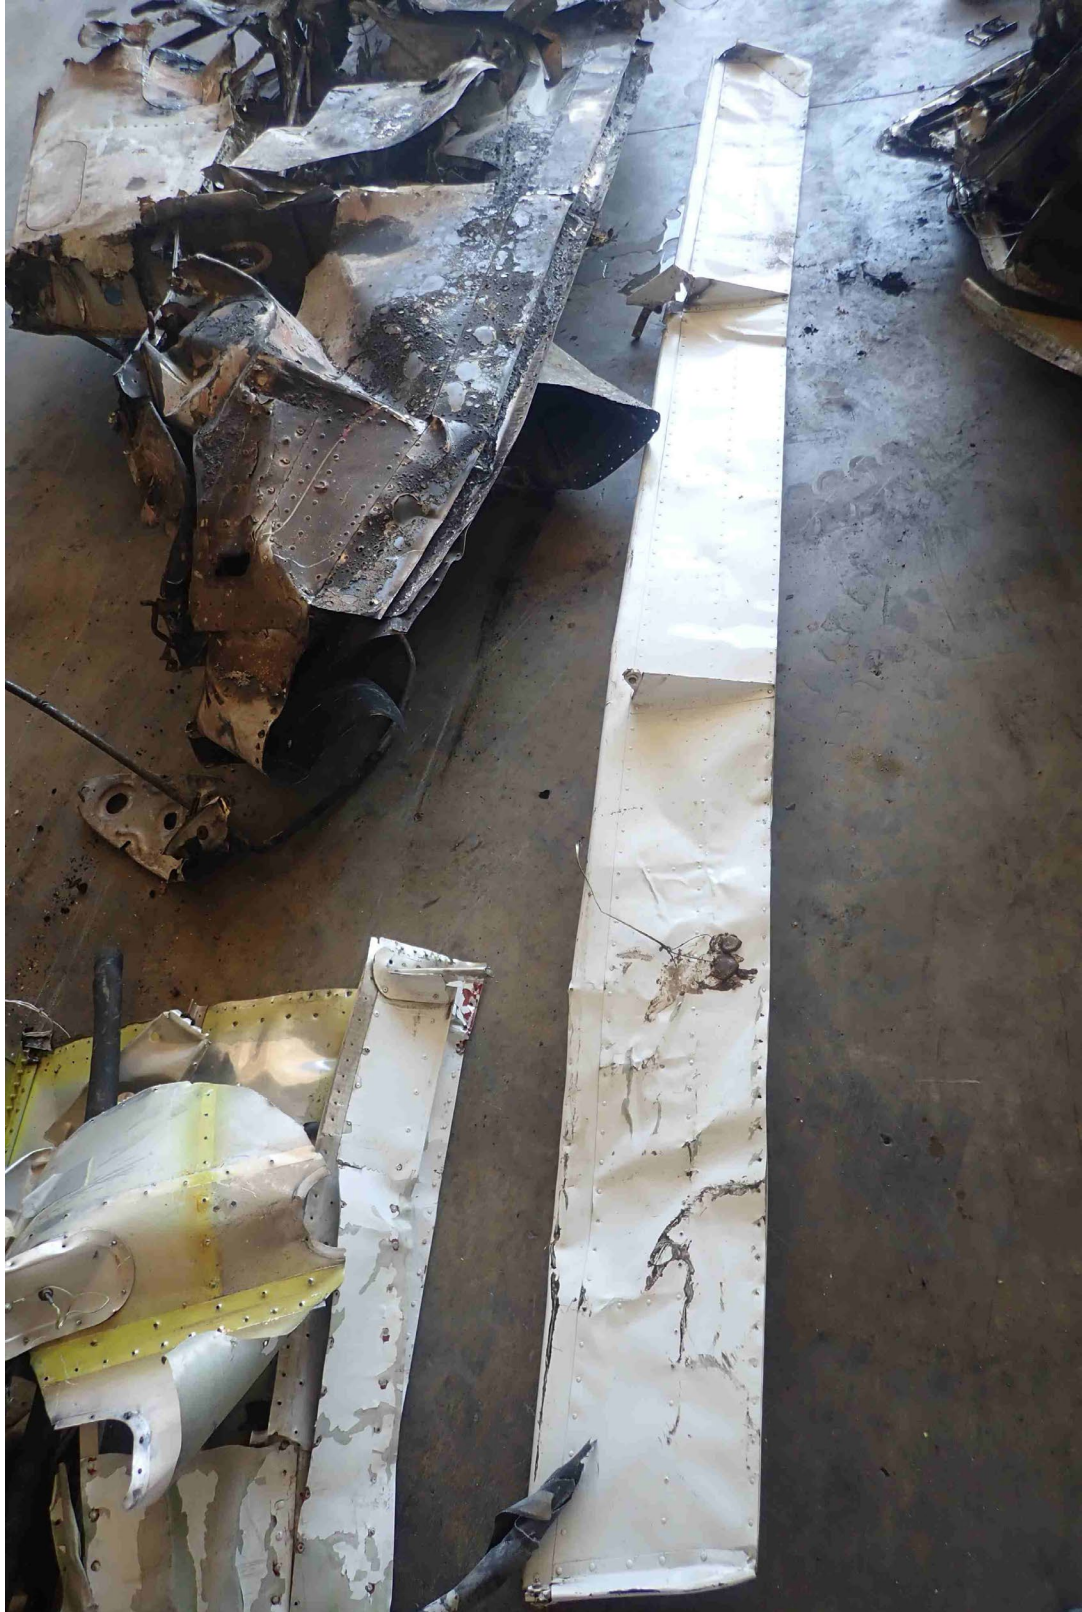
Figure 18 - Right flap

The right flap was intact and bent and had detached from the wing (figure 18). It was located on the ground, about 200 ft beyond the first impact point on the building. The hinges remained attached to the flap and had pulled away from there corresponding attach points on the aft wing spar. The control arm had broken away from the inboard flap root and remained attached to the flap torque tube (figure 19).

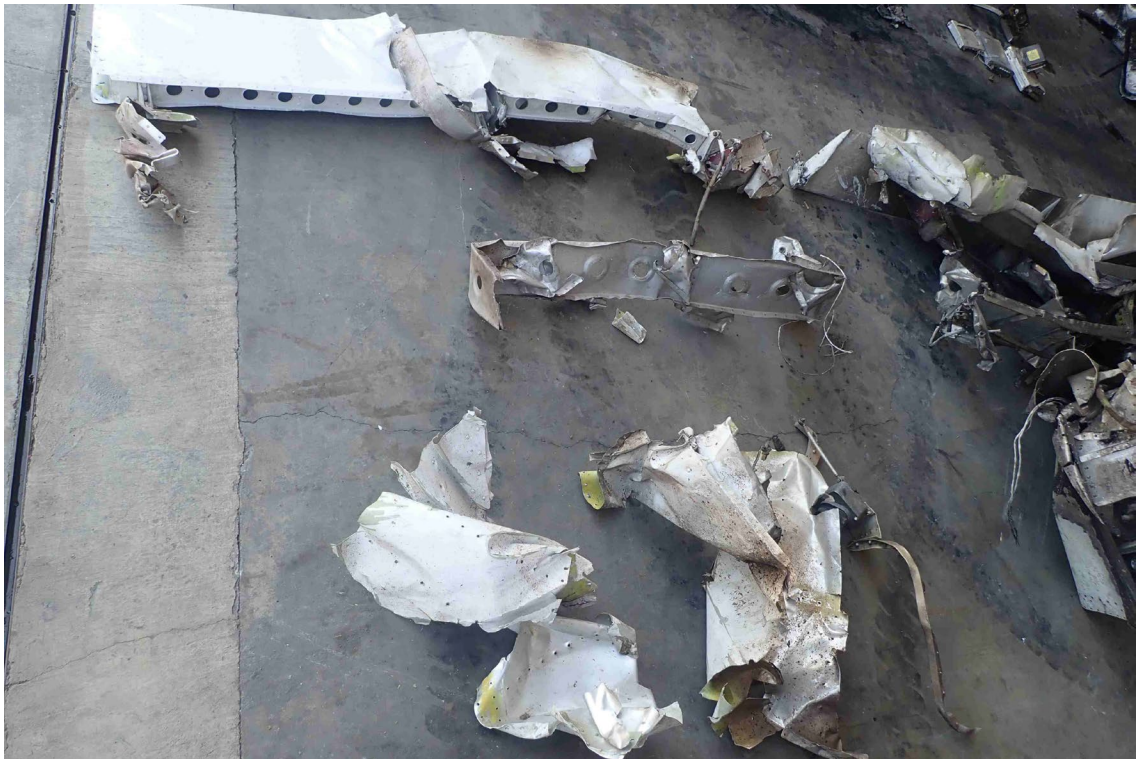
Figure 20- Outboard left wing fragments

The outboard section of the left wing along with its aileron had sustained significant crush, fragmentation, and thermal damage (figure 20). The aileron had detached, and was spilt in two, midspan. The outboard aileron hinge remained attached and had pulled away from the aft spar (figure 21). The push-pull tube remained attached to the aileron and had pulled away from the wing bellcrank. The lateral bellcrank had fragmented with a remnant remaining within the inboard section of the wing (figure 22).

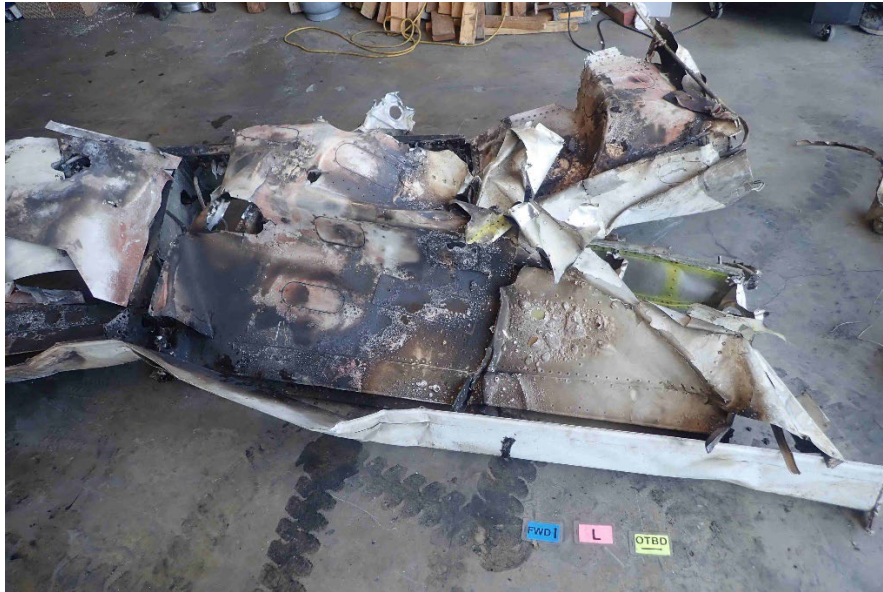
Figure 23 - Left flap and inboard wing

The flap was bent and buckled around the form of the wing but remained attached at all but its inboard hinge (figure 23). The flap control arm remained connected to the flap torque tube (figure 24).

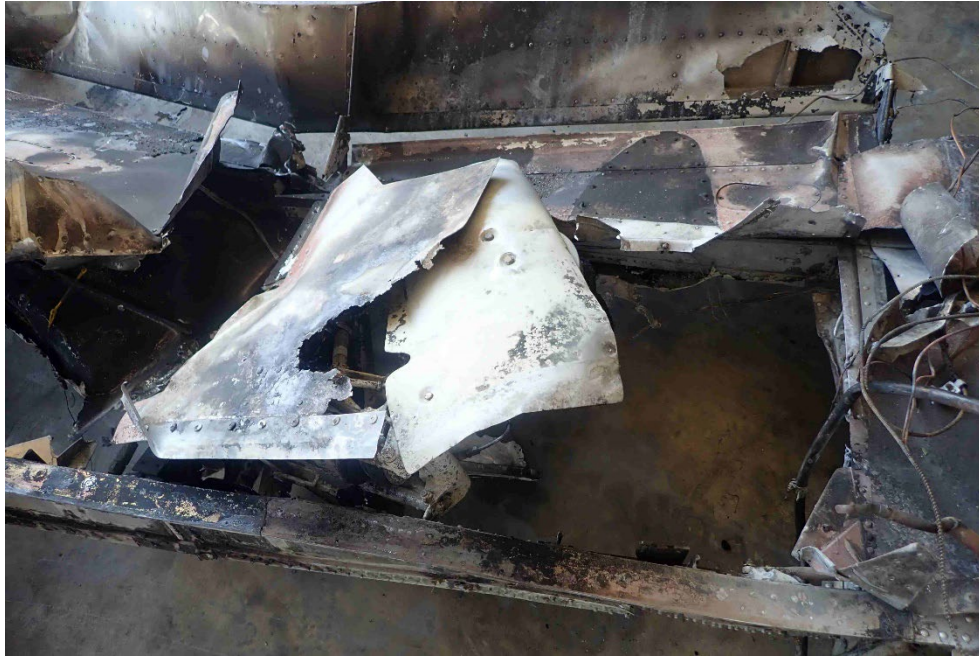
Figure 25 - Left main landing gear assembly.

Both the left and right main landing gear remained partially attached to the airframe within their wheel wells, both tires had burnt (figure 25 left, figure 26 right). The nose landing gear had sustained crush damage within the forward fuselage. Examination of the landing gear electric actuator revealed that its jackscrew was extended, consistent with the landing gear being raised (figure 27).

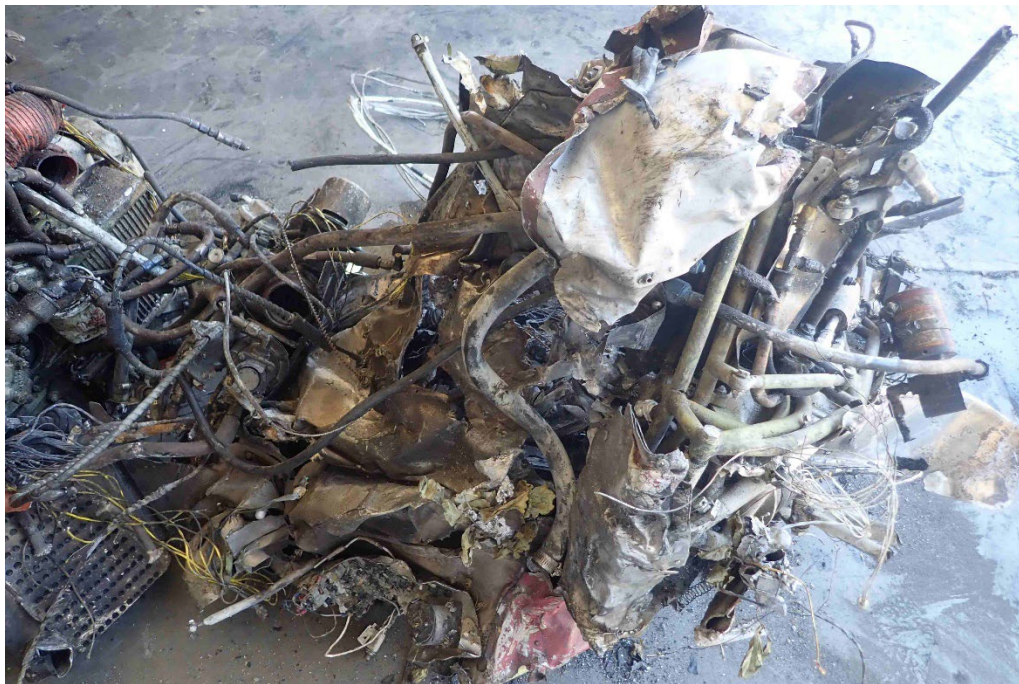
Figure 28 - Engine

The engine remained attached to its mount, which remained partially attached to the firewall by control lines, electrical cables, and engine supply lines (figure 28). The oil pan had formed around the crankshaft, and there was no evidence catastrophic internal failure such as a perforated crankcase or oil pan. The alternator had detached and was found in the debris field. Examination into the crankcase through the alternator hole similarly revealed no evidence of catastrophic internal failure. Both magnetos detached from their respective pads, leaving fragments of their mounting tabs still engaged.

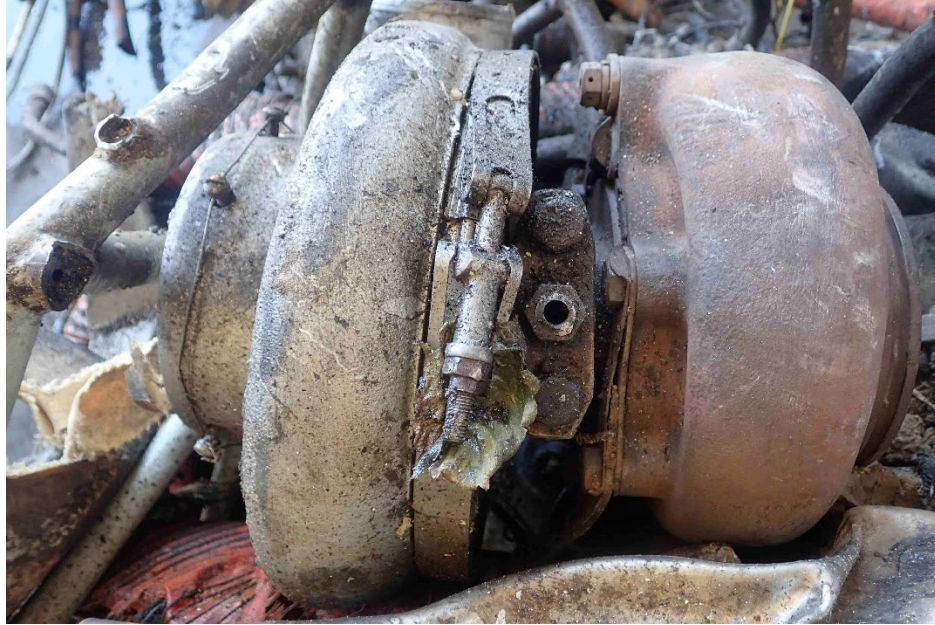
Figure 29 - Turbocharger

The turbocharger assembly remained attached to the engine mount. The compressor and turbine assemblies appeared to be slightly bent at the center housing hub (figure 29). The blades of the compressor were exposed and exhibited blade tears and bending opposite the direction of rotation (figure 30). The turbine wheel was also exposed and caked with mud. With the mud removed, rubbing was observed between the blade tips and outer scroll (figure 31).

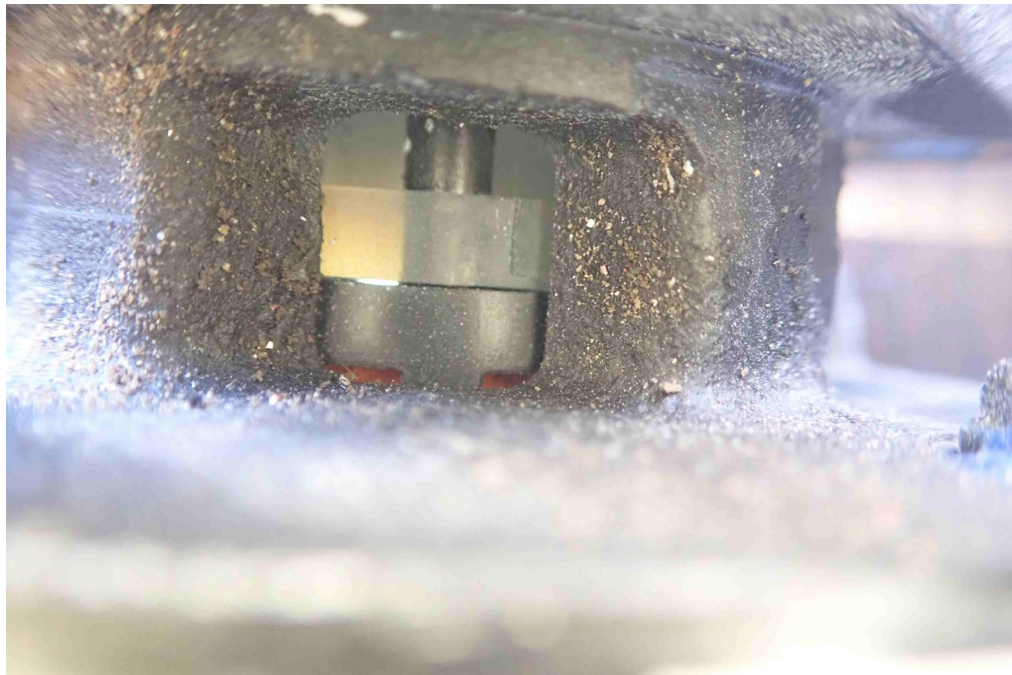
Figure 32- Vacuum pump coupling

The vacuum pump was undamaged and remained attached to its pad on the engine accessory case. The unit was removed, and its plastic coupling was intact (figure 32). The input drive gear could be rotated by hand with no noticeable binding. Disassembly of the unit revealed that the internal rotor and vanes were undamaged and intact (figure 33).

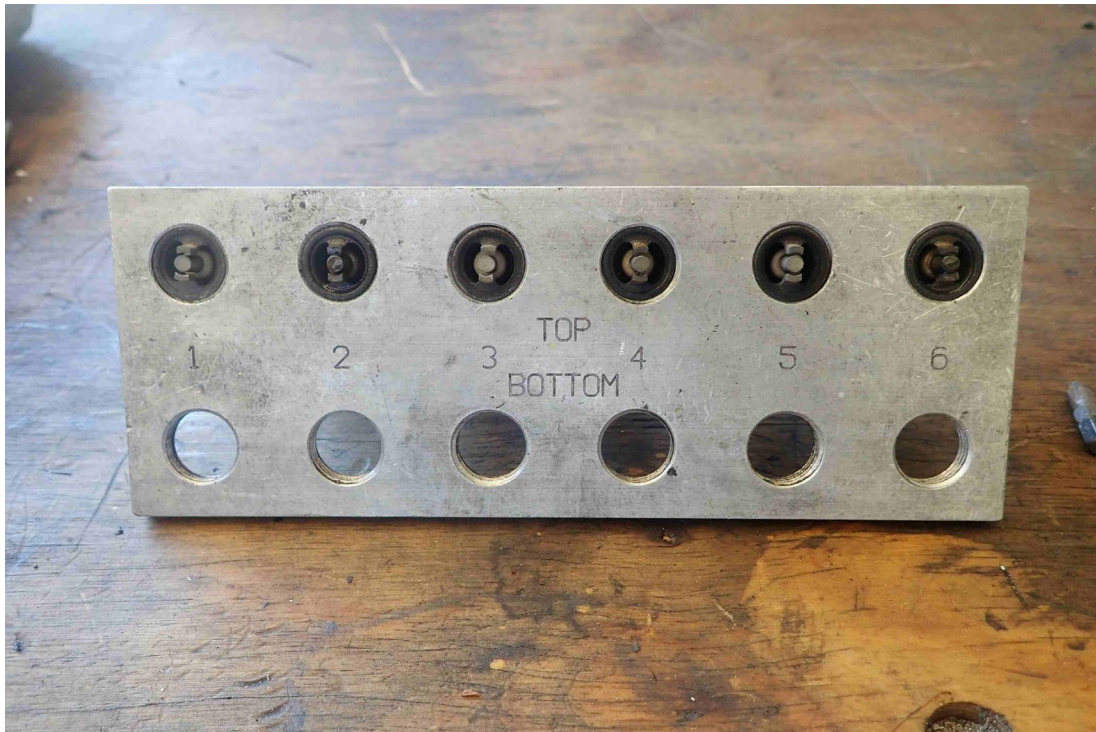
Figure 34 - Top spark plugs

All six rocker covers were removed; all rockers were wet with clean oil, and the springs were intact. The top spark plugs were removed, exhibited no mechanical damage, and normal short service life signatures (figure 34) when compared to the Champion AV-27 Aviation Check-A-Plug chart.

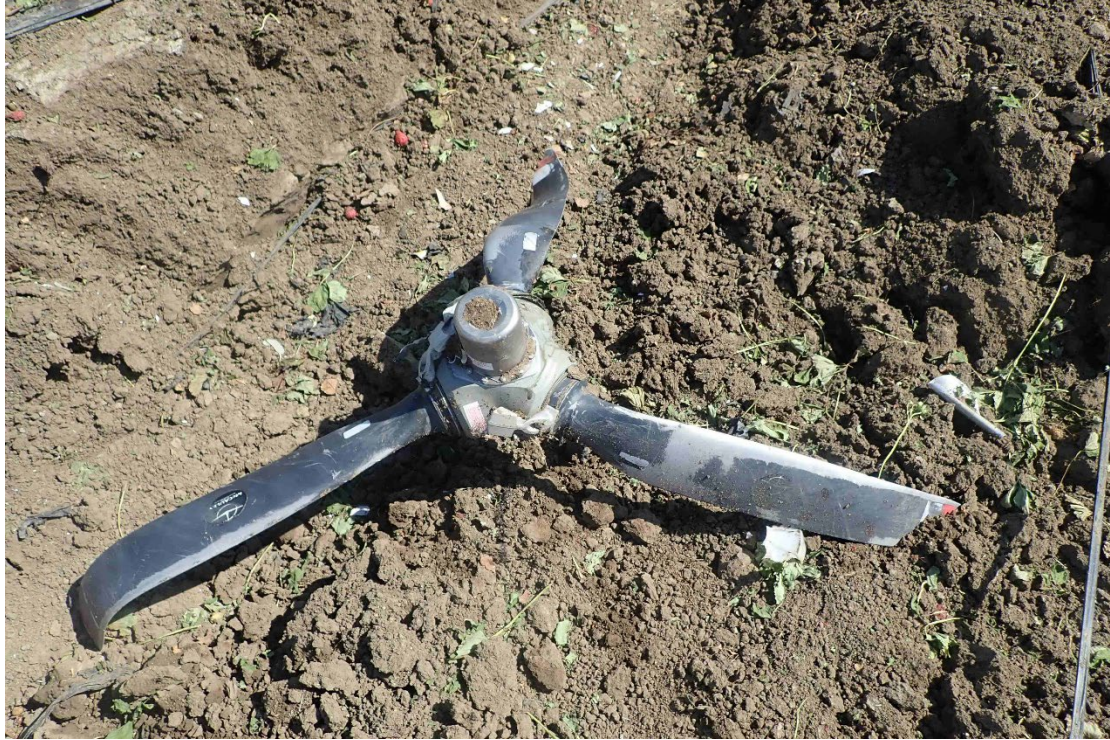
Figure 35 - Propeller

All blades remained attached to the hub, which had detached from the crankshaft. Two of the balance weights had detached and were located within the debris field. All three blades exhibited leading edge nicks and abrasions, along with and chordwise scratches (Photo 35). One blade exhibited trailing edge s-bending. Slash marks within the dirt in the debris field suggest engine rotation at impact.
