NATIONAL TRANSPORTATION SAFETY BOARD

ENGINE TEST RUN

CEN20LA004

Location: Ranger, Texas
Date: October 6, 2019
Aircraft: N36LS, Beech B36TC
NTSB Investigator-in-Charge: Joshua Lindberg

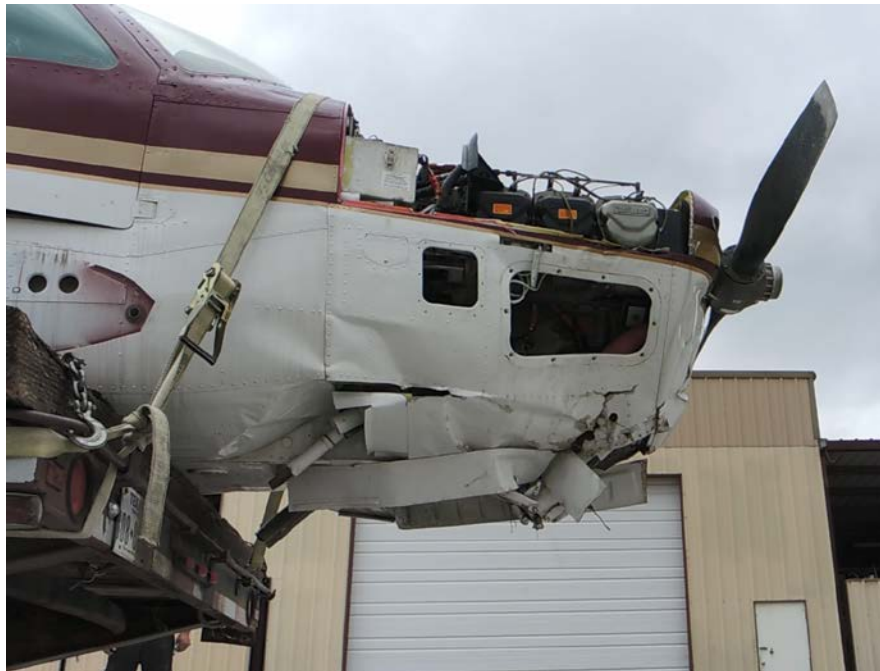
The engine was prepared and secured on a trailer for the engine run. ASOD had to replace the No. 5 valve cover, repair the No. 3 wiring harness to the top spark plug, and re-secure the bottom right engine mount. A test propeller was installed since the original propeller was damaged during the accident. The original airplane battery was charged prior to the test run but the battery did not work. A replacement battery was installed and worked normally. No other fixes were necessary.
