Group Chairman's Factual Report Survival Factors

CONCEPTION DCA19MM047

Group Chairman's Factual Report Survival factors

Group Chairman's Medical/Pathological Addendum Survival Factors

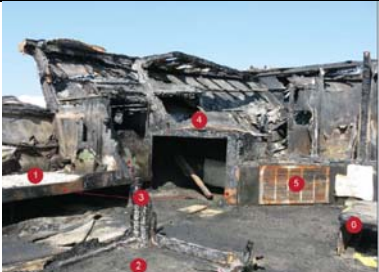
<ul style="list-style-type: none"> 1. Bunk 19L 2. Changing room 3. Silhouettes 4. Bunk 17L 5. Air conditioning intake 6. Bottom of main stairs to salon 	#2 is actually forward section of lower single bunks. There was no threshold to changing room	We concur and have made the requested change.
