National Transportation Safety Board

HWY24MH001

VEHICLE FACTORS

Group Chair's Factual Report

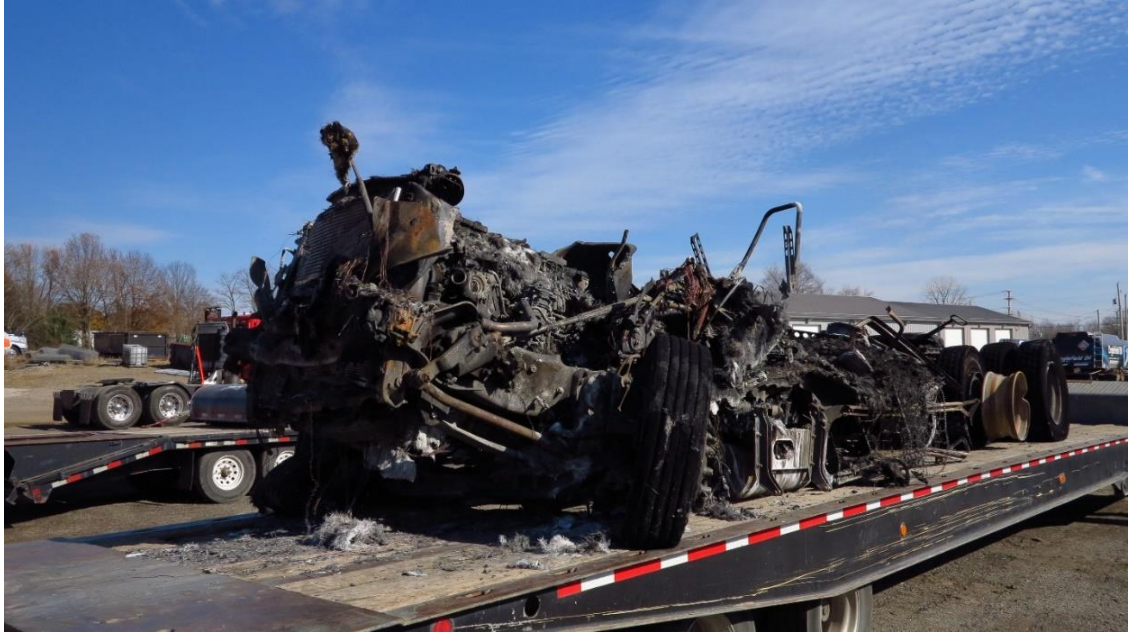
Figure 1 – 2019 Freightliner Truck-Tractor.

The 2019 Freightliner Cascadia truck-tractor (truck-tractor) was completely burned from the post-crash fire. All combustible materials from the front bumper to rear of the last drive axle, such as the electrical wiring, rubber and plastic air hoses and lines, all driver controls, and vehicle body parts were damaged – See **Figure 1**.

The front frame horns and rails were bowed upward and rearward. The right-side frame rail was bowed outward above the steering axle, and the left-side frame rail was buckled outward and bowed upward above the steering axle. The right-side frame rail was bowed upward beneath the sleeper berth. The cab was separated from the front and rear mounts.

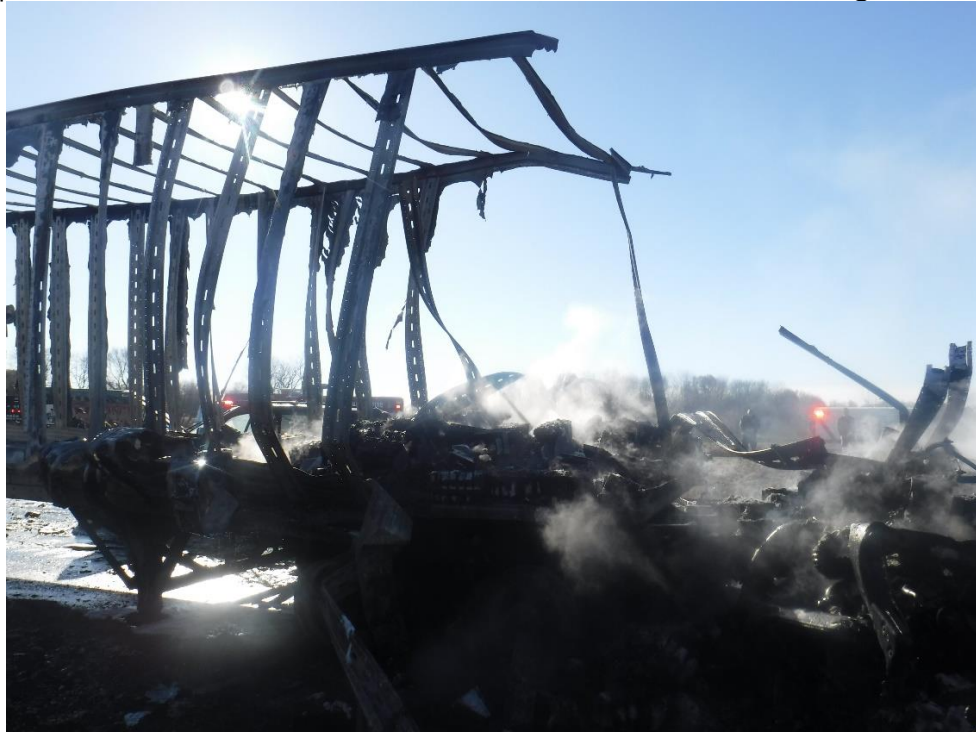
The front portion of the semitrailer was missing along with the king pin and upper fifth wheel plate. As seen in **Figure 2**, all that remained at the front of the semitrailer were the vertical ribs and roof rails. The vertical ribs were bowed forward, and there are pieces of the semitrailer located on the deck of the truck-tractor. There were remnants of batteries and semitrailer pieces located on the truck-tractor at the

Figure 2 The front of the semitrailer at the crash scene. (Courtesy of the OSHP)

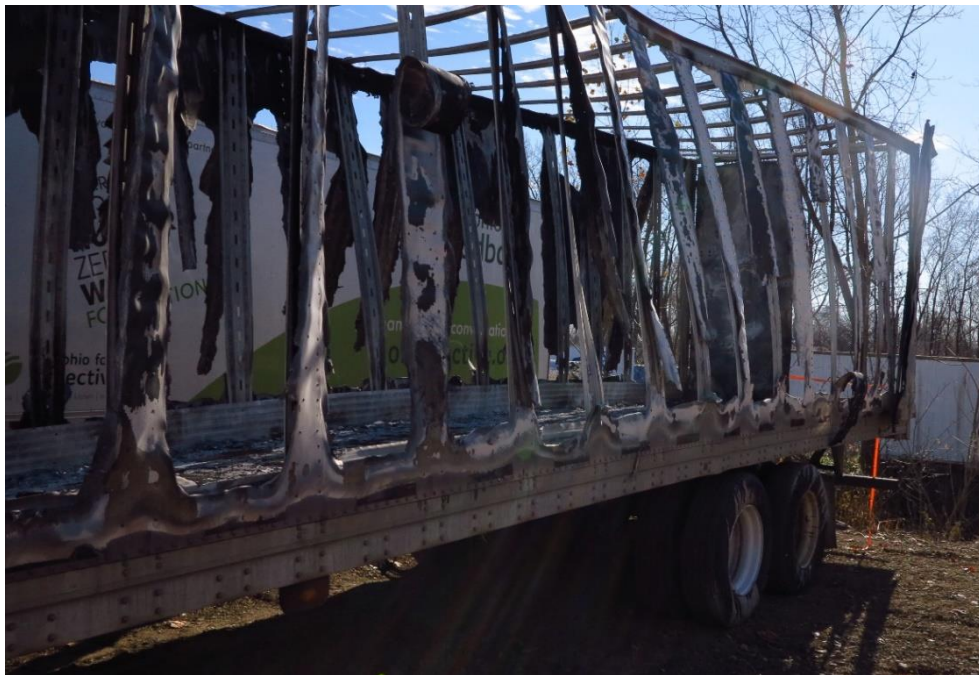
Figure 3 – 2017 Strick Semitrailer.

tow yard. The complete exterior skin of the semitrailer was consumed by the post-crash fire – See **Figure 3**. From the landing gear to the rear bumper, the cargo floor and the components below the floor remained intact with limited damage.

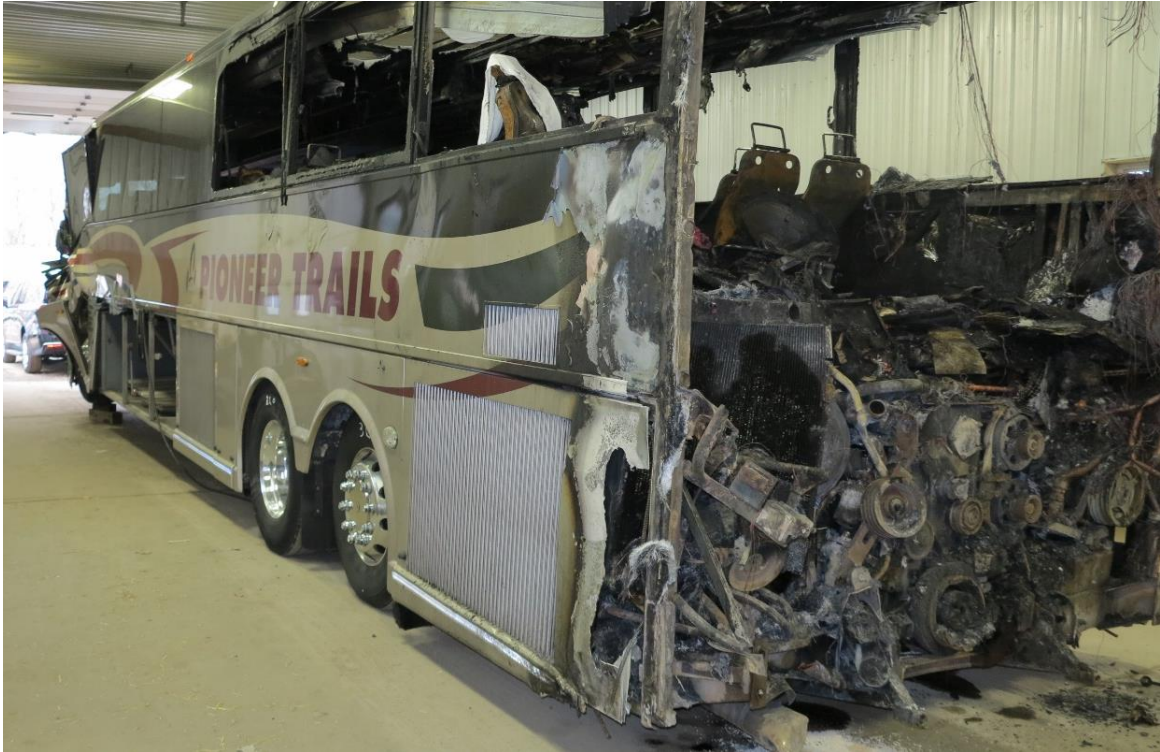
Figure 4 – Left Rear of 2009 Van Hool Motorcoach.

The rear of the motorcoach sustained most of the damage from the crash and post-crash fire - **See Figure 4**. At the front of the motorcoach, both windshield glass panes were missing, the left front was torn open exposing the driver's compartment and fuse panel, the steering wheel and dash were displaced forward toward the outside of the vehicle, and the forward portion of the left-front wheel well was displaced rearward into the steer tire. The front three cargo bay doors on the left side and the 2nd and 4th cargo bay doors on the right side of the motorcoach were missing.
