NATIONAL TRANSPORTATION SAFETY BOARD

Aircraft Exam Summary at Accident Site

CEN22FA317

Aircraft: Bell UH-1H+

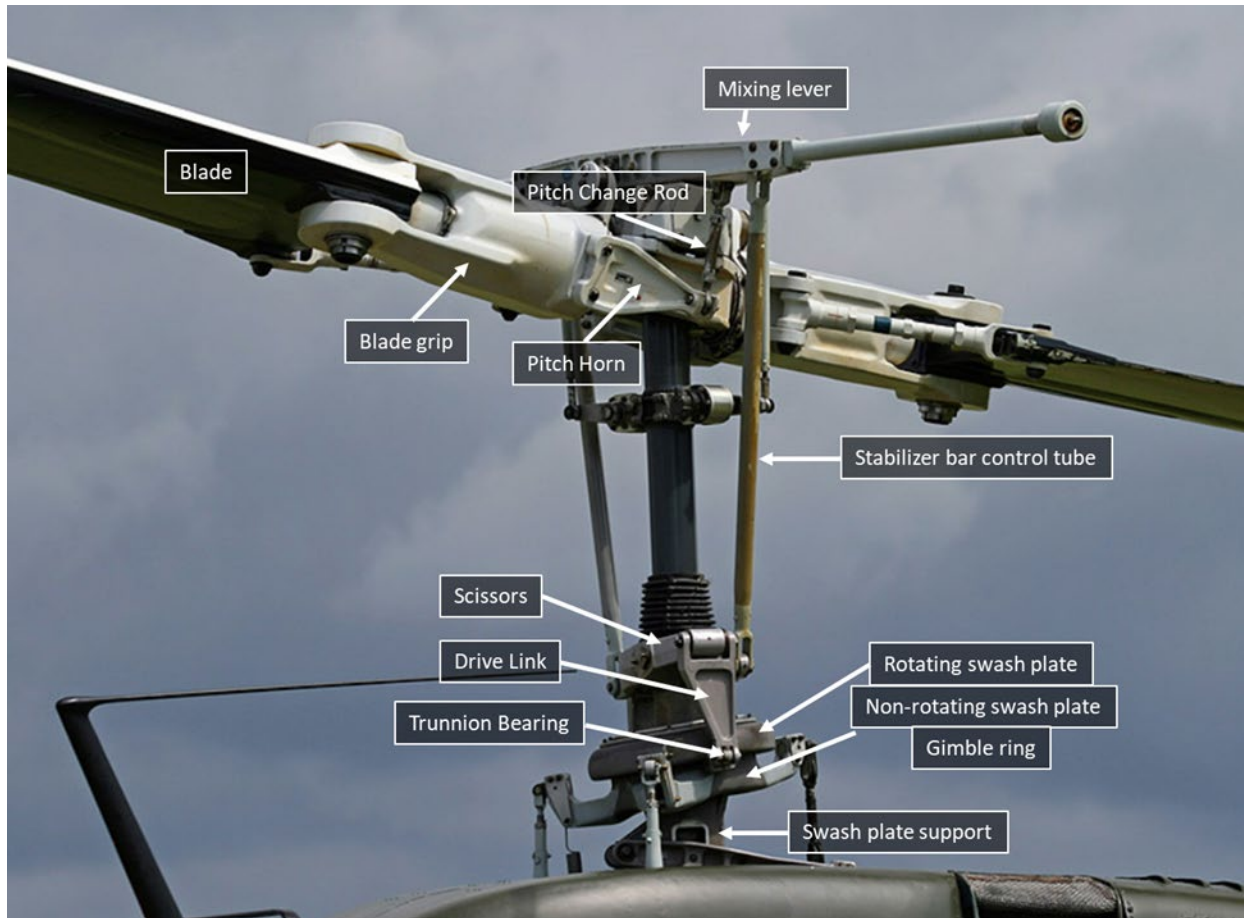
Main Rotor Control System. The main rotor control system remained intact and exhibited minimal damage. The swashplate support remained secure to the top of the transmission. The collective lavers remained secured to the collective sleeve. The non-rotating swash plate remained secured to the swash plate support. The rotating swash plate remained secured to the non-rotating swash plate. The two trunnion bearings for the top of the cyclic servos (longitudinal and lateral) remained secured in the rotating swash plate. The scissors and sleeve assembly remained attached to the mast. Both drive links remained attached at both of their ends. The main stabilizer bar control tubes fractured about mid length. Both mixer levers remained attached to the stabilizer bar assembly. One exhibited a fracture at the top of the bearing that holds the control tube. That section of the assembly was not recovered but may be with the wreckage. The pitch change links remained attached to the mixer and the pitch horns. Both pitch horns separated from the blade grips. Both blade grips remained attached to the hub and retained the end of the main rotor blades. Both drag links remained attached to the blade grip and aft end of each blade. One end of the stabilizer bar was bent about 45° in the direction of rotation. One damper separated from the mast and was found in the wreckage. Figure 1 is an exemplar main rotor control system.

Figure 1. Main rotor control system. Photo courtesy of the internet.
