On August 7th, 2020 at 1700 I performed an inspection of N827WS located at [REDACTED]
[REDACTED]

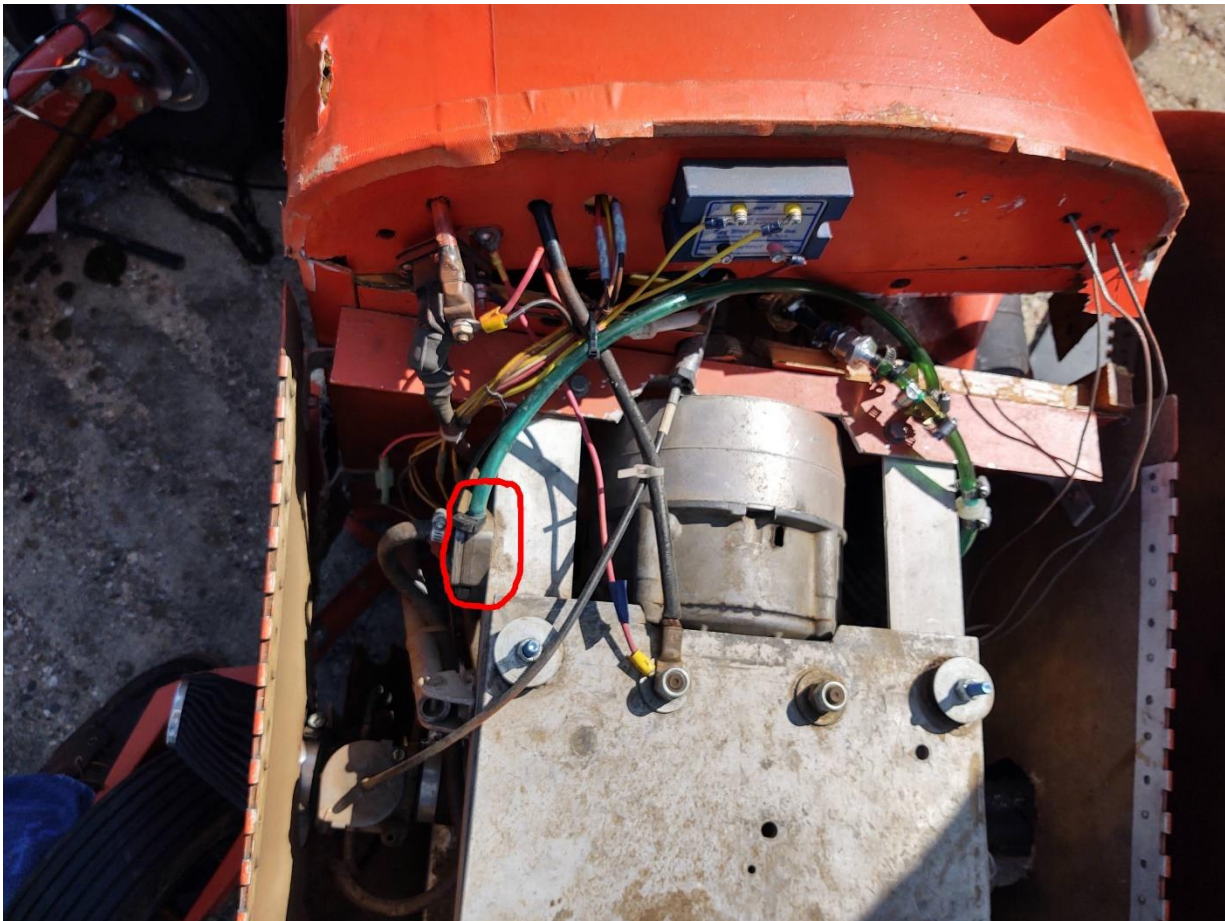
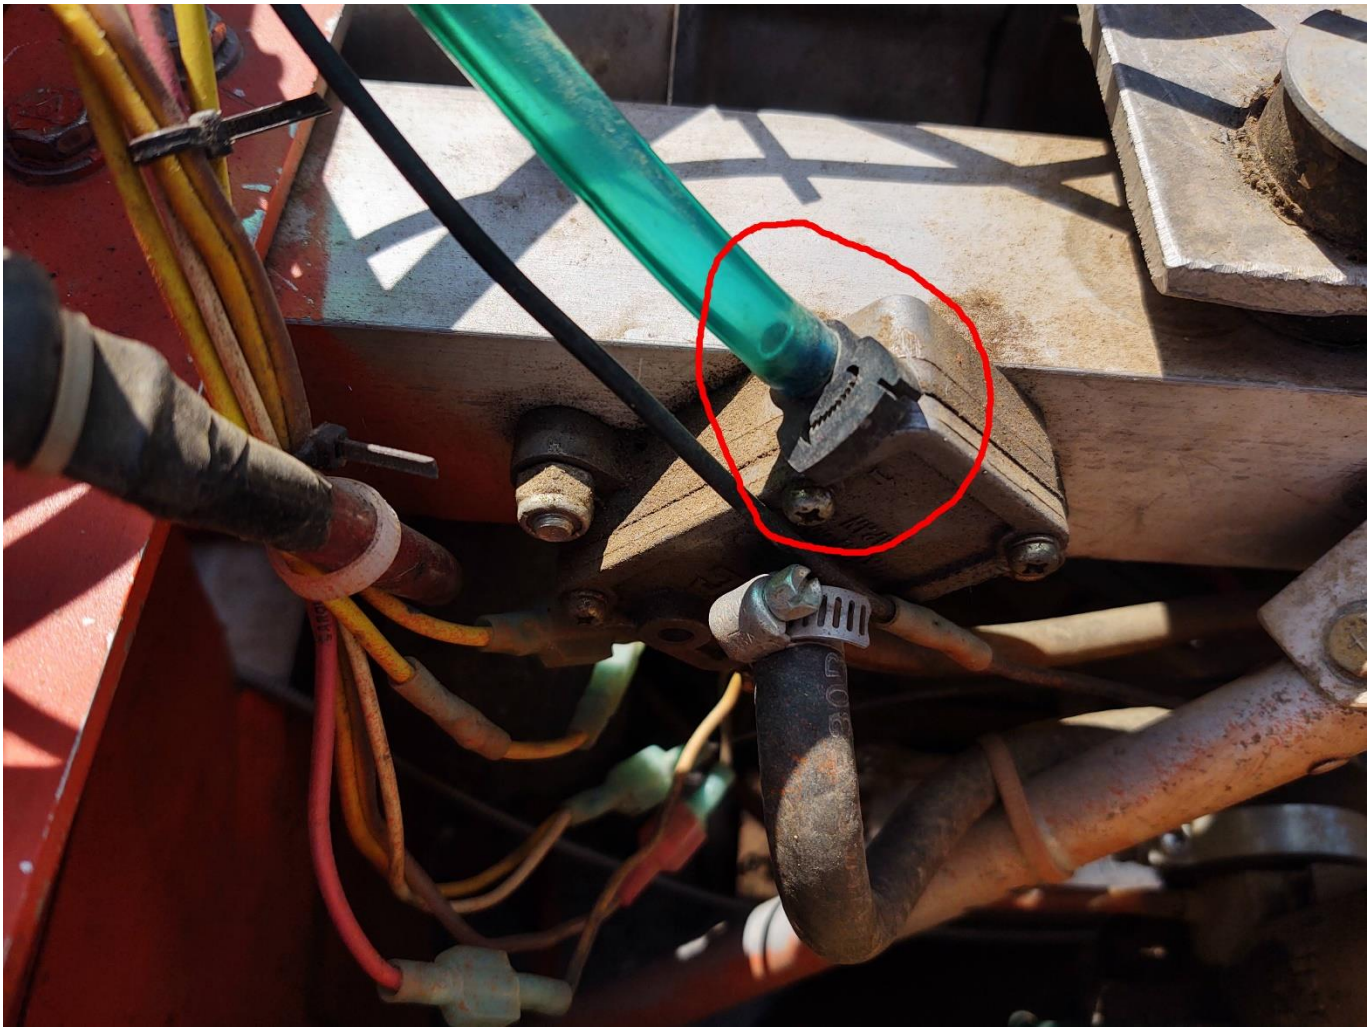
The only discrepancy found, which could most definitely have caused the loss of engine power which caused the airplane to crash, was that the fuel supply line to the inlet fitting of the vacuum driven fuel pump was loose on the barbed fitting. The black plastic hose clamp that was securing the blue-green vinyl fuel hose to the barbed inlet fitting on the Mikuni fuel pump was tightened to its maximum clamping position, however the fuel hose was loose on the inlet fitting. I believe that at takeoff power this allowed the fuel pump to ingest air which caused a loss of fuel delivery to the carburetor.

The described fuel pump is circled in red on the attached pictures that I took.
