## **CEN20LA125**

### **Propeller Examination**

Location: Myers Aviation  
545 Aviation Way  
Oshkosh, WI 54902

Date: May 13, 2020

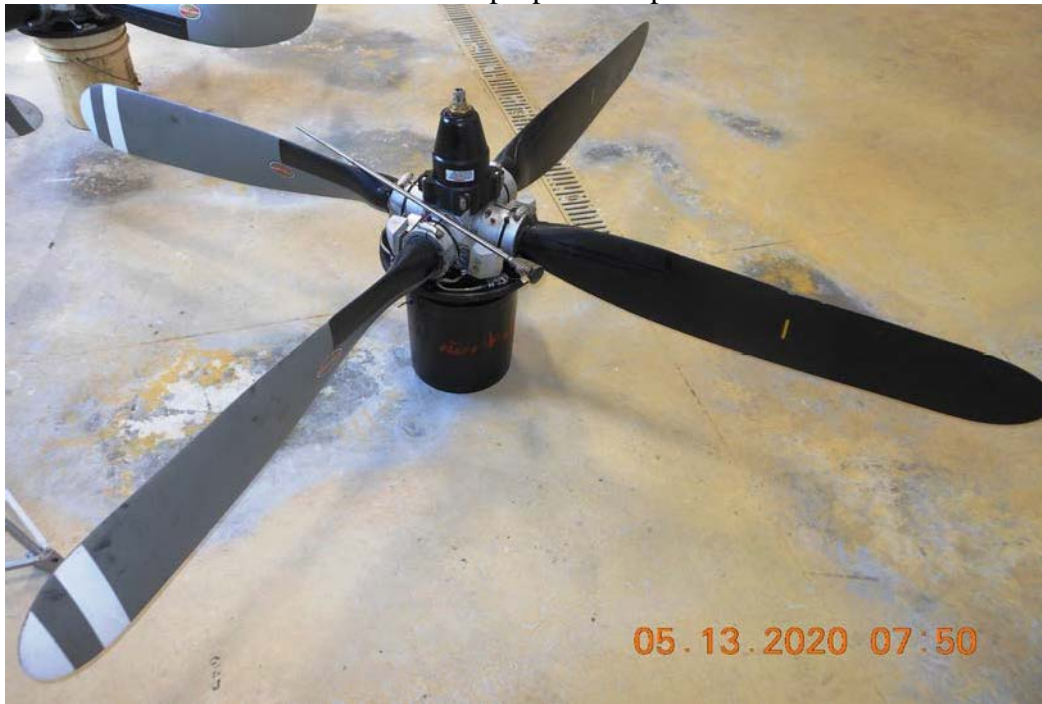
The left propeller was presented for examination in the condition shown in Photo #1. The propeller was presented in the feathered position. The four blades were labeled L1, L2, L3 and L4 in sequence of rotation.

There was no remarkable damage on the left propeller. The beta tube had been removed, appeared straight and rolled-true on a flat table. All four blades were secure in their clamps with no looseness or free play detected. All the slip indicators were aligned. There were no remarkable indications of grease leaks from the blade bearings/clamps as suggested by the last logbook entry (Photo #2). The feather angles were measured at the 30” station (yellow stripe) and also at the inboard tip stripe before any work was performed on the propeller. The following angles were measured:

Photo #1 – Left propeller as-presented

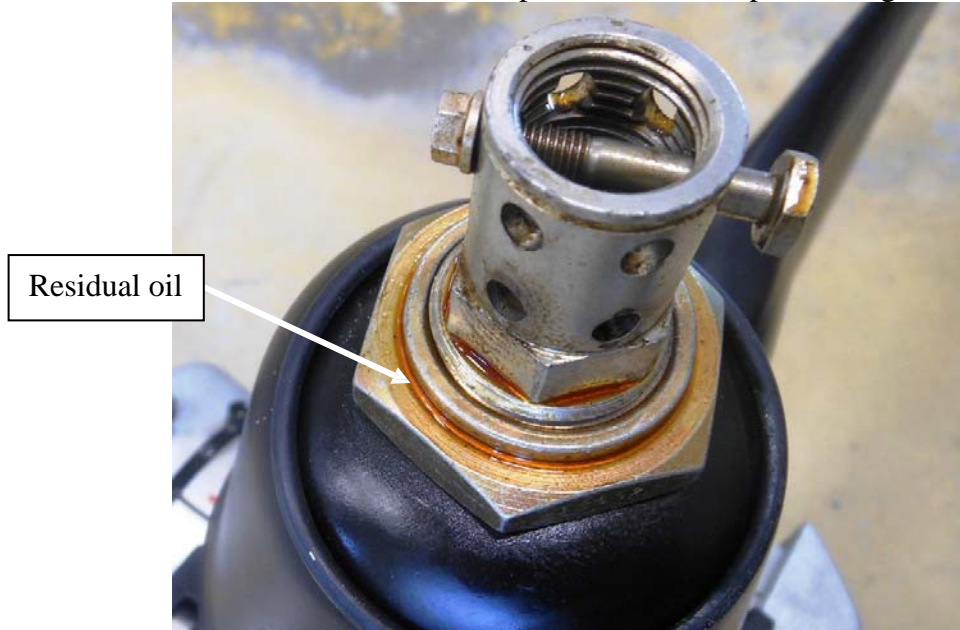
One of the L3 grease fitting caps was dislodged and the fitting was visible (Photo #4). There was some residual oil on the forward end of the piston and piston nut that appeared to be turbine oil (Photo #3).

Photo #3 – Residual oil on piston nut/around pitch change rod

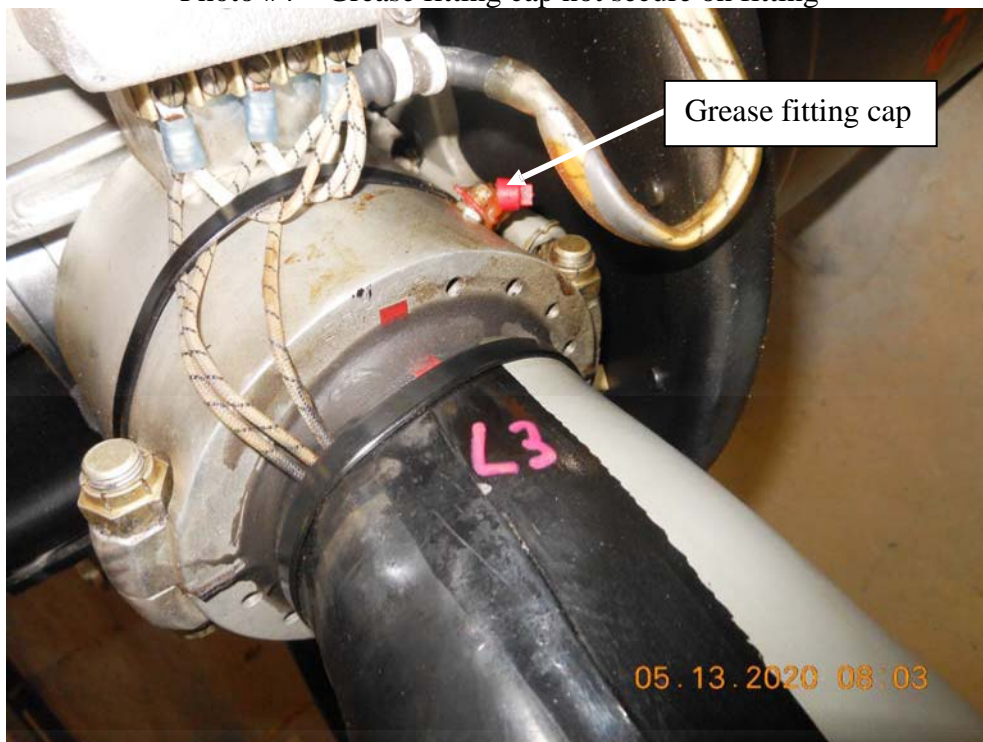
Photo #4 – Grease fitting cap not secure on fitting

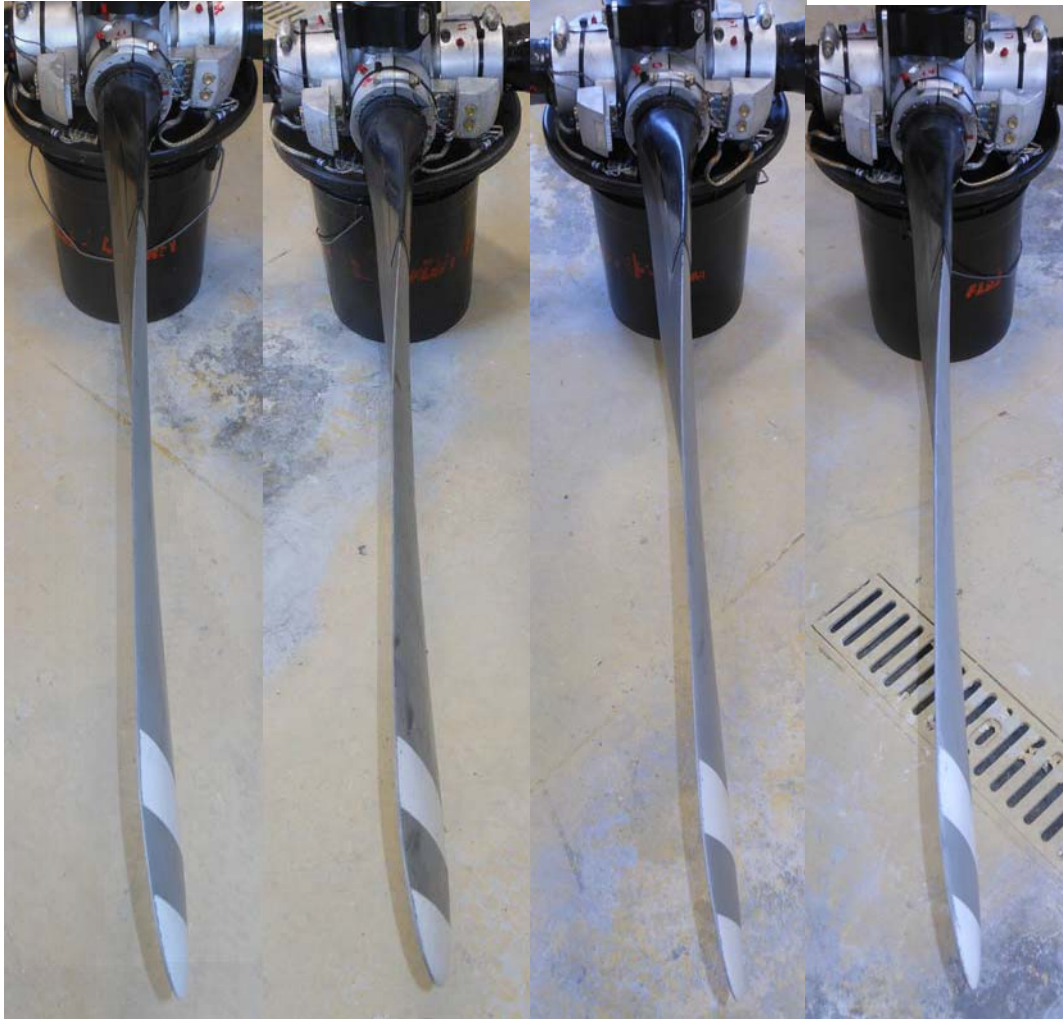
At 30” Station	At Inboard Tip Stripe
L1 – 88.7°	81.0°
L2 – 87.5°	79.9°
L3 – 89.5°	81.8°
L4 – 89.6°	81.6°

Although the feather angle tolerance is 88.0 +/- 0.7° at the 30” radius, angles at the tip were closer together indicating the blades were not twisted or bent due to impact damage (Photo #5). All four blade leading edges and surfaces exhibited normal wear and erosion.

Photo #5 – Left propeller blades leading edge-on view (L1-L4 left-to-right)

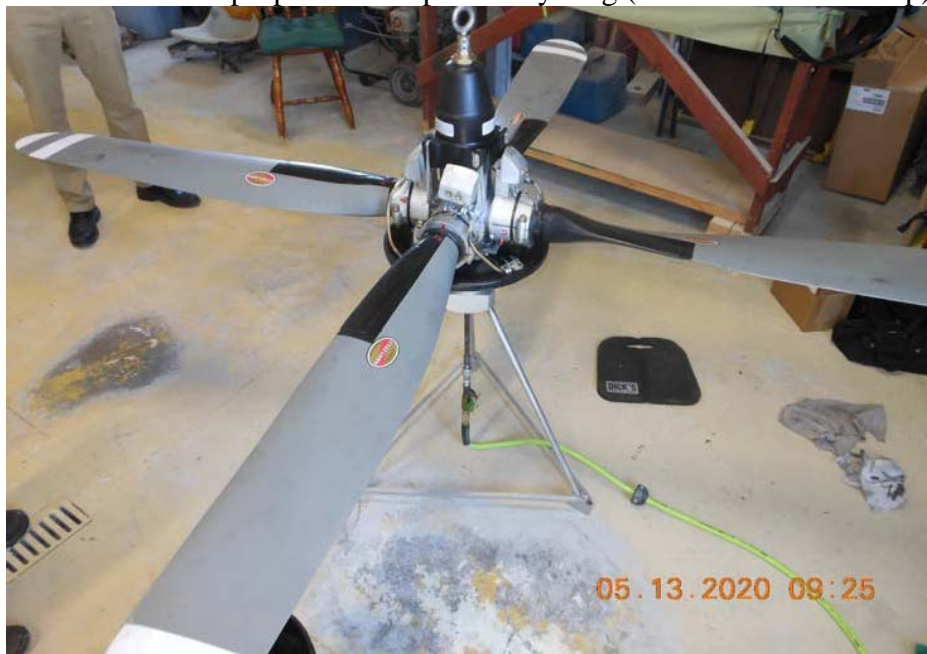
The left propeller was mounted on a tripod and cycled with air pressure between the reverse pitch stop and the feather stop (Photo #6). There were no remarkable characteristics noted during this cycling. During the first cycle from feather to reverse, all four start locks engaged normally and the start lock plungers were free to move without obstruction. No air leaks were detected from the hydraulic unit.

Photo #6 – Left propeller on tripod for cycling (shown on reverse stop)

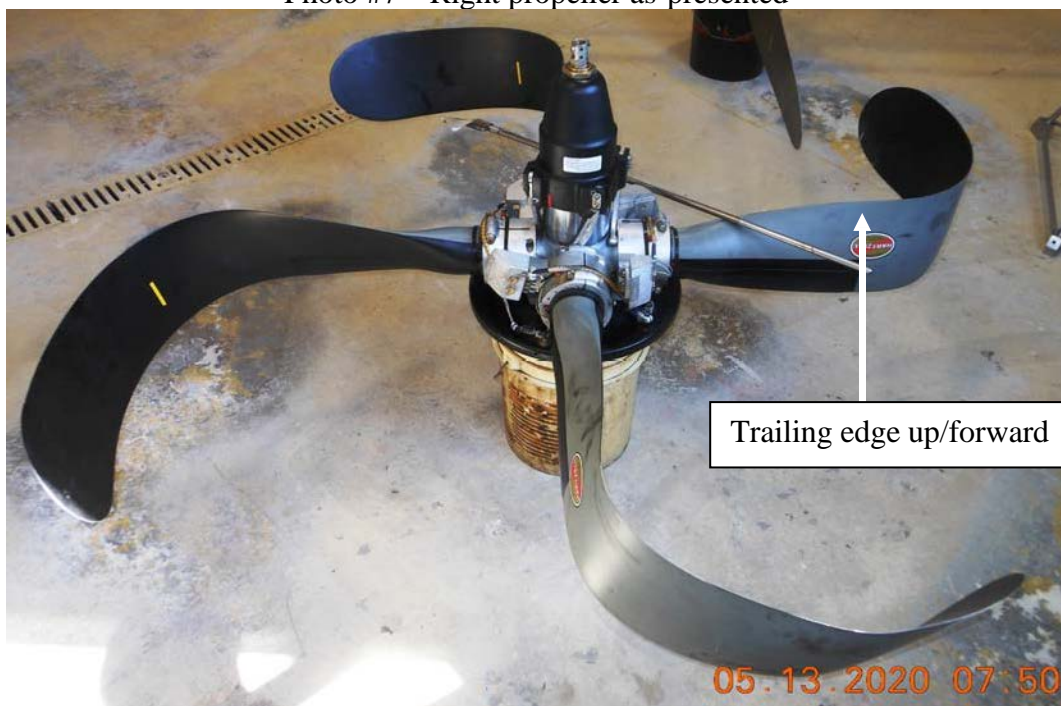
The right propeller was presented in the condition shown in Photo #7. All four blades had been forcefully rotated in the low pitch direction by impact forces. The blade/clamp/counterweight had rotated past the propeller rotational axis, approximately 180 degrees from the feathered position, essentially in a “backwards feathered” position with the blade trailing edges pointing forward. With the clamp link screws on the opposite side of the rotational axis, the feathering spring pressure effectively locked the propeller in its as-presented position (Photo #8). All four blades were secure in their clamps with no looseness or free play detected. All the slip indicators were aligned. The four blades were labeled R1, R2, R3 and R4 in sequence of rotation.

Photo #7 – Right propeller as-presented

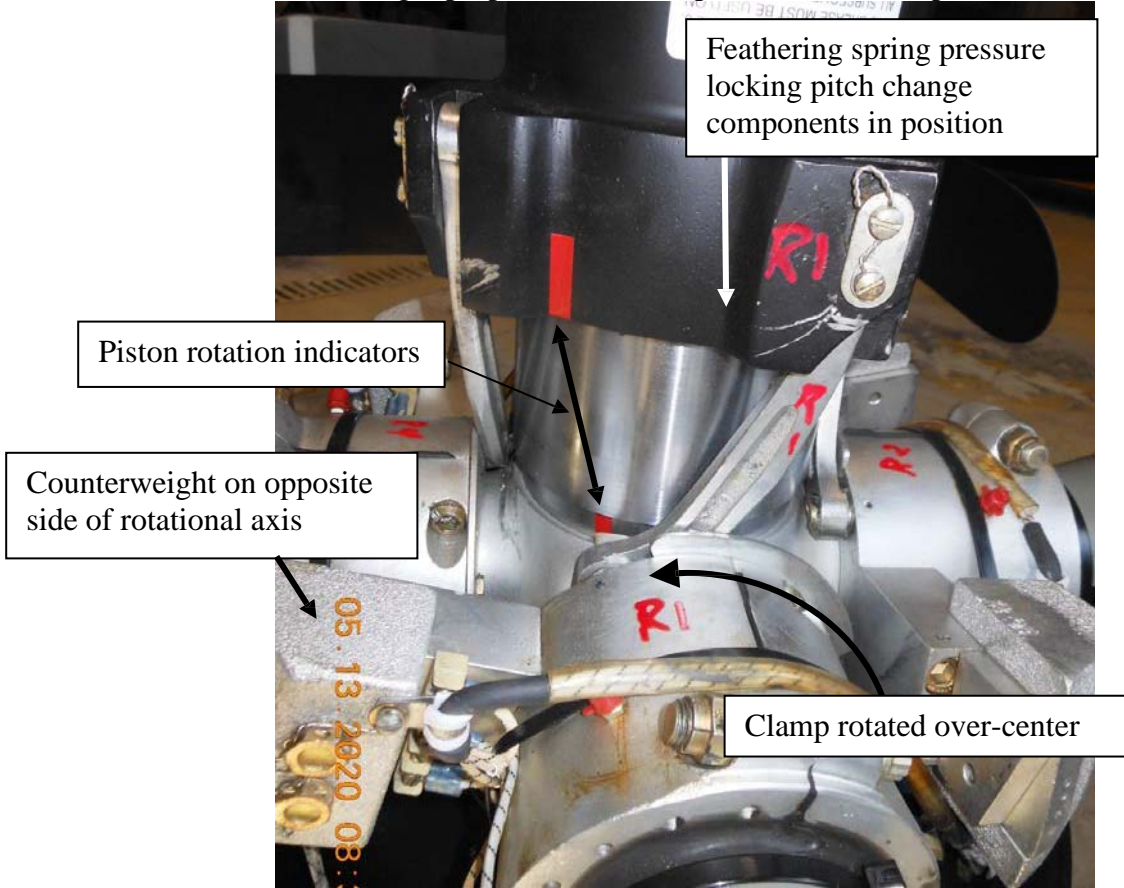
Photo #8 – Right propeller locked in position with clamps “over-center”

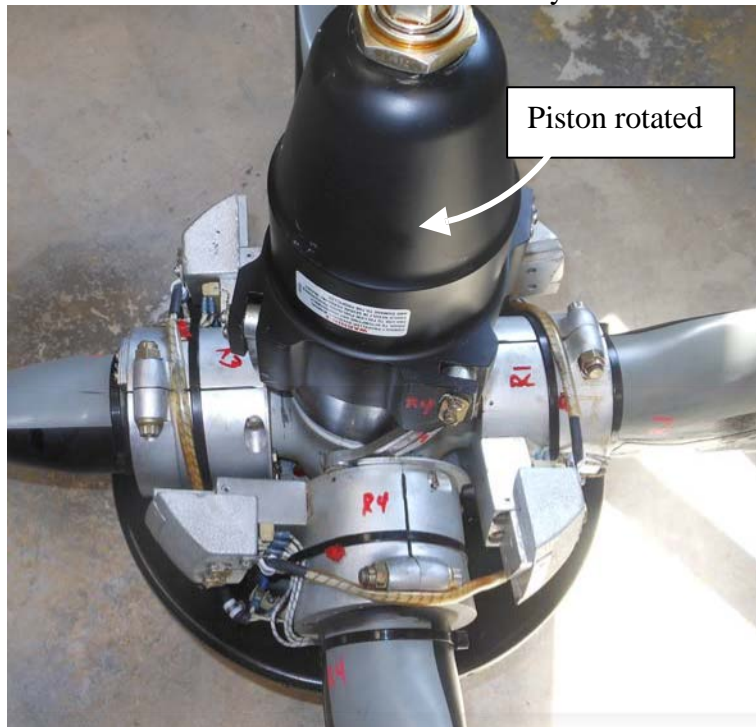
Photo #9 – Piston rotated about cylinder

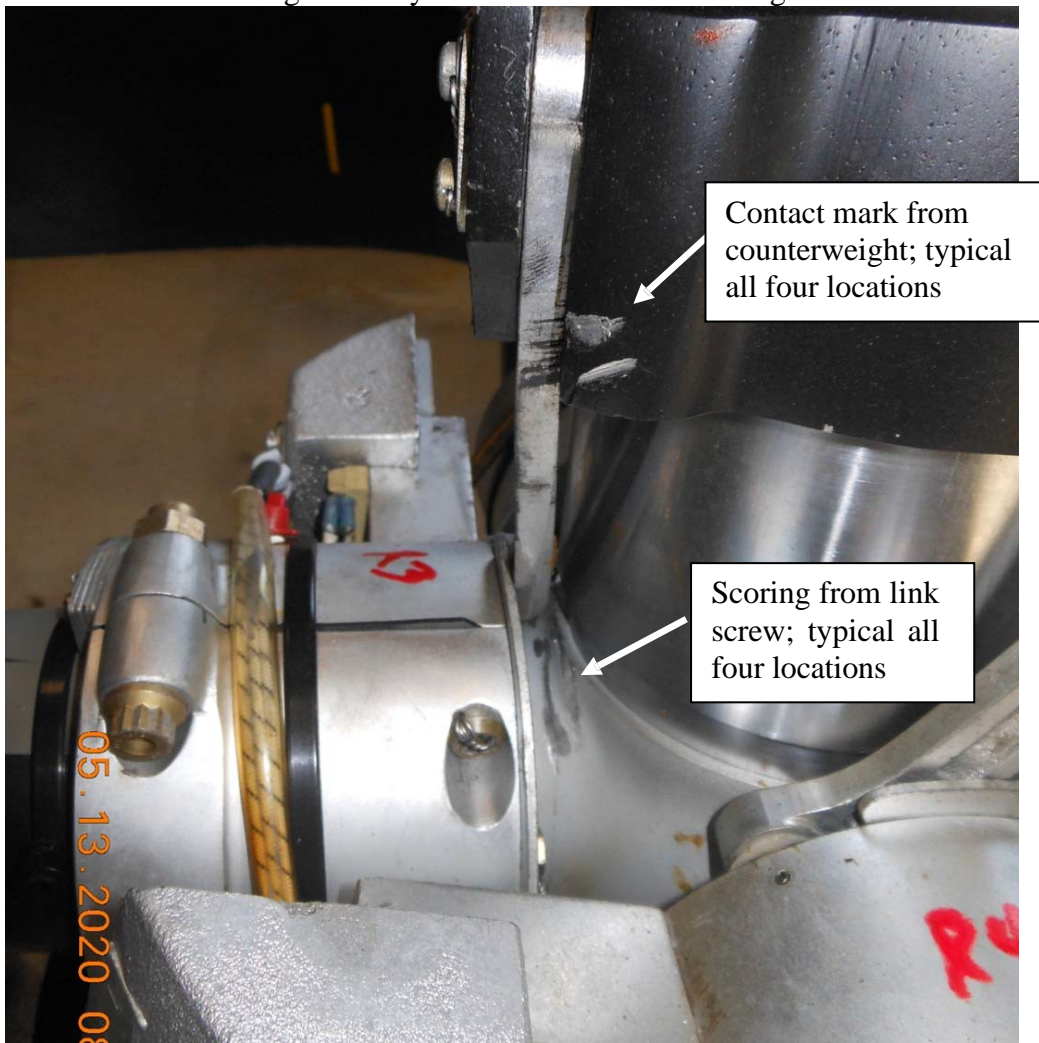
The beta tube had been removed, appeared straight and rolled-true on a flat table. There were contact marks on each hub arm made by the link screw as it rotated over the arm (Photo #10). There were also contact marks on the piston link arm attach points made by contact with the counterweight arms/slugs as they rotated past the rotational axis (Photo #10). All four link arms appeared bent in compression. There was some rotational free play between the blade clamp and link arm suggesting the link screw hole was elongated from impact forces. The piston was also visibly rotated/dragged around on the cylinder by the link arms and/or contact by the counterweights (Photo #9). It could not be determined if the piston had lifted off the cylinder during the impact sequence or if the forward spring cup remained attached to the cylinder.

Photo #10 – Scoring marks by link screw and counterweight contact mark

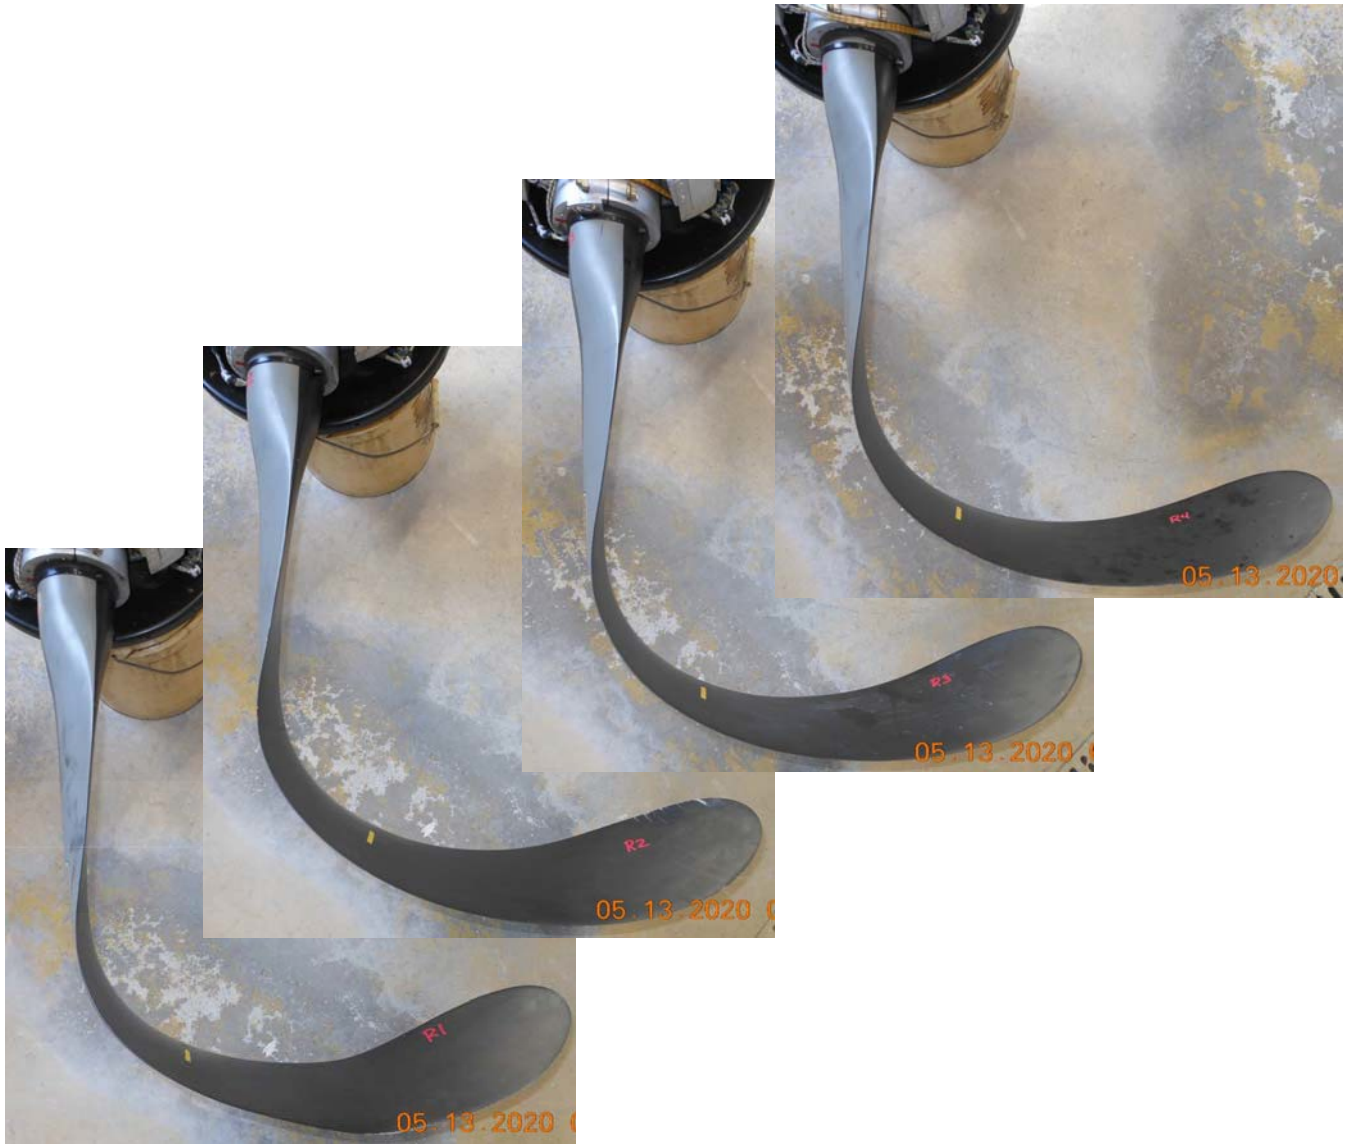
All four blades were bent in a similar fashion; aft and slightly opposite rotation. All four blades were also twisted in a similar fashion; towards low pitch (Photo #12). Only blade R2 displayed any remarkable chordwise/rotational scoring, on the face side near the tip (Photo #13). All four blades had spanwise abrasion in the mid-blade bend area suggesting the airplane continued a skid/slide after propeller rotation stopped (Photo #14).

Photo #12 – Right propeller blades relative bend and twist (R1-R4 left-to-right)

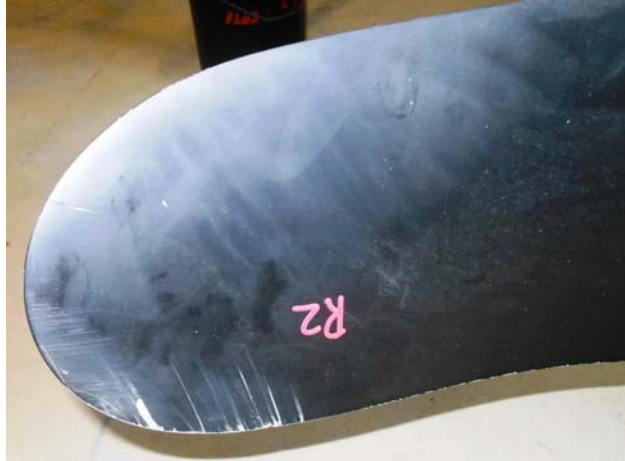
Photo #13 – Chordwise/rotational scoring on R2 face side

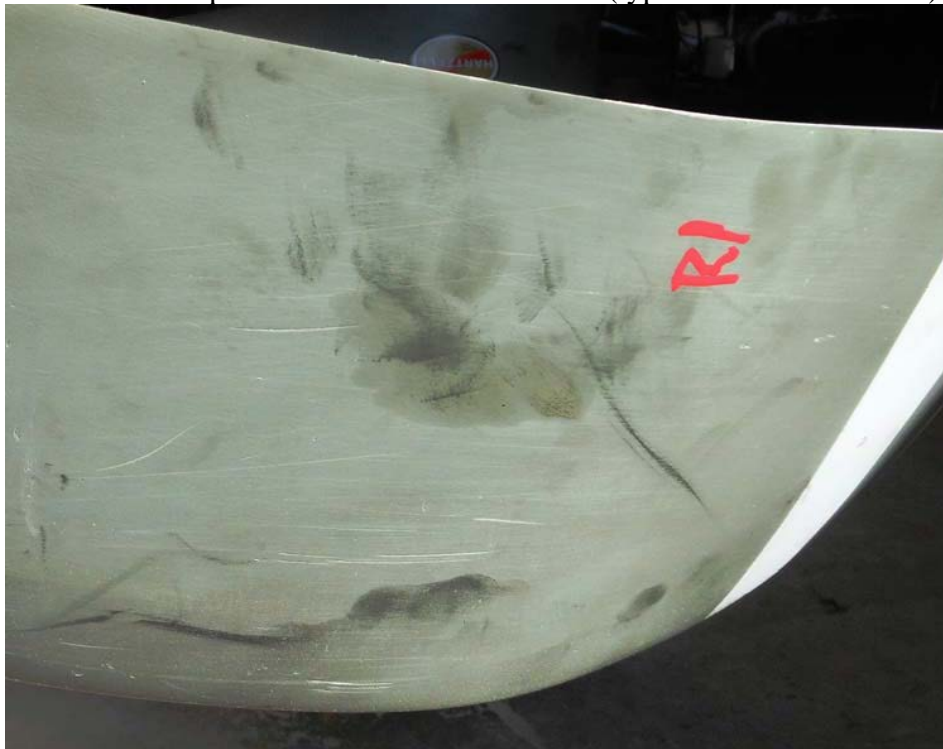
Photo #14 – Spanwise abrasion in mid-blade (typical of all four blades)
