National Transportation Safety Board

CEN22FA347

EXAMINATION NOTES

Location: Ute, IA
Date: July 30, 2022
Time: 1300 (Local)
1800 (UTC)
Airplane: Air Tractor AT-502

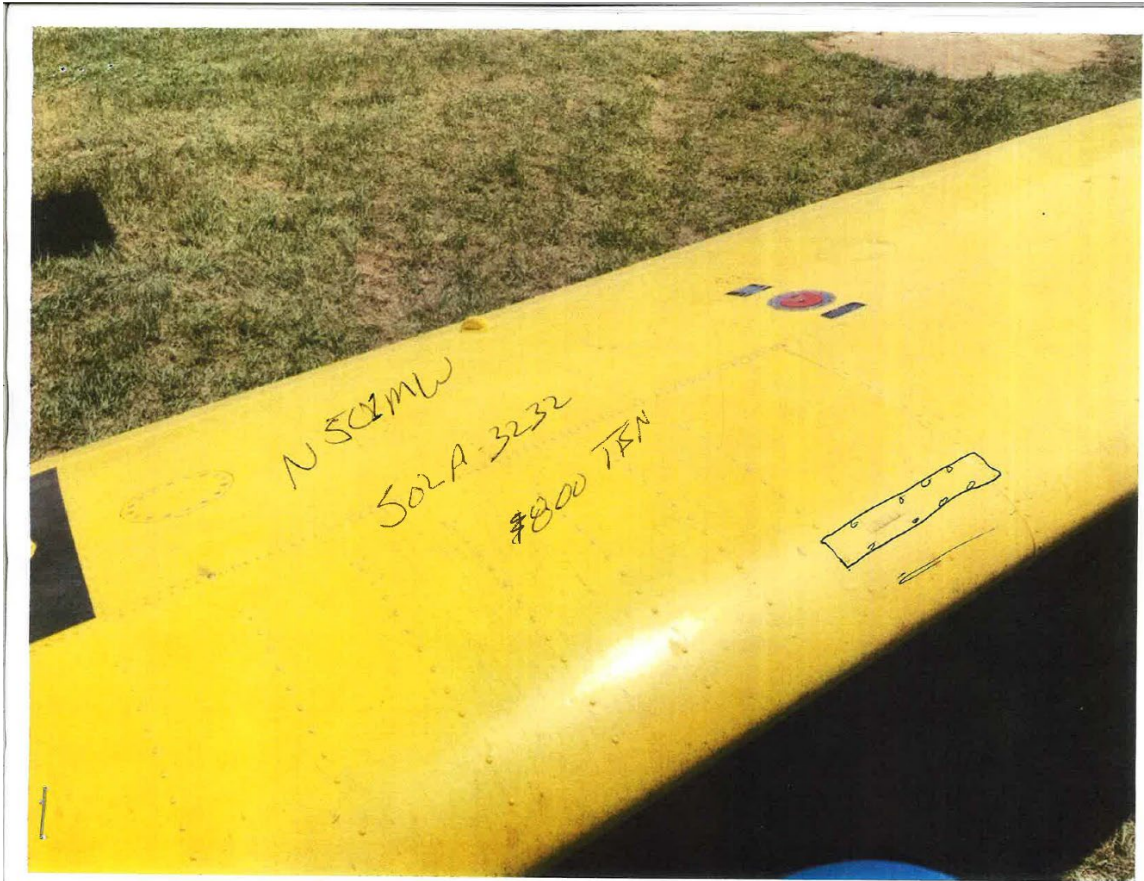
The pilot's wife reported that the pilot told her there was a crack in the wing of the airplane. The operator reported that there was a crack in the left wing about 5.5 ft outboard from the fuselage and 16 inches forward of the leading edge spar. The crack measured about 3 inches long and ran lengthwise on the wing.

Figure 1 Photo of Crack (Photo From Operator)

Air Tractor engineering reviewed the information on the crack. They recommended that they "stop drill" the crack and repair with a vinyl patch until a sheet metal patch could be installed. Engineering reported there were no structural issues suspected with the crack.
