NATIONAL TRANSPORTATION SAFETY BOARD

AIRFRAME / ENGINE EXAMINATION SUMMARY

WPR19FA075

Location: Oceanside, CA
Date: January 28, 2019
Aircraft: Piper PA-28-151, N37RV
NTSB Investigator-in-Charge: Tealeye Cornejo

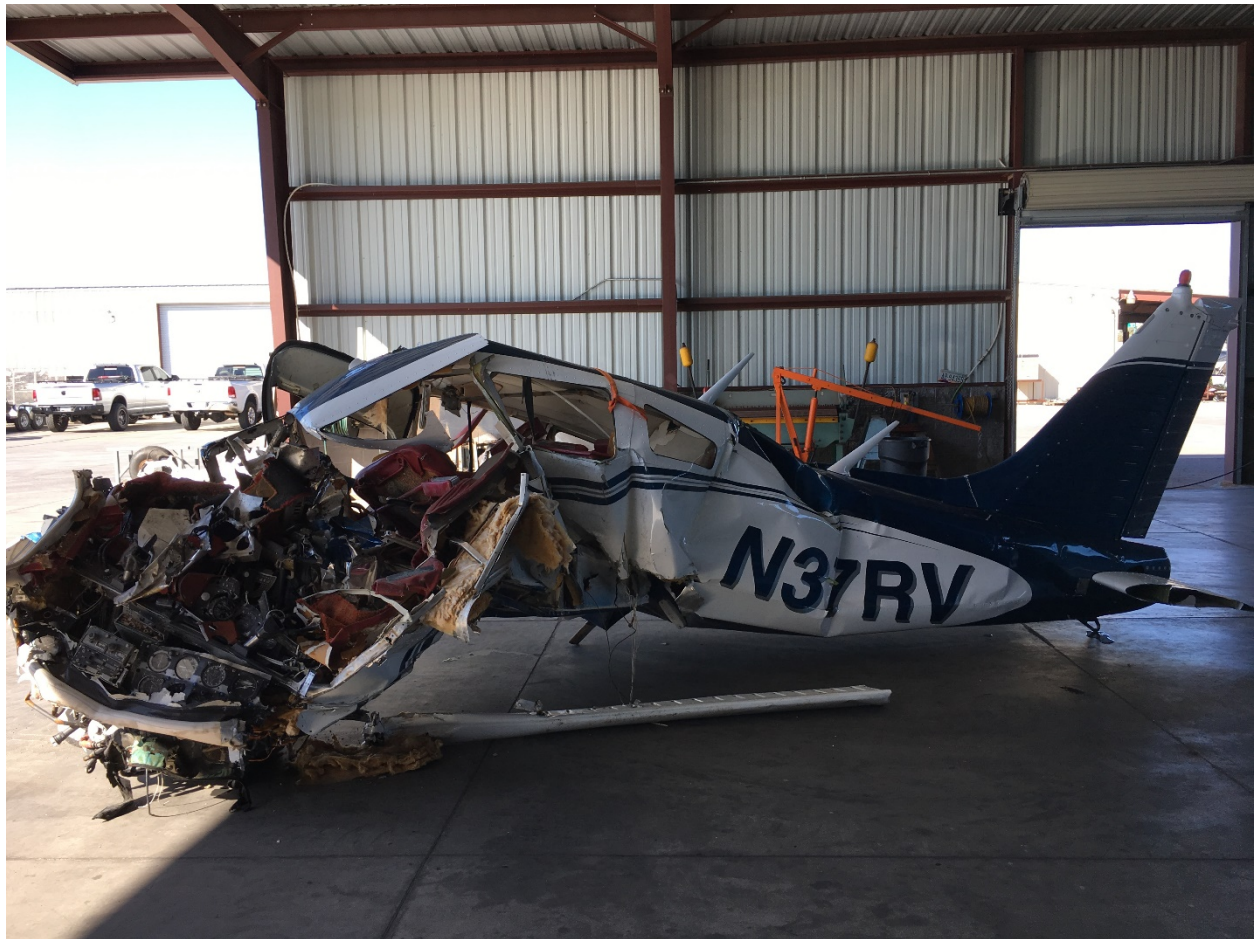
The airplane was laid out for further examination and exhibited crush and damage deformation throughout the entire fuselage. The right wing had been cut for recovery purposes. The left wing had separated due to impact forces. Pitch trim was in a slightly neutral/nose down attitude. The ELT remained secured in its container and attached to the airframe. The battery was removed from the container and had a 2020 expiration date. When activated for a field test, it did not work. General condition of the airplane – salt/corrosion.

Photo 1: View of the right wing

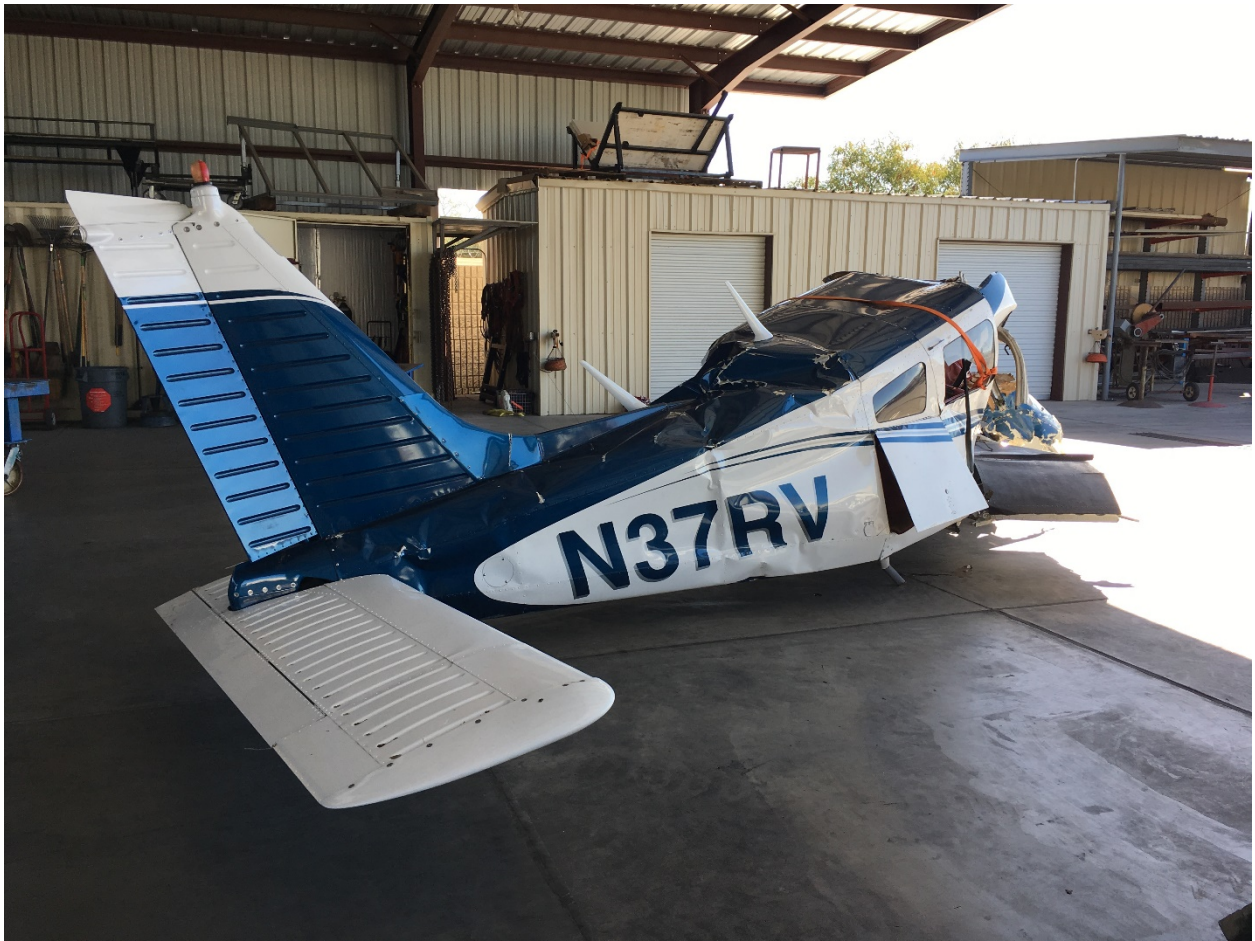
Photo 3: Right side view of airframe

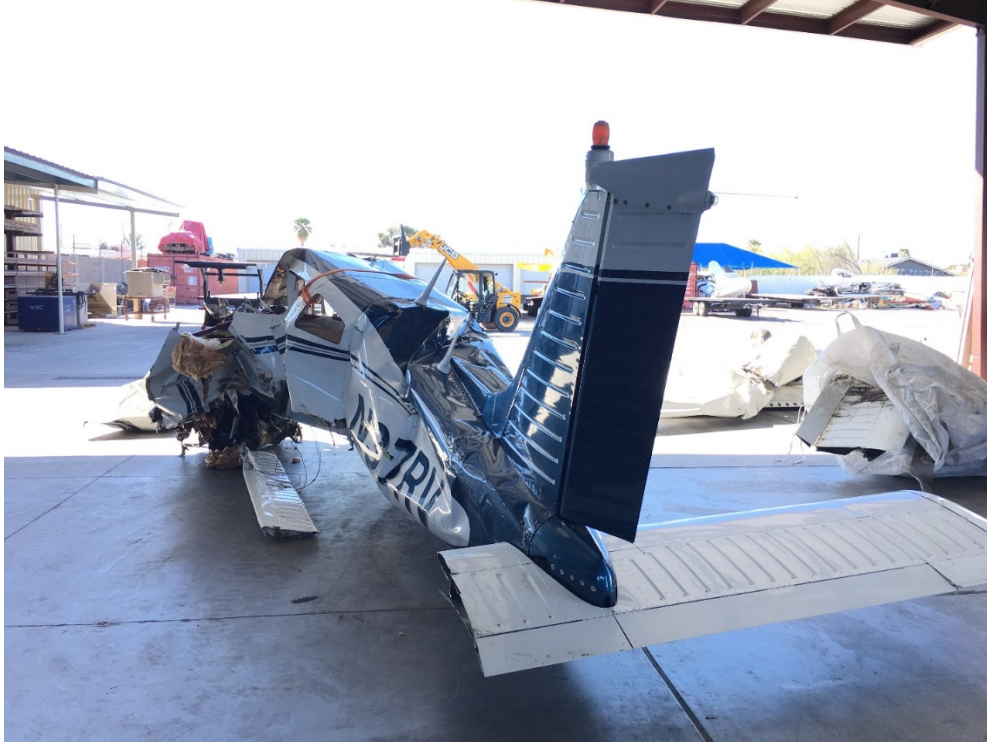
Photo 4: Rear View of Airframe

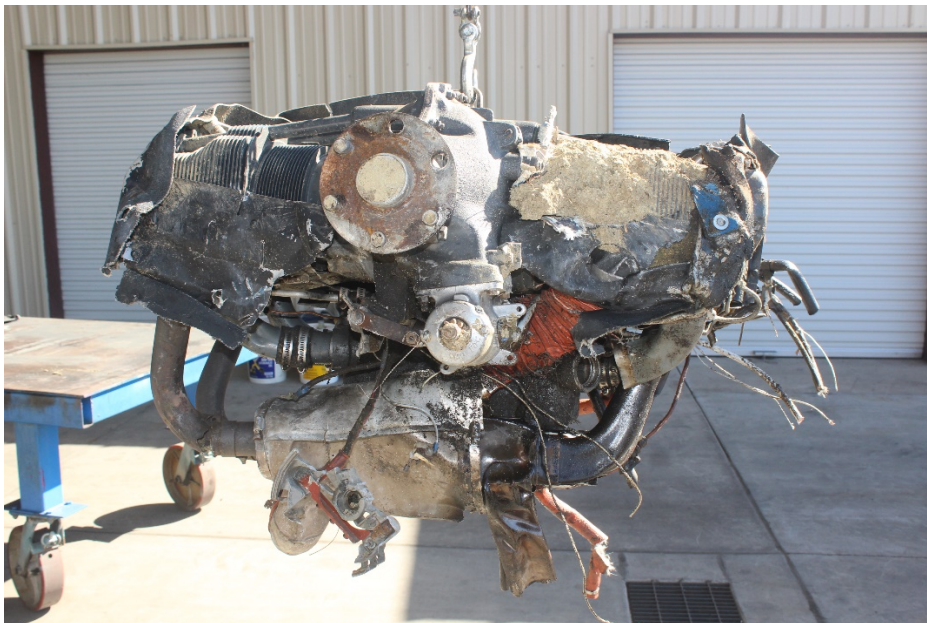
Photo 5: Front view of Engine

- Fly wheel from drive shaft
- Left magneto sustained impact damage
- Oil filter sustained impact damage
- Oil suction screen was clean
- Oil sump case housing sustained impact damage -Vacuum pump sustained impact damage -Alternator sustained impact damage -Engine mounts damaged

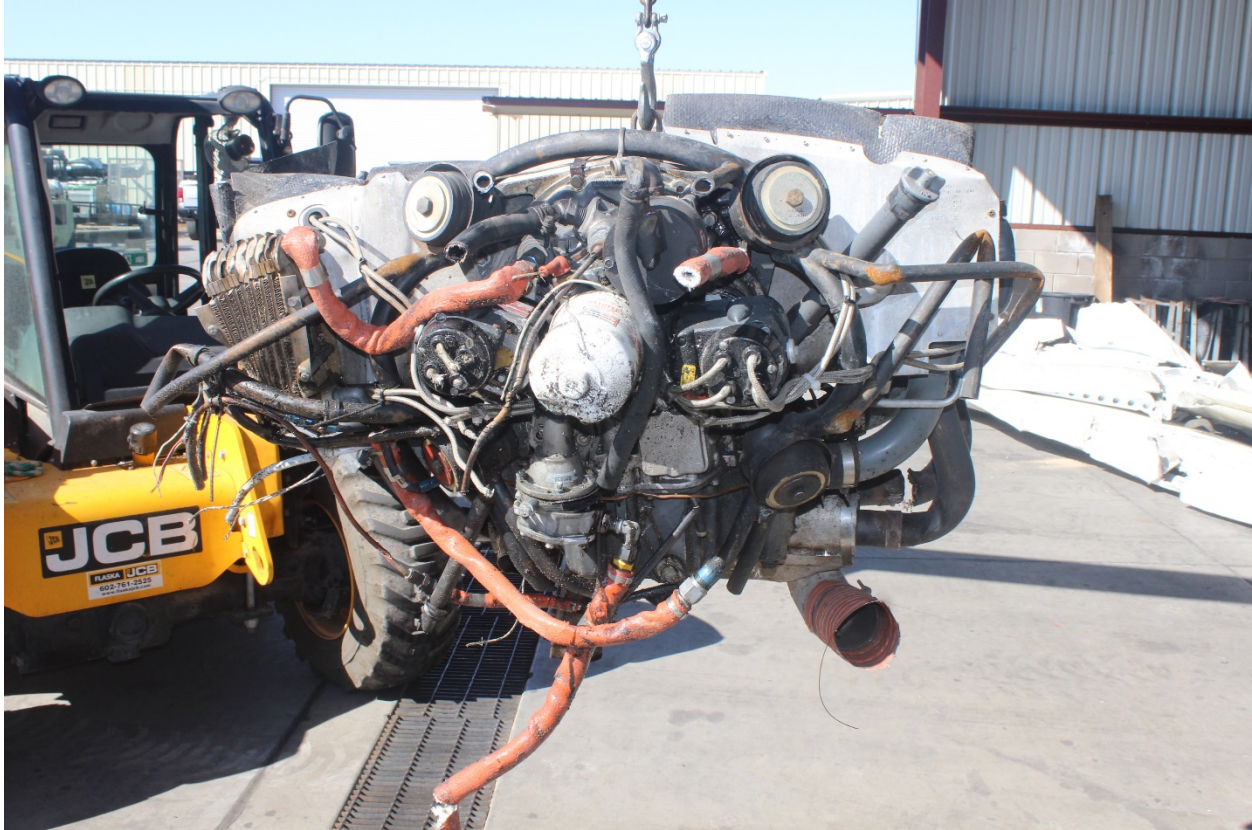
Photo 6: Rear View of Engine

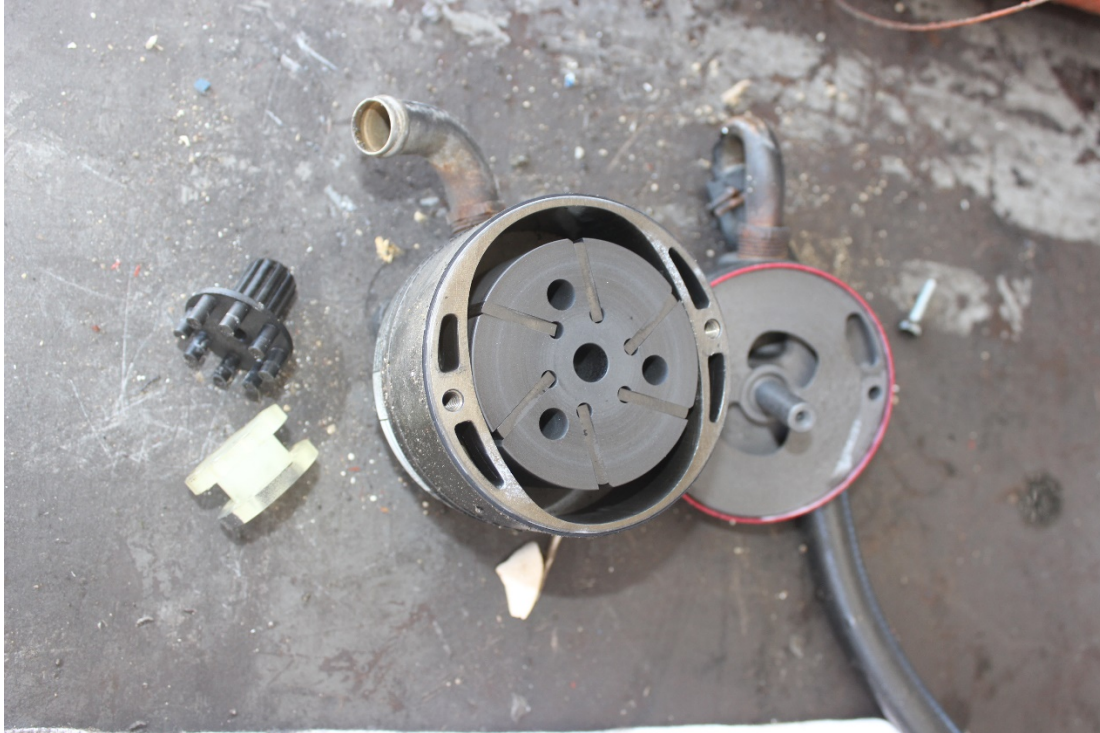
Photo 7: Vacuum pump

*Vacuum pump- drive is intact but it binds at a certain point in rotation. When opened, there was no part separation and movement was unimpeded.

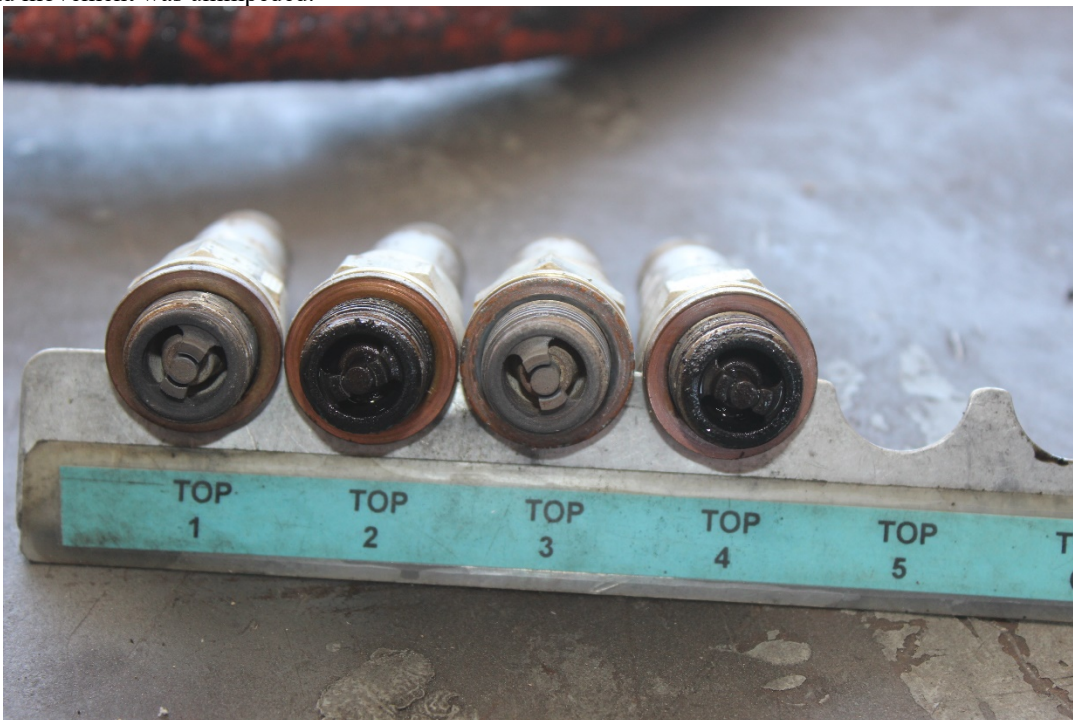
Photo 8: Spark Plugs

*Spark plugs -1/3 good condition and no anomalies. But oil was found in 2/4 with no deformation -Static oil signs suspected (No oil found on #2 and #4 exhaust pipes).

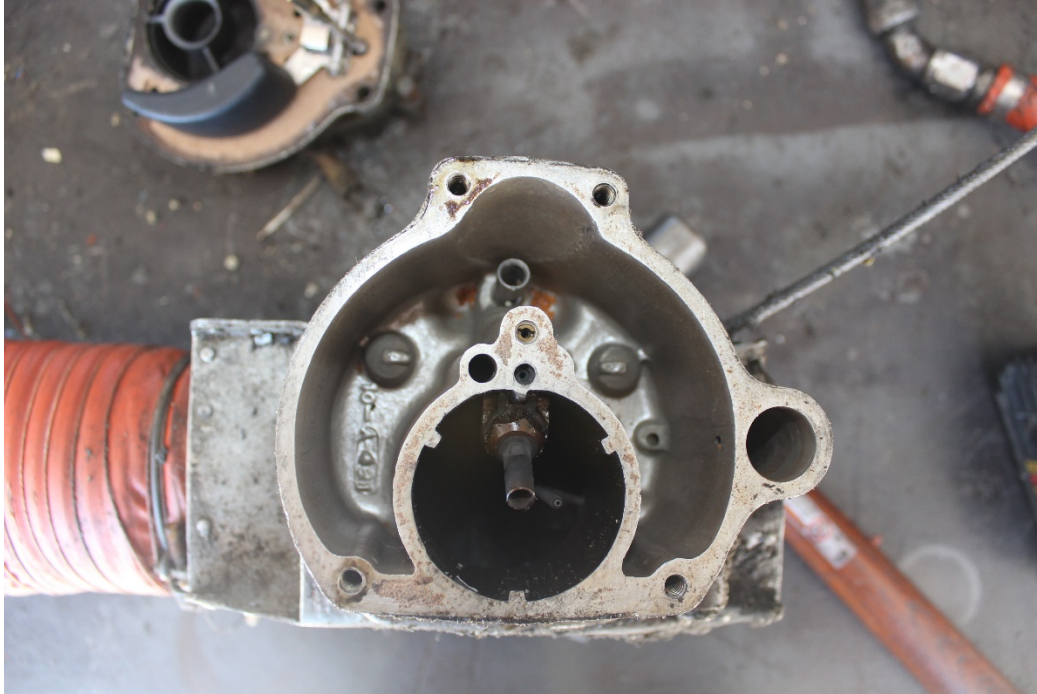
Photo 9: Carburetor bowl

*Carburetor air box sustained impact damage and the Carburetor was showed signs of overload and was fractured at the mounting flange, and the mounting flange is secure to the engine. When opened, the composite floats and

assembly were intact; the float bowl was free of contamination; the finger screen was clean and free of contamination; main jet is open.

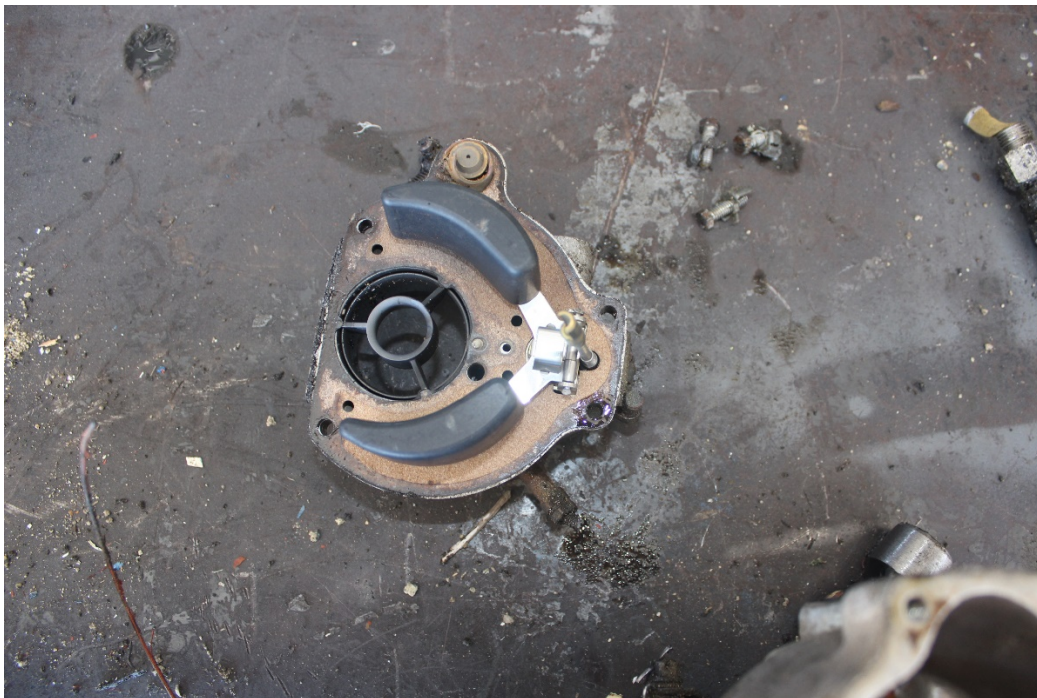
Photo 10: Carburetor floats

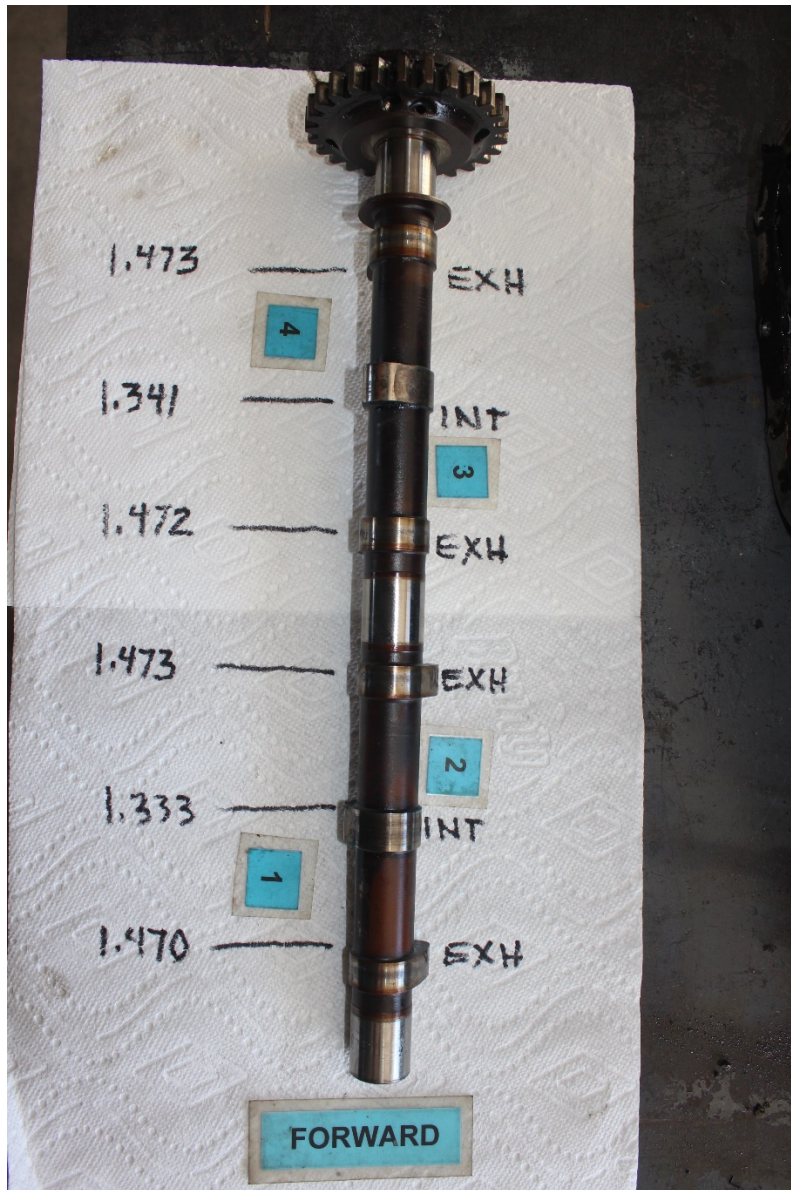
PHOTO 11: Camshaft

Cam shaft exhaust valves were normal in operation and appearance. However, the intake cam lobes were rounded in appearance and the tappets exhibited abnormal corrosion on the #2 and #4 tappets. The #1 and #3 tappets exhibited a normal round wear pattern, but #2 and #4 tappets were severely corroded, to a point that the round wear pattern was unnoticeable. Surface rust and corrosion were found on each of cam shaft tappets. The bearings exhibited extreme erosion and scratches.

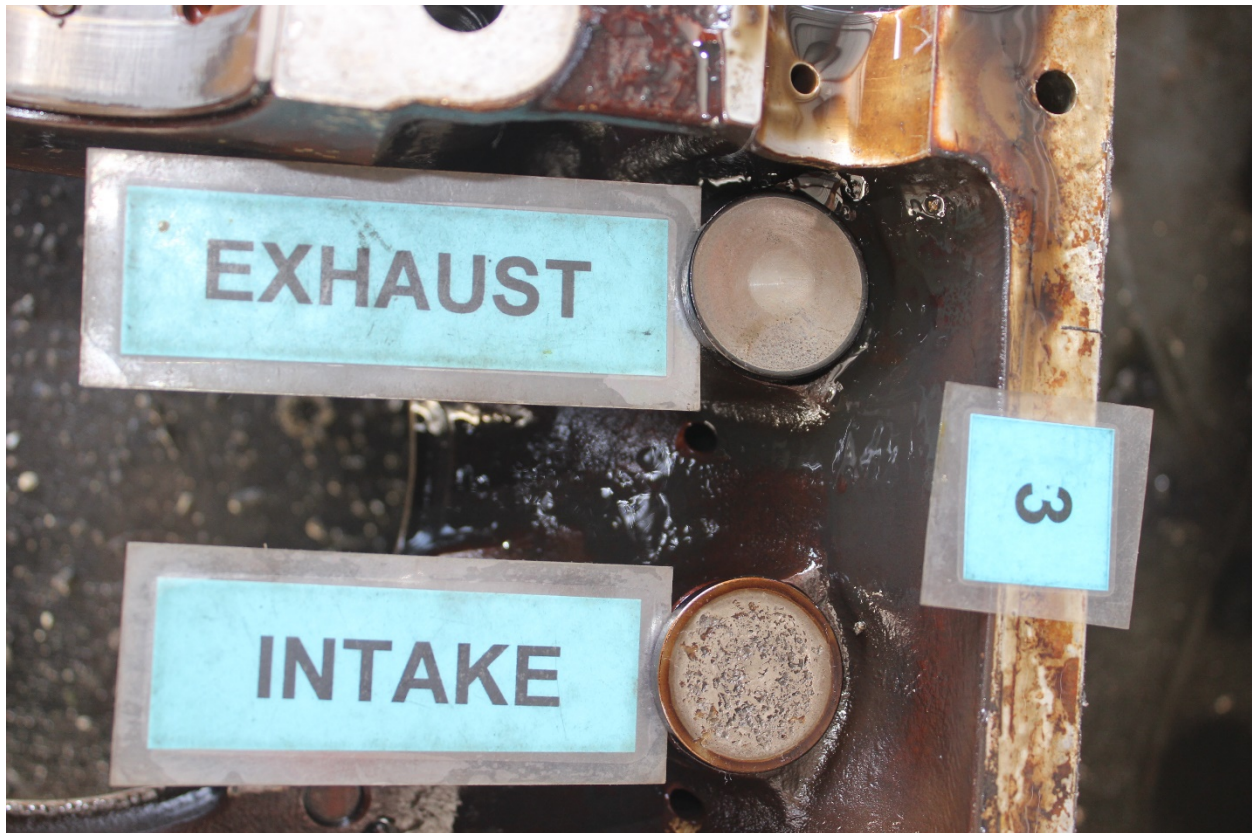
Photo 12: No 3 Exhaust and Intake tappets

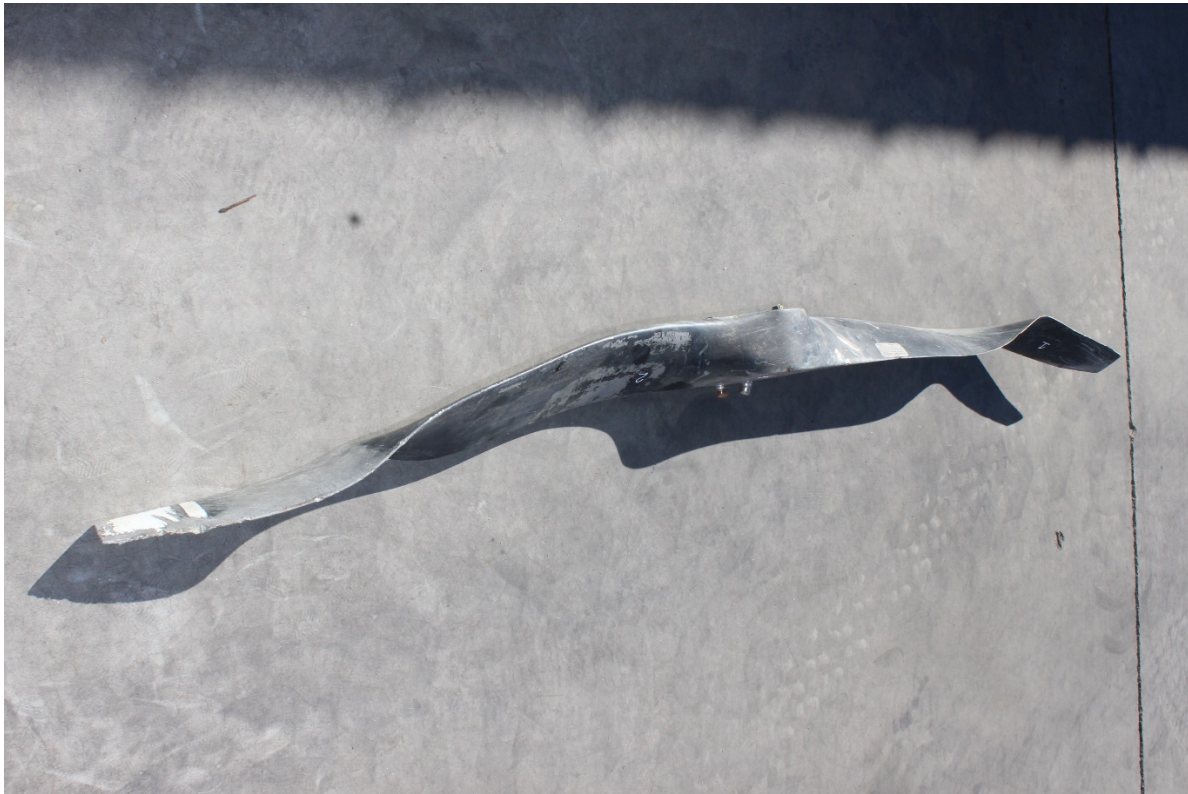
The metal two-bladed propeller exhibited torsional twist the length of blades, as well as leading edge gouging and chordwise striations.

Photo 13: View of the propeller blades
