NATIONAL TRANSPORTATIONS SAFETY BOARD
Office of Aviation Safety
Washington, DC 20594

SUMMARY OF ENGINE/AIRFRAME EXAMINATION

-- CEN21LA273 --

Location: Fort Worth, Texas
Aircraft: N878TD, Vans RV10

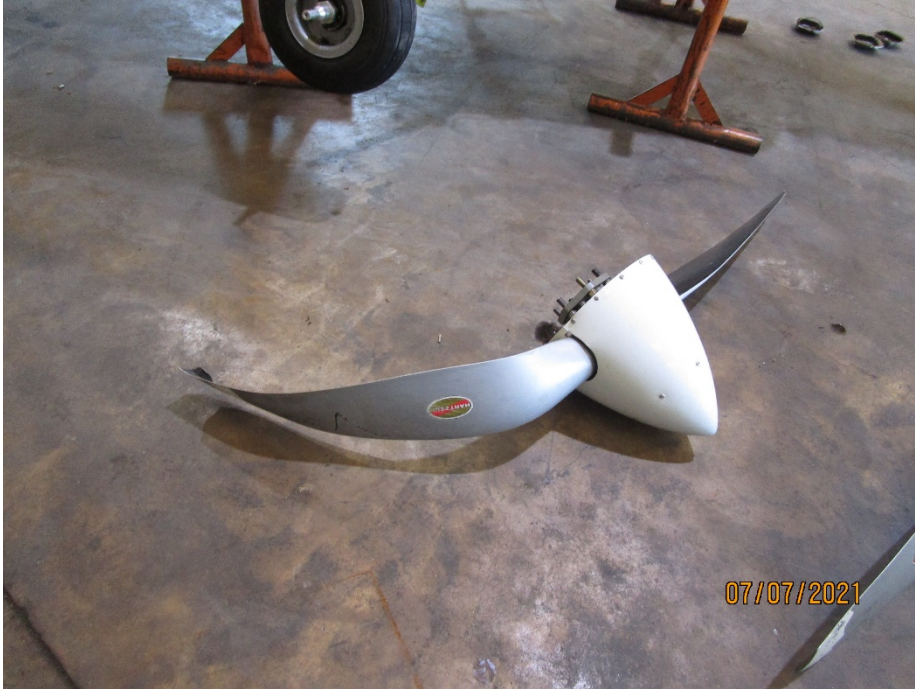
- Engine remained attached to the airframe, but the airframe and engine mounts were broken.
- Propeller remained attached to the crankshaft flange and the propeller.
- One blade tip had damage, the other blade was curved back toward the non-camber side, about mid-span, and the small portion of the blade tip appeared to be missing.

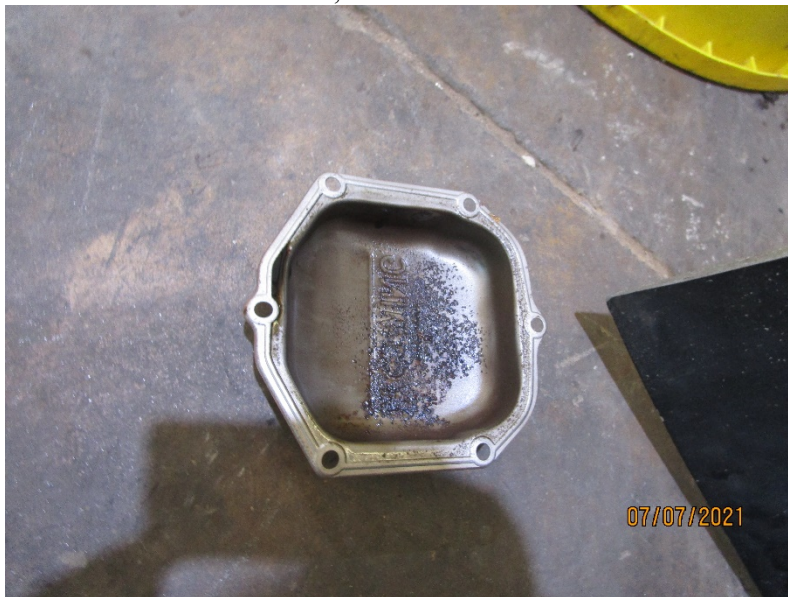
- Removed top and bottom set of (automotive style) sparkplugs, top right appeared normal. Top left appeared dark, both sets of bottom plugs appeared wet and black.
- Valve covers were removed, inside of each cover were rusted.

Each valve cover had similar appearance

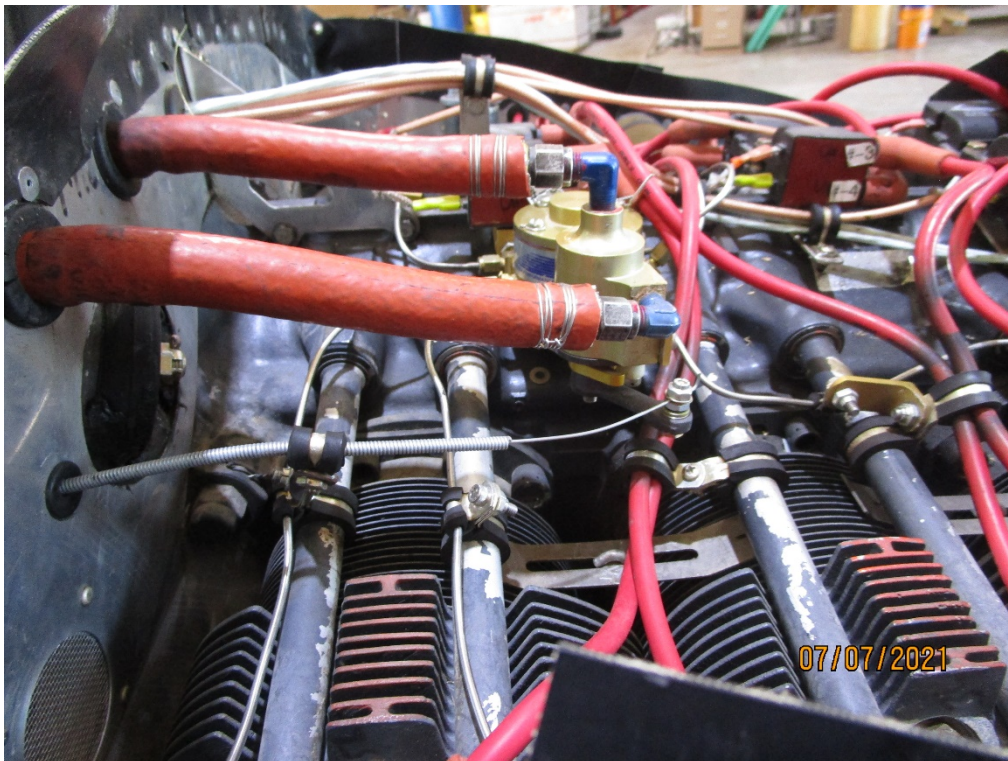
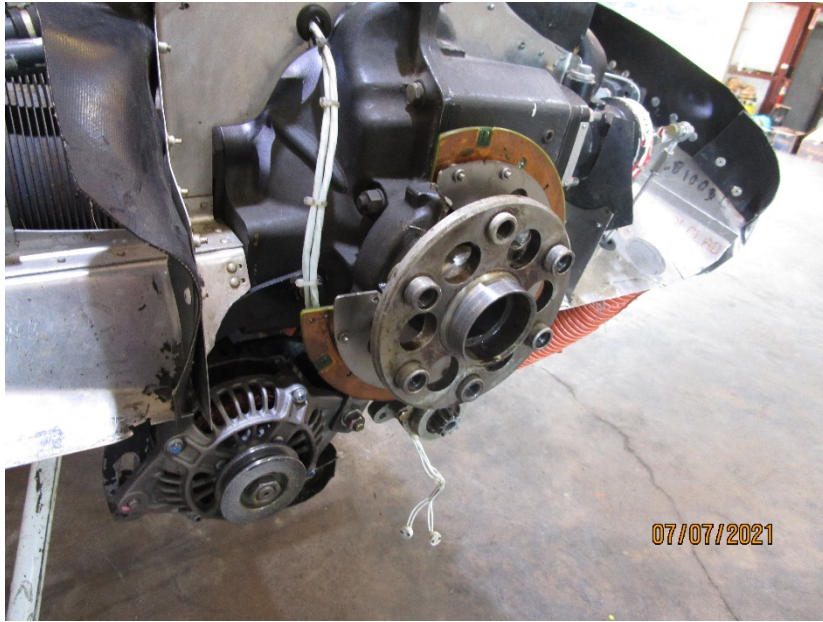
- Both PFD and MFD SD cards were absent.
- Fuel injection; mounting of “Bowden” style cable is noted

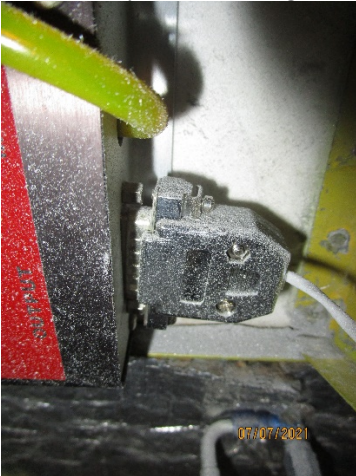
- Crankshaft flange and crankshaft position sensor
- Magnet was used to trigger ignition system, first attempt did not produce any sparks, subsequent attempts were able to produce spark on one set of ignition.
- Labeling of ignition wires and coil packs didn't always correspond, nor correspond to the cylinder it was associated with. (firing order of ignition vs engine firing order ?)
- Ignition control boxes located behind firewall, above rudder pedals (difficult/limited access)
- Angle grinder was used to cut fuselage skin, (just behind firewall, and in front of windscreen) to allow access to ignition boxes.
- (output) pin connector to box #1 not connected, other pin connector were observed not fully secured to ignition boxes.
