**NATIONAL TRANSPORTATIONS SAFETY BOARD**  
**Office of Aviation Safety**  
**Washington, DC 20594**

**SUMMARY OF ENGINE/AIRFRAME EXAMINATION**

-- CEN21LA306 --

Location: Pottsboro, Texas  
Aircraft: N181BW, Piper PA28

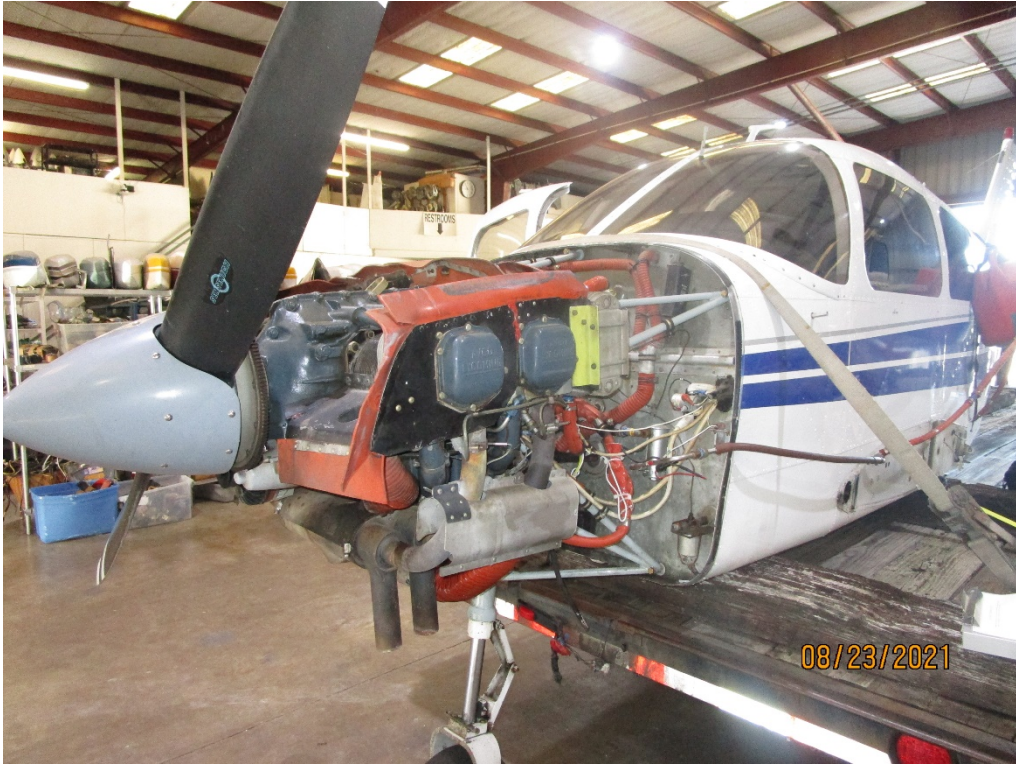
Fuselage on a trailer; ready for the engine run

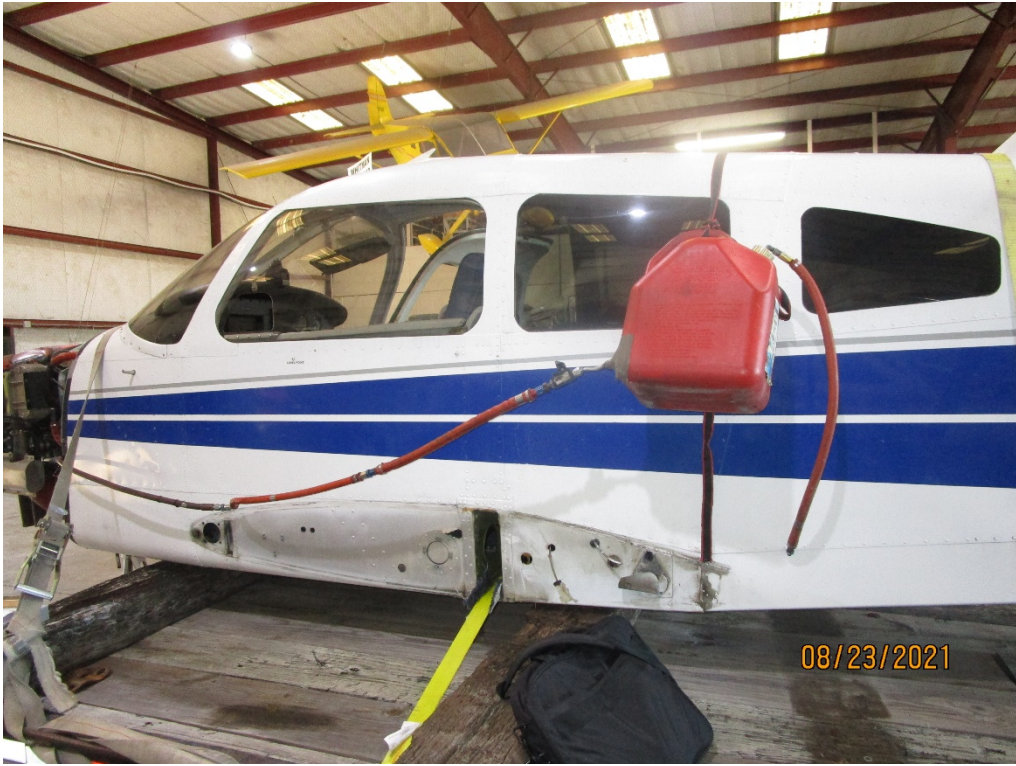
Fuel can, plumbed to the engine

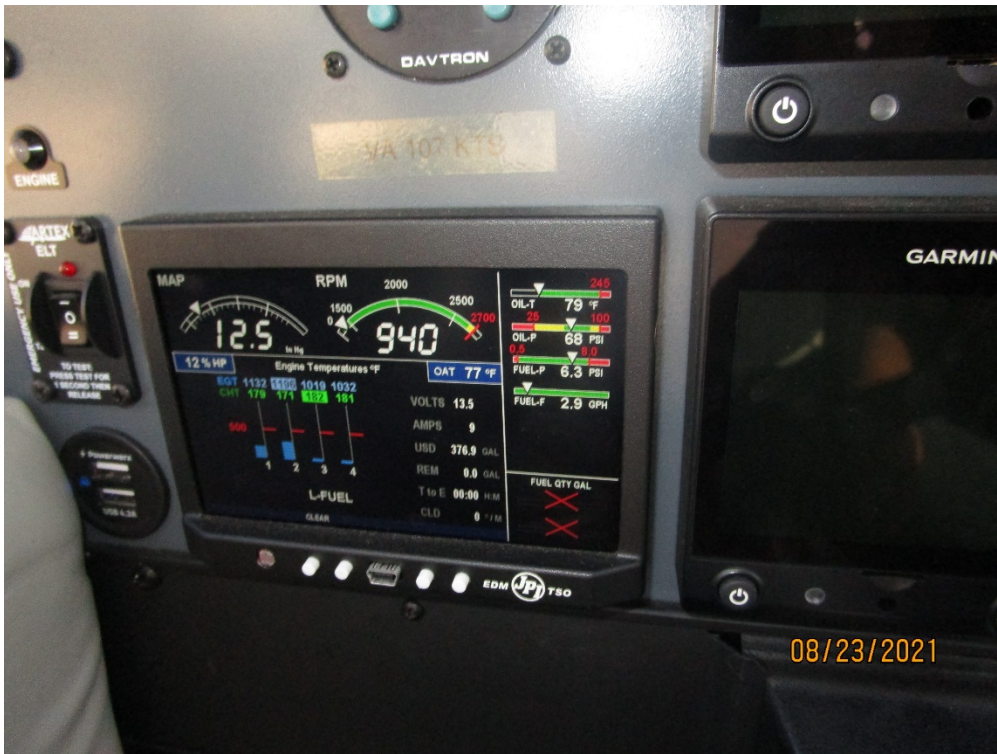
- The engine started without hesitation or delay.
- Engine was allowed to warm up before advancing the throttle.
- A magneto and carb heat check was performed
- With the engine at full throttle, a slight increase in rpm could be achieved by using the mixture control and leaning the engine slightly.
- The engine appeared to make rated power without any decrease in rpm or issues.

Engine monitor during the engine test run
