**NATIONAL TRANSPORTATIONS SAFETY BOARD**  
**Office of Aviation Safety**  
**Washington, DC 20594**

**SUMMARY OF ENGINE/AIRFRAME EXAMINATION**

-- CEN21LA382 --

Location: Granbury, Texas  
Aircraft: N67CW

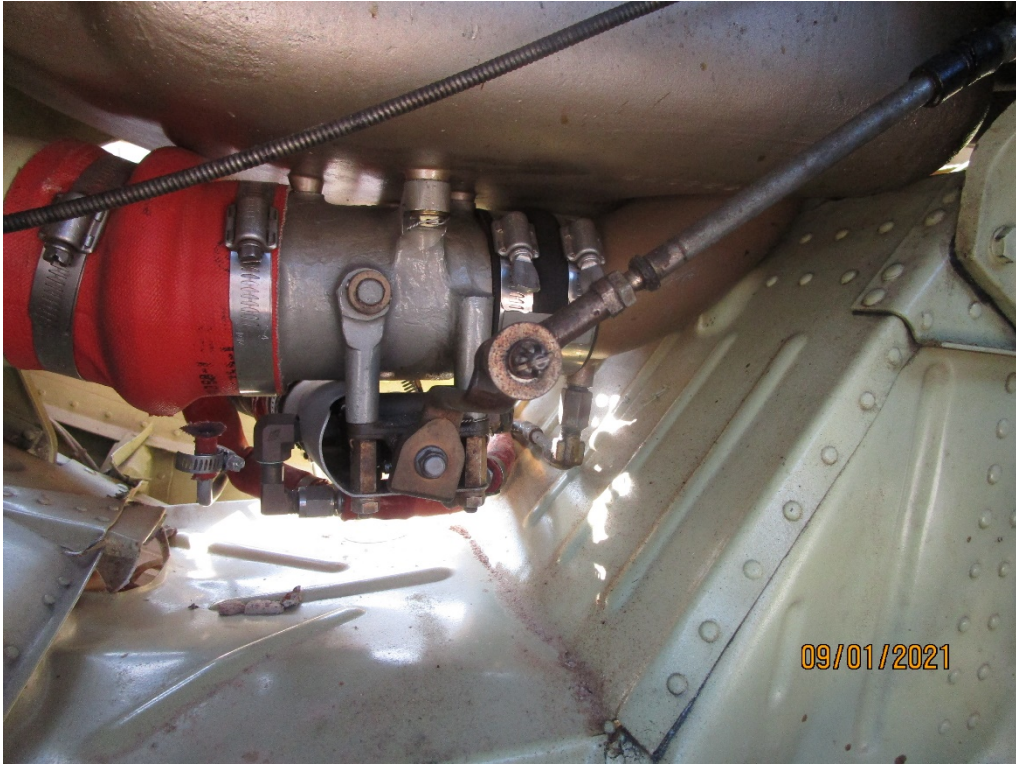
Throttle body; engine controls connected.

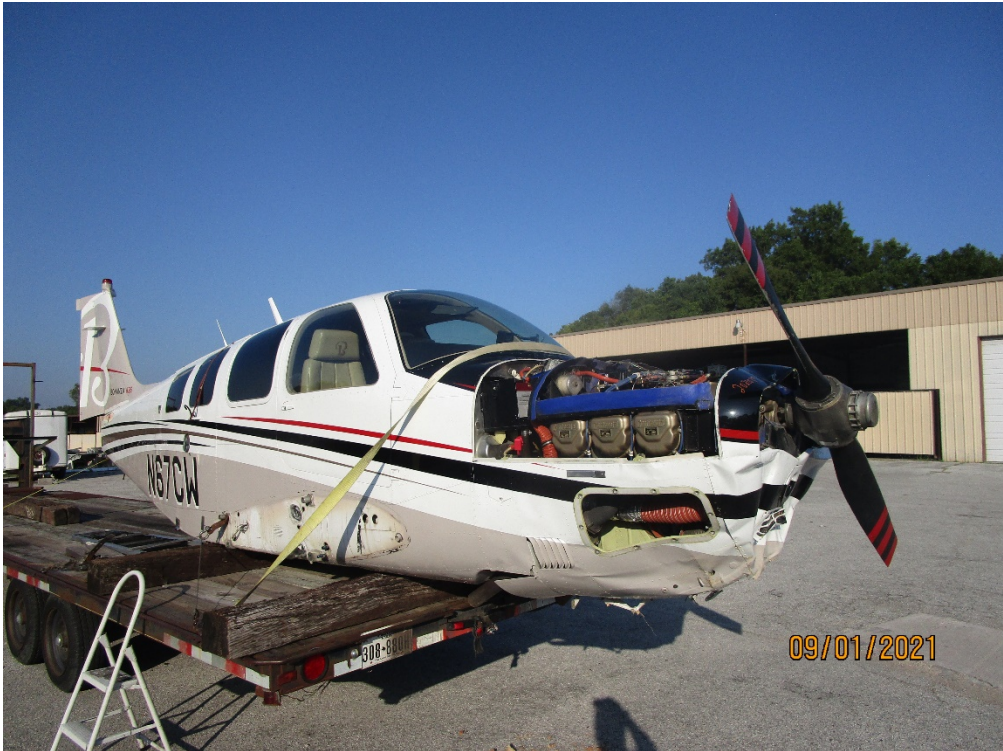
Airplane strapped down to trailer, for the engine run, with a replacement propeller installed

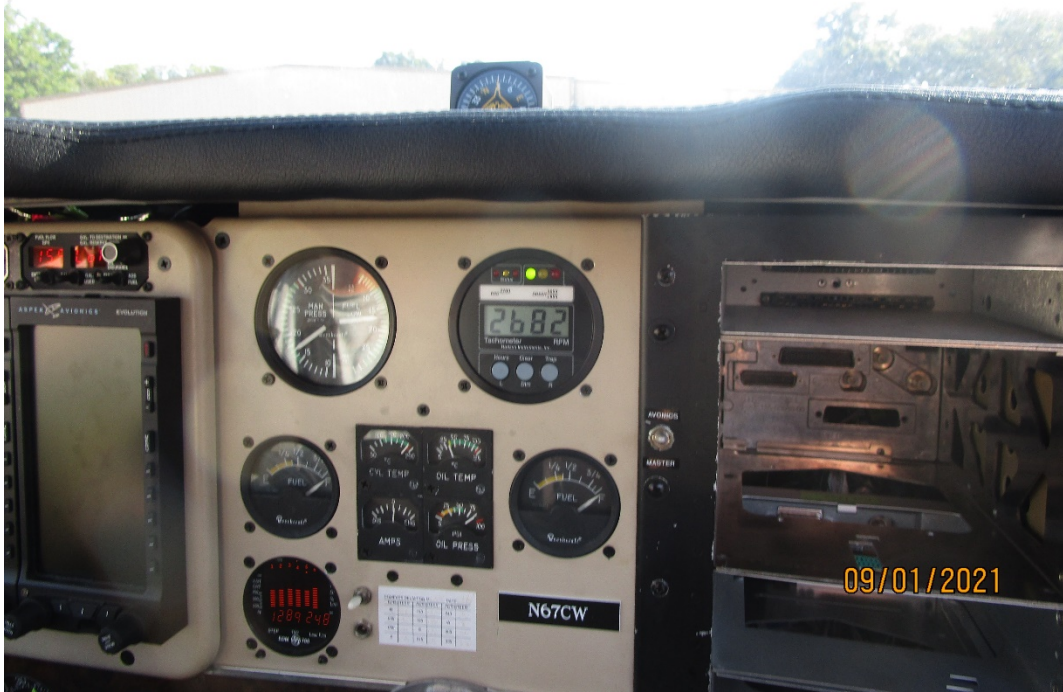
- The engine started without hesitation or delay; however, the engine stopped a couple times, and the electric fuel pump was used to prime the engine. Once the air was out of the fuel line the engine ran without issue.
- Engine was allowed to warm up before advancing the throttle.
- A magneto check was performed
- The engine appeared to make rated power without any decrease in rpm or issues.

Engine gauges during the engine test run

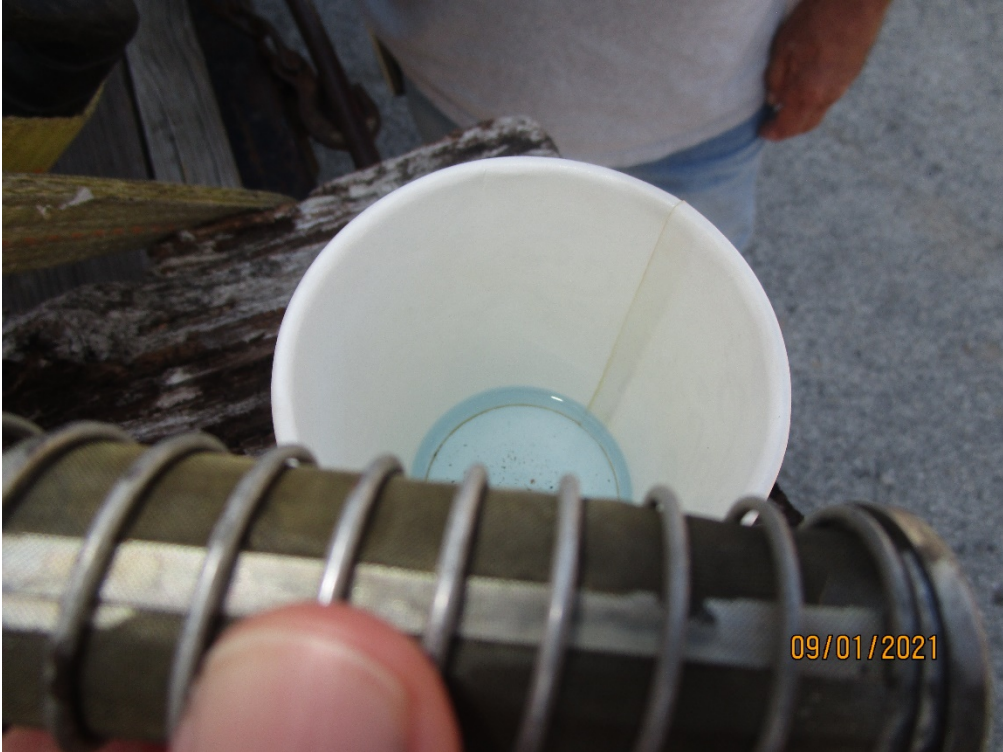
Main fuel strainer, was clear with very little debris noted

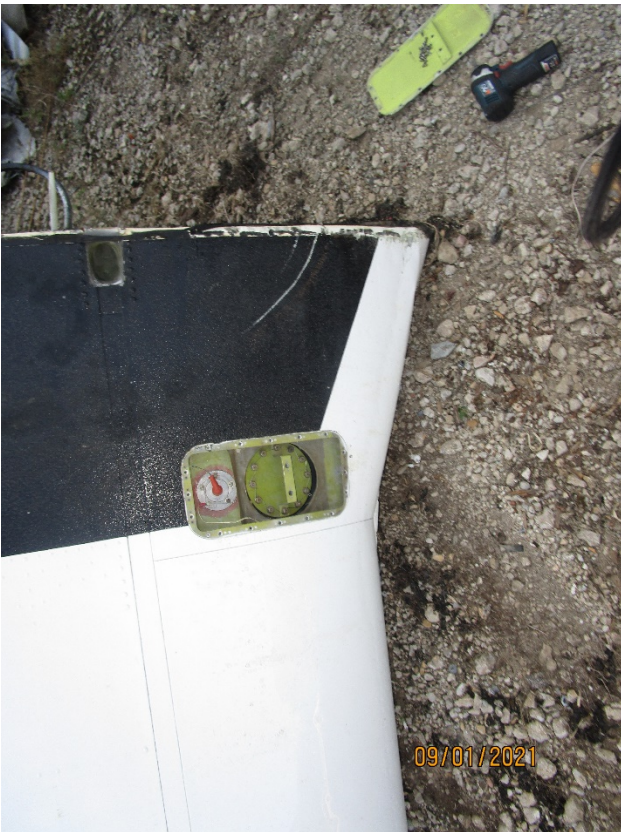
Wing tank

- Both left and right wing fuel tanks were opened. Both fuel bladders appeared to be in good condition and no obstructions were found.
