National Transportation Safety Board

CEN23FA333

AIRCRAFT EXAMINATION SUMMARY

Location: Oshkosh, WI
Date: 07/29/2023
Time: 1227 CDT
Aircraft: Rotorway 162F; N193AZ / ELA Eclipse 10; N221EL

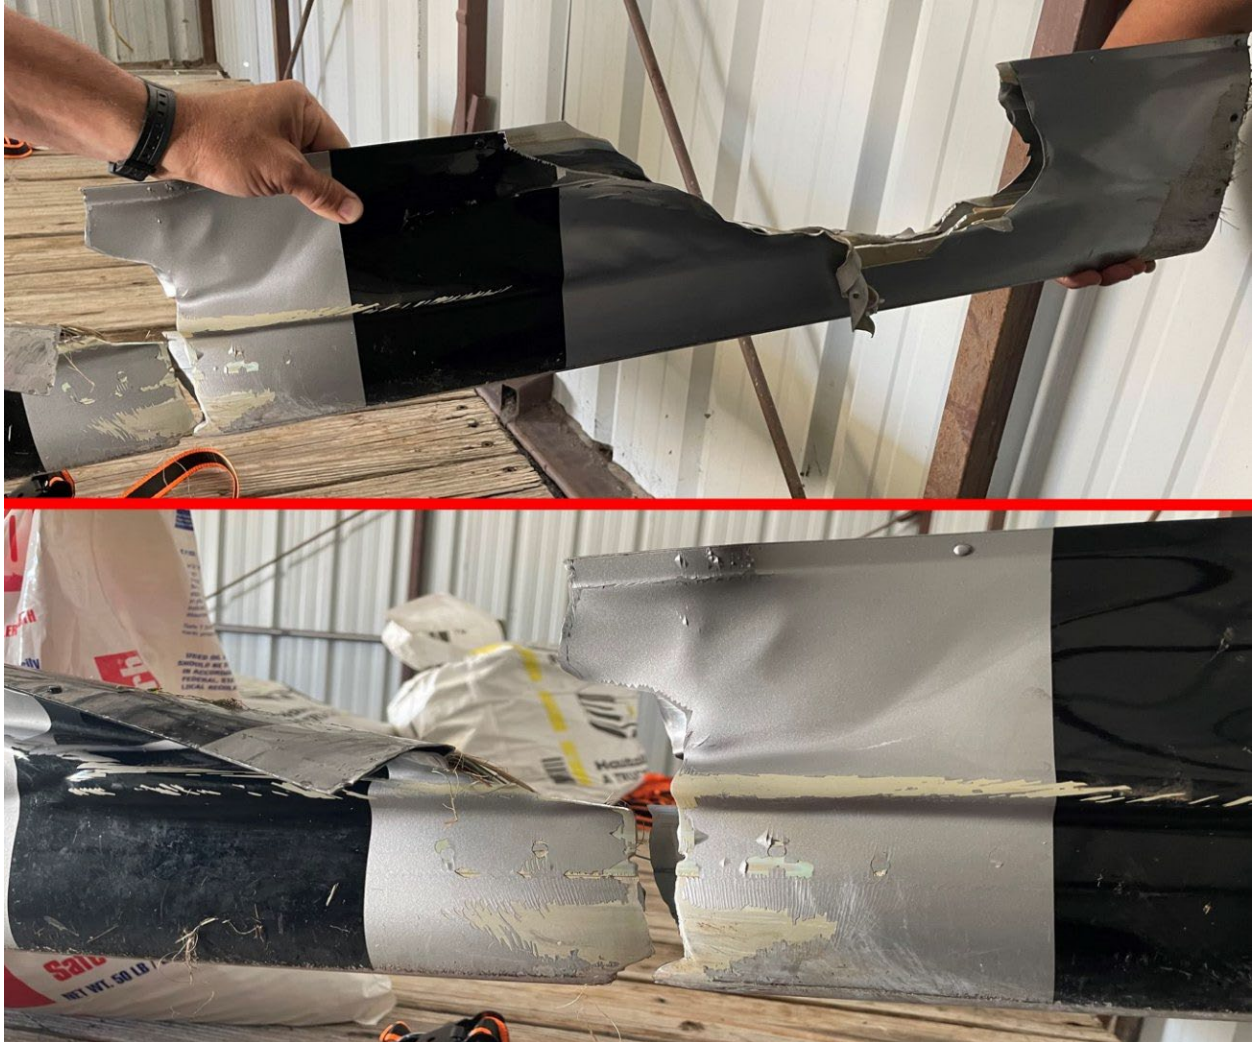
Postaccident examination of the helicopter revealed both outboard sections of the main rotor blades were separated and came to rest in the debris field. The main rotor blade's structure displayed impact marks and white paint transfers, consistent with the gyroplane's structure and paint color. The gyroplane's right horizontal and vertical stabilizers displayed shear cuts and separated structure consistent with helicopter main rotor blade contact. The gyroplane's main rotor mast was separated about mid-length with an impact signature consistent with the helicopter's main rotor

Photograph 1. Separated outboard sections of the helicopter's main rotor blades.

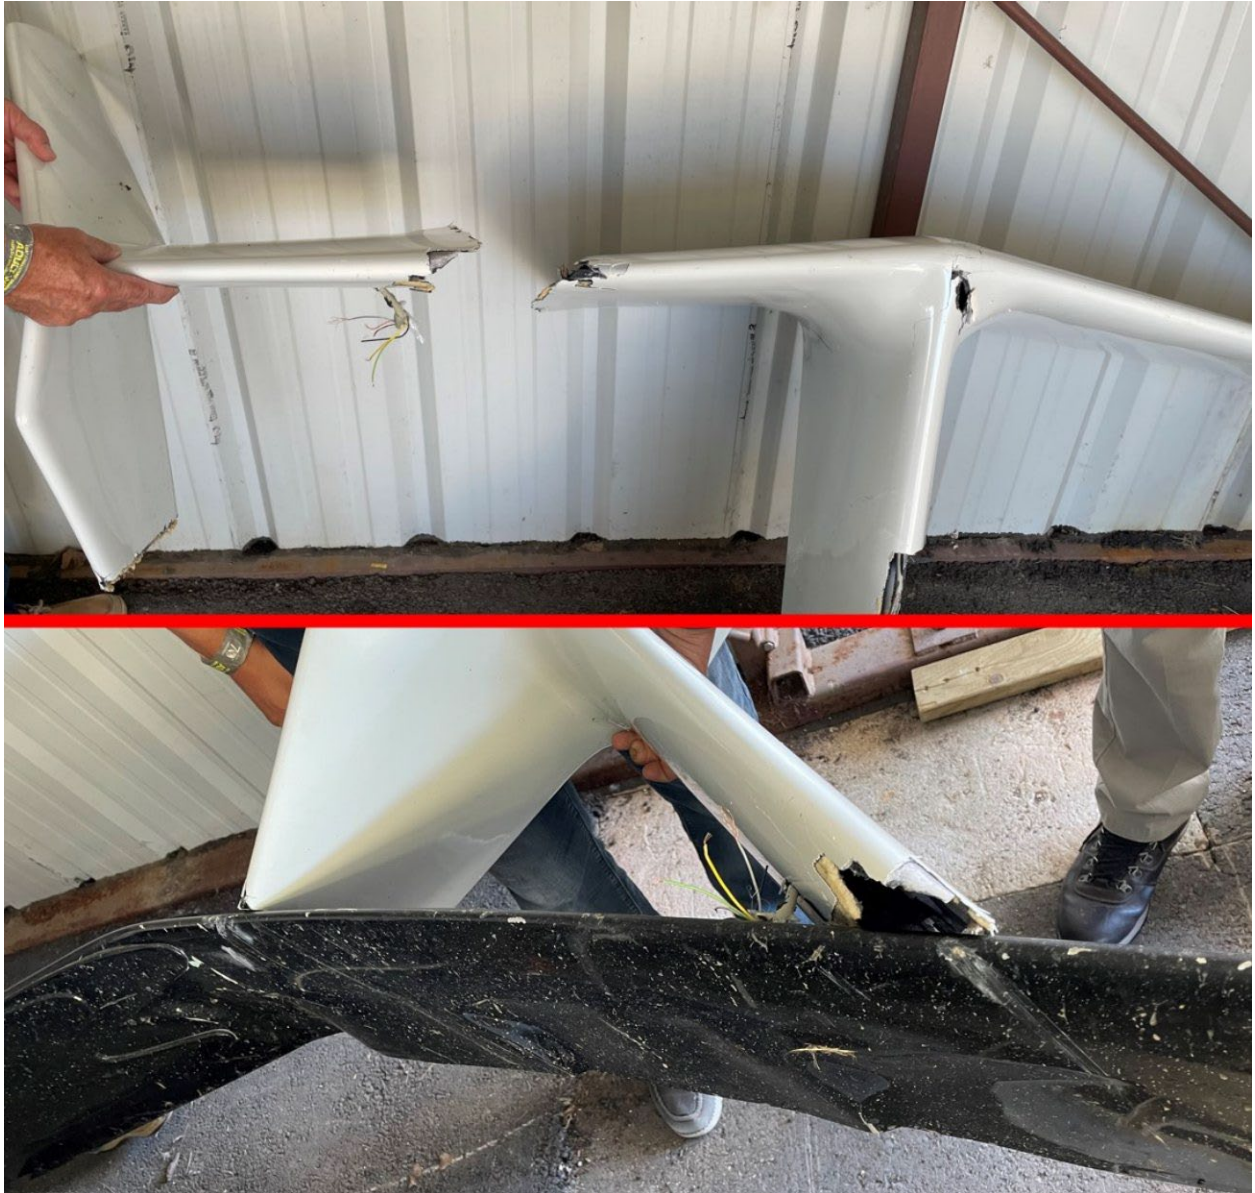
Photograph 2. The upper photograph depicts the gyroplane's separated right horizontal stabilizer and lower vertical stabilizer. The lower photograph depicts the separated stabilizer section in comparison with the helicopter main rotor blade contact witness marks and white paint transfer.

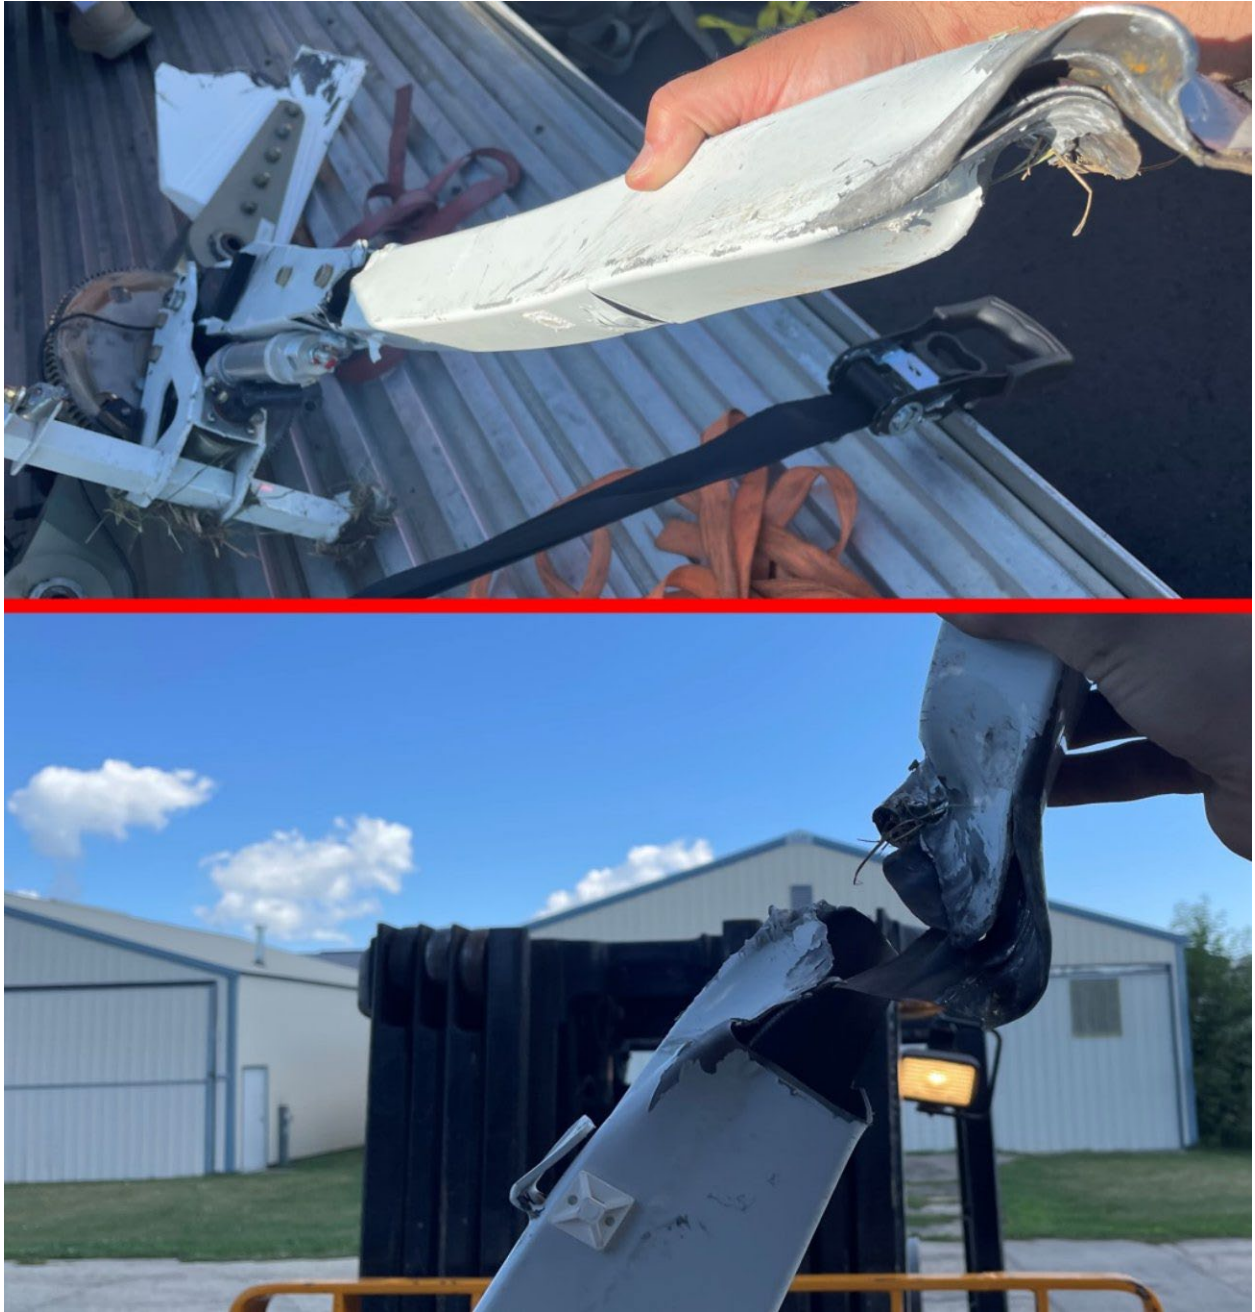
blade. Examination of both aircraft revealed no evidence of any preimpact mechanical malfunctions or failures that would have precluded normal operation.

Photograph 3. Gyroplane's separated rotor mast section and the helicopter's main rotor blade contact witness mark.
