AIRPLANE INFORMATION

WRECKAGE & IMPACT INFORMATION

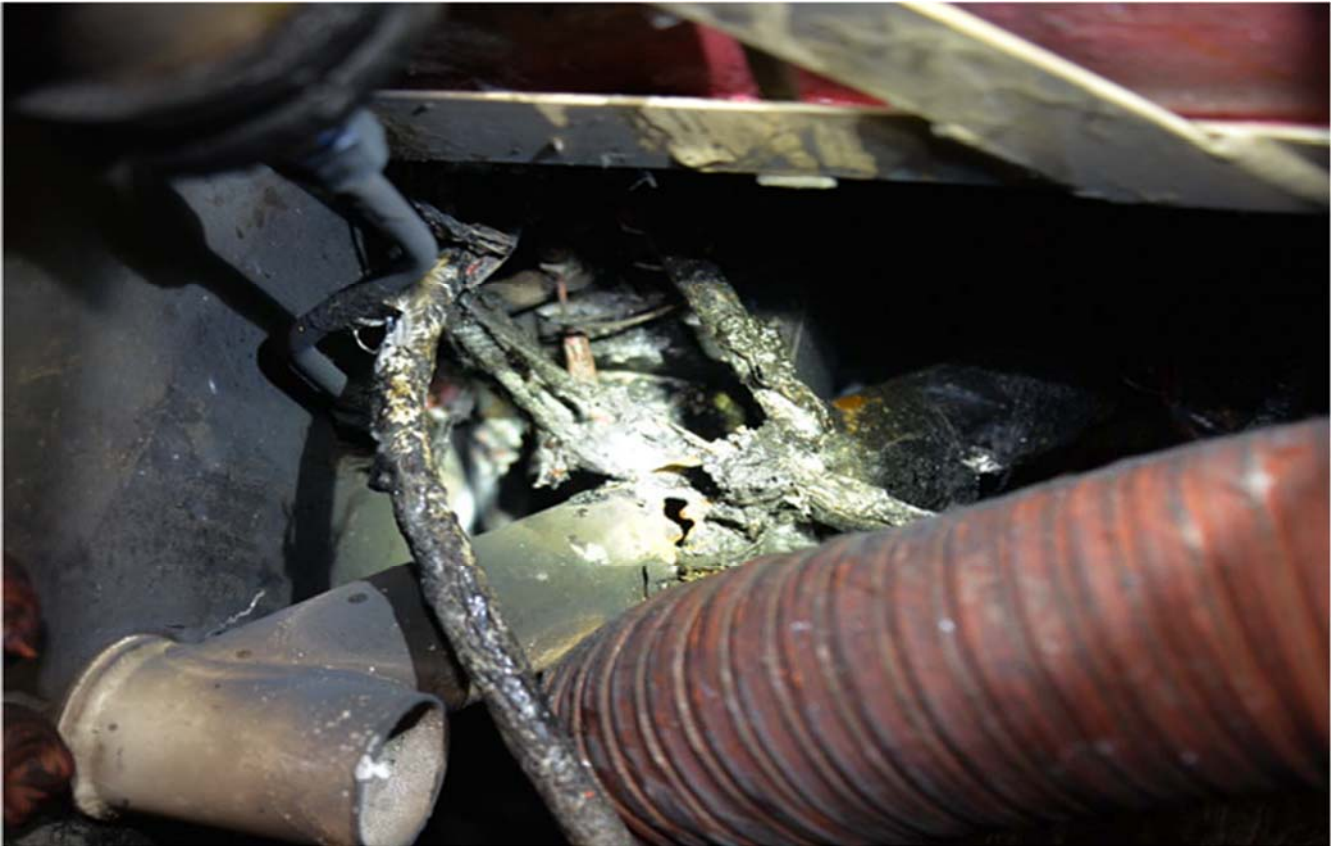
Figure 2 – Thermal Damage

A hole was present on the forward right side of the lower engine cowling measuring roughly 6-8 inches in diameter. The appearance of the hole was consistent with a portion of the cowling having been consumed by fire. Thermal damage extended from approximately three inches aft

of the right air inlet to approximately the mid-point on the lower cowl. External thermal damage was limited to the lower nose cowl on the right side.

The right forward side of the firewall and various components in this vicinity exhibited thermal damage (figure 2). Numerous wires near the right side of the firewall had melted insulation. Numerous white areas consistent with electrical arcing were present with the most notable being near the battery one cables. Battery one exhibited thermal heat damage near its top right side. The magneto P-leads also had melted insulation and indications of electrical arcing present.
