## Inspector Statement for N24605 Accident in Lebanon, TN

On January 4, 2021 at approximately 1345 local time, N24605, a Beechcraft Musketeer (B19) serial number MB-553 hit a fence on approach to runway 19 in Lebanon, TN (M54). No injuries were noted. The airport manager, Mrs. Heather Bay, notified the Federal Aviation Administration (FAA). Mrs. Bay was asked to take pictures of the aircraft and area of the airport involved and to also get statements from anyone on board the aircraft. The airport manager was then authorized to move the aircraft from the runway.

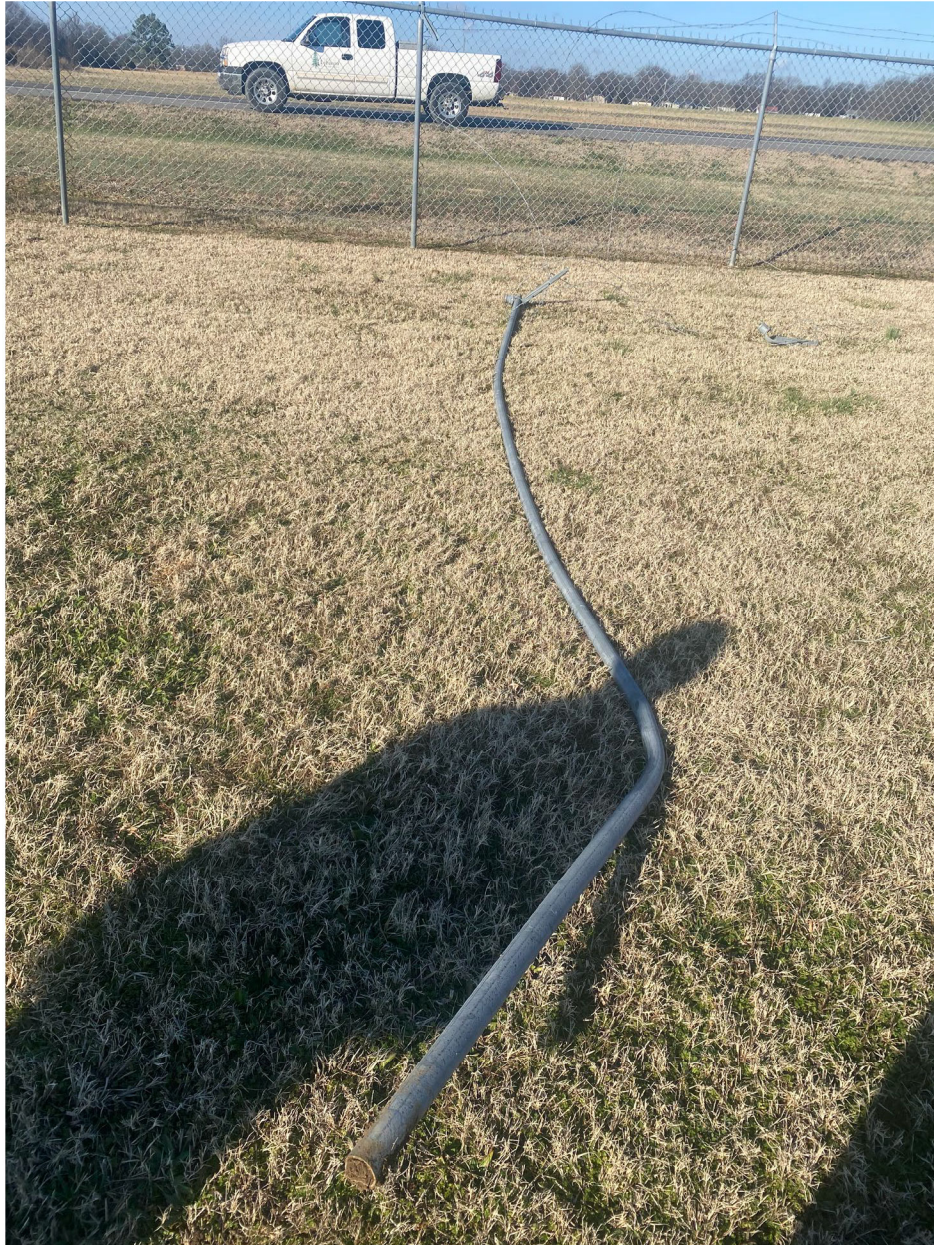
Fence Cross Bar impact point. The fence is an 8 foot perimeter fence with 3 barbed wire lines on top.
