NATIONAL TRANSPORTATION SAFETY BOARD  
**Investigative Hearing**

Norfolk Southern Railway general merchandise freight train 32N  
derailment with subsequent hazardous material release and fires,  
in East Palestine, Ohio, on February 3, 2023

<b>GROUP</b>	<b>E</b>
<b>EXHIBIT</b>	
1

**Exhibit 1- bearing images**

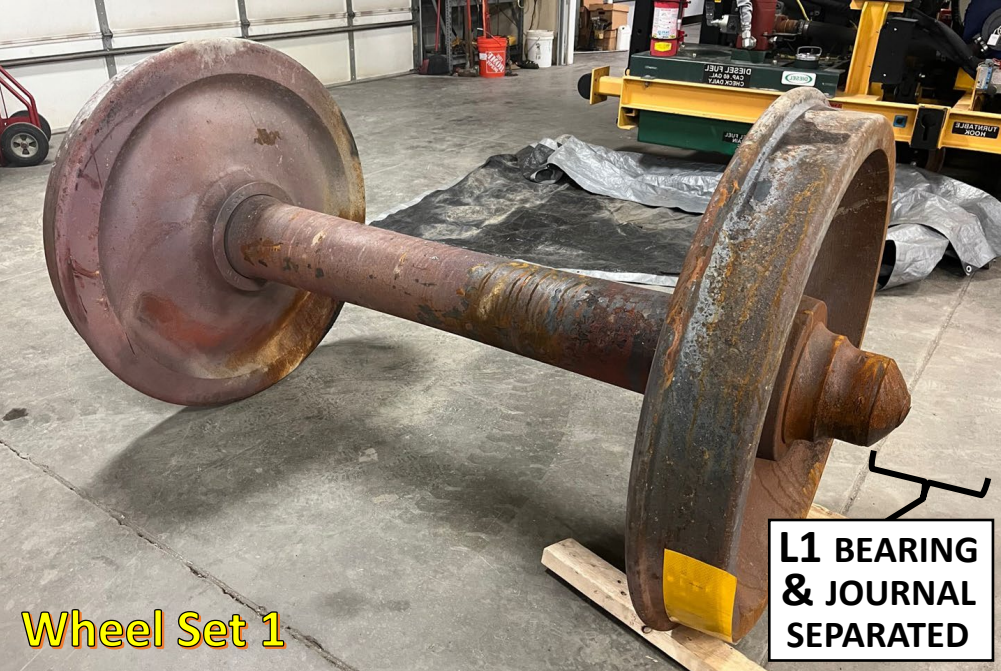
**L1 BEARING & JOURNAL SEPARATED**

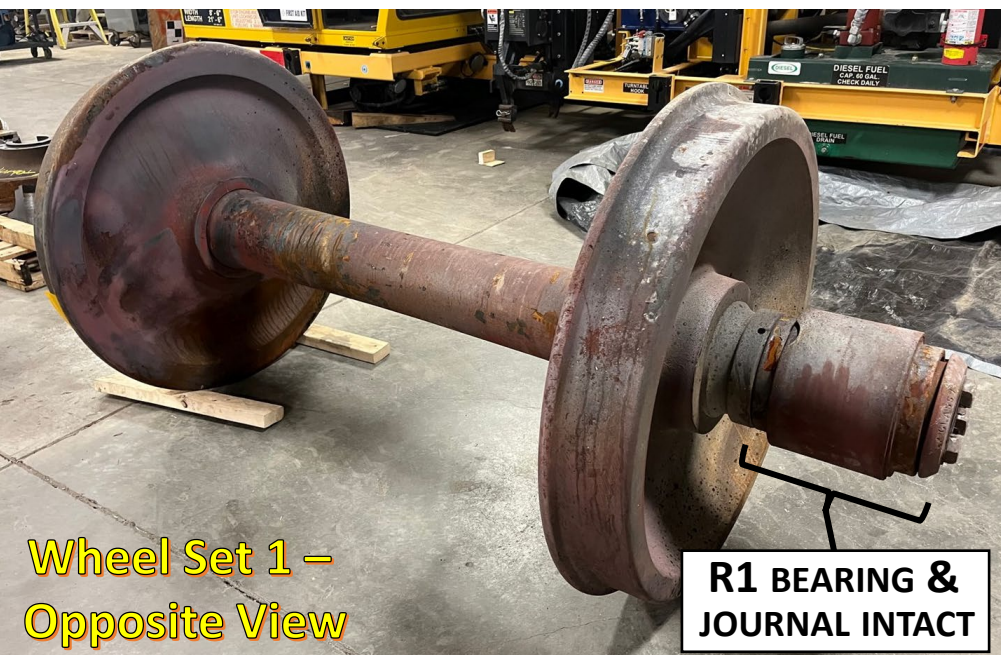
**Wheel Set 1 – Opposite View**

**R1 BEARING & JOURNAL INTACT**

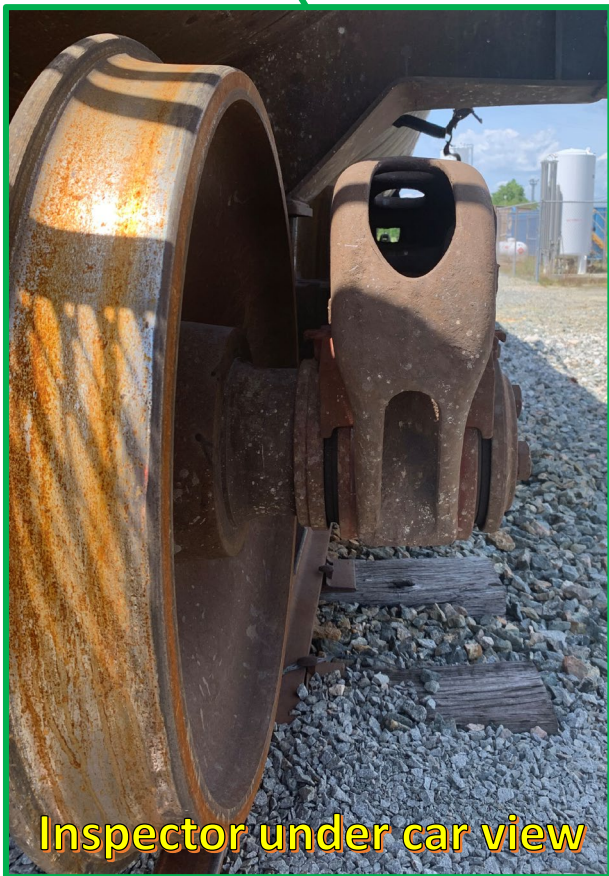
**VISIBLY LEAKING BEARING WITH CLEARLY FORMED DROPLETS**

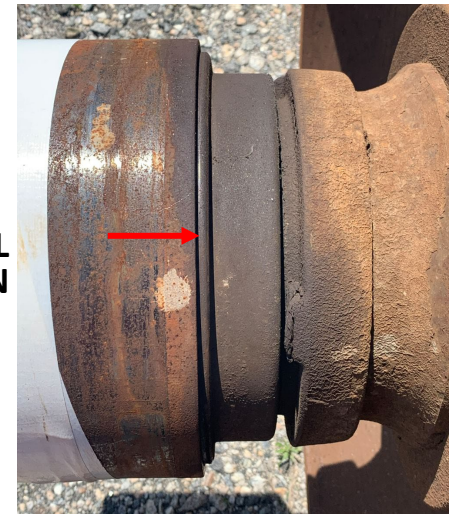
**INBOARD SEAL OUT OF POSITION**

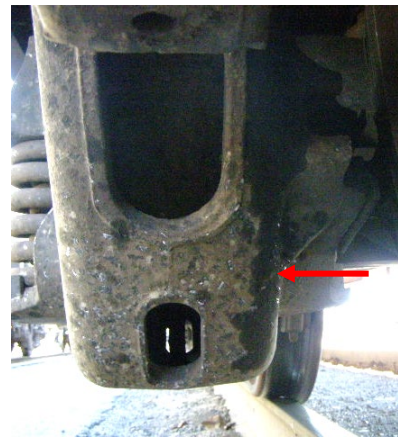
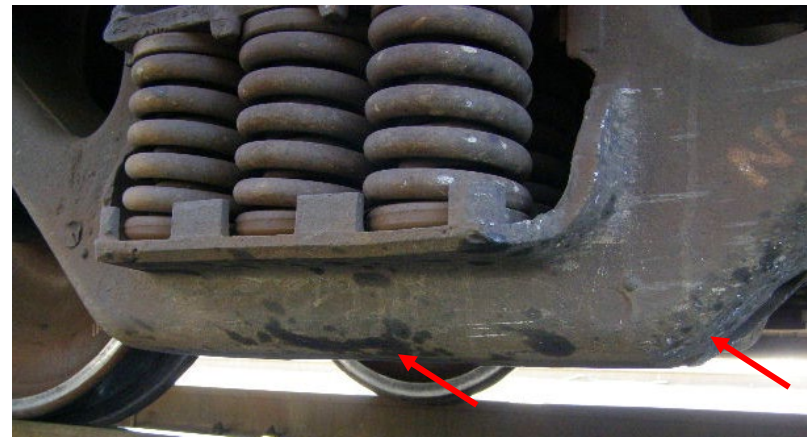
**BEARING LEAK INDICATION - SLUNG GREASE**
