NATIONAL TRANSPORTATION SAFETY BOARD
Investigative Hearing

Norfolk Southern Railway general merchandise freight train 32N
derailment with subsequent hazardous material release and fires,
in East Palestine, Ohio, on February 3, 2023

GROUP	E
EXHIBIT	
2

**Exhibit 2- Iwand, ASM 11A,
2021**

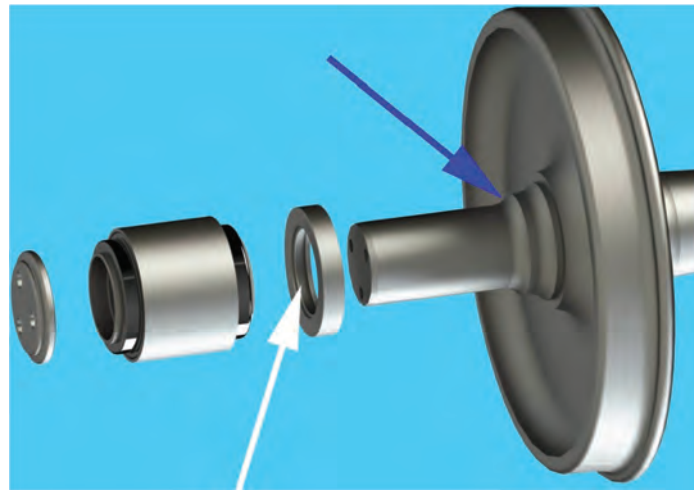
Fig. 12 One-half of wheelset showing journal fillet (blue arrow), backing ring blend radius (white arrow), cartridge bearing, and end cap (at left)

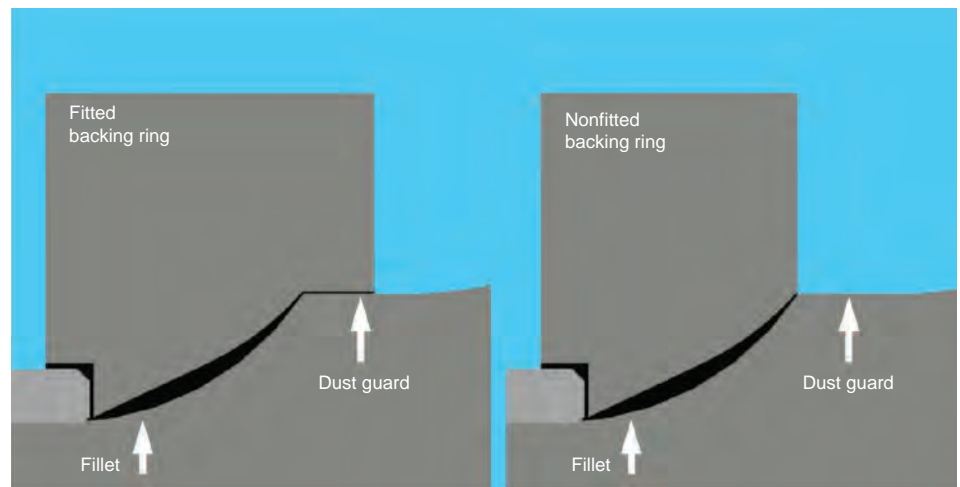
Since the adoption of the 286,000 lb gross rail load (GRL) freight cars, all wheelsets must be assembled with fitted backing rings on fitted axles. This means that the backing ring must have an interference press-fit onto the axle. Figure 13 compares a fitted backing ring with a nonfitted backing ring arrangement. This axle was found to have a fitted backing ring. (For non-286,000 lb GRL axles, it is possible that fitted backing rings could be applied to nonfitted axles. The backing ring would cover the dust guard of the axle; however, the axle dust guard would be too small in diameter to provide a press fit.)

Fig. 13 Cross-sectional view of fitted backing ring on a fitted axle versus a nonfitted backing ring on a nonfitted axle

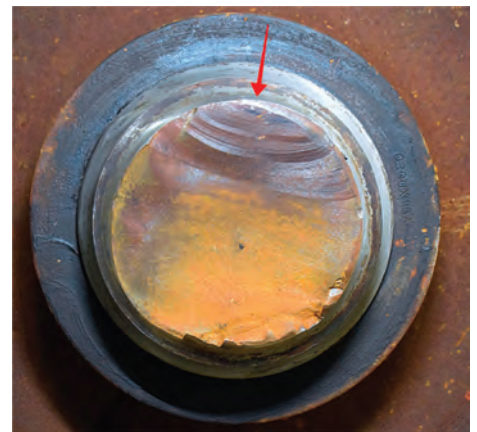
The fracture surfaces were cleaned with a nylon brush and soapy water to facilitate a more thorough inspection. Figures 14 and 15 show both halves of the fracture surfaces, with a singular fatigue-crack-initiation site along the outer surface. Beach marks present on the fracture surface confirmed that the crack grew much of the distance through the cross section of the axle prior to sudden rupture and complete separation of the journal. The fracture surface on the wheelset was mechanically damaged postfracture. The postfracture damage destroyed the initiation site of the fracture surface.

Fig. 14 Fracture surface of subject journal, axle side (arrow indicates initiation location)

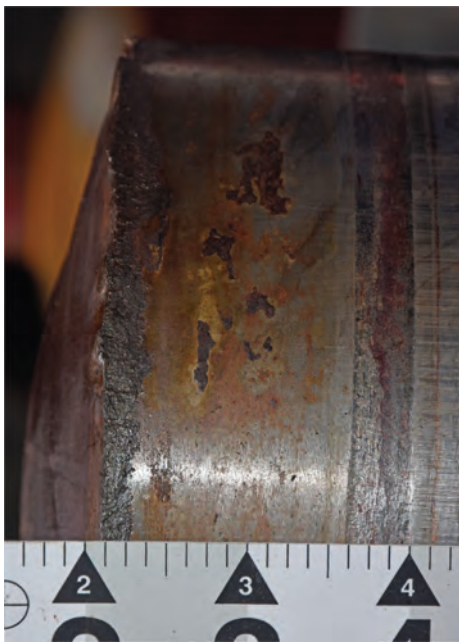
Fig. 35 Side view of axle stub, with fracture on left, showing heavy buildup and groove from seal wear ring

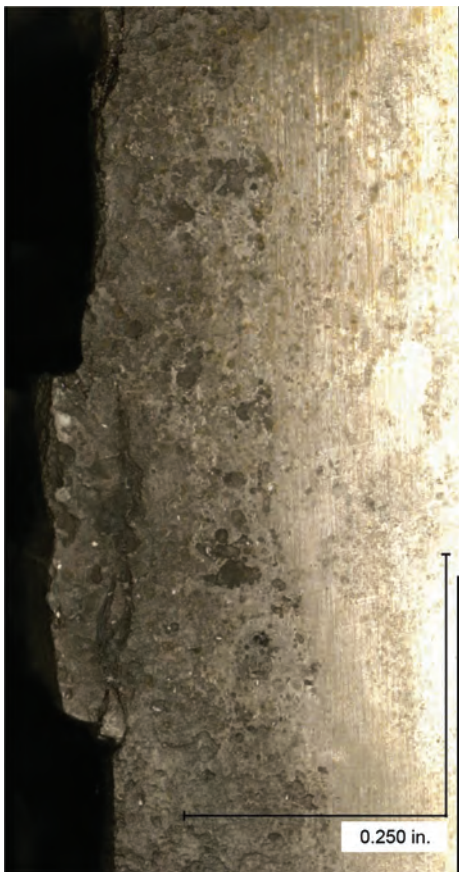
Advanced pitting corrosion occurred between the fitted backing ring and the axle journal. The pitting acted as stress-concentration locations when the axle rotated under load. Fatigue cracks initiated in multiple locations around the circumference of the journal in the area of corrosion, leaving the distinctive ratchet marks observed on both fracture surfaces. The fatigue cracks then coalesced into a primary crack, which progressively propagated through the cross section of the axle and finally failing in bending overload, causing the derailment. In contrast, journals that have

The axle journal failed due to the presence of corrosion pits around the circumference of the journal below the backing ring and seal wear ring. The corrosion pits raised the localized bending stress above the endurance limit and initiated multiple fatigue cracks on the circumference of the journal. The fracture surfaces were consistent with the morphology of rotating-bending fatigue.

Fig. 36 Overall view of pitting near fracture surface

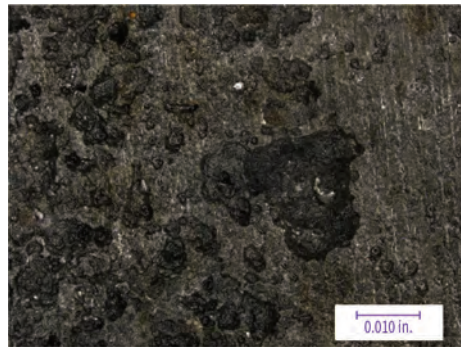
Fig. 37 General pitting present in the axle. Note parallel lathe tooling marks interrupted by corrosion pits

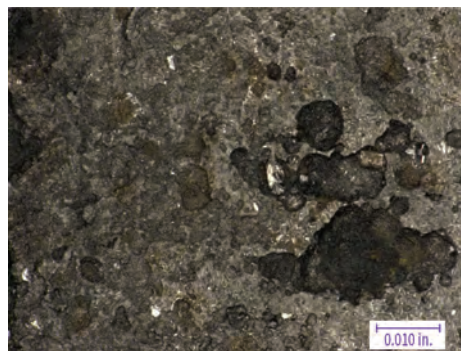
the pits (Fig. 38, 39). It is noteworthy that there are no abrasion marks present in the embedded debris. In reconditioned bearings, it has been observed that the embedded debris contains abrasion markings due to the abrasion that occurs during the reconditioning process. Of course, if properly reconditioned, there should be no pitting present in the fillet area of the journal.

Fig. 38 Pronounced pitting present on journal surface. Note the corrosion material embedded in some of the pits

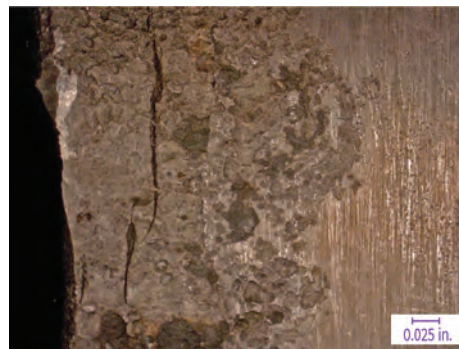
Greater magnification inspection around the circumference of the axle revealed additional fatigue cracks (secondary) near the fracture surface (Fig. 39).

Fig. 39 Secondary fatigue cracks present near primary fracture surface

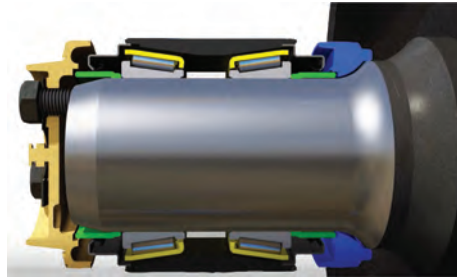
The general arrangement of the axle journal and bearing is shown in Fig. 40. Note that the double-taper roller bearing inner races as well as the seal wear rings are interference-fit to the axle journal. After pressing the bearing onto the axle journal, an end cap and three cap screws maintain the compressive load onto the bearing stack.

Fig. 40 Sectional view of the cartridge bearing and related components on the axle journal

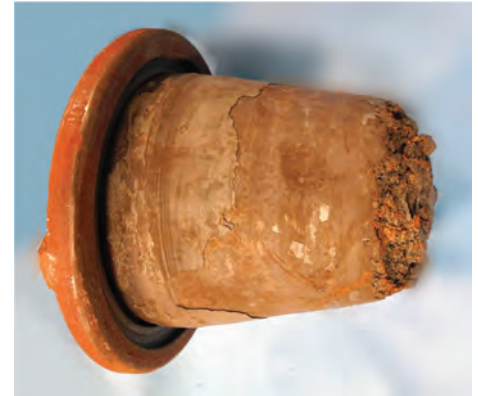
Fig. 41 Burned-off journal stub. The short, rough stub indicates high heat over a short time period and is associated with an inner cone failure

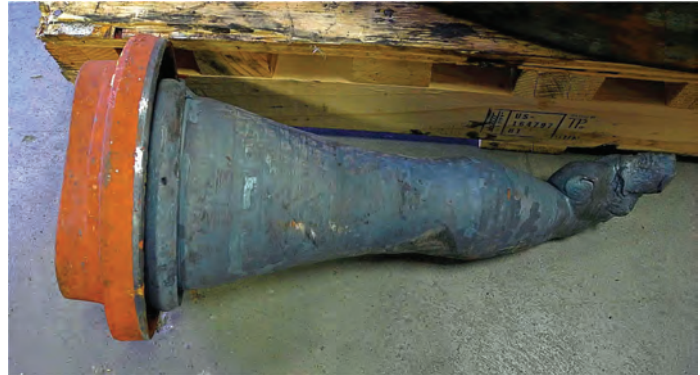
Fig. 42 Burned-off journal stub. The long, thinned-out journal indicates that the bearing was hot over a long time period and is associated with an outer cone failure

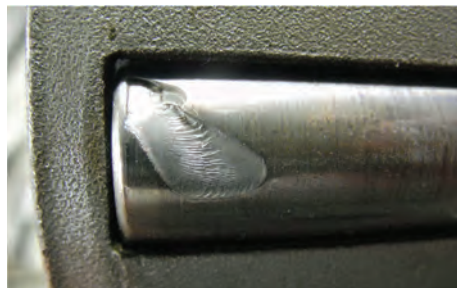
rollers are end loaded, the ends of the bearings will spall and fail (Fig. 43).

Fig. 43 Tapered roller bearing fracture from end loading due to loss of lateral clamp force

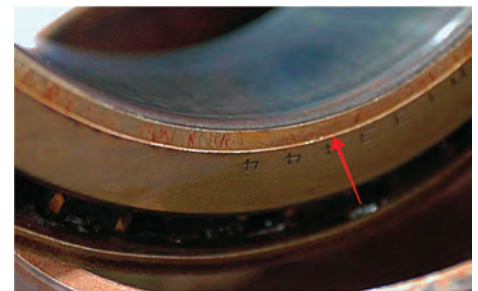
While the cap screws were likely installed with the proper torque, over time and usage the flexing of the axle journal will lead to fretting damage between the bearing cones and seal wear rings. When the components of the bearing begin to lose the lateral clamp load, movement of the components can exacerbate the issue by wearing further. Back face wear of the roller cones occurs when the cone interacts with the seal wear ring, wearing a step into the cone. The loss of material reduces the lateral preload. Figure 44 shows the step created from back face wear in the roller cone.

Fig. 44 Back face wear of a bearing cone. Arrow indicates the step present from wear against the seal wear ring

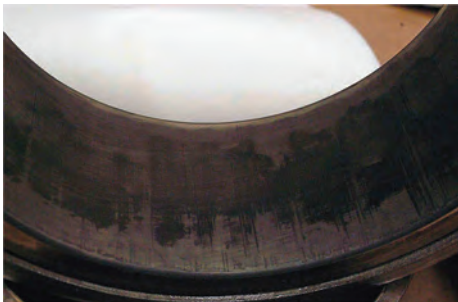
to the failed side had a cone that showed fretting wear (Fig. 45) and discolored rollers. The failed-side bearing had fused together the inner bearing components (Fig. 46).

Fig. 45 Fretting wear on the inside diameter of a bearing with a spun cone

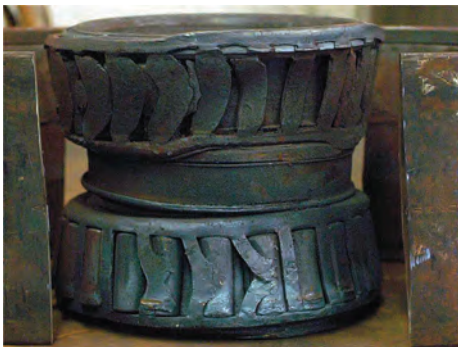
Fig. 46 Damage from a spun cone bearing failure. All internal components were fused together

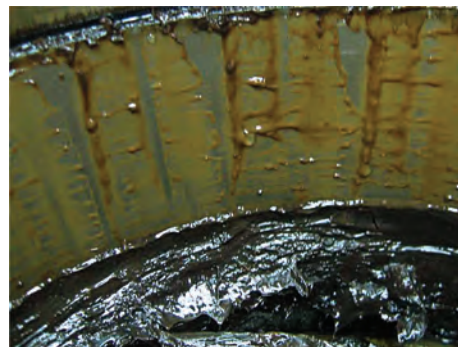
Another common failure mode is water ingress into freight rail bearings, causing accelerated failure. The most prevalent sign of water ingress is free water during the bearing removal and disassembly process, followed by emulsified grease. Grease that has had water emulsified into it appears milky (Fig. 47) rather than the normal black or yellow. It should be noted that the aforementioned fretting damage stains the grease a red-rust color, but this coloring could also be due to rusting of components. Therefore, caution should be practiced to evaluate the seal condition for wear before concluding that the grease discoloration is due to water ingress. Water intrusion into the bearing results in lubrication breakdown. When teardowns of bearings are performed, the amount of grease present is measured by weight; if the amount of grease is over the specified amount, it can be assumed that at least that much water has been trapped. Water ingress often happens from worn-out seals, fit, or the cars were exposed to flood water.

Fig. 47 Grease condition during bearing disassembly with water ingress. Free water was noted, and milky grease is present along the rolling-contact surfaces

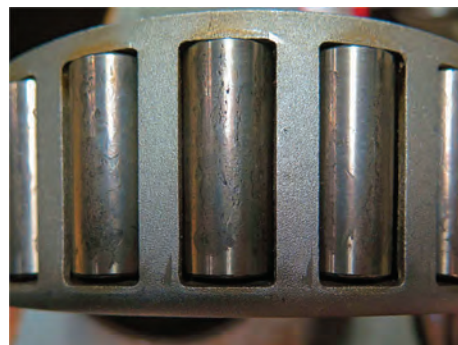
Water entrainment in the grease leads to water etching of the rolling bearing components (Fig. 48). Water etching leads to spalling

Fig. 48 Water etching present on rollers

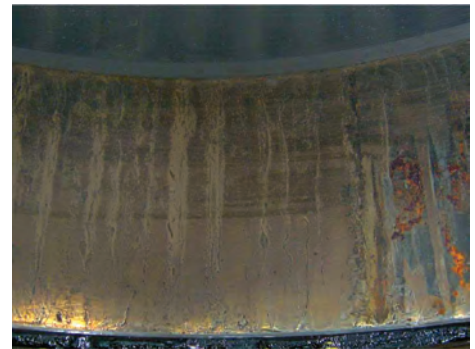
of the races and rollers. These spalled fragments that are now also entrained in the grease act as an abrasive, wearing rollers and cages. If the cage roller pockets wear sufficiently, the rollers skew in the pockets and slide rather than roll. Water etching can result in cracking of the internal components of the bearings if the condition is pronounced or if sufficient time has transpired to reach a critical point. Figure 49 shows microcracking present with water etching and rust on the cup of a bearing.

Fig. 49 Water etching with microcracking present on the cup of a bearing

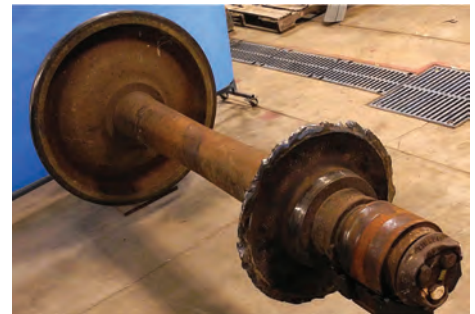
A failed wheel was found when a dragging equipment warning occurred. The train was stopped, and it was noted that a wheel was broken but riding on the rail on the hub. The failed wheel was a J33 design, forged from grade C steel and manufactured in September 1992. The locking plates on the bearings indicated that the bearings were rebuilt and installed in March 1994. Figures 50 and 51

Fig. 50 As-received wheelset with portion missing

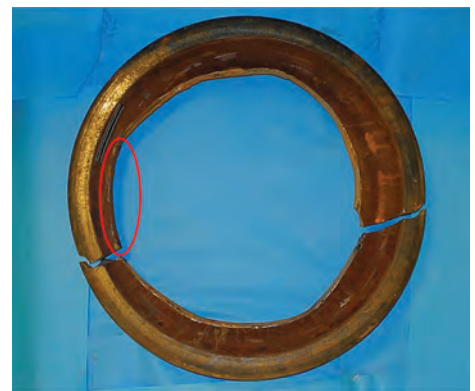
Fig. 51 As-received rim sections viewed from the back rim face. Circled area indicates initiation region
