NATIONAL TRANSPORTATION SAFETY BOARD
Investigative Hearing

Norfolk Southern Railway general merchandise freight train 32N
derailment with subsequent hazardous material release and fires,
in East Palestine, Ohio, on February 3, 2023

GROUP	E
EXHIBIT	
3

MECHANISTIC ASPECTS OF BEARING BURN-OFF

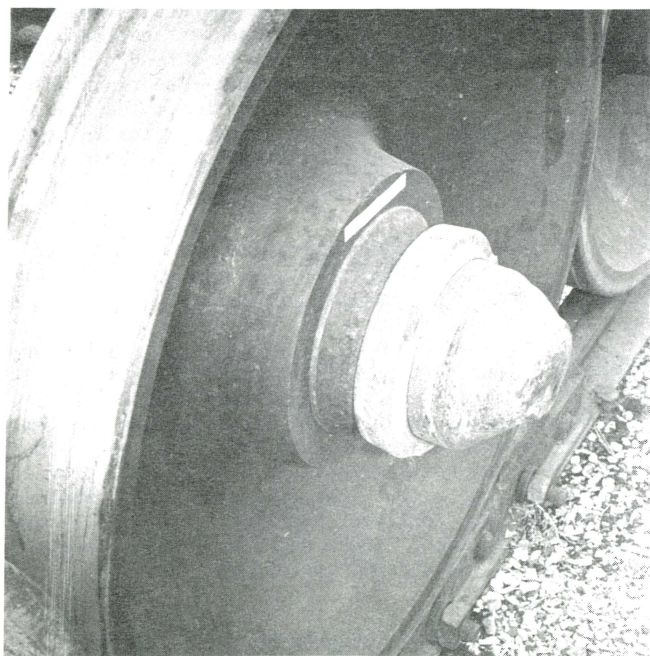
FIGURE 2 TYPICAL APPEARANCE OF BURNED-OFF AXLE.

failure of the axle is always a result of a bending overload failure, due to the fact that in the last phases of burn-off extreme heat has been produced, which along with the rotation of bearing, has necked the axle down in size. The size reduction of the axle, in conjunction with the reduction in yield strength of the steel at elevated temperature, will eventually result in a condition where the axle can no longer support the weight of the car. This is usually evidenced by the fact that the last-to-fail area contains remnants of the final bending event as also shown in Figure 3.

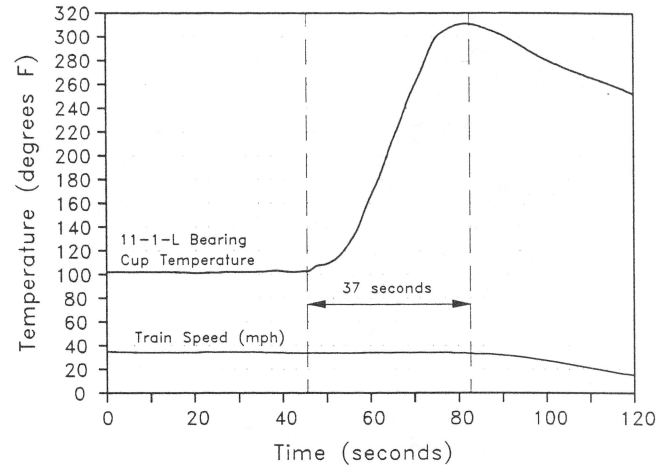
The first bearing to fail had a loose cone defect. This bearing, which was given identification as 11-1-L, had not been torn down and documented prior to testing, but was selected by "hand rolling" the bearing while on the wheel set in order to determine that at least one cone was apparently loose on the axle. During testing the cup temperature of this bearing rose 230 F in only 37 seconds. This thermal runaway occurred 4.5 miles past one HBD and 6.3 miles past the other. HBD. Figure 5 displays a time history plot of bearing #11-1-L's rapid temperature rise. Figure 6 displays a complete time history plot of bearing #11-1-L which shows not only the rapid temperature rise, but also the rate at which bearing cooled. It took only 20 minutes for the bearing to cool back to ambient temperature. This data demonstrates the reason for so many HBD alarmed bearings going unconfirmed. Train crews, when alerted to a suspect bearing by an HBD, stop the train so a crew member can try to locate the defective bearing. Train crews predominantly use temperature sensitive sticks which melt at prescribed temperatures (200 F

FIGURE 5 THERMAL RUNAWAY OF BEARING 11-1-L.

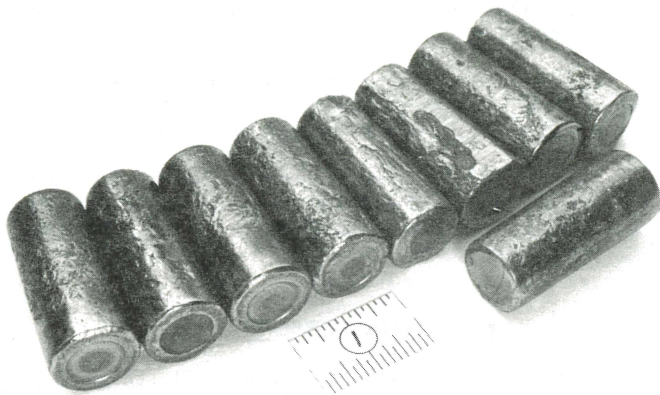
FIGURE 11 TYPICAL APPEARANCE OF ROLLERS FROM OUTBOARD CONE OF BEARING 6-3-L.

except for the outboard cone which contained severely spalled rollers. When the bearing became loaded on this side (outboard), the deteriorated surface of the rollers apparently resulted in excessive wear to the cage. This, combined with the fact that the rollers already had decreased diameters, allowed the rollers to be pushed under the separator bars and/or the separator bars failed as a result of wear and skewed loading. This eventually caused the entire roller set to become free in the bearing. The origin of the outboard cone for this bearing is unknown, and as previously described, all other components and tolerances were within standards. The condition of the rollers in this case, however, were not unlike those which are typically seen in bearings with loose cones, and in fact were in poorer condition than those of bearing 11-1-L. It is highly possible that this cone assembly was originally recovered from a bearing with a loose cone.

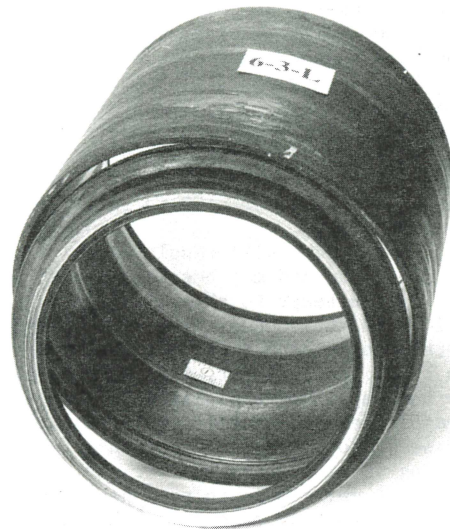
FIGURE 12 CUP AND FRONT SEAL OF BEARING 6-3-L.

Other Components. This bearing still contained sufficient grease for lubrication. The front seal was severely scored as a result of the action of the end cap on the seal after lateral fit was lost.

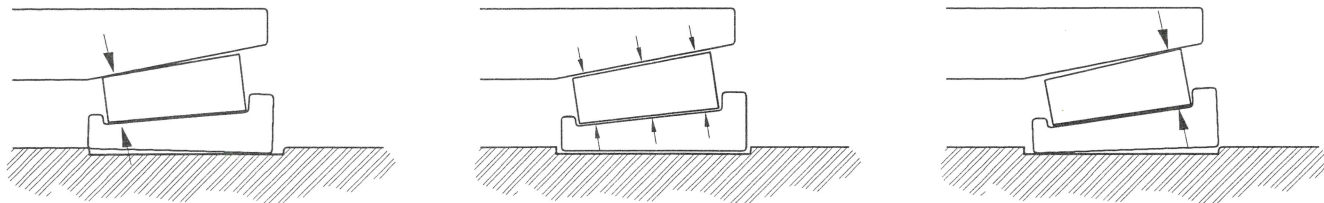
The loss of the cage in the case of roller bearing 11-1-L, which contained a loose cone, appears to be the result of a combination of cage wear from the rollers, and a loss of geometry between the axle, cone, roller and cup. The change in bearing geometry

FIGURE 13 CONCENTRATED LOADING OF ROLLERS AS CAUSED BY THE ACTION OF A LOOSE CONE ON GROOVED AXLE.
