Survivability Notes

I. ACCIDENT INFORMATION:

NTSB ID: CEN19FA185
Location: Brainerd, MN
Aircraft: Agusta A109S
Tail number: N11NM
Accident date: June 28, 2019 0041 CDT
Injuries: 2 fatal (Pilot/ Passenger), 1 serious (Passenger)

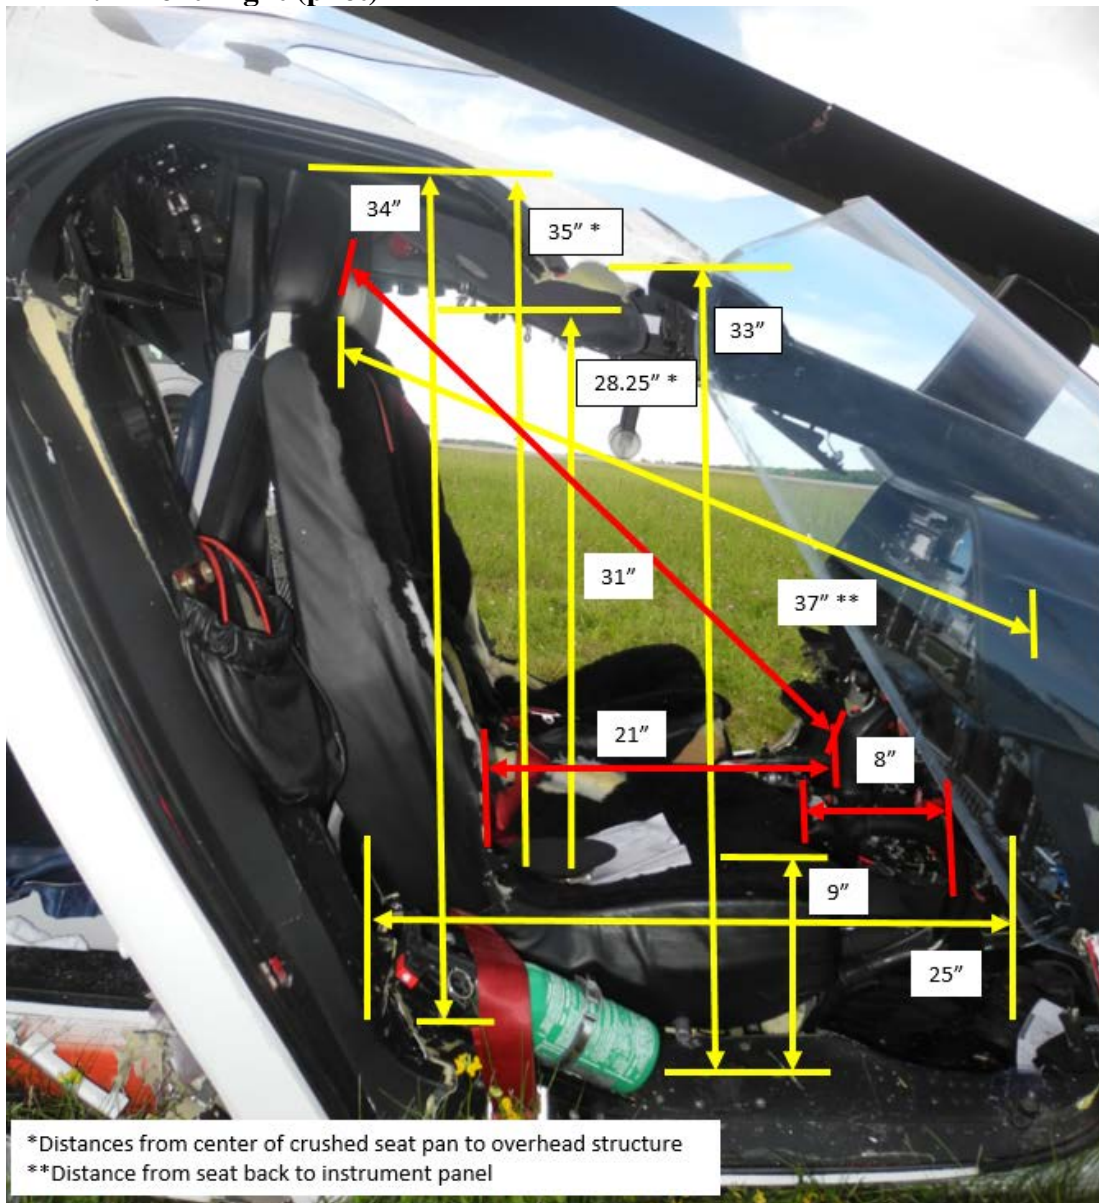
Photograph 1 - Pilot Seat Structural Measurements (Side View)

The pilot seat was located on the right side of the cockpit, it is an Agusta seat P/N 109-0700V07-105 and attaches via a seat track to a boxed structure integrated into the aircraft it was still attached to this structure on both sides, and the seat pan crushed downwards.

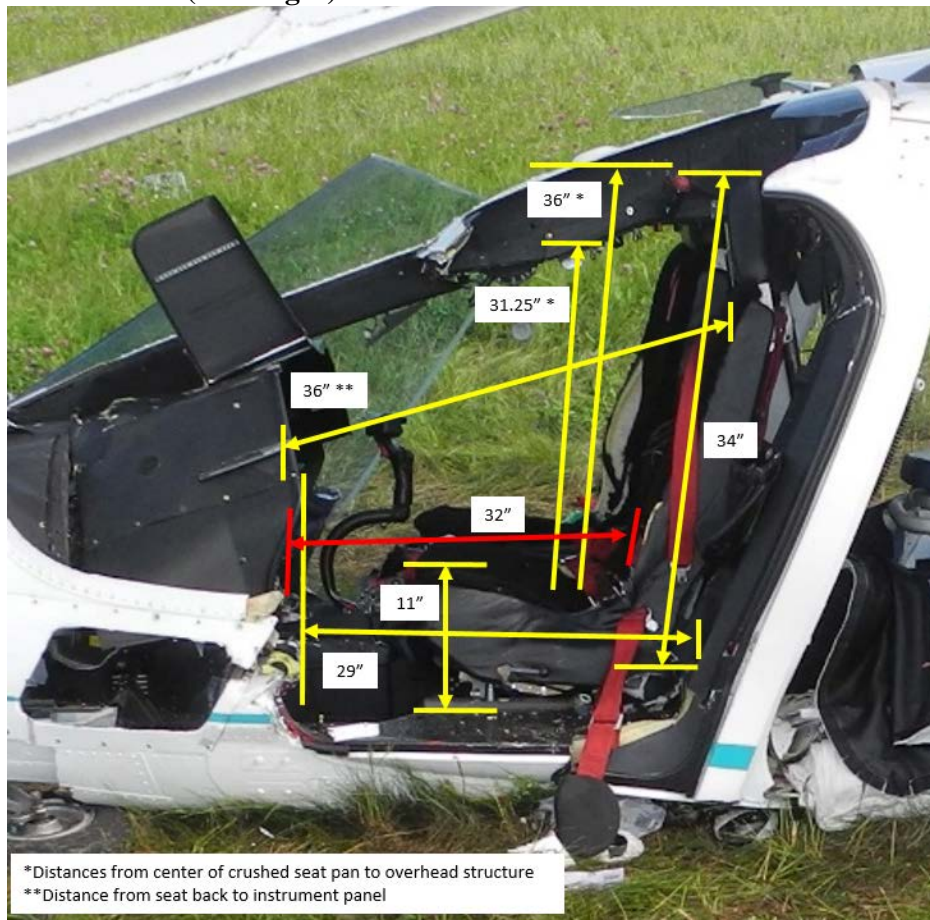
Photograph 2 – Front Left Passenger Seat Structural Measurements (Side View)

The passenger seat was located on the left side of the cockpit, it is an Agusta seat P/N 109-0700V07-105 and attaches via a seat track to a boxed structure integrated into

the aircraft it was still attached to this structure on both sides, and the seat pan crushed downwards. The seat place had no cyclic or collective controls installed.

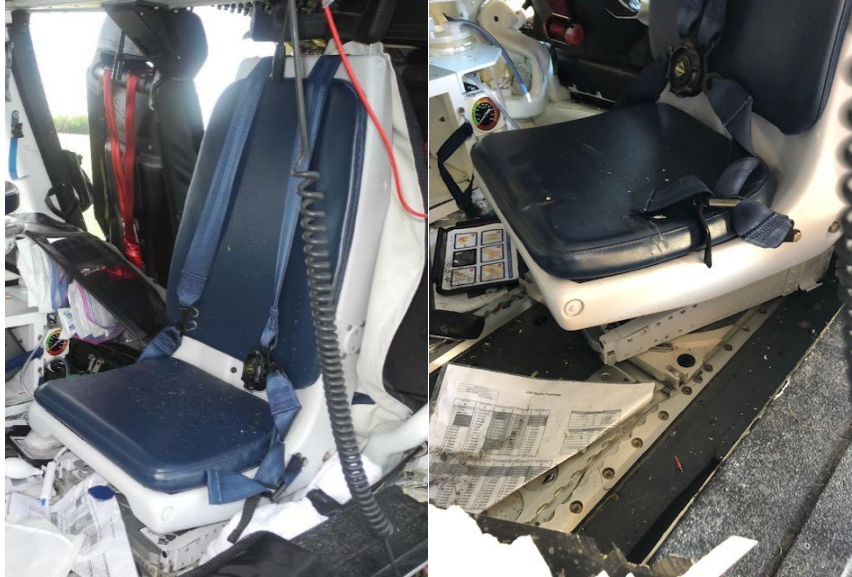
Photograph 3 – Aft Rear-Facing Seat

The aft rear-facing seat is located on the right side of the aircraft directly behind the pilot seat, and is still attached to the floor; this seat was unoccupied at the time of the accident. This seat has the ability to swivel to allow access to the patient during flight.

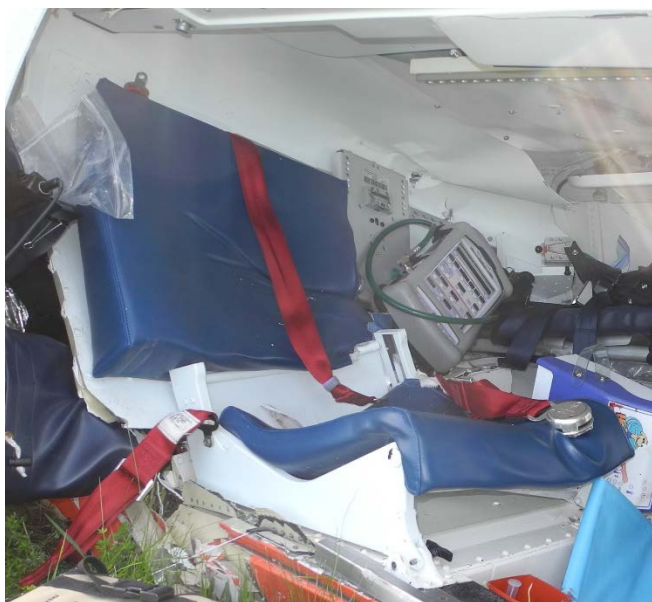
Photograph 4 – Aft Forward Facing Passenger Seat

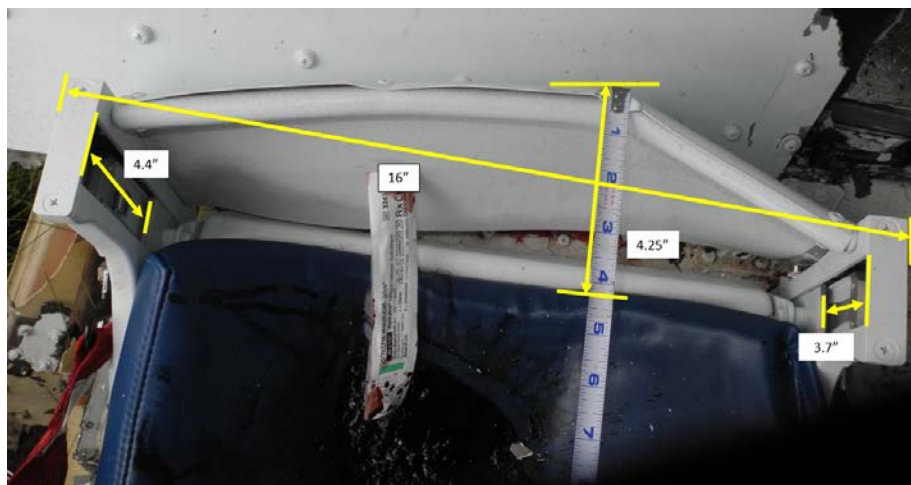
Photograph 5 – Overhead View and Deformation Measurements of Aft Forward Facing Seat

The aft forward facing seat is a forward facing structure-mounted seat located on the right side of the aircraft against the aft bulkhead. It is an Agusta seat P/N 109-0700V07-106, and is secured to a boxed structure integrated into the aircraft structure in the aft part of the aircraft cabin, with the seat back cushion secured to the aft bulkhead;

this is shown in Photograph 5. The seat rear support portions stroked downward, and the front left attachment point failed.

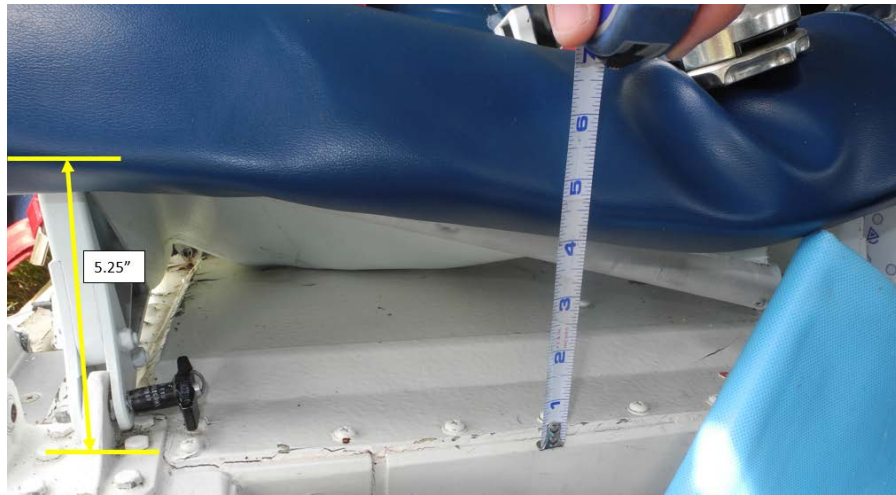
Photograph 6 – Front View and Deformation Measurements of Aft Forward Facing Seat

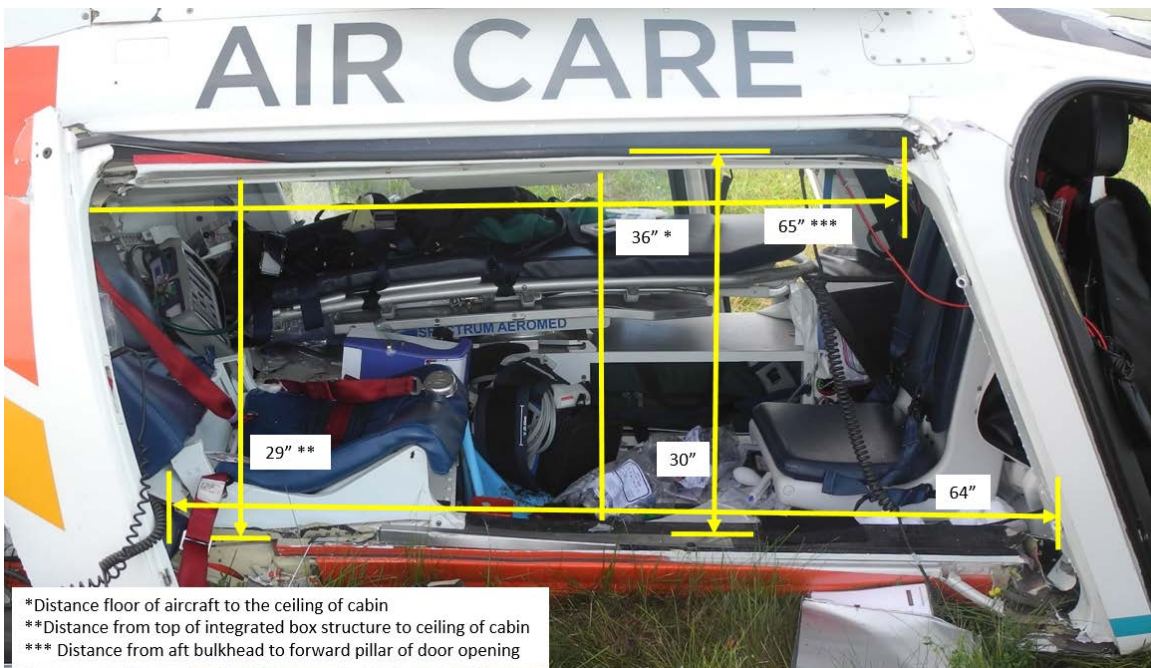
Photograph 7 – Right Side Cabin Structure Measurements

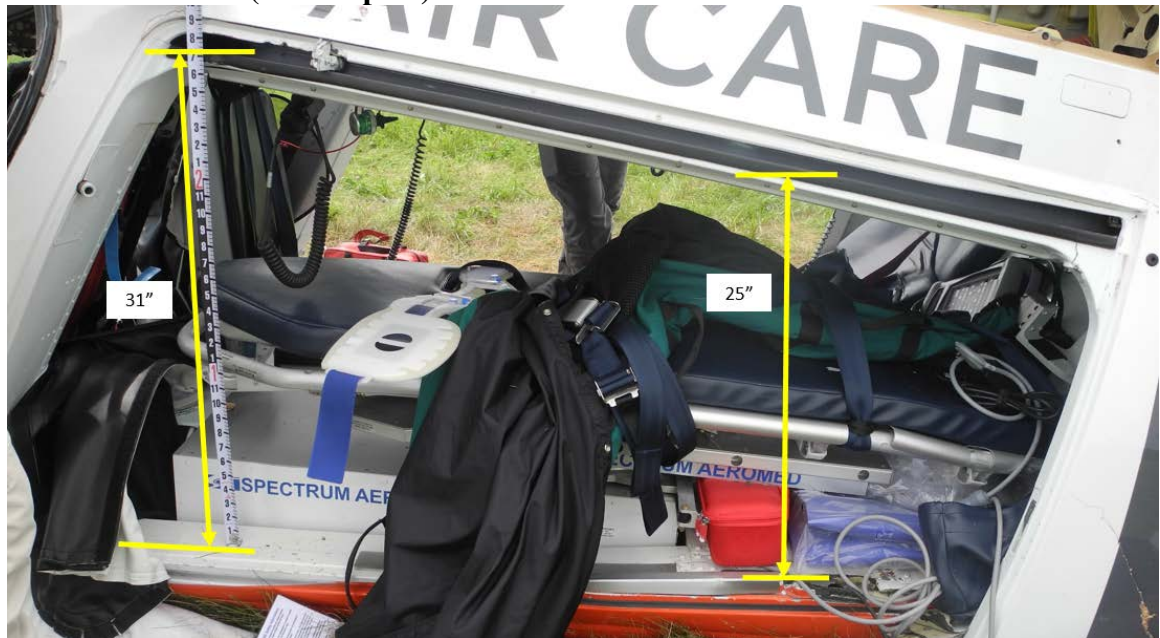
Photograph 8 – Patient Litter

The patient litter was located in the aft part of the cabin on the left side directly behind the left side cockpit passenger seat. The head of the litter was pointed towards aircraft forward, the litter is an articulating stretcher manufactured by Spectrum Aeromed. The portion of the stretcher closest to the aft bulkhead was bent downwards.
