2020-05-20, 0937L, N612R FLIPPED OVER ON TAKEOFF AFTER LAUNCHING FROM SURFSIDE SEA BASE, LINO LAKES, MN WX VFR, WINDS 120/09 PERHAPS UP TO 13KTS

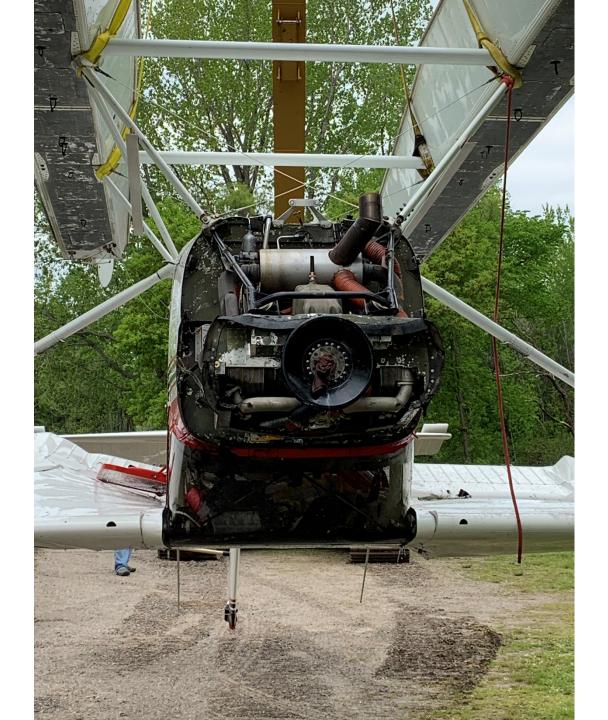
NO APPARENT FIREWALL OR ENGINE OUNT DAMAGE.
