## **TEXAS EASTERN TRANSMISSION, LP**

### **MAY 4, 2020 FLEMING COUNTY INCIDENT GEOTECHNICAL CAUSATION REPORT**

PROJECT NO.: 1607024  
DOCUMENT NO.: Rev A

DATE: April 26, 2021

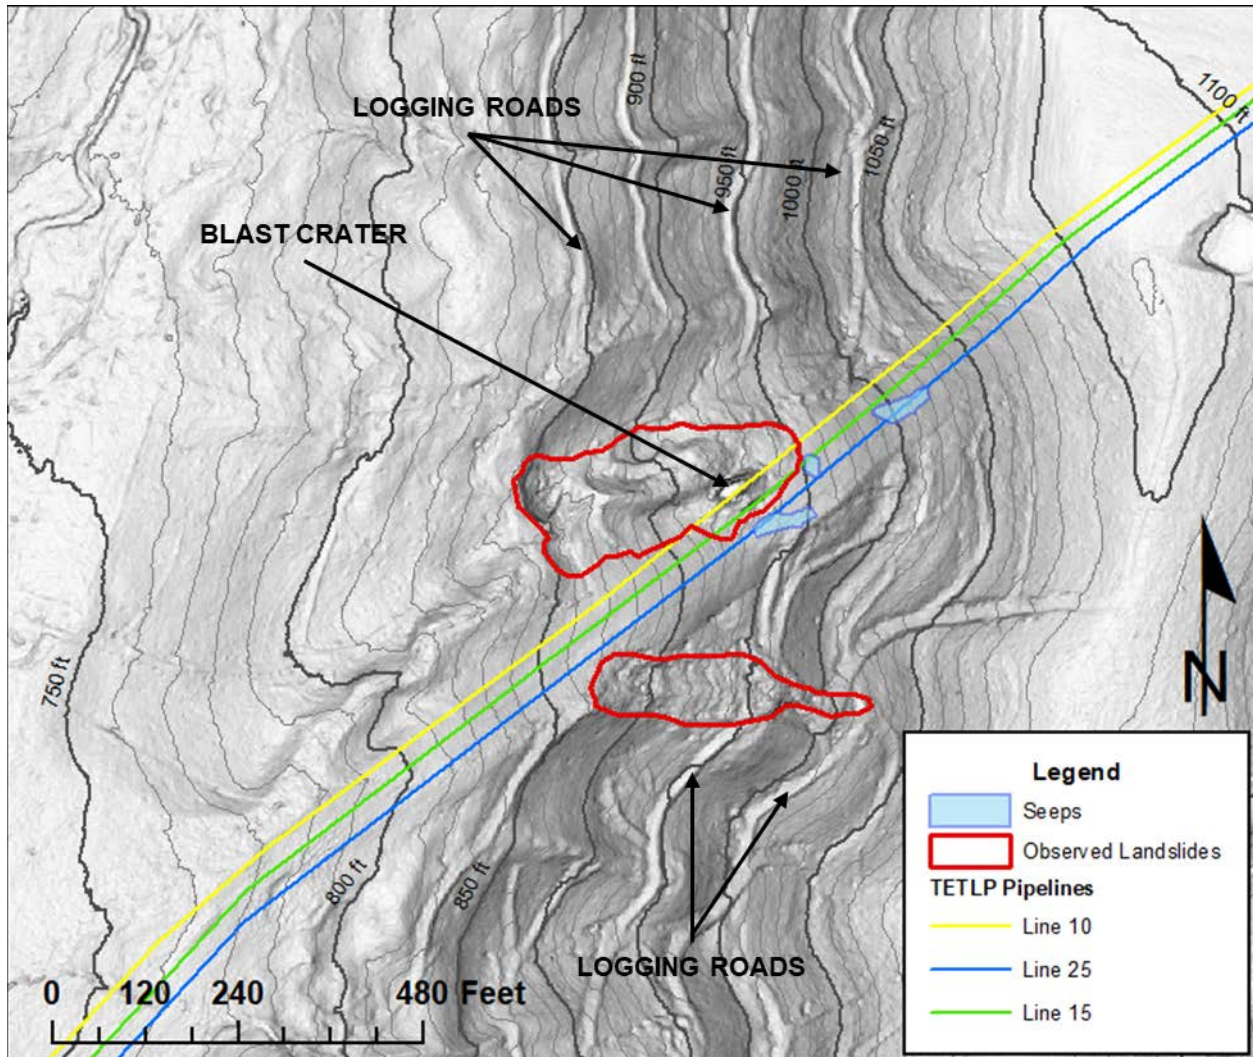
On the TETLP corridor, a main scarp (ground cracking with vertical offset) was observed crossing Lines 10 and 15 (see Photo C-3 and Figure 3-2). Tension cracks (ground cracking with horizontal offset) were observed further upslope and over Line 25. The scarp extended off the downslope (north) side of the corridor and a distinct active toe bulge was observed 300 ft downslope of the Site. A detailed description of the landslide is provided in the following section. An additional landslide was observed upslope of the corridor, south of the FCI site. The toe of this landslide was upslope but not over any of the TETLP pipelines (see Figure 3-1).

Outside of the crater, seepage was observed flowing from multiple locations at the ground surface upslope of the FCI site. These areas are shown in Photo C-4 and Figure 3-1. Two distinct seeps were observed over Lines 15 and 25, suggesting that the backfilled pipeline trench may serve as a conduit for seepage. A major seep was observed upslope of Line 25 immediately upslope (southeast) of the Site in an area where shale bedrock was observed at surface along the cut for the TETLP corridor. Free flowing water was observed at this seep.

Multiple logging roads were observed on both sides of the corridor, suspected to be from past timber harvest activities (see Section 3.5 for further detail). These roads crisscrossed the Site and were observed going through the main landslide mass downslope of the TETLP corridor (see Figure 3-1).

Figure 3-1. Map showing the slope at the FCI site. The blast crater (visible in the lidar imagery) and former logging roads can be seen. Observed landslides and seeps are also shown. Centerline and May 6, 2020 lidar imagery provided by TETLP.

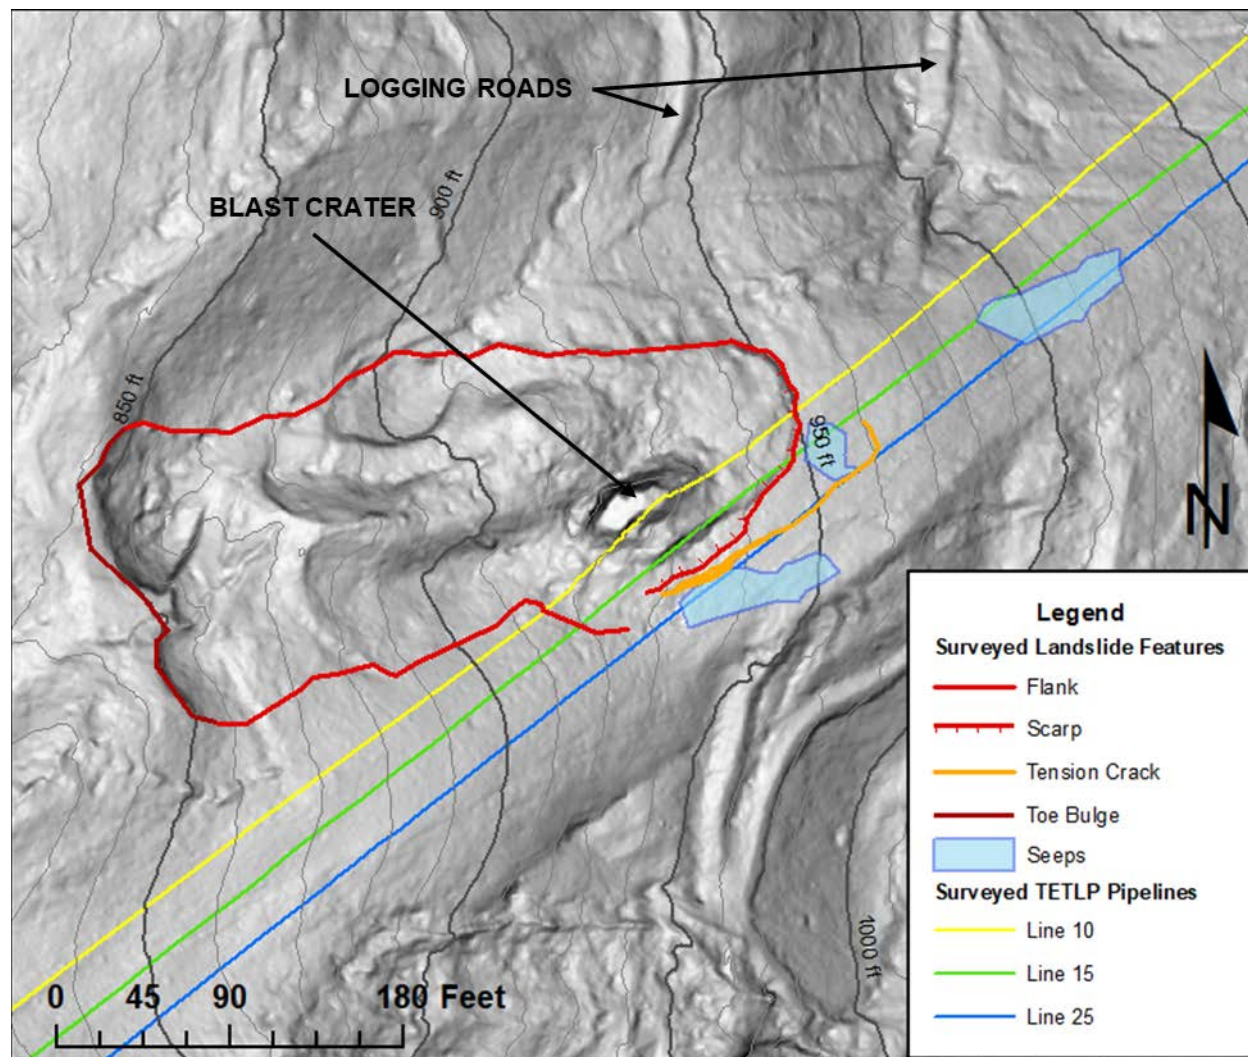
**Figure 3-2. Map showing the surveyed landslide features at the FCI site, the blast crater (visible in the lidar imagery) and former logging roads. Surveyed centerlines, landslide extents and seepage extents provided by SGC. May 6, 2020 lidar imagery provided by TETLP.**

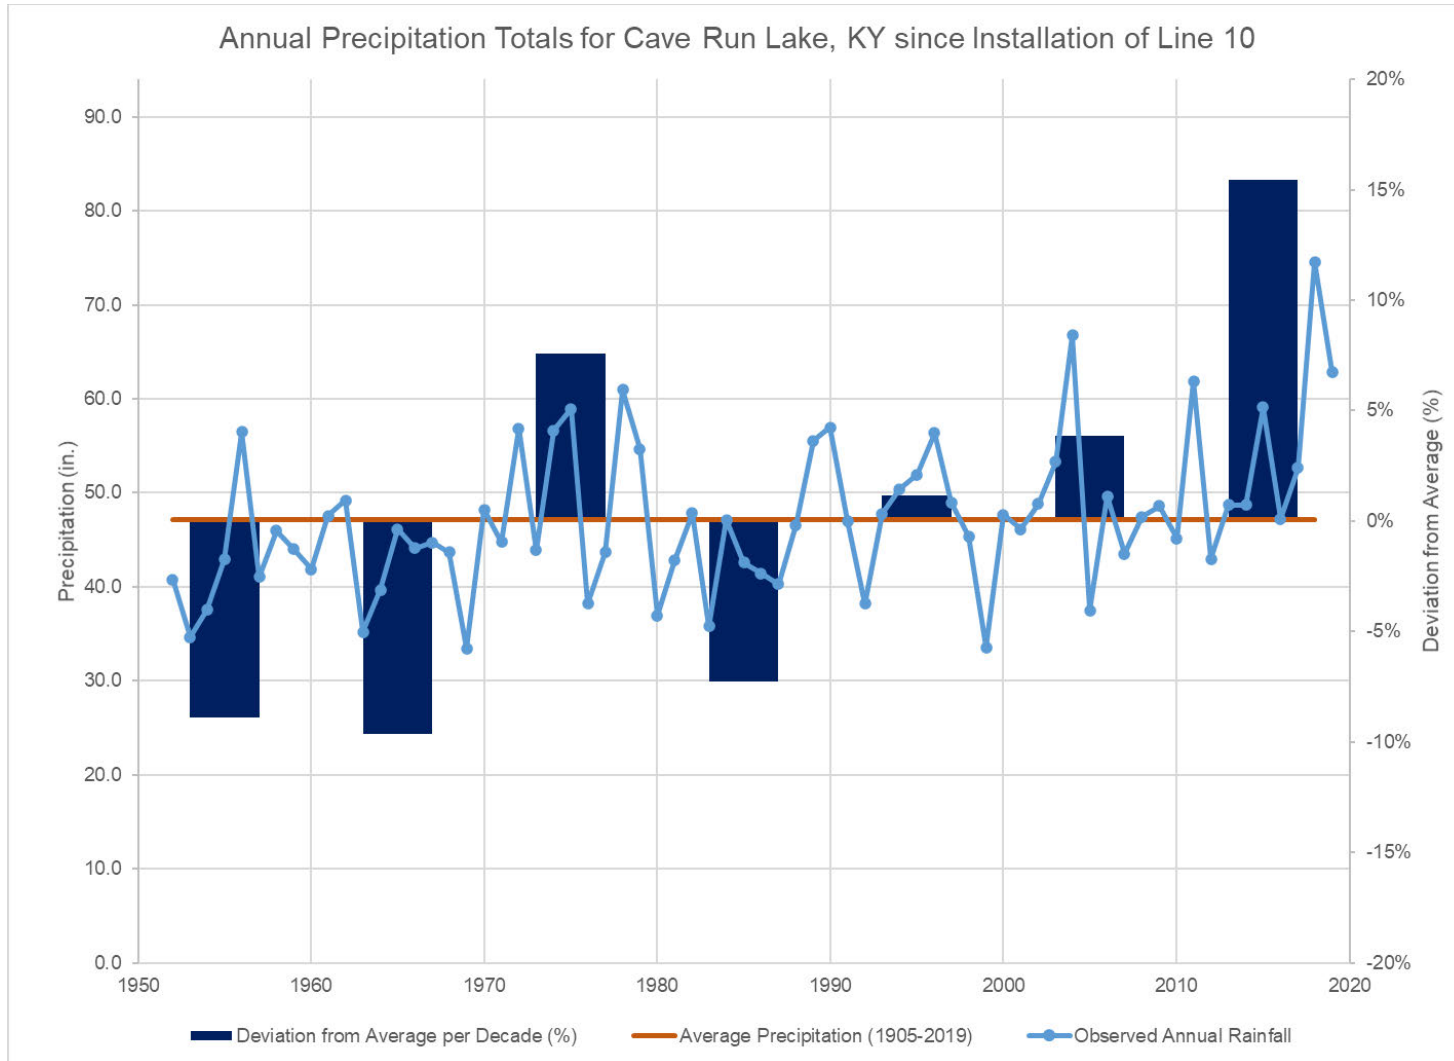
Lake weather station. This includes above-average precipitation totals for nine months in the year leading up to the FCI. The annual precipitation total for the 12-month period preceding the FCI was 63.8 in., exceeding the long-term average by 35%. Much of this precipitation occurred between October 2019 and May 2020. Figure 3-14 shows the cumulative precipitation and the percentage deviation from the long-term average monthly rainfall for the fall through spring months (October through April). October 2019 to April 2020 was 46% above the long-term average rainfall, while the similar time frame in 2018 to 2019 was 17% above the average and for 2017 to 2018 it was 22% above the average (see Figure 3-14). Homing in directly on the winter months is important as there is less daylight and temperatures are lower, reducing rates of evaporation. Plants, both deciduous and coniferous, are also not removing nearly as much water from the soil through evapotranspiration during this time (Weaver and Mogensen, 1919). The cooler temperatures decrease in sunlight and decrease in evapotranspiration mean precipitation that falls during these months will not evaporate or be pulled from the ground as readily as the summer months and will be more likely to infiltrate and increase porewater pressures which can accelerate ground movement.

**Figure 3-11. Observed annual precipitation data over the lifespan of Line 10 (1952 to 2019) from the Cave Run Lake Weather Station. The percentage deviation from the average precipitation over each decade is shown by the dark blue bars. Data obtained from NOAA (2020).**

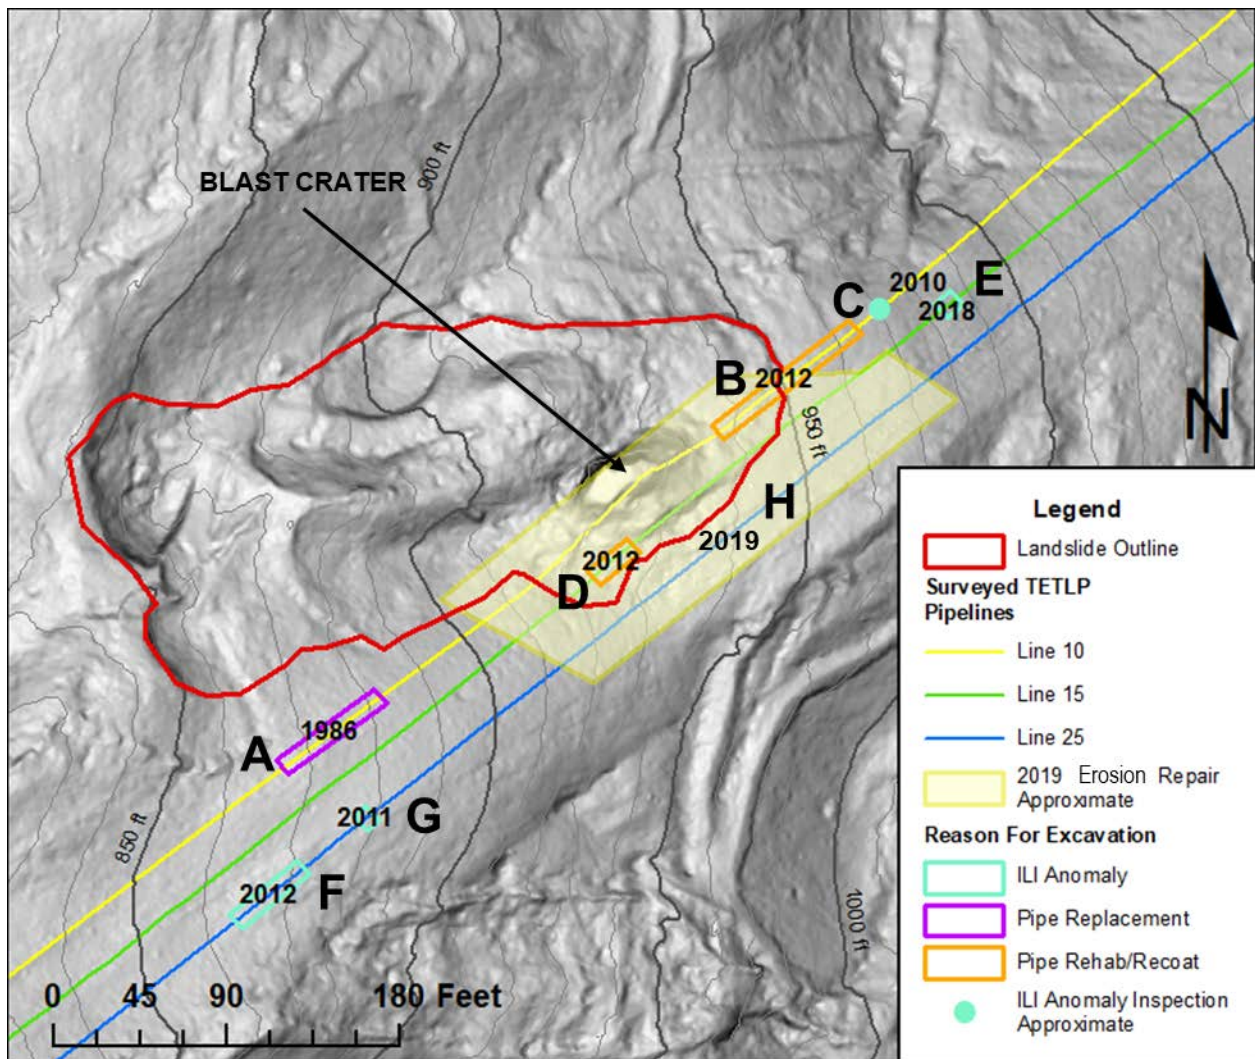
TETLP provided BGC with the locations of past documented construction activities along the TETLP corridor at the Site. The location of each of the various activities is illustrated on Figure 3-15, and the information obtained for each project is summarized in Table 3-9. The most complete information covers the 10 years preceding the FCI. Formally documented information at TETLP for past corridor activities mainly relates to integrity digs involving exposure of one of the pipelines, as opposed to work on the slope that did not involve pipeline exposure, such as the grading and erosion control work done in 2019 discussed below. Other than the June and July 2019 erosion repair work, only the year of past construction work was provided.

Figure 3-15. Map showing the locations, extents and dates of documented past excavations and repairs at the FCI site. Excavations and repairs have been labeled A through H and details of each can be found in Table 3-9. The extent of the 2019 erosion repair was estimated by BGC from site photographs. May 6, 2020 lidar imagery and excavation data provided by TETLP.

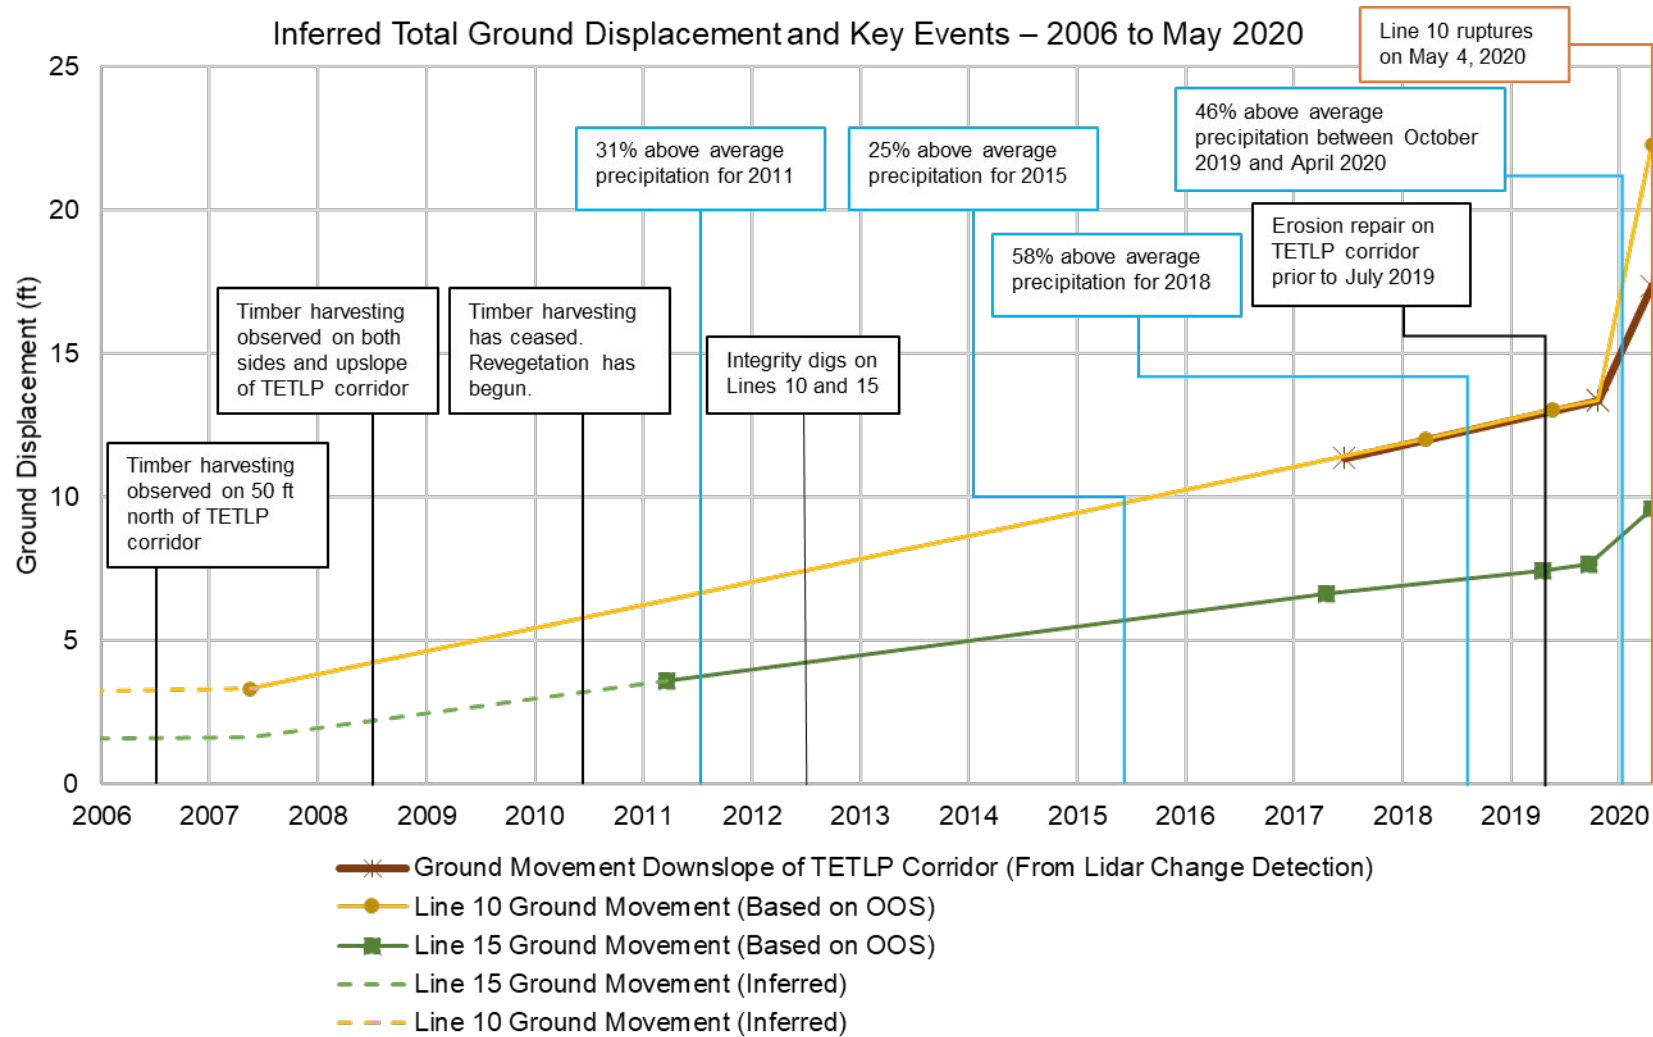
Additional water was also directed into the moving landslide feature at the Site via the three existing backfilled pipeline trenches. Seepage was observed along the pipeline trenches following the FCI and it is suspected the trenches served to collect and convey additional groundwater from upslope seepage sources directly into the landslide mass. The ground cracks and the preferential groundwater flow along the backfilled pipeline trenches would increase the impact of the high levels of precipitation over the winter months and are suspected to have led to the rapid acceleration of the landslide between November 2019 and May 2020. This elevated movement rate of the landslide is what appears to have led to an additional 8.9 ft of ground movement and an additional 3.6 ft of OOS on Line 10 by May 4, 2020. This movement induced additional strain on GW 11330 and likely resulted in the failure of GW 11330. Between November 2019 and May 4, 2020, nearly 40% of the OOS on Line 10 occurred, approximately the same amount that had occurred on Line 10 in the preceding period between June 2007 and the June 2019.

**Figure 4-4. Plot showing the inferred approximate total ground movement on Lines 10 and 15 as well as downslope of the TETLP corridor over time along with notable corridor activities (black boxes) and precipitation anomalies (blue boxes).**

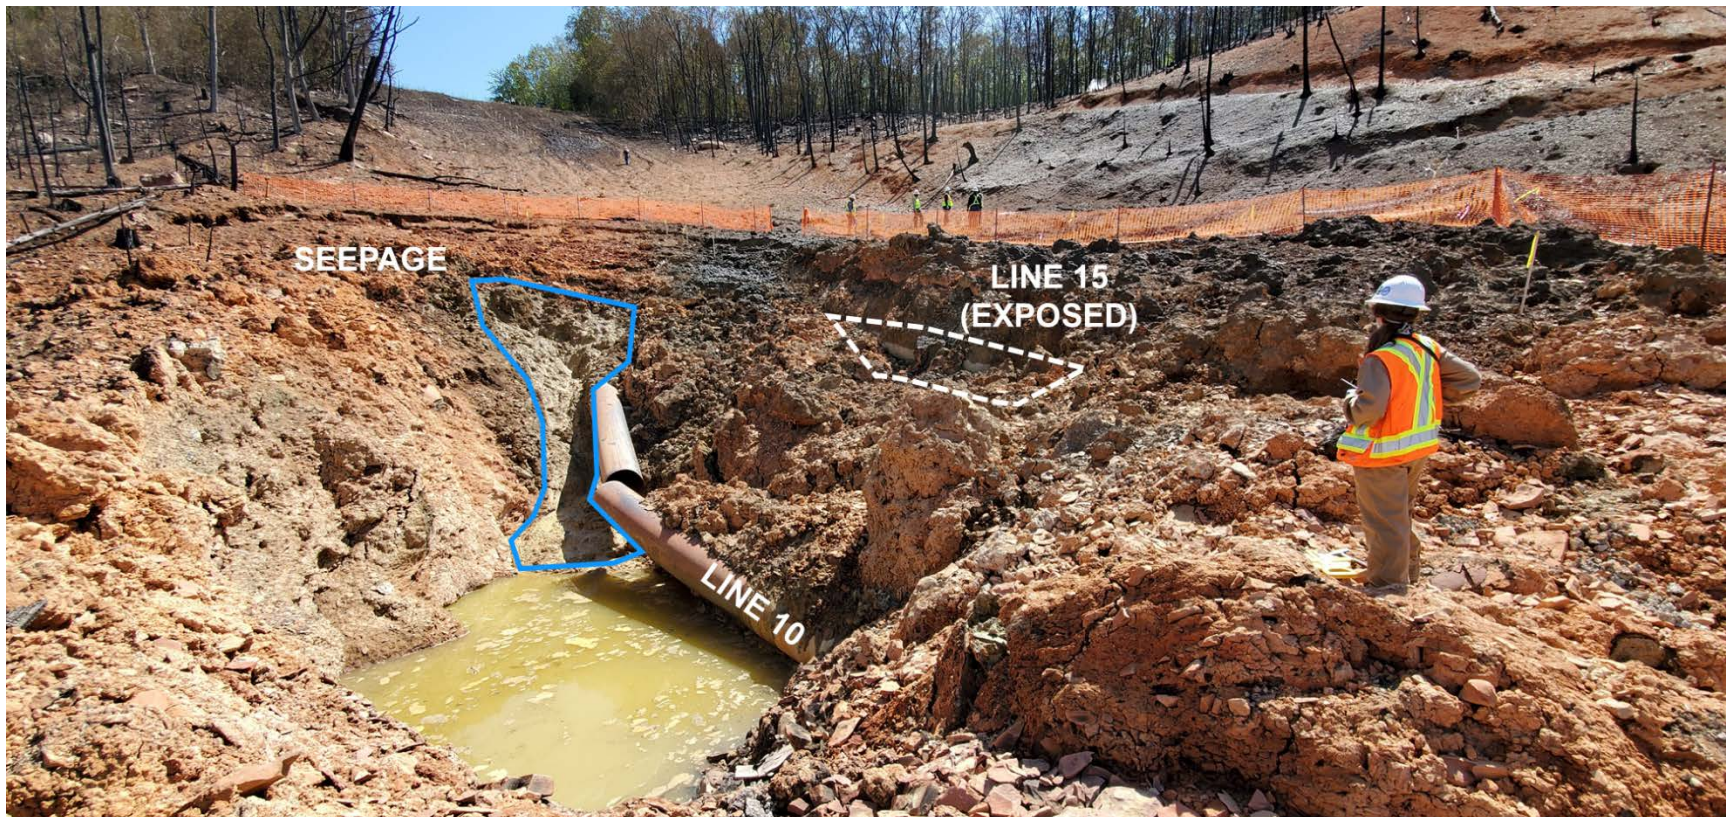
**Photo C-2. Looking northeast (upslope) at the Line 10 blast crater. The failed girth weld is GW 11330. Seepage can be observed from the Line 10 trench backfill on the upslope side of the crater. Note the unstable material calving off the right (upslope) wall. Line 15 is within the upslope wall. BGC photo taken May 7, 2020.**

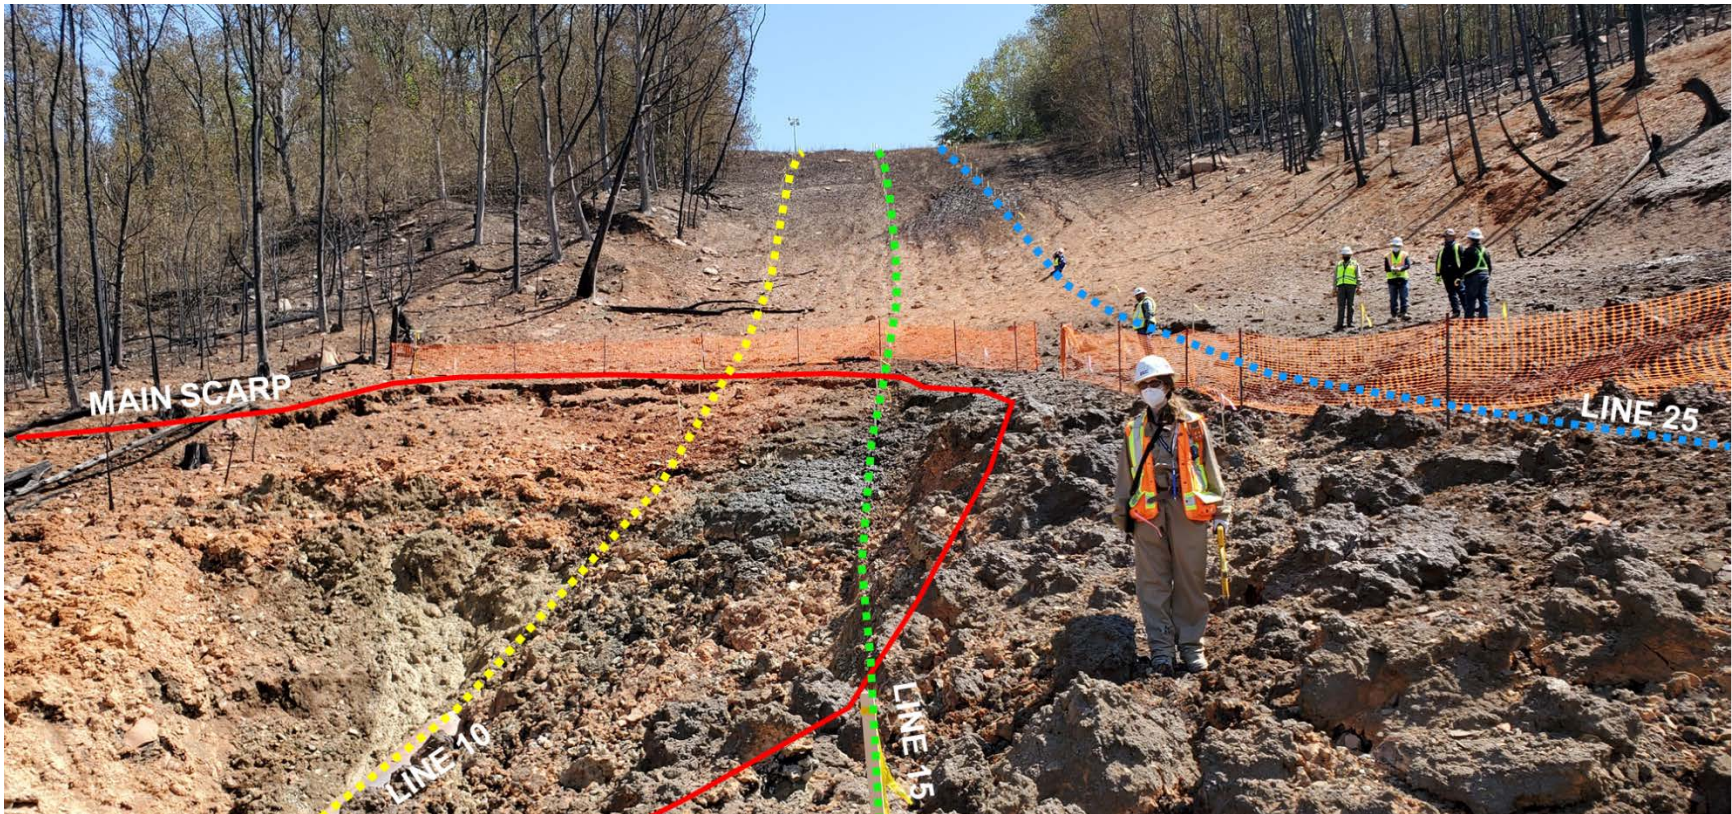
Photo C-3. Looking northeast (upslope) at the headscarp (denoted by the red line). Line 10 is exposed in the blast crater in the lower left portion of the photo. BGC photo taken May 7, 2020.

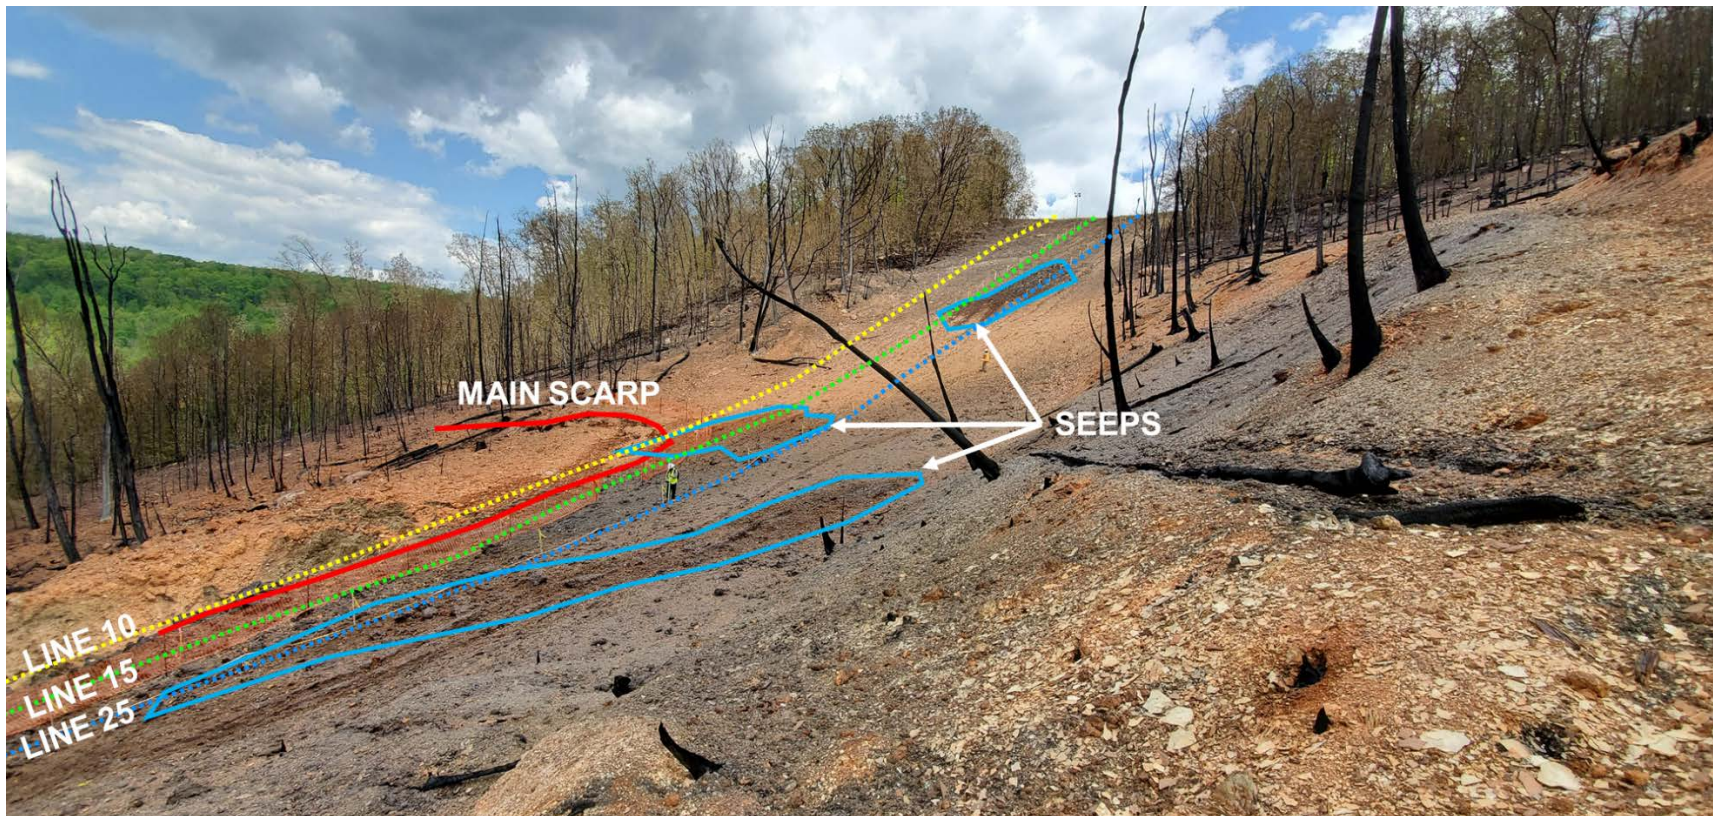
Photo C-4. Looking north (cross slope) at the seepage observed following the FCI.

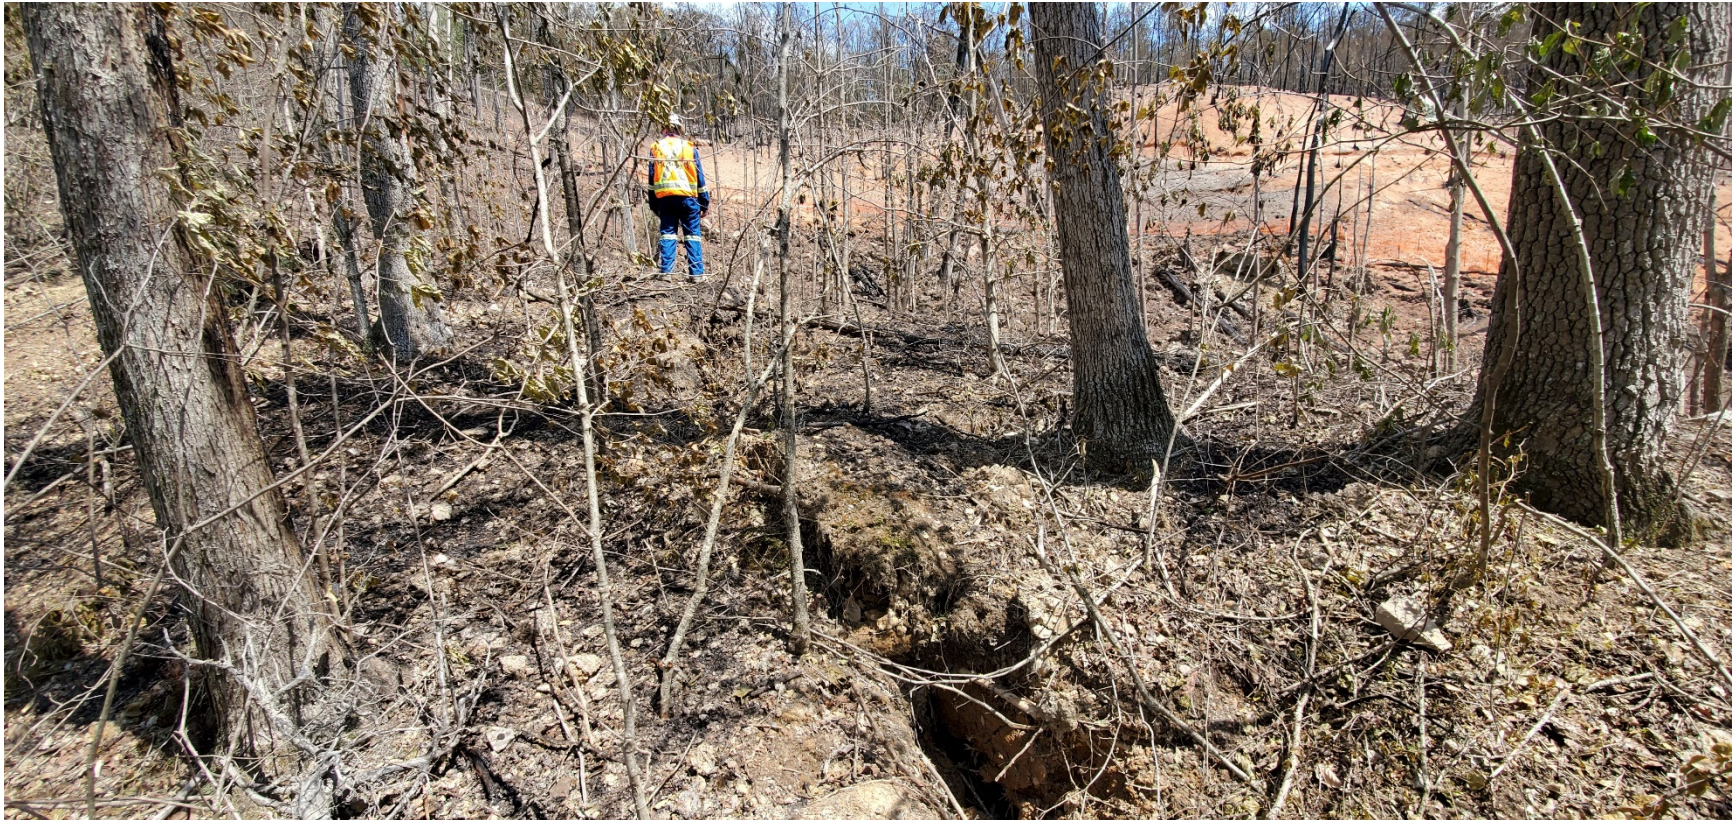
**Photo C-5. Looking southeast (upslope) at lateral cracking on the northern flank of the landslide downslope of the TETLP ROW. Note tree roots in tension across the crack. This area is also where unburnt roots were observed, indicating additional movement following the FCI. BGC photo taken May 7, 2020.**

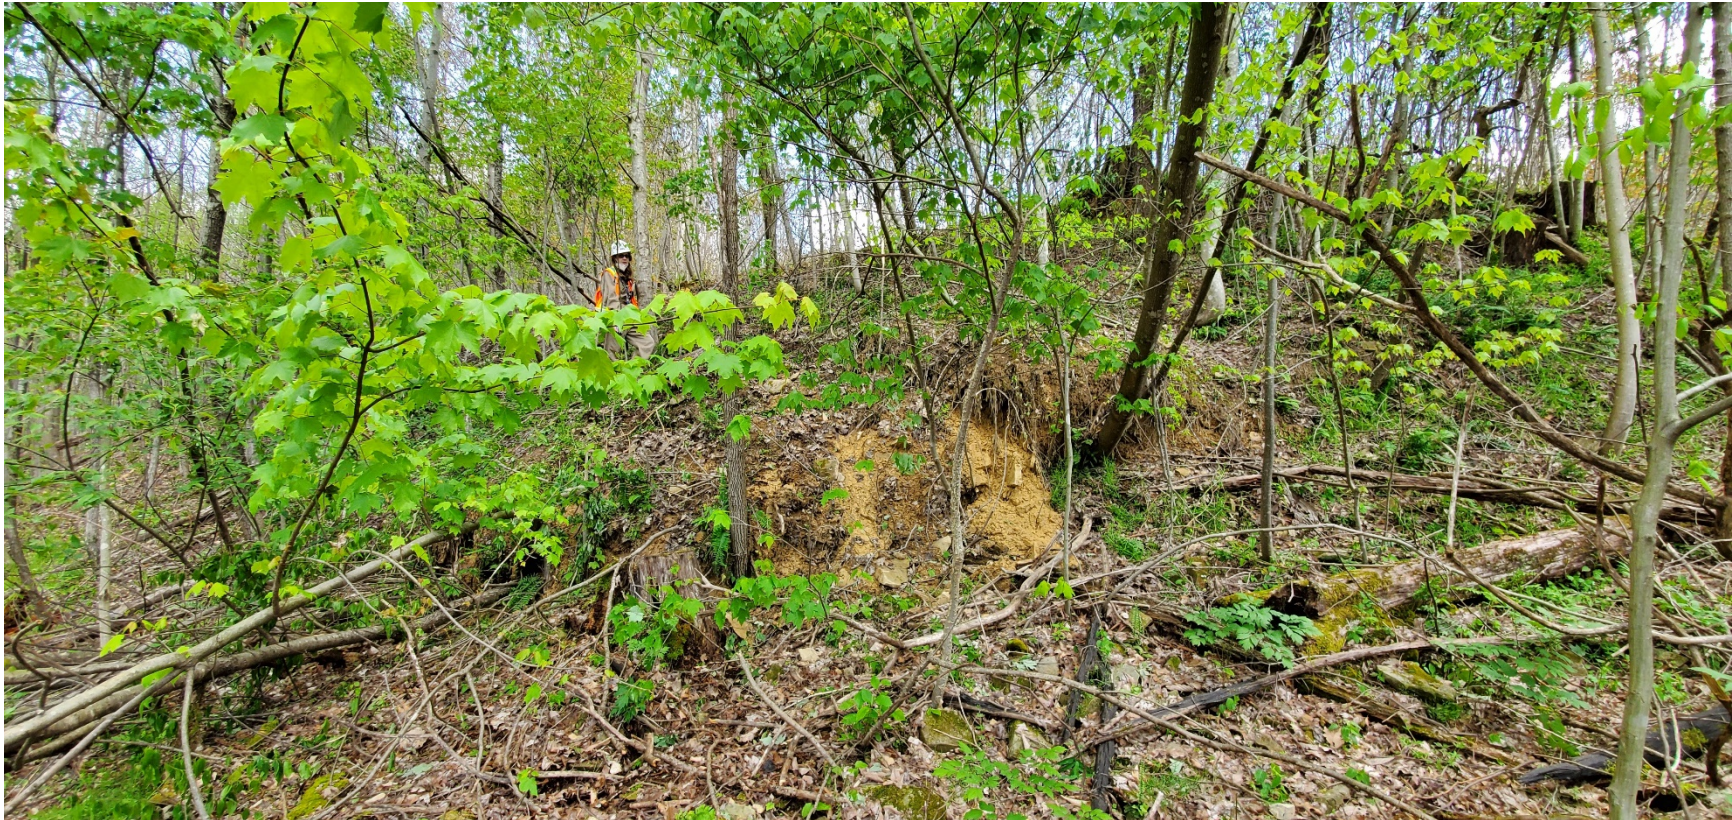
Downslope and off the TETLP corridor, lateral cracks were observed along the landslide flank east and west of a prominent gully feature. Stretched tree roots were observed in the cracks, and unburned soil was also observed (see Photo C-5). The uncharred soil indicated that additional movement had occurred within the three days following the FCI. At the base of the landslide two distinct toe bulges were observed. The toe bulges were observed overriding living trees and the soil was saturated (Photo C-6).

**Photo C-6. Looking southeast (upslope) at the active toe. Note the fresh, saturated soil and the living trees being overridden by the landslide toe. BGC photo taken May 7, 2020.**

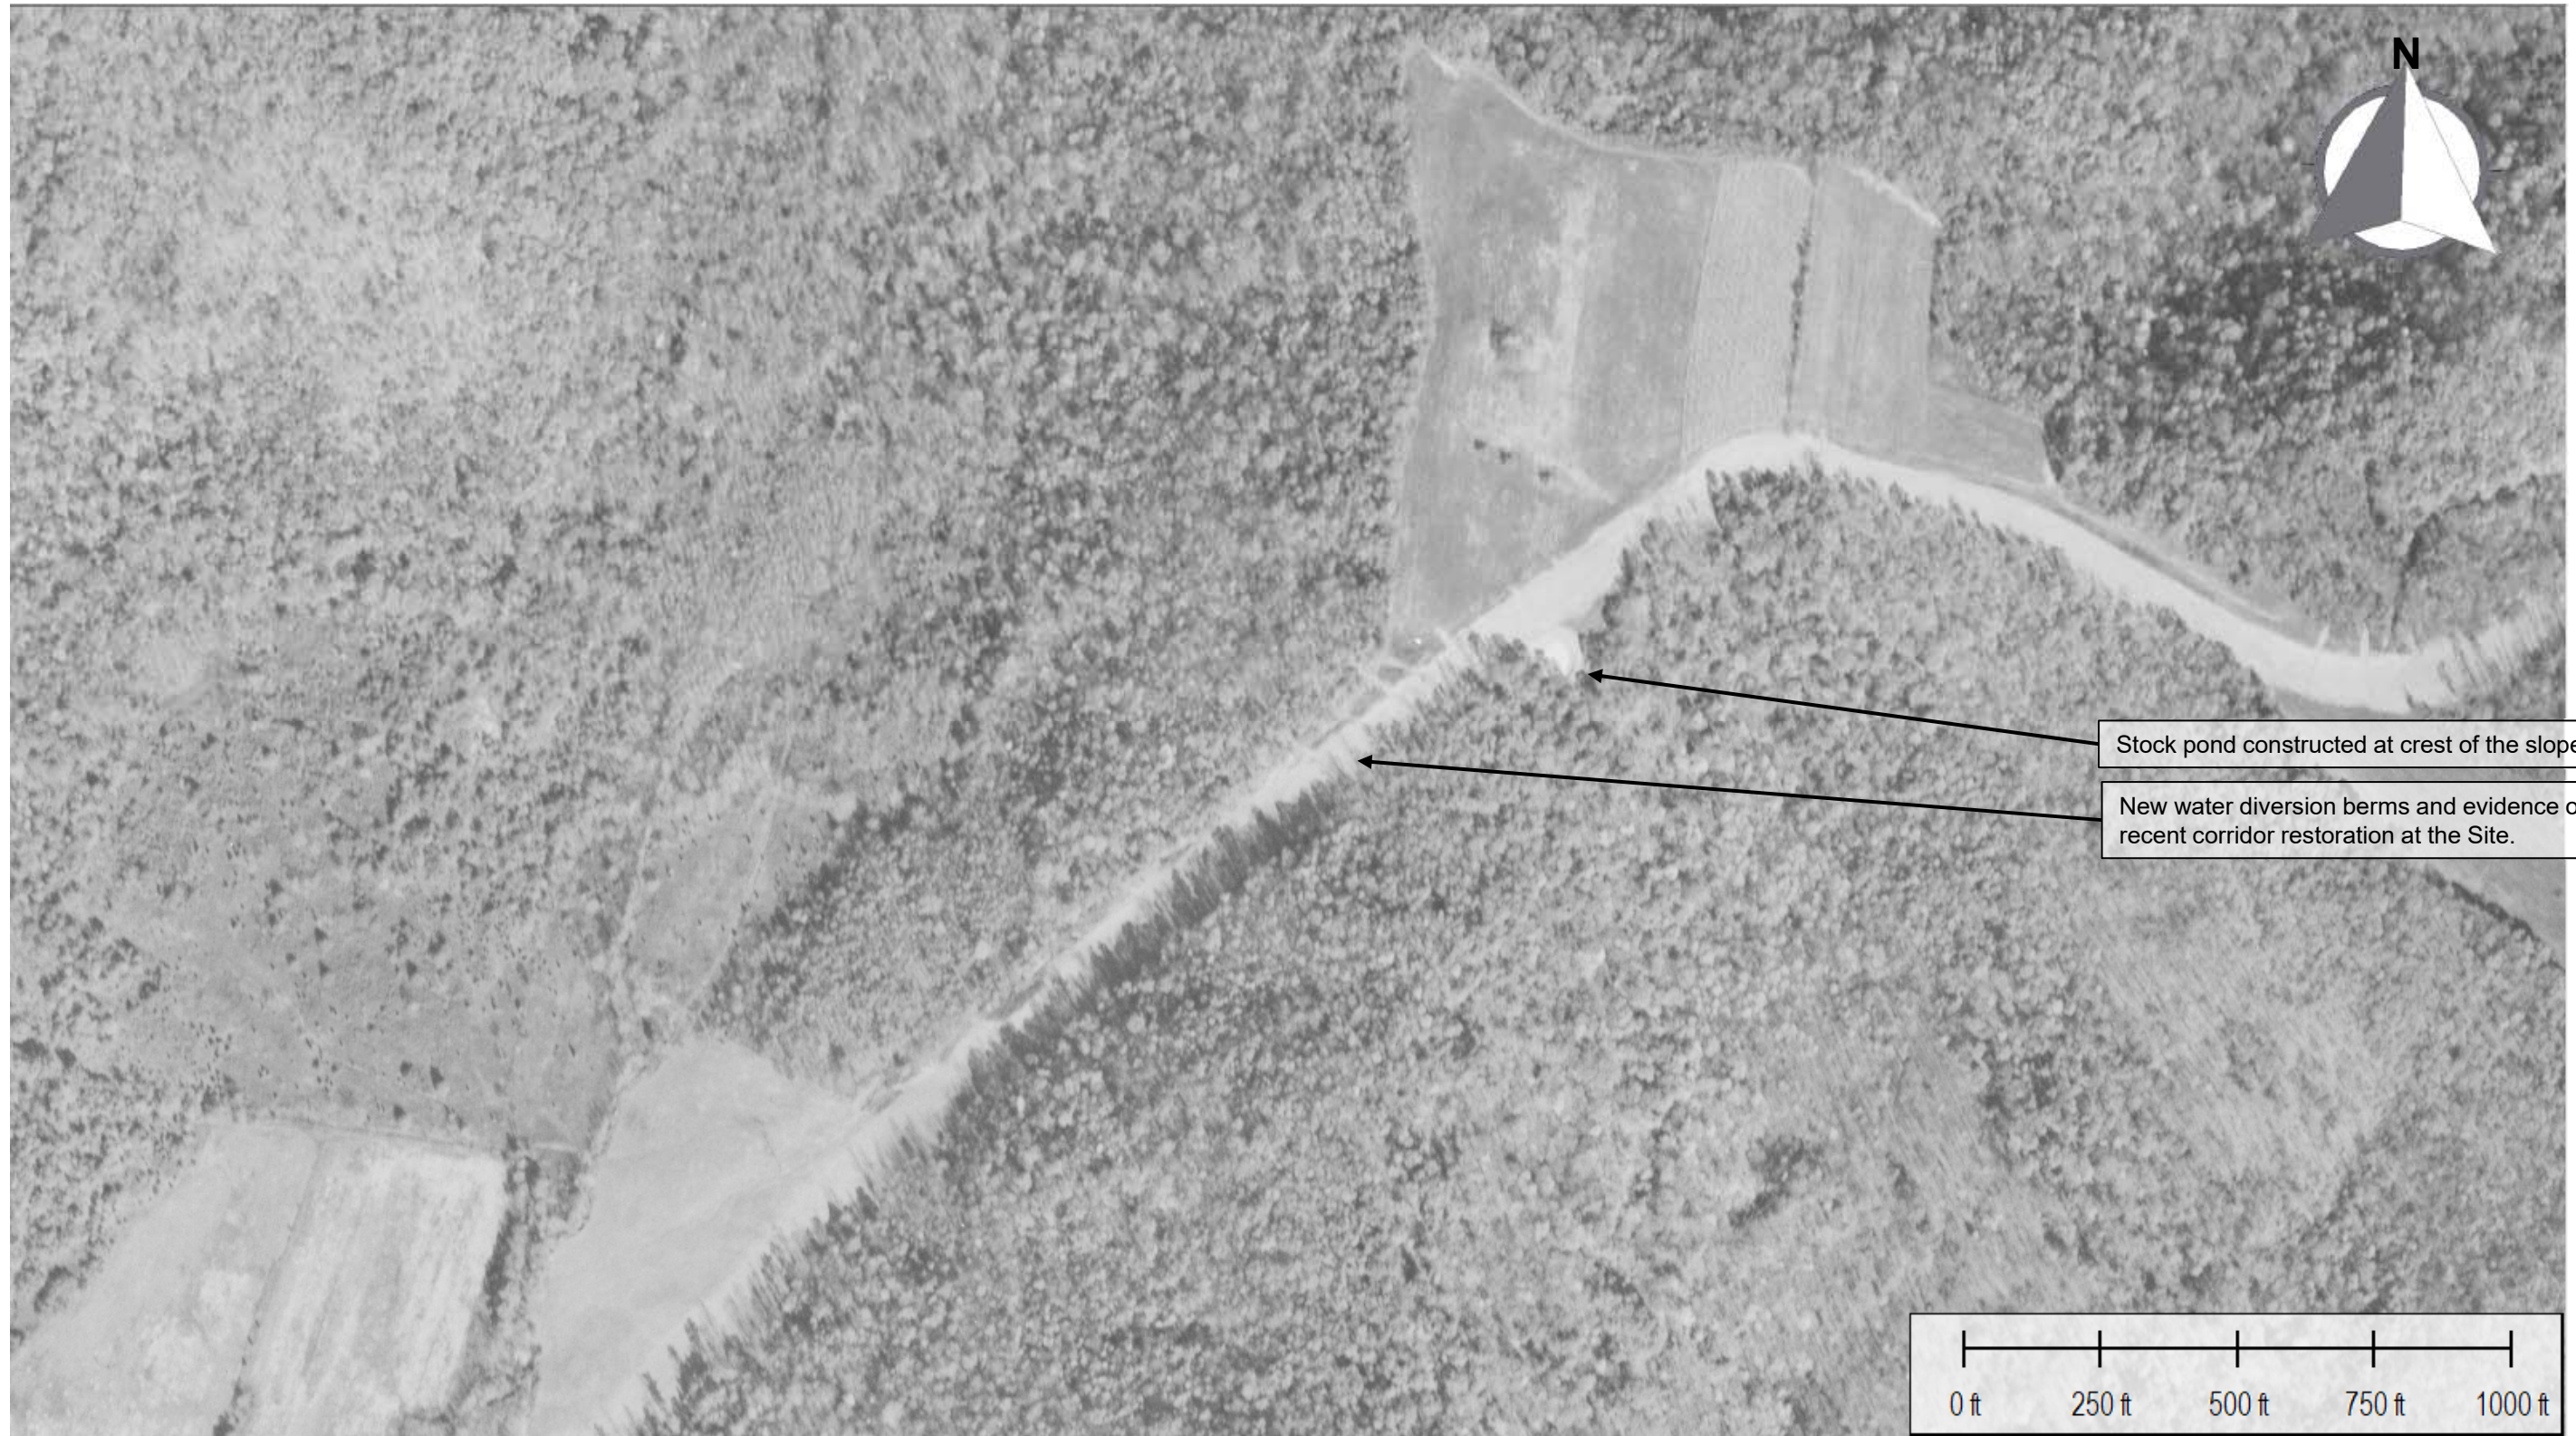
Stock pond constructed at crest of the slope.
