## **TEXAS EASTERN TRANSMISSION, LP**

### **MAY 4, 2020 FLEMING COUNTY INCIDENT GEOTECHNICAL CAUSATION REPORT**

PROJECT NO.: 1607024  
DOCUMENT NO.: Rev A

DATE: April 26, 2021

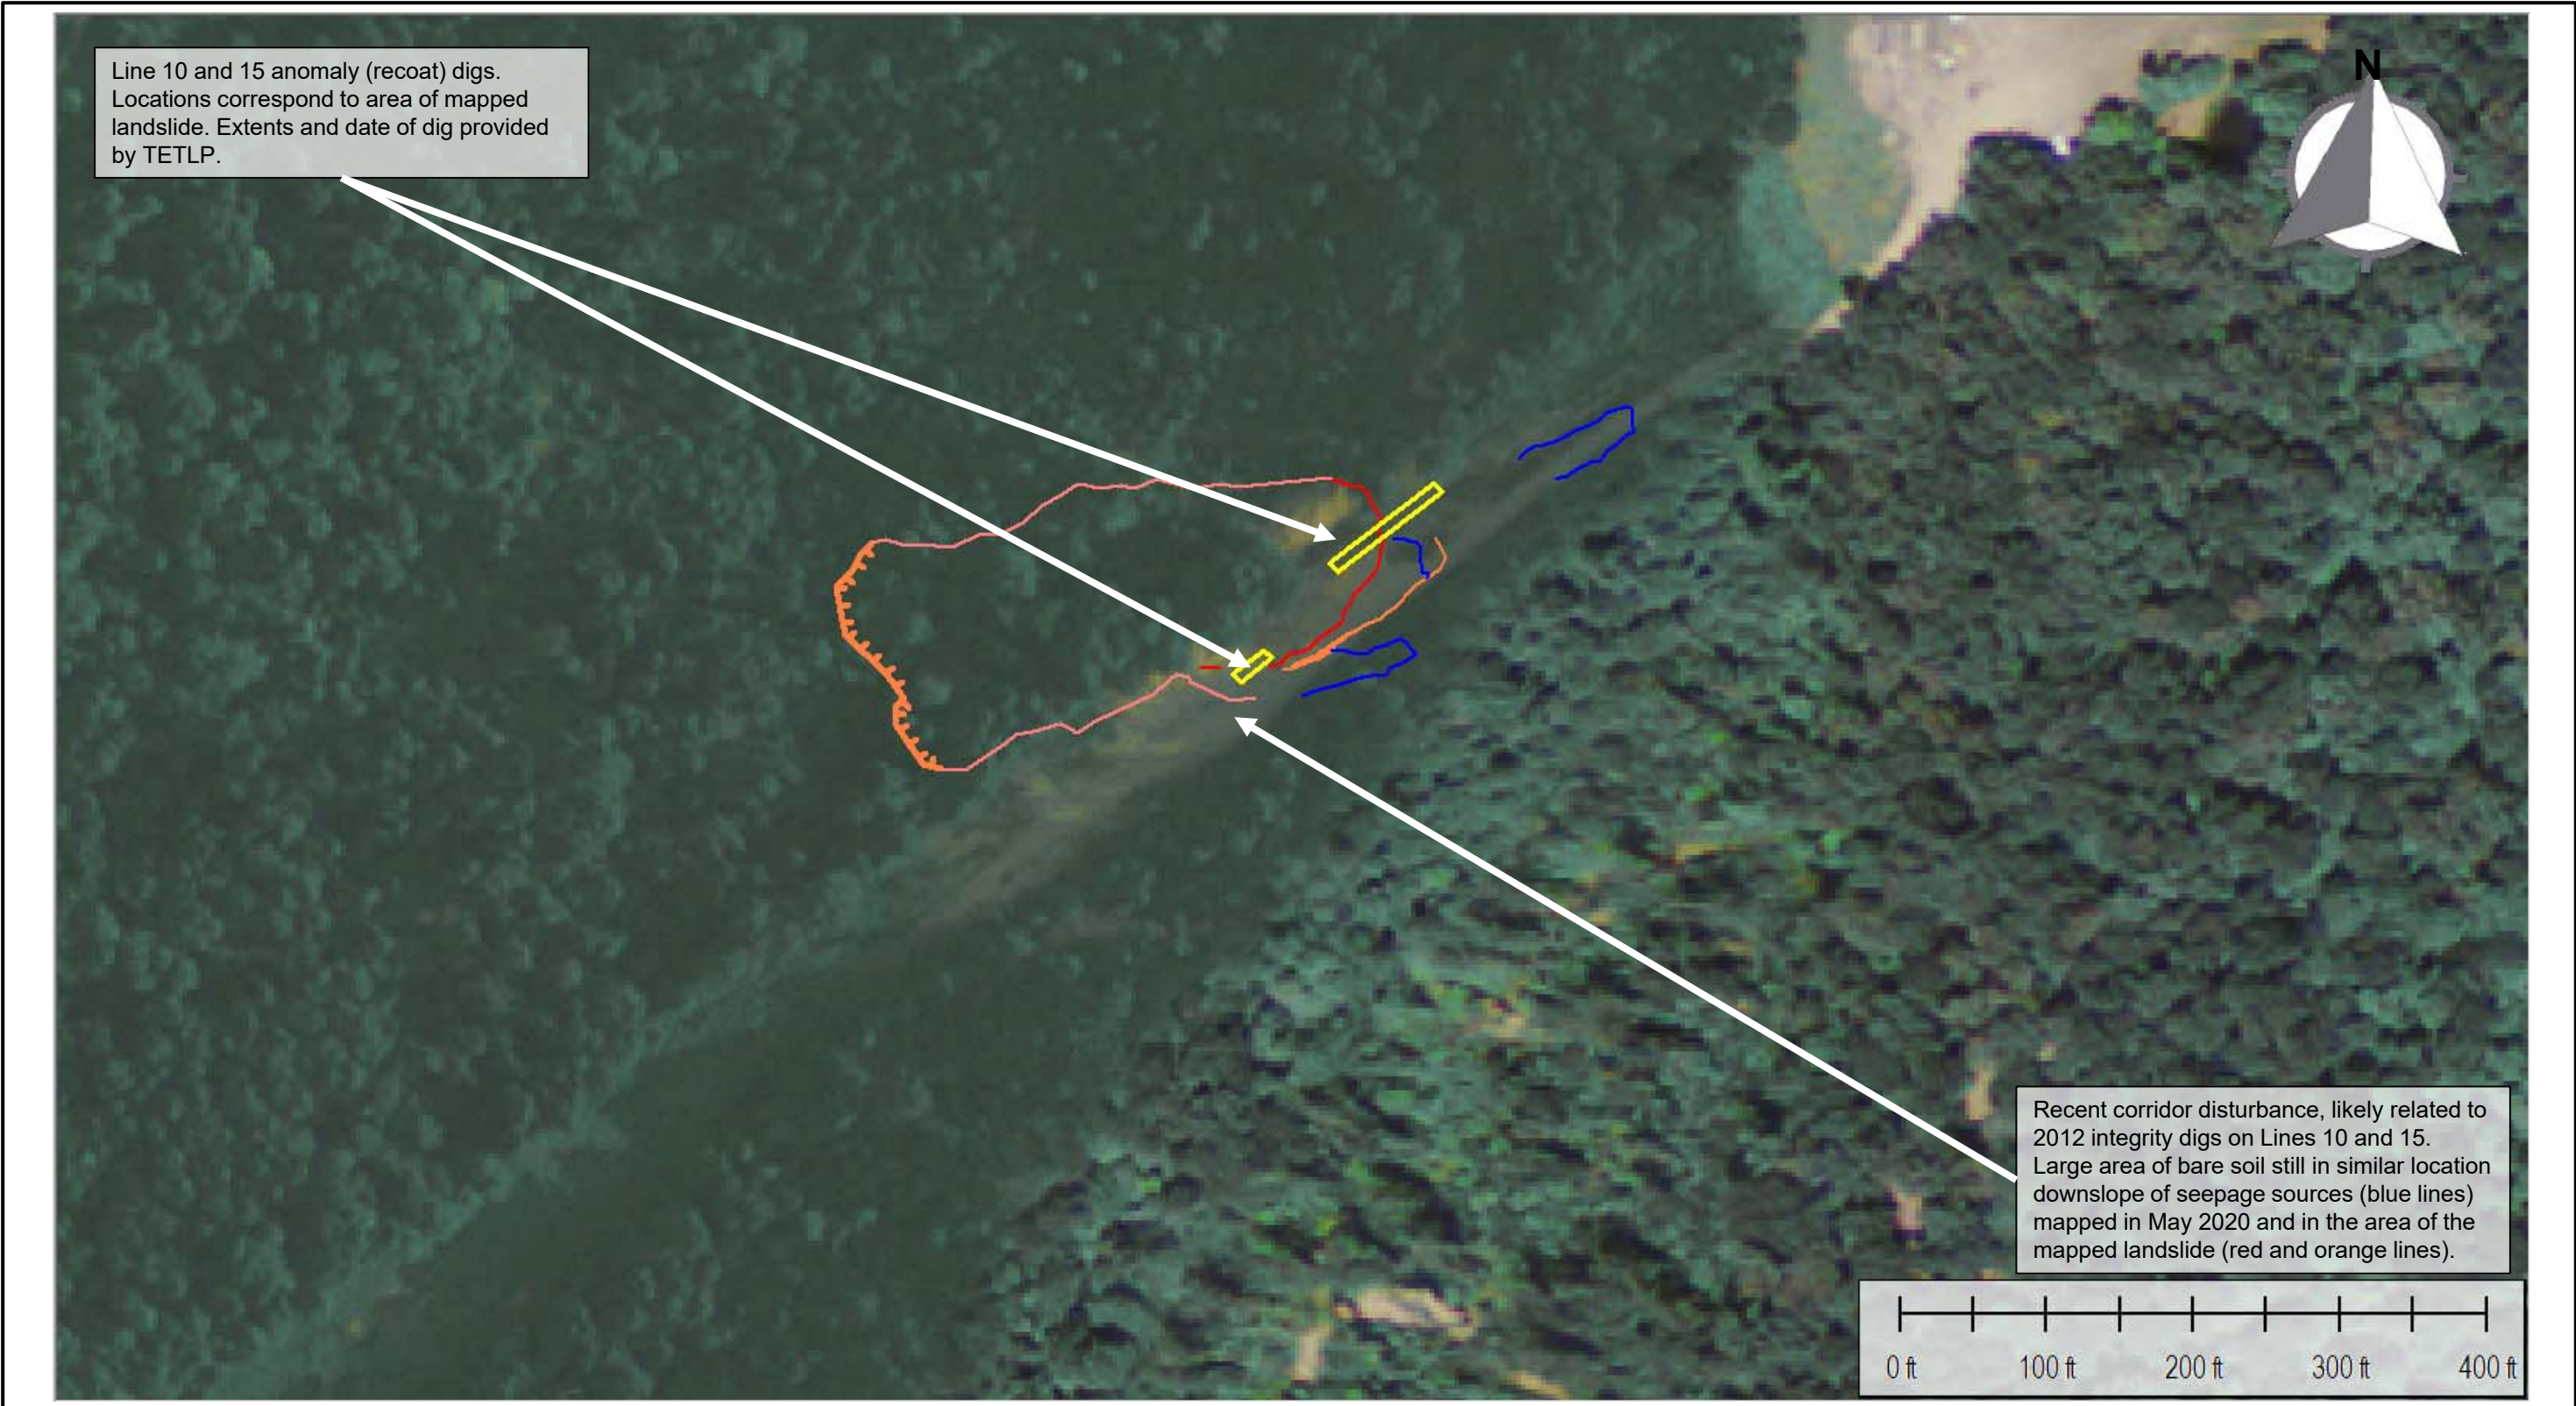
Line 10 and 15 anomaly (recoat) digs. Locations correspond to area of mapped landslide. Extents and date of dig provided by TETLP.
