PRESENTATION OF PARTY SUBMISSION TO THE NATIONAL TRANSPORTATION SAFETY BOARD

**FIU UniversityCity Prosperity Pedestrian Bridge
Construction Accident of March 15, 2018**

FIU University City Prosperity Pedestrian Bridge
Construction Accident
Miami, Florida | March 15, 2018
Submitted by - Figg Bridge Engineers, Inc.

**PARTY
SUBMISSION
BY FIGG
BRIDGE
ENGINEERS**

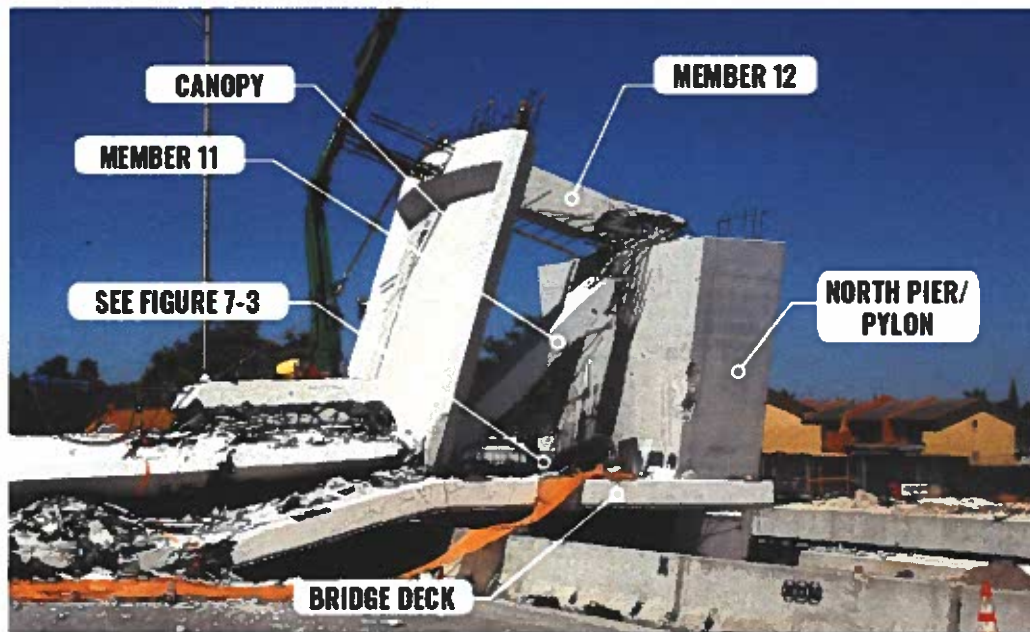
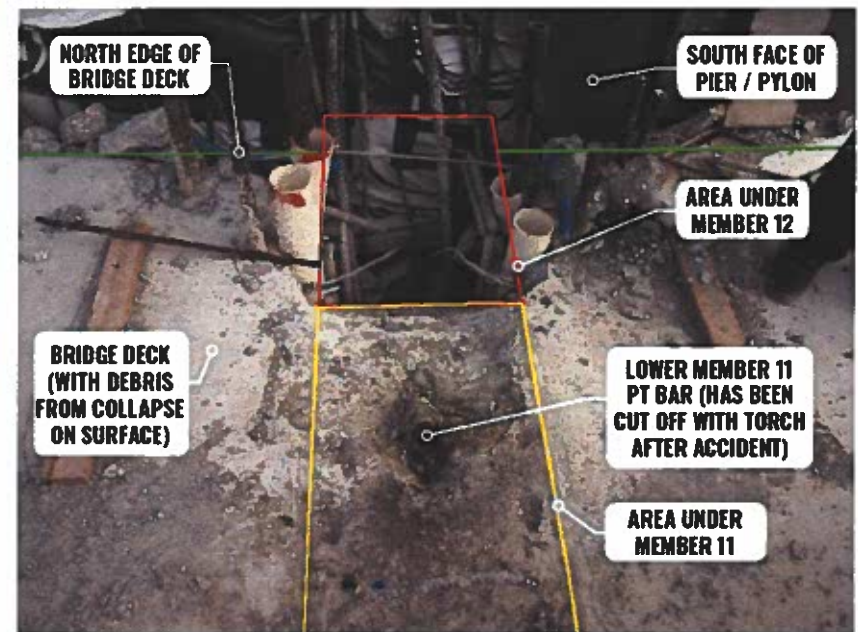
Accident Analysis -

Failure of construction joint between members 11/12 and the bridge deck at the north end.

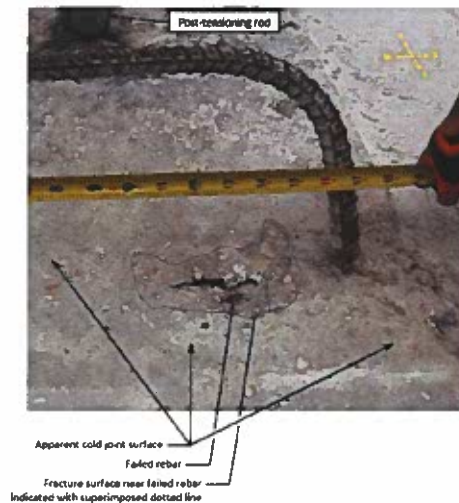
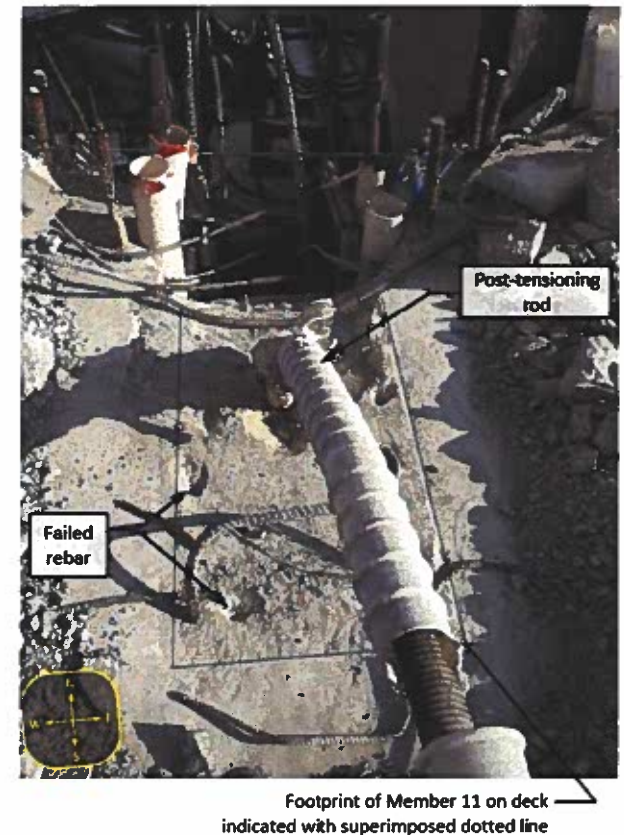
1. FHWA Turner Fairbank Highway Research Center Factual Report “Concrete Interface Under Members 11 and 12”

“...the failure interface coincides with the original cold joint and that the cold joint was not intentionally roughened”.

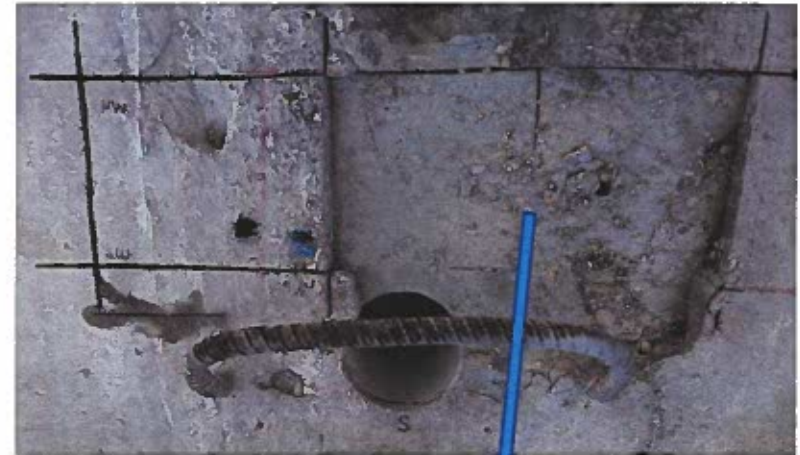
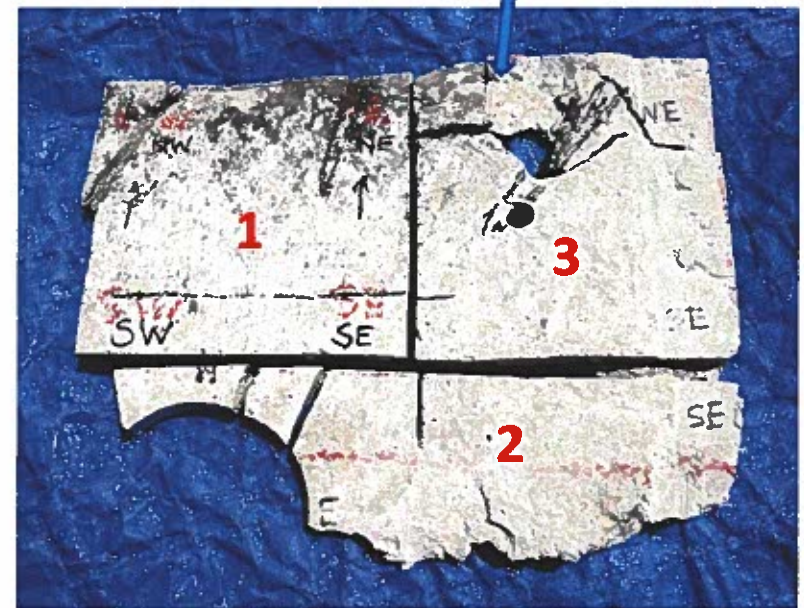
The NTSB investigation determined that the construction joint was not roughened

2. NTSB Materials Laboratory Study
Report No. 19-043 discusses results of a laser scan of the construction joint post-accident:

“The average S_a (roughness measurement) for the flat areas evaluated on both the Member 11 pieces as well as the Member 12 surface was approximately 1mm (0.04 in.)...”

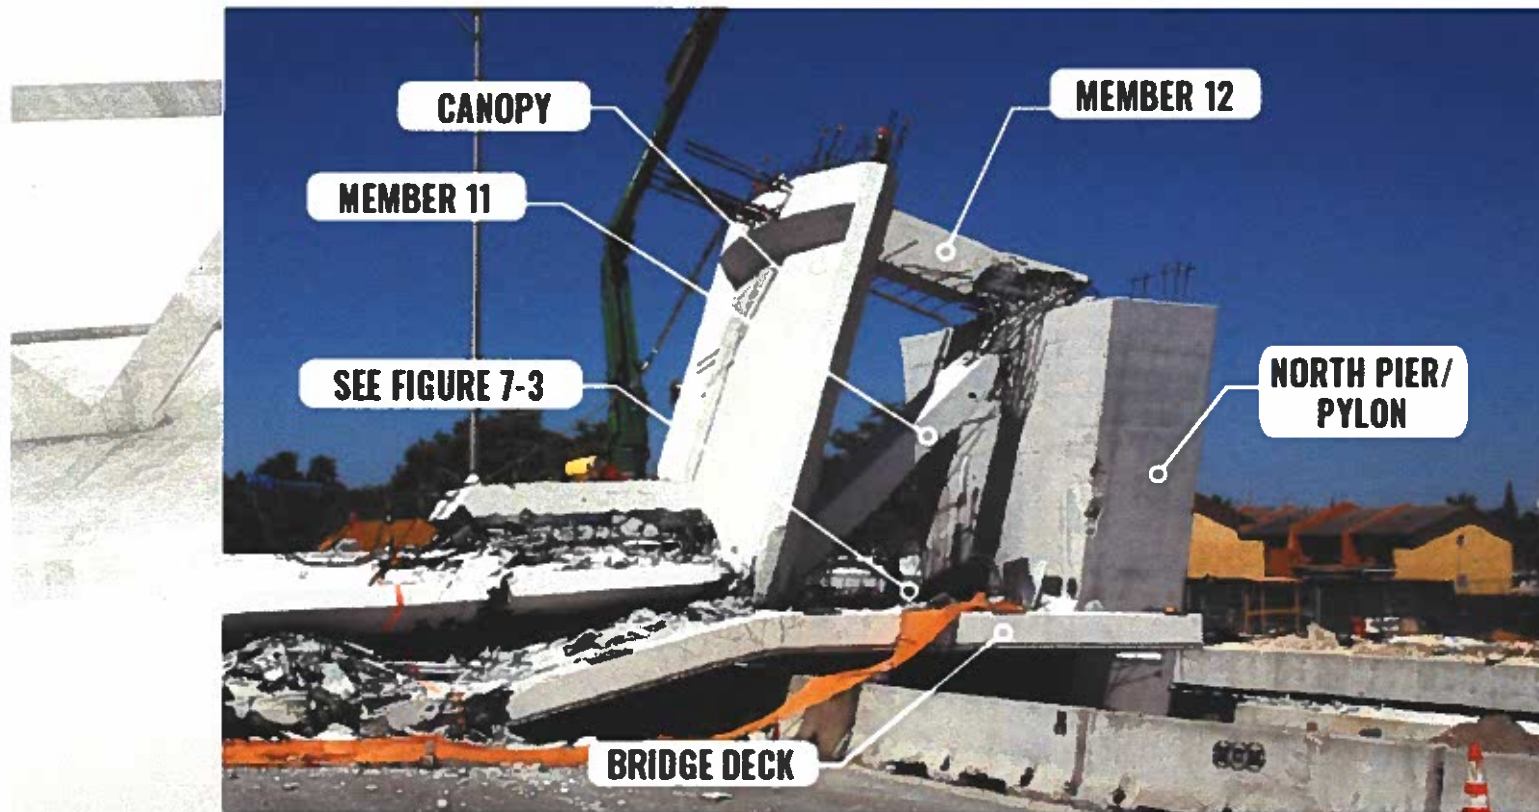
Non-roughened construction joint is consistent with forensic analysis of failure mode by Wiss, Janney, Elstner (WJE)

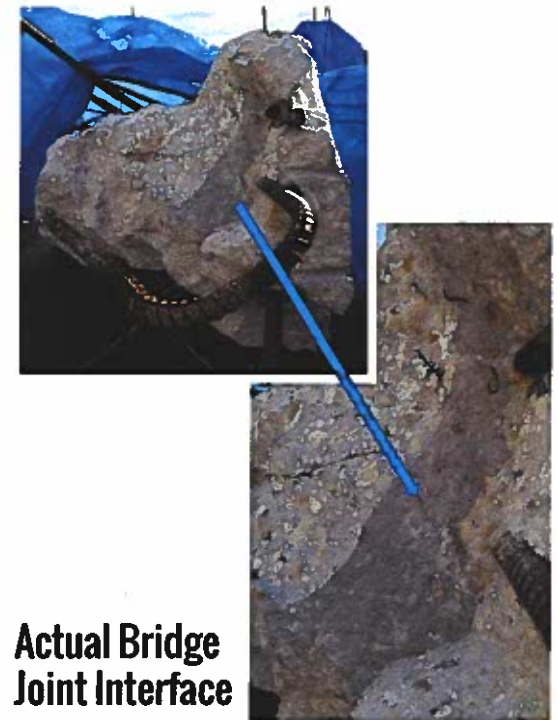
Actual Bridge
Joint Interface

No Fractured Aggregate
Proves actual bridge joint
was non-roughened

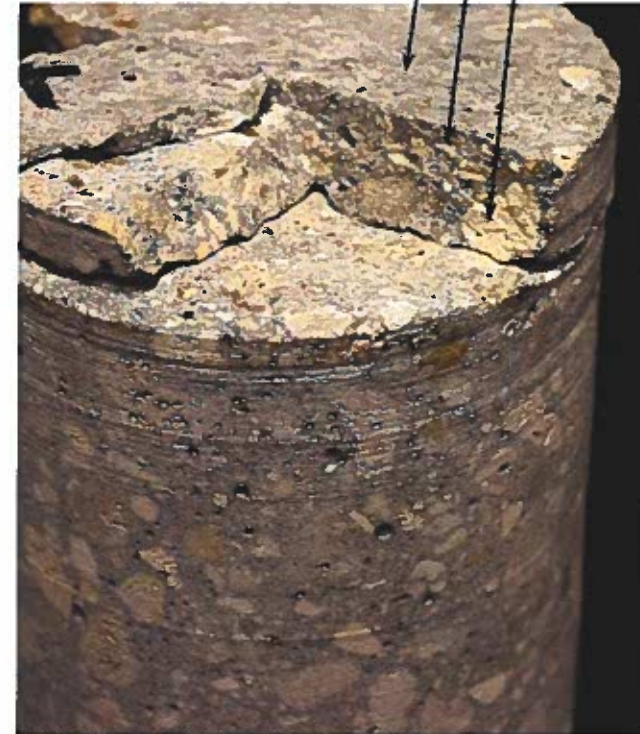
**FHWA Turner Fairbanks Interface Report indicates
joint non-roughened**

Aggregate bridging across delamination plane
Small aggregates under apparent cold joint
Apparent cold joint surface

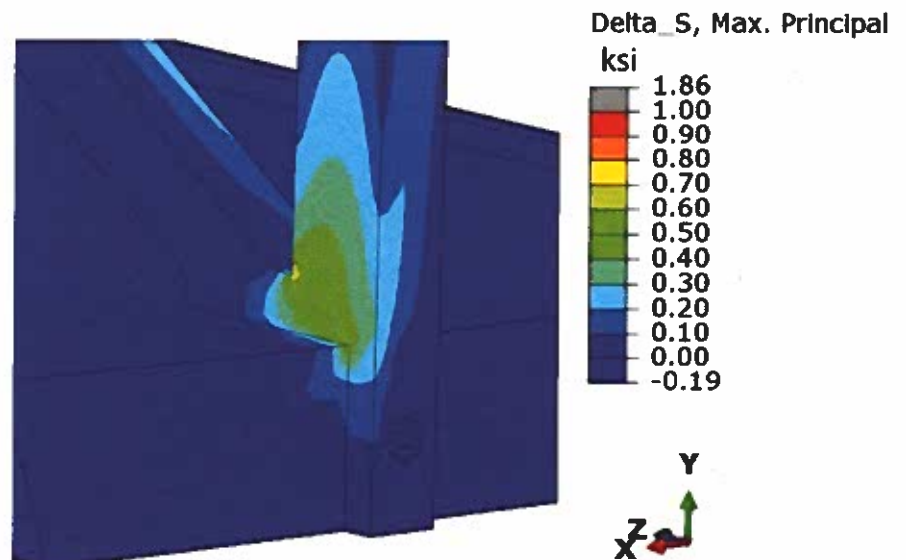
Looking southwest at north end and east face. Green color indicates more than 500 psi tensile stress.

Dark blue areas have zero tensile stresses or they are compression dominant

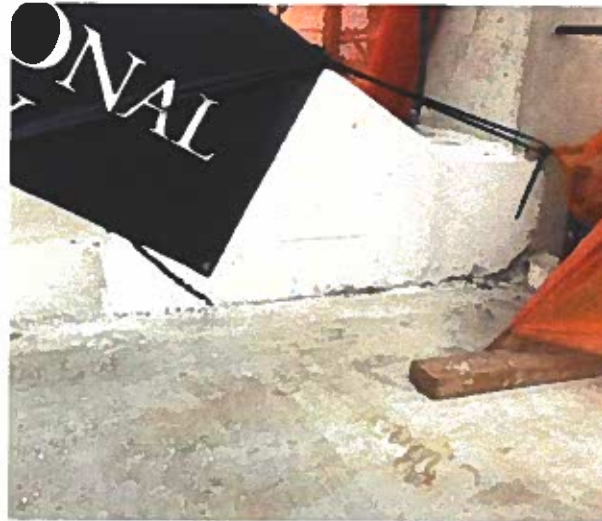
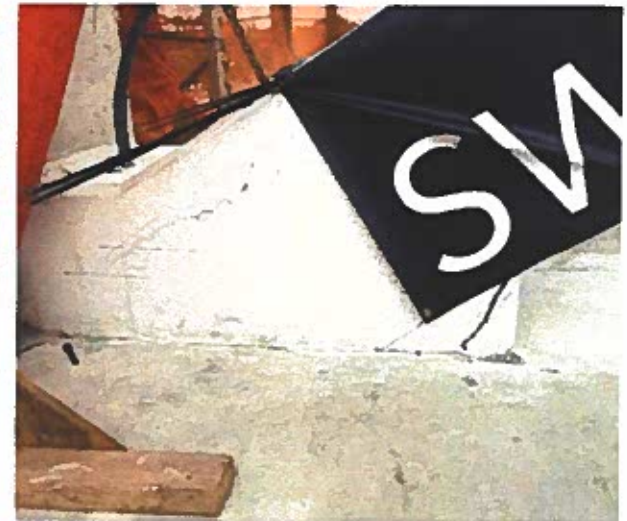
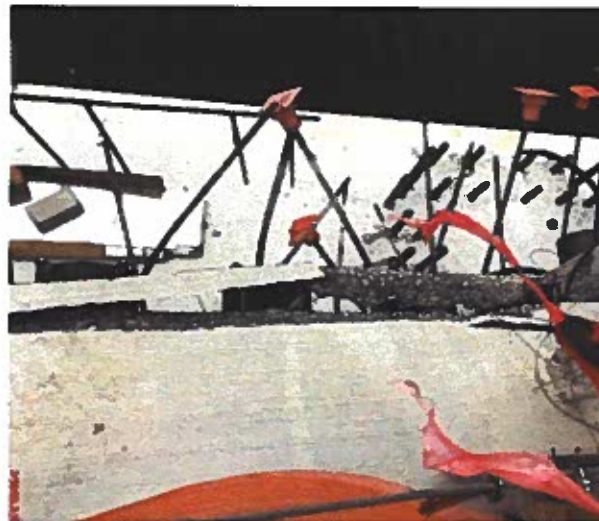
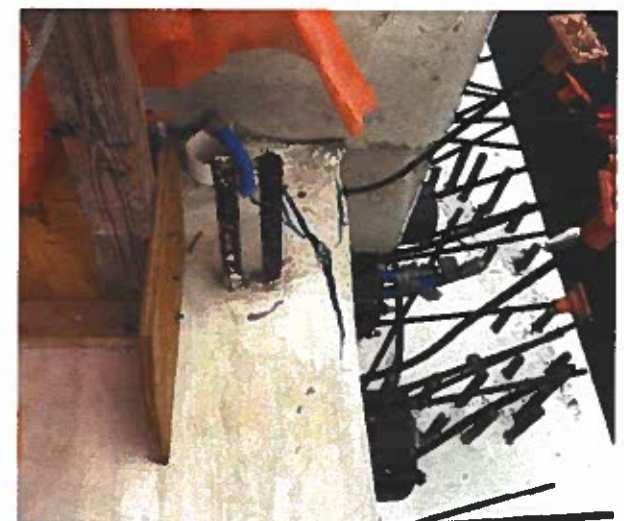
Cracks in Member 11/12
connection increased
dramatically in afternoon after
the bridge move

Stress from excessive twist
contributed to damage in
Member 11/12 connection region

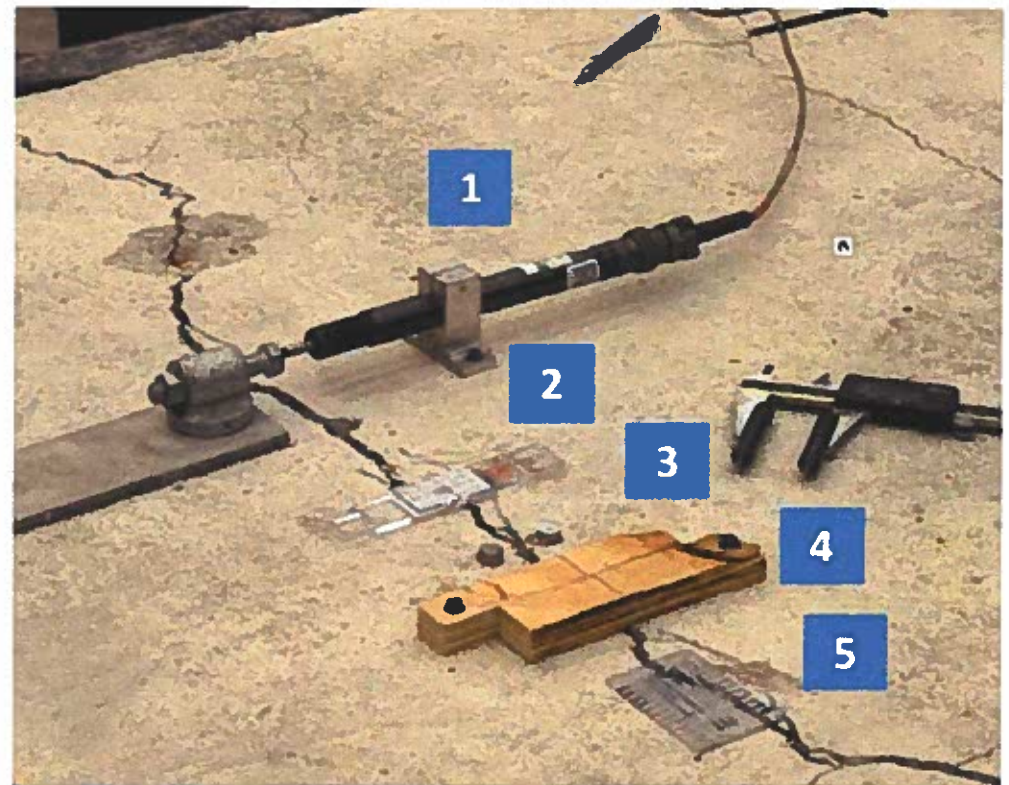
Contributory Cause - Failure To Monitor Cracks While Restressing Member #11

Closely monitor cracks

Immediately stop and notify FIGG if cracks get larger

PT subcontractor's shop drawings also required stopping if cracks increased

Proper crack monitoring instruments were not used

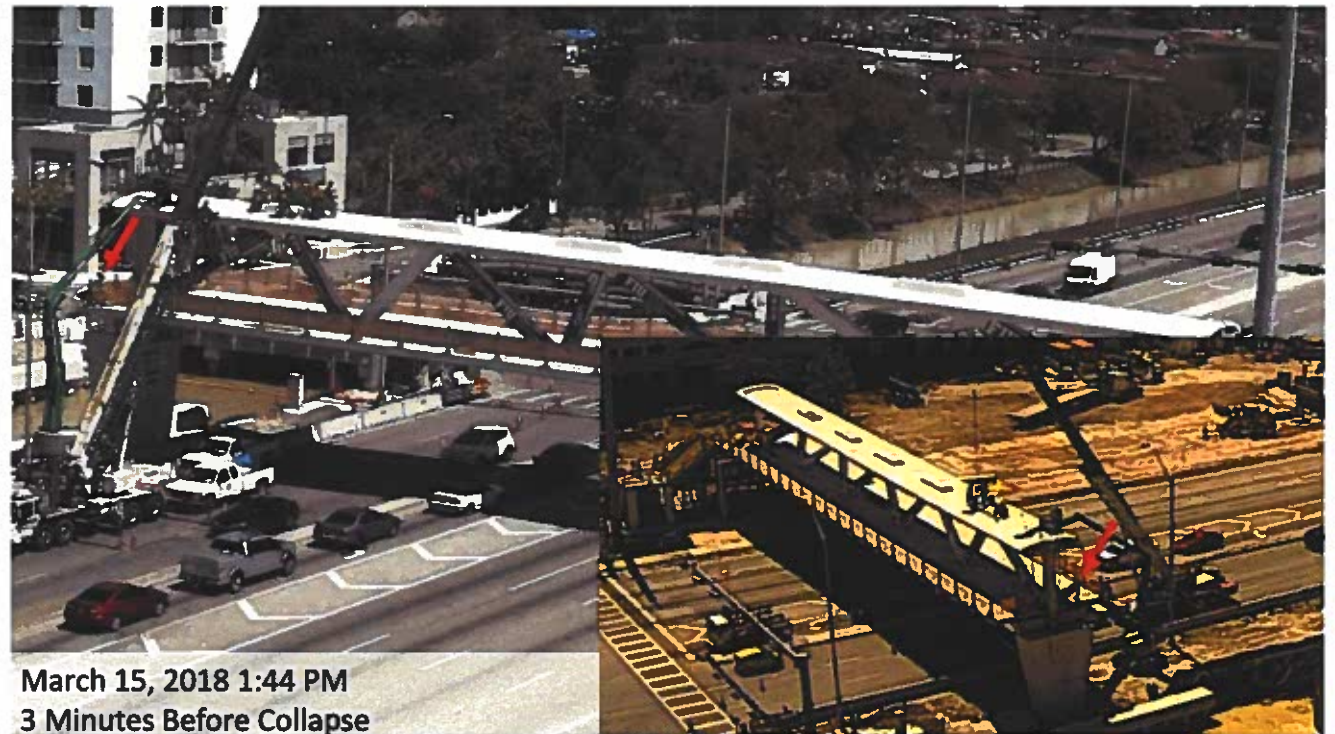
Construction webcam video indicates cracks were not closely monitored during restressing

Had proper crack monitoring been performed, the accident may have been prevented
