PARTY SUBMISSION

TO THE
NATIONAL TRANSPORTATION
SAFETY BOARD

FIU University City Prosperity Pedestrian Bridge
Construction Accident
Miami, Florida | March 15, 2018

Submitted by - Figg Bridge Engineers, Inc.

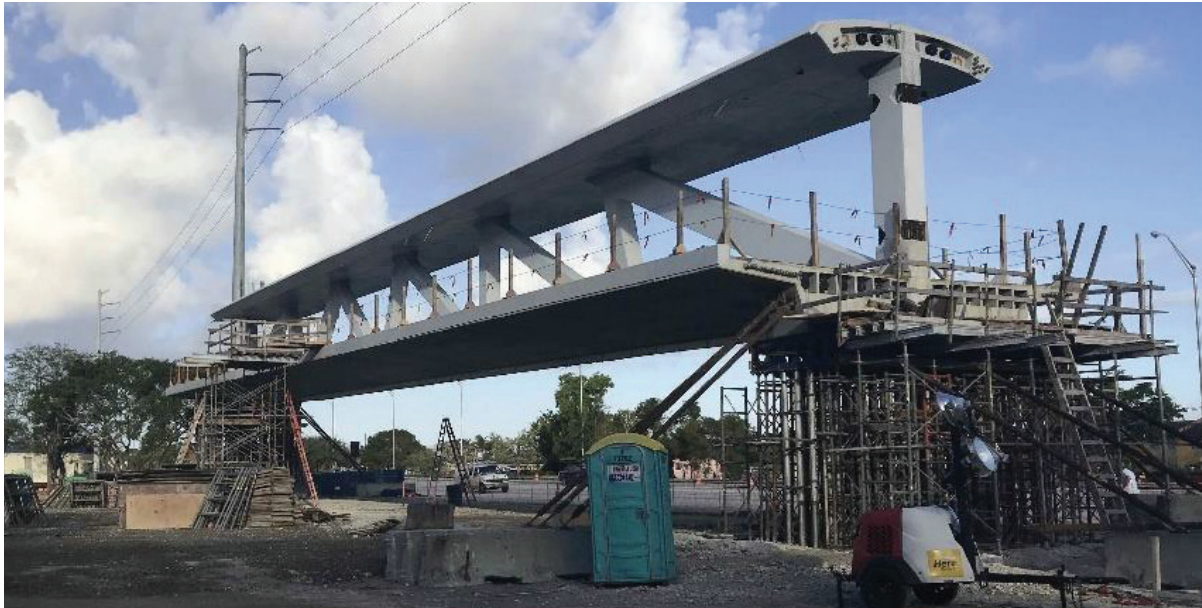
Completed precast main span truss supported on temporary shoring at both ends in casting area. Bridge was in this self supporting position for two weeks. (Source: Bridge Factors Photo 41)

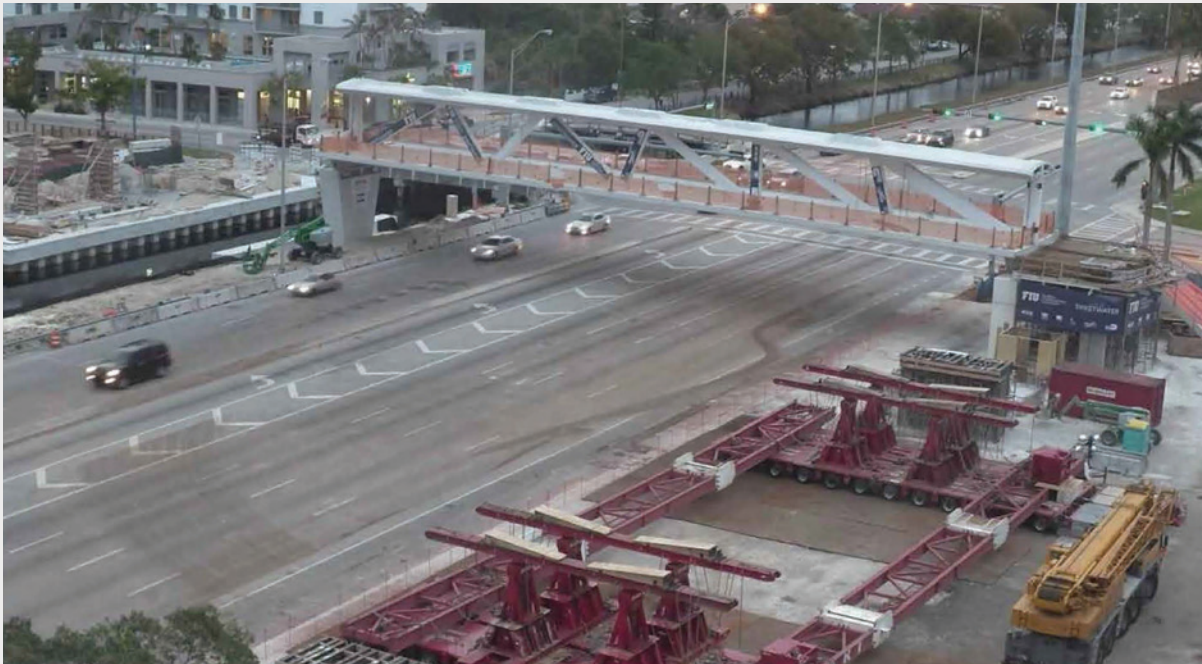
Traffic reopens on SW 8th Street on March 10, 2018, at approximately 6:00 p.m. after members 2 and 11 PT bar destressing. (Source FIGG's Photo Submission FCA 23-6)

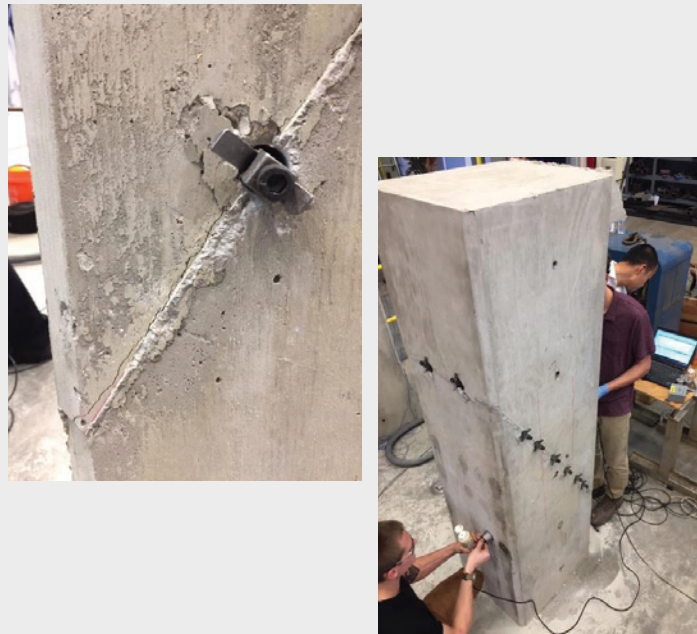
Five of the six test specimens were pre-cracked with stone splitting wedges along the construction joint prior to testing to simulate actual conditions of the member 11 connection with the bridge deck. (Source: WJE)

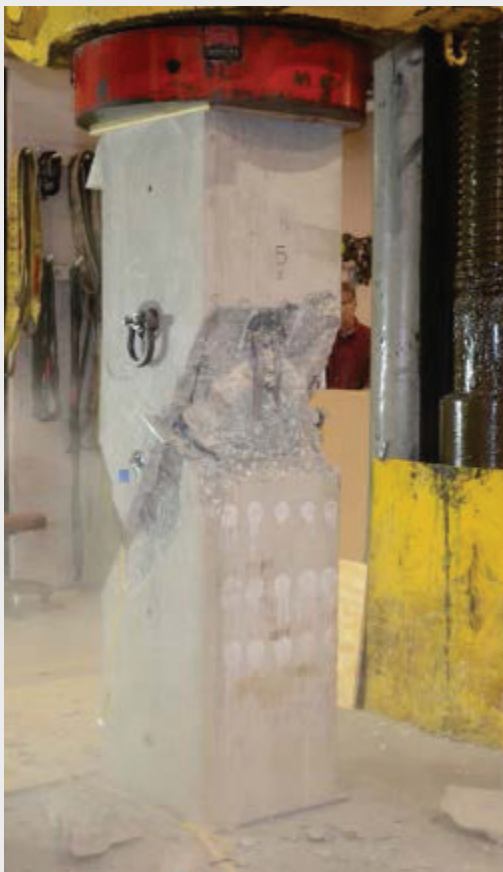
FIGURE 6-29
Specimen after failure along the construction joint.
Detail shows close-up of sliding along the joint
surface. This specimen had a roughened pre-cracked
construction joint surface. (Source: WJE)

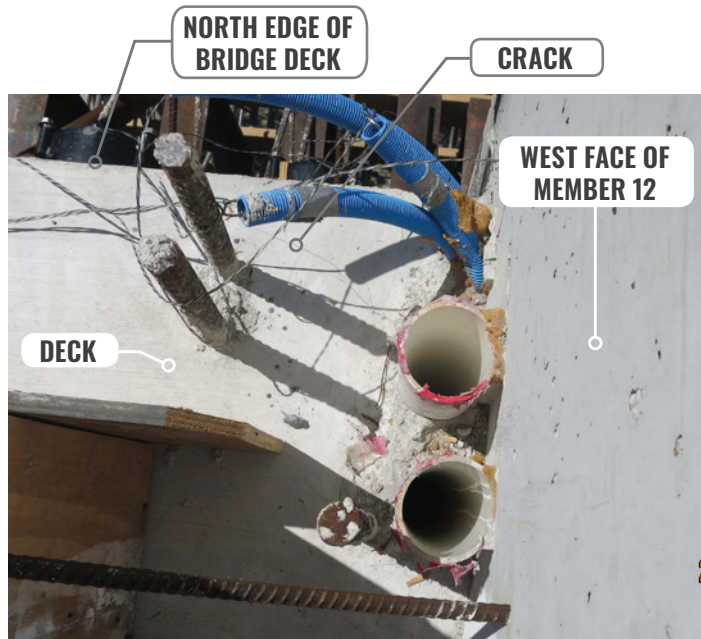
Crack in deck on the west side of member 12 before the span move on March 8, 2019. (Source: Barnhart)

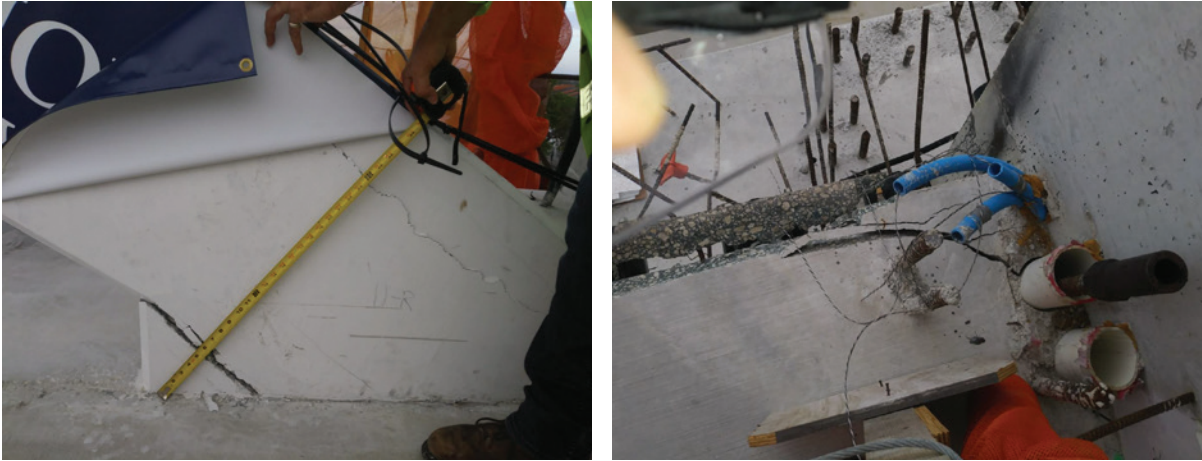
Cracking observed on March 12 had slightly widened from that observed on March 10, 2018. (Source: MCM)

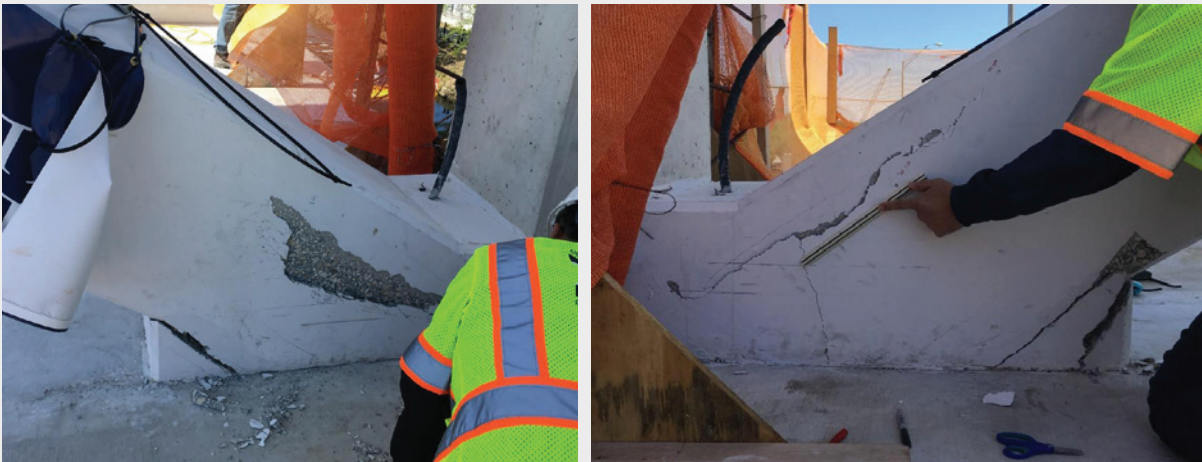
FIGURE 7-9

Member 11 crack progression on March 14, 2018. Per WJE in Appendix A, at the time of the accident the next day, the cracks divided the base of member 11 into smaller individual pieces such that the element no longer acted as a composite member. (Source: Bridge Factors Photograph #s 90 and 83)

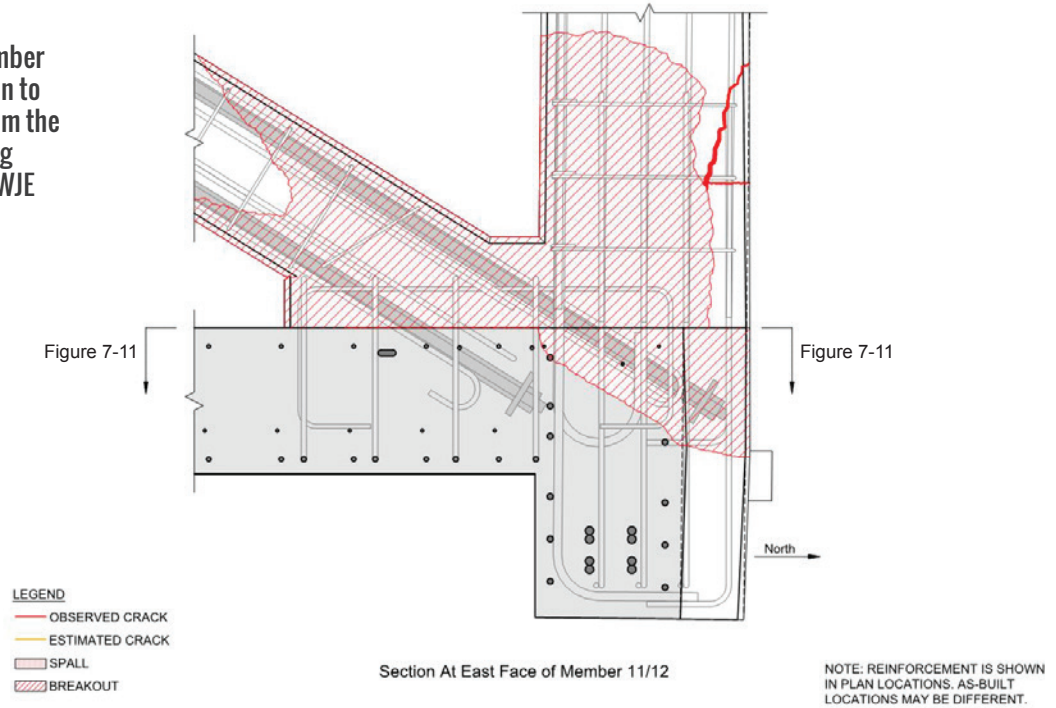
FIGURE 7-10
 Damage to member 11/12 connection to bridge deck from the collapse looking west. (Source: WJE modified)

permanent piers before member 11 was de-tensioned. Northward sliding of member 11 led to breakout failure of the north end diaphragm below member 12 while existing cracks continued to widen. New cracks developed at the base of member 11 as it separated into smaller individual sections.

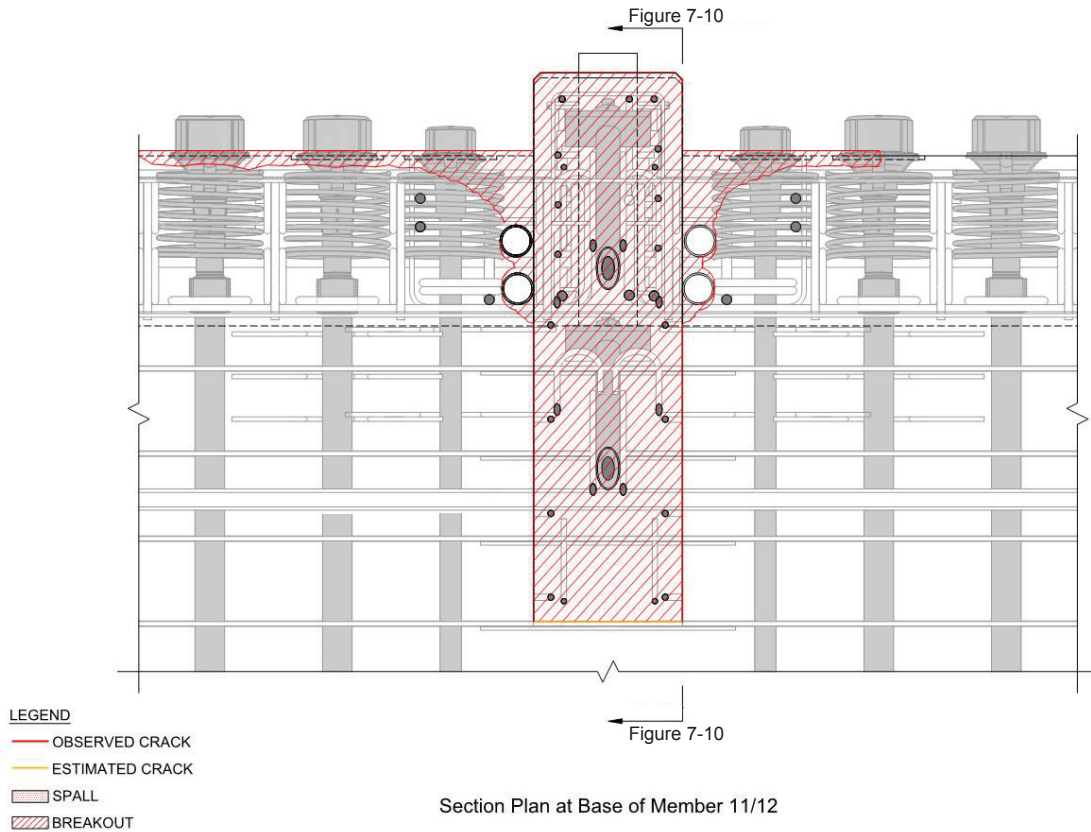
FIGURE 7-11
 Damage to member 11/12 connection to bridge deck from the collapse looking down (plan view). (Source: WJE modified)

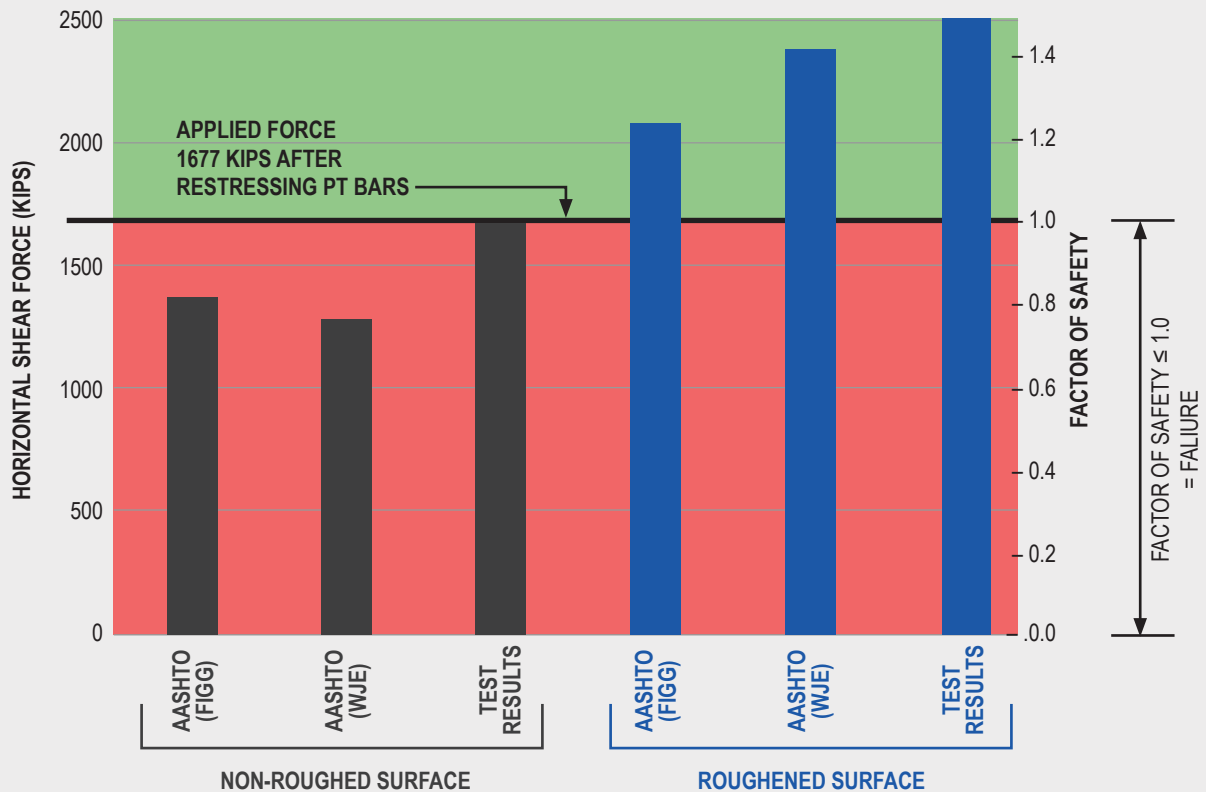
FIGURE 7-12
Member 11/12 connection capacity (kips) for non-rough versus roughened joint

The graph in **FIGURE 7-12** provides a comparison of these capacities to the applied force along with the respective Factors of Safety. As noted in **TABLE 7-1** and **FIGURE 7-12**, all three methods of calculating the Factor of Safety for the roughened joint result in a factor greater than 1.0, with the minimum being 1.25. This indicates that the capacity of the member 11/12 nodal connection if roughened would be 25% higher than the applied load.

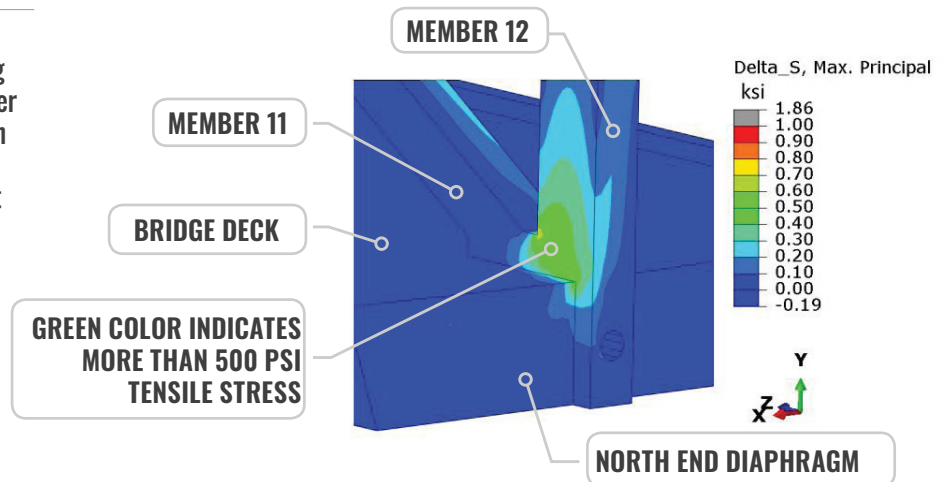
FIGURE 7-14
WJE analysis results showing maximum stresses in member 11/12 node from twist of main span during bridge move on March 10 (looking southwest at the north end of the main span). (Source: WJE)

member 12, the northernmost vertical. Although the calculated stress is somewhat less than that needed to initiate cracking, the stress from the tilt would tend to exacerbate cracking in the region **(FIGURE 7-14)**.

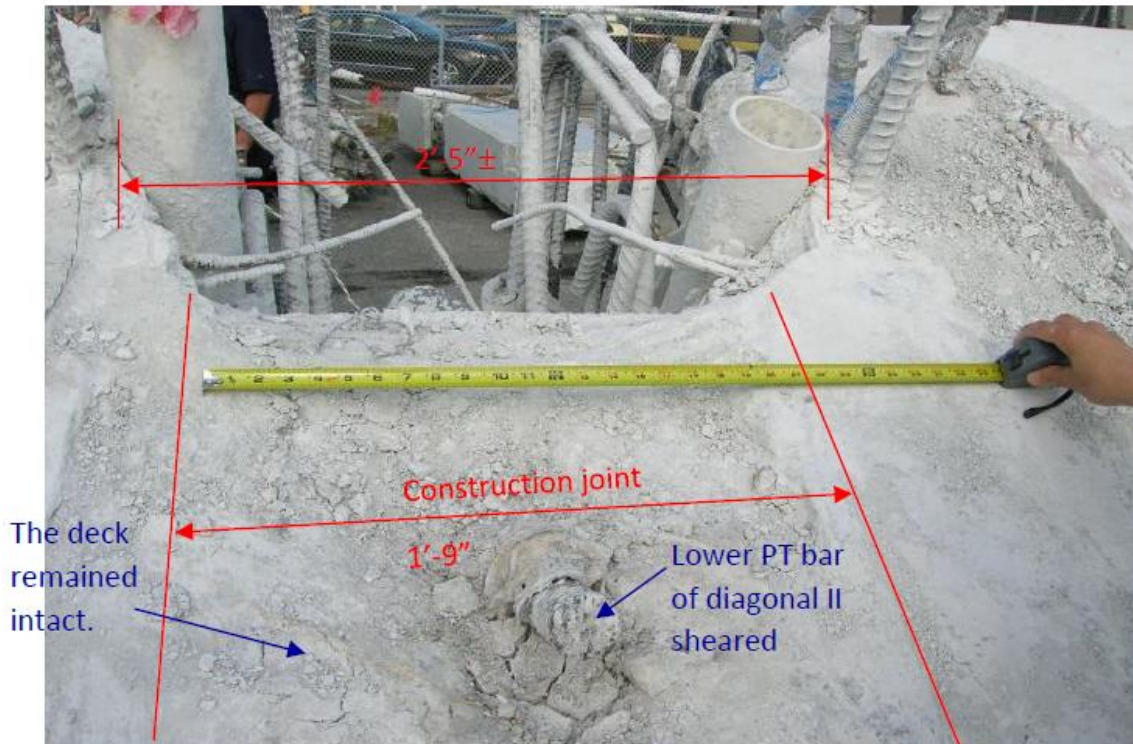
Figure 3.5. Construction joint below Member 11. (North is upward in the photograph.)

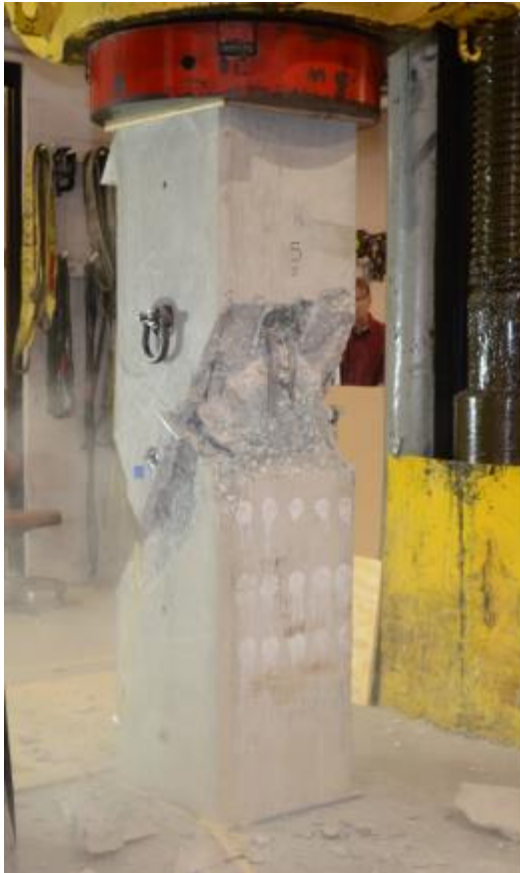
Figure 4.12. Specimen 5 after failure: overall view looking southwest (left); close-up of sliding on east side (right)

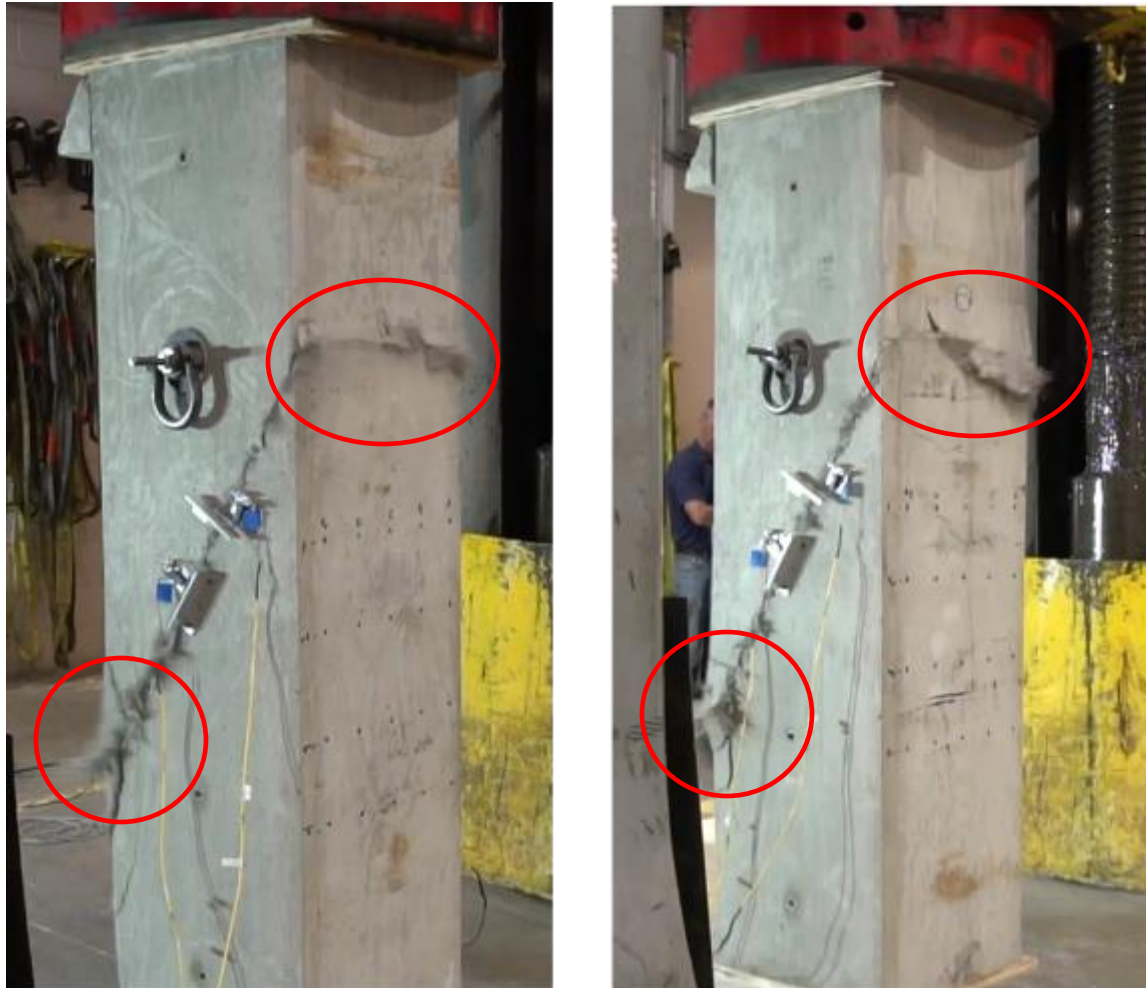
Figure 4.13. Screenshots from slow-motion video showing instant of failure: Specimen 3 (left) and Specimen 6 (right)

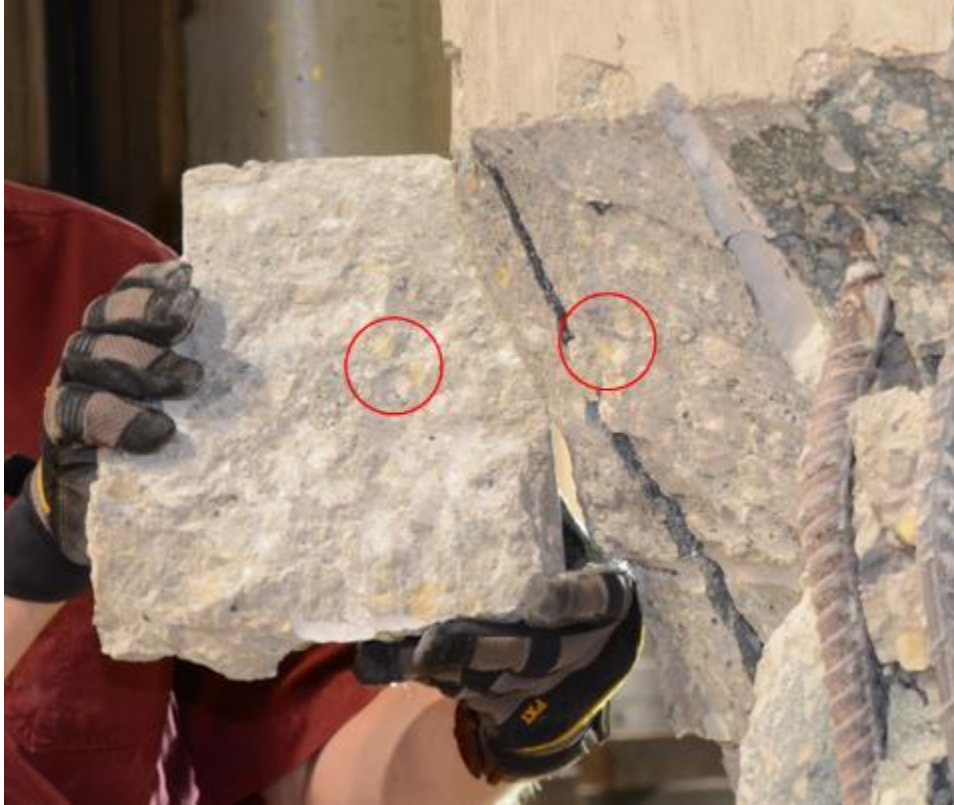
Figure 4.14. Construction joint interface of Specimen 5 (roughened, cracked) after failure. Circled areas show corresponding fractured aggregate on each side of interface.

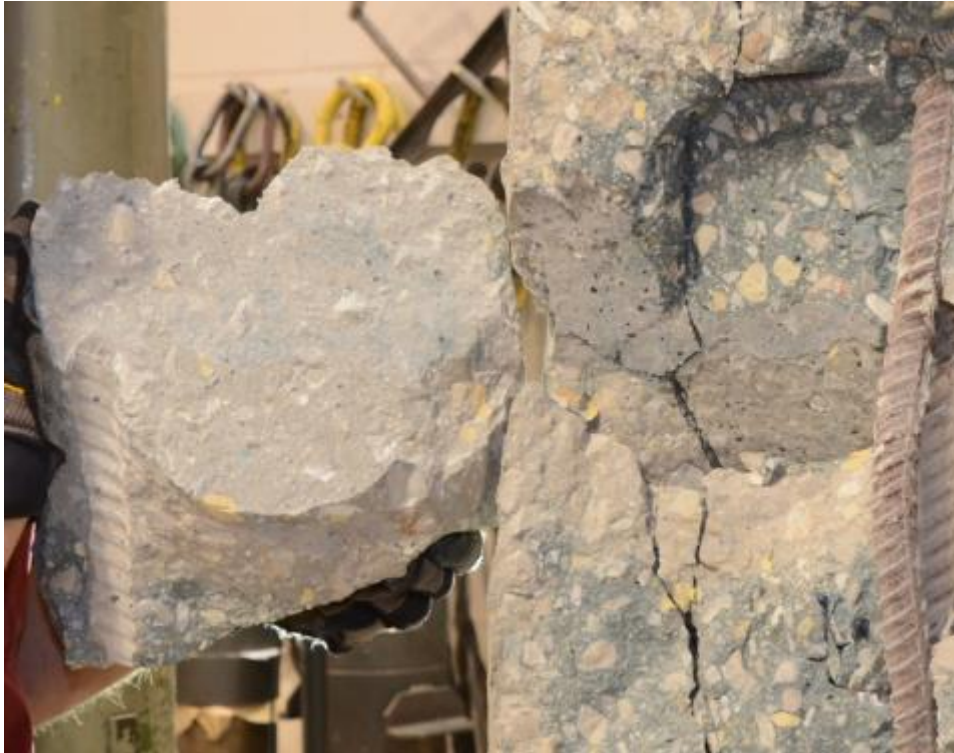
Figure 4.15. Construction joint interface of Specimen 1 (as-placed, cracked) after failure.

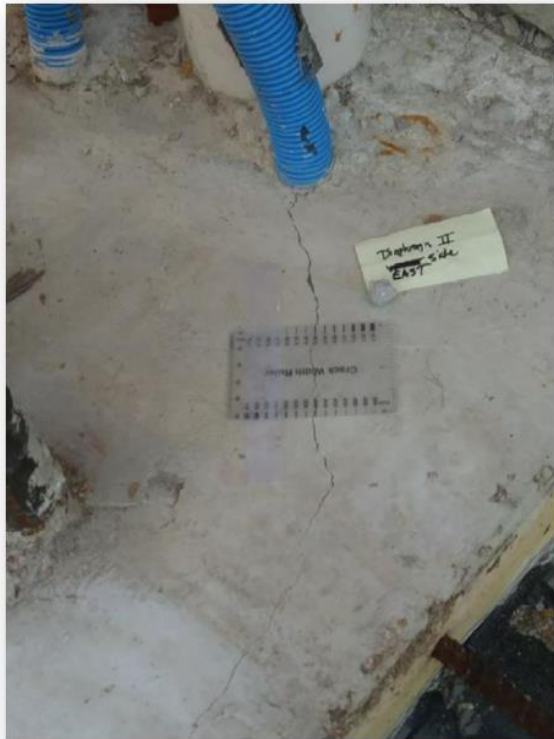
Photo 13 from BPA crack inspection after formwork/scaffolding removal. February 28.

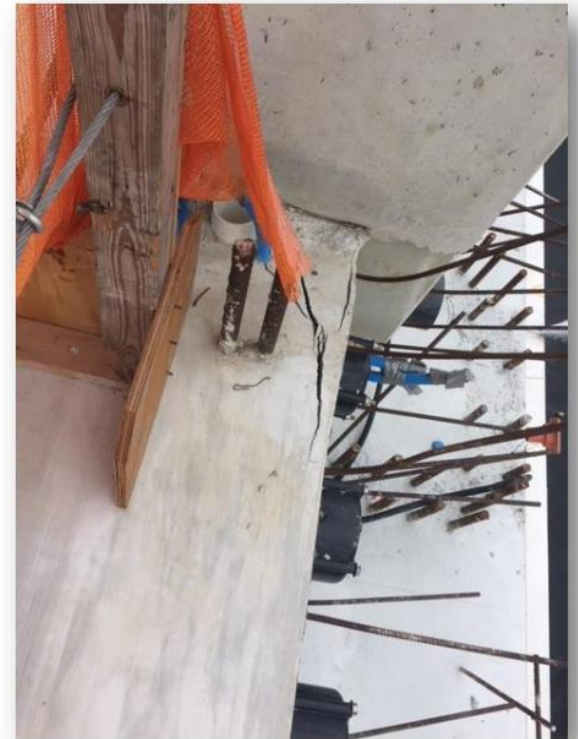
March 10 photo by Corradino showing same crack after move at 3:14 p.m.

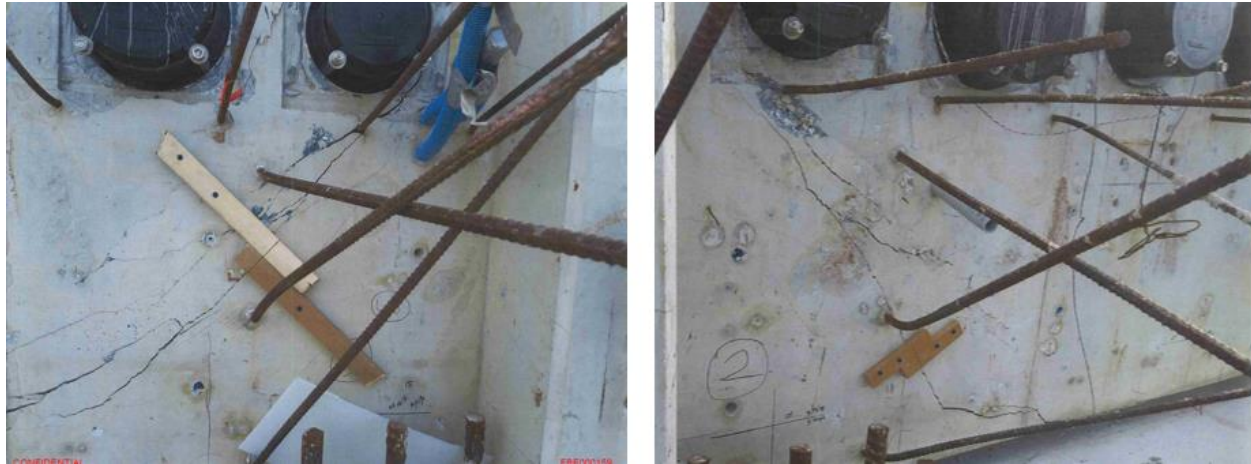
Figure 8.1. Wood blocks mounted across cracks on the north face of the north and diaphragm

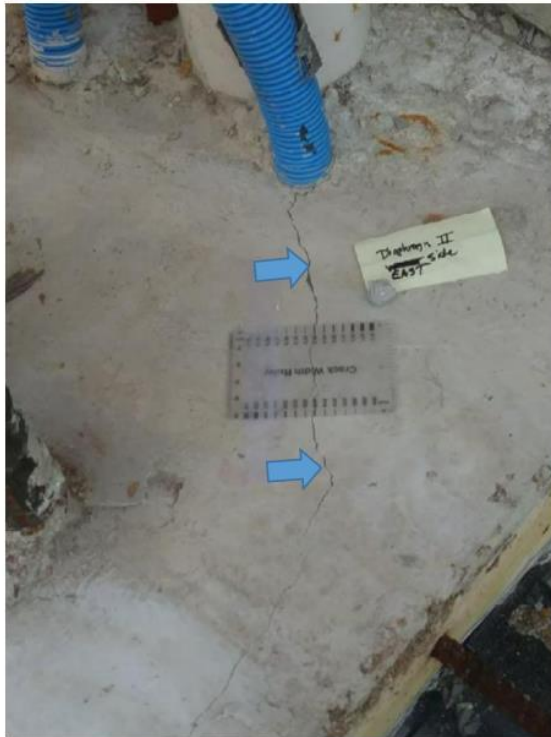
East side of Member 12. Photo 13 from BPA crack inspection after formwork/scaffolding removal, February 28. Crack is indicated by blue arrows. Crack width ruler appears to indicate 0.020 inches.

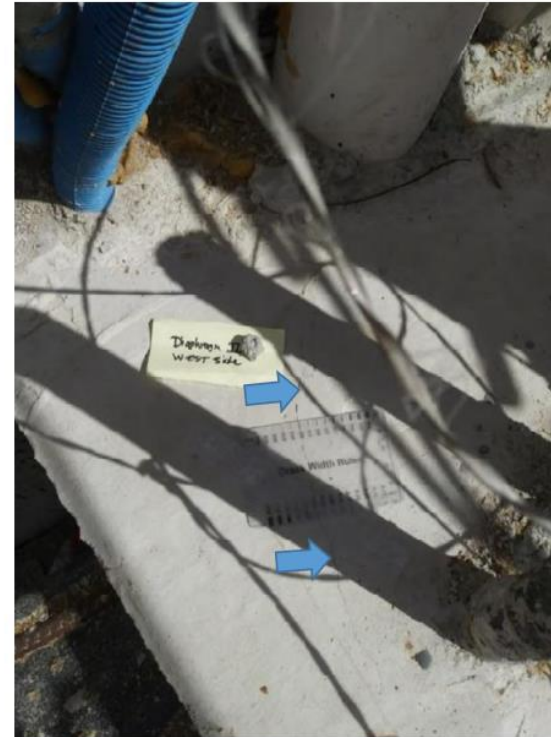
West side of Member 12. Photo 12 from BPA crack inspection report after formwork/scaffolding removal, February 28. Crack is indicated by blue arrows. Crack width ruler appears to indicate 0.014 inches.

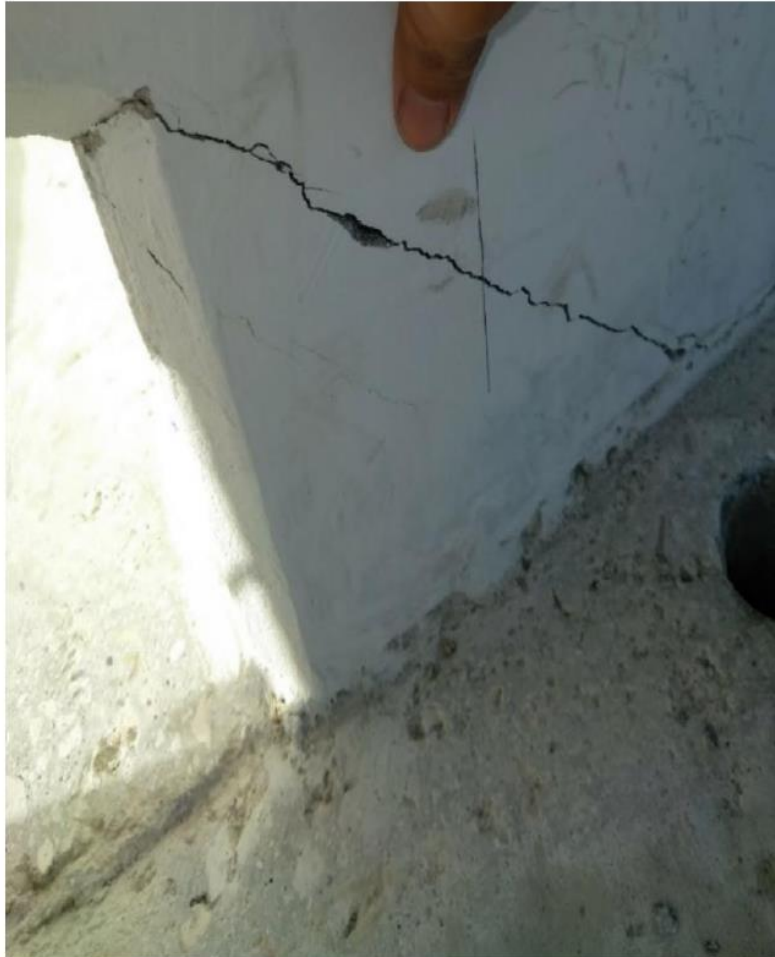
Diagonal “wedge” crack along the bottom of Diagonal 11 on the east face. Photo taken by BPA on February 24, 2018, prior to the move.

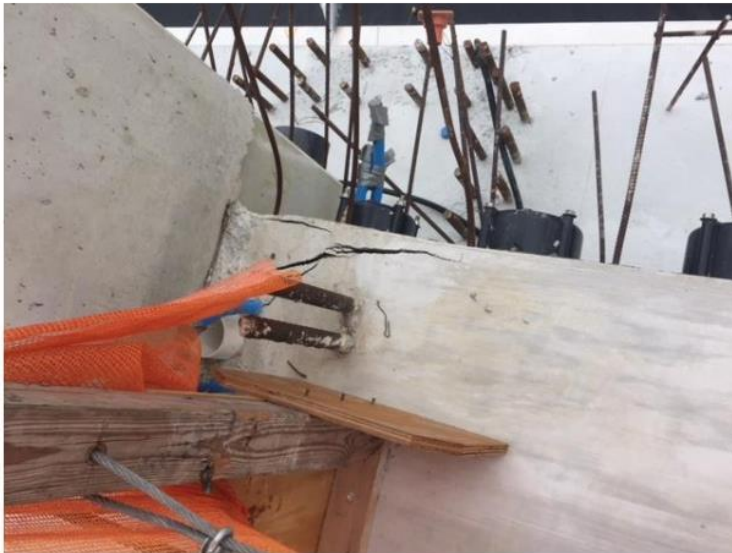
East side of Member 12. March 10 photo by Corradino showing same crack after move at 3:14 p.m.

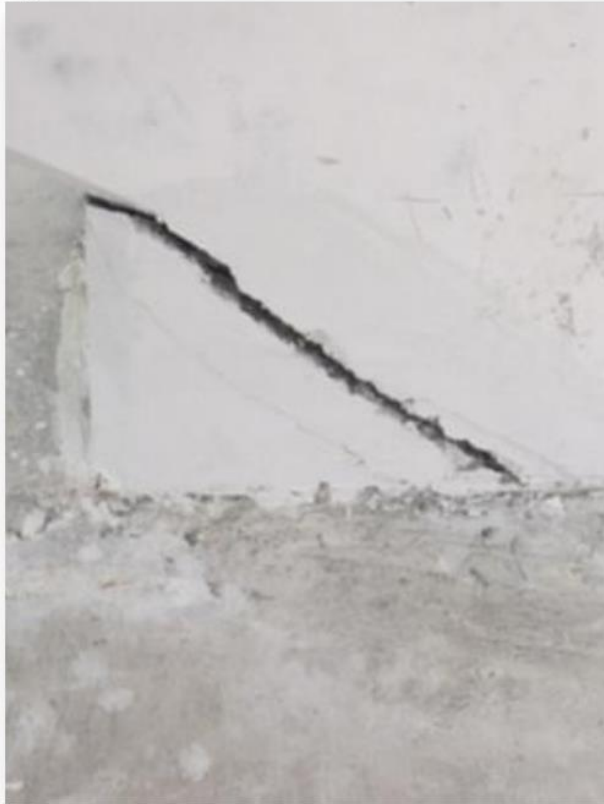
Diagonal “wedge” crack at base of Member 11 after the move on the east face. Photo taken by Corradino on March 10, 2018 at 3:07pm.

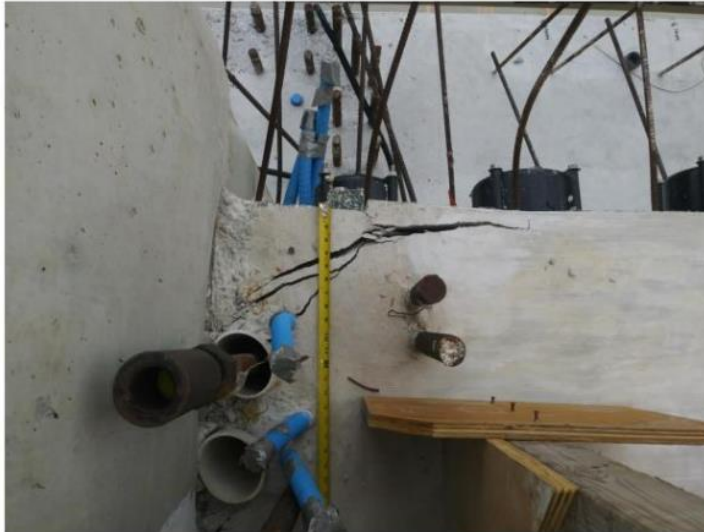
East side of Member 12. Photo taken March 12, 2018 by MCM.

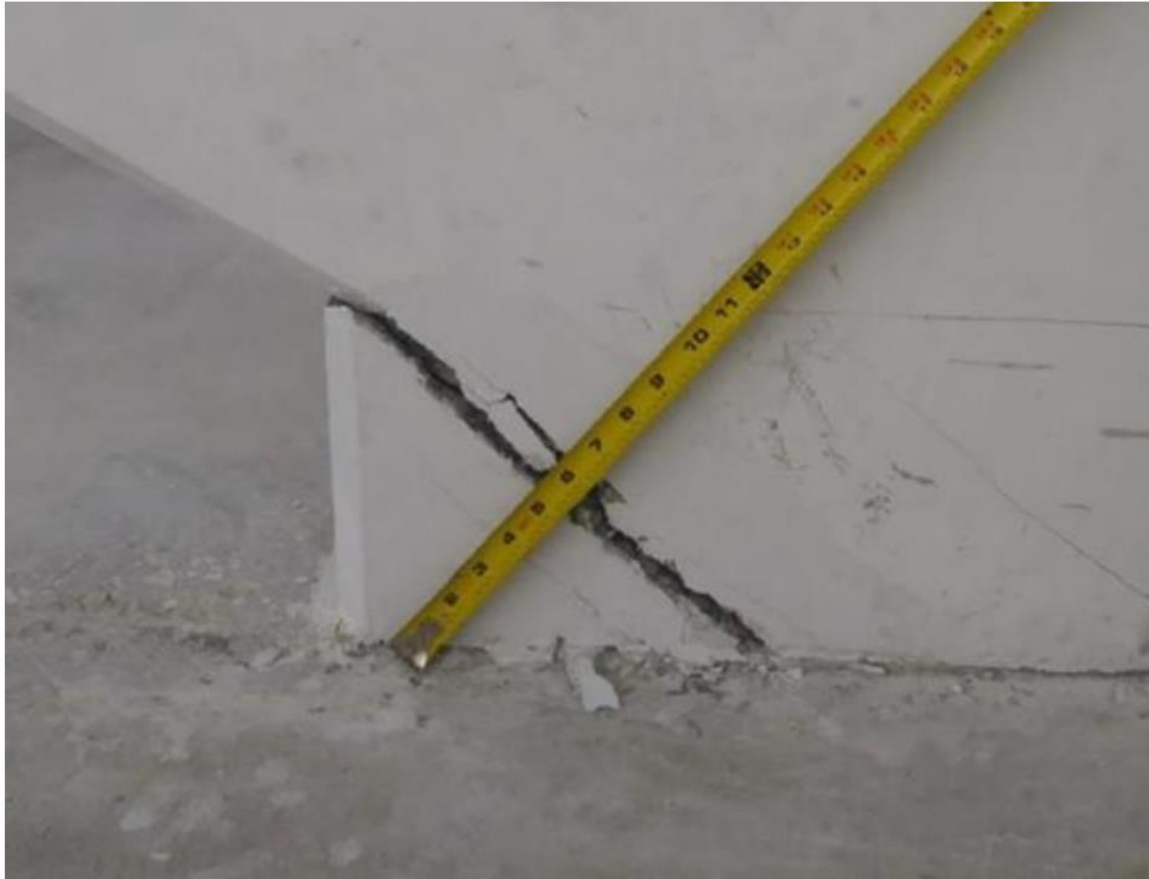
Diagonal “wedge” crack at base of Member 11 on the east face. Photo taken by MCM on March 12, 2018.

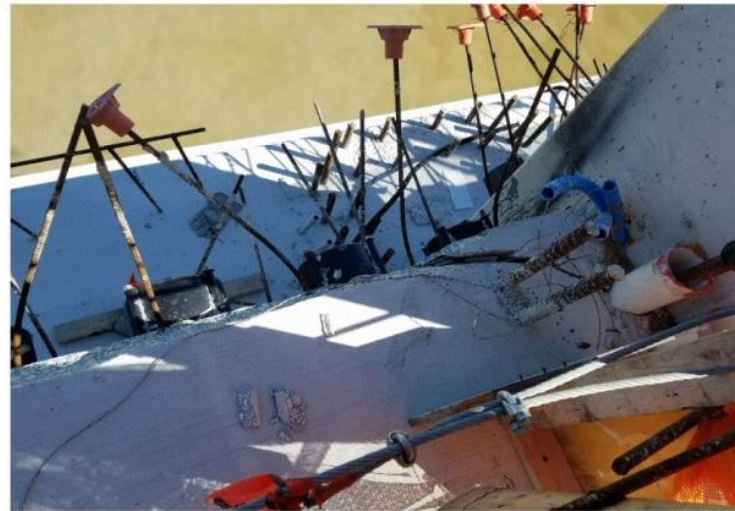
West side of Member 12. Photo taken March 13, 2018 by BPA.

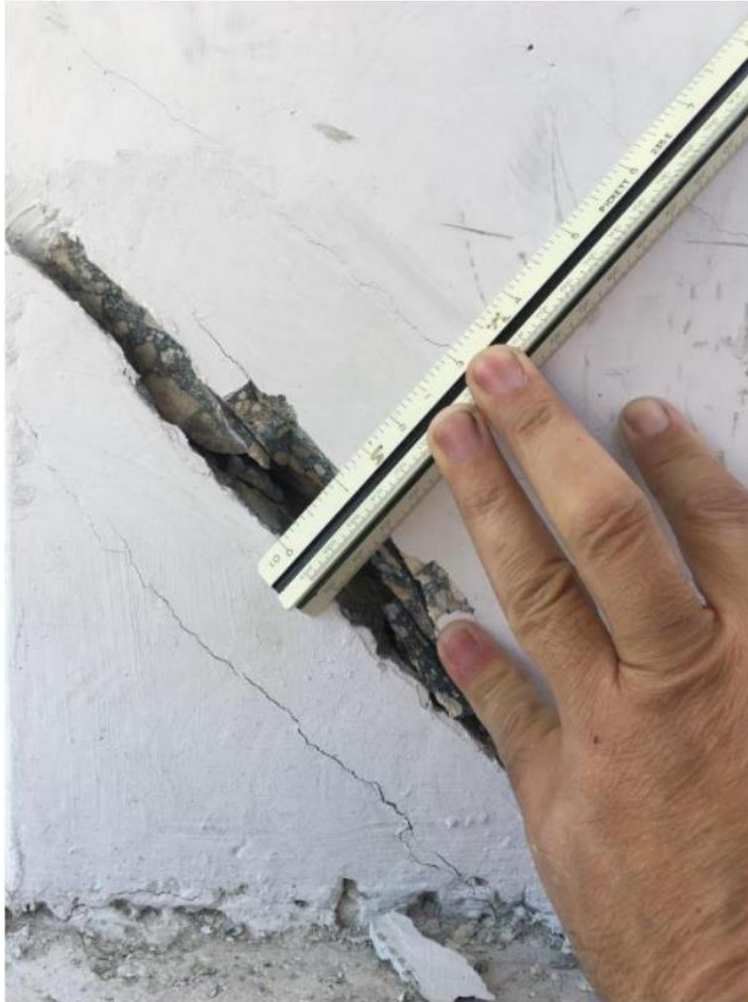
Diagonal “wedge” crack at base of Member 11. Photo taken by BPA on March 13, 2018. Note the spall seen in Exhibit 3.2 has been removed.

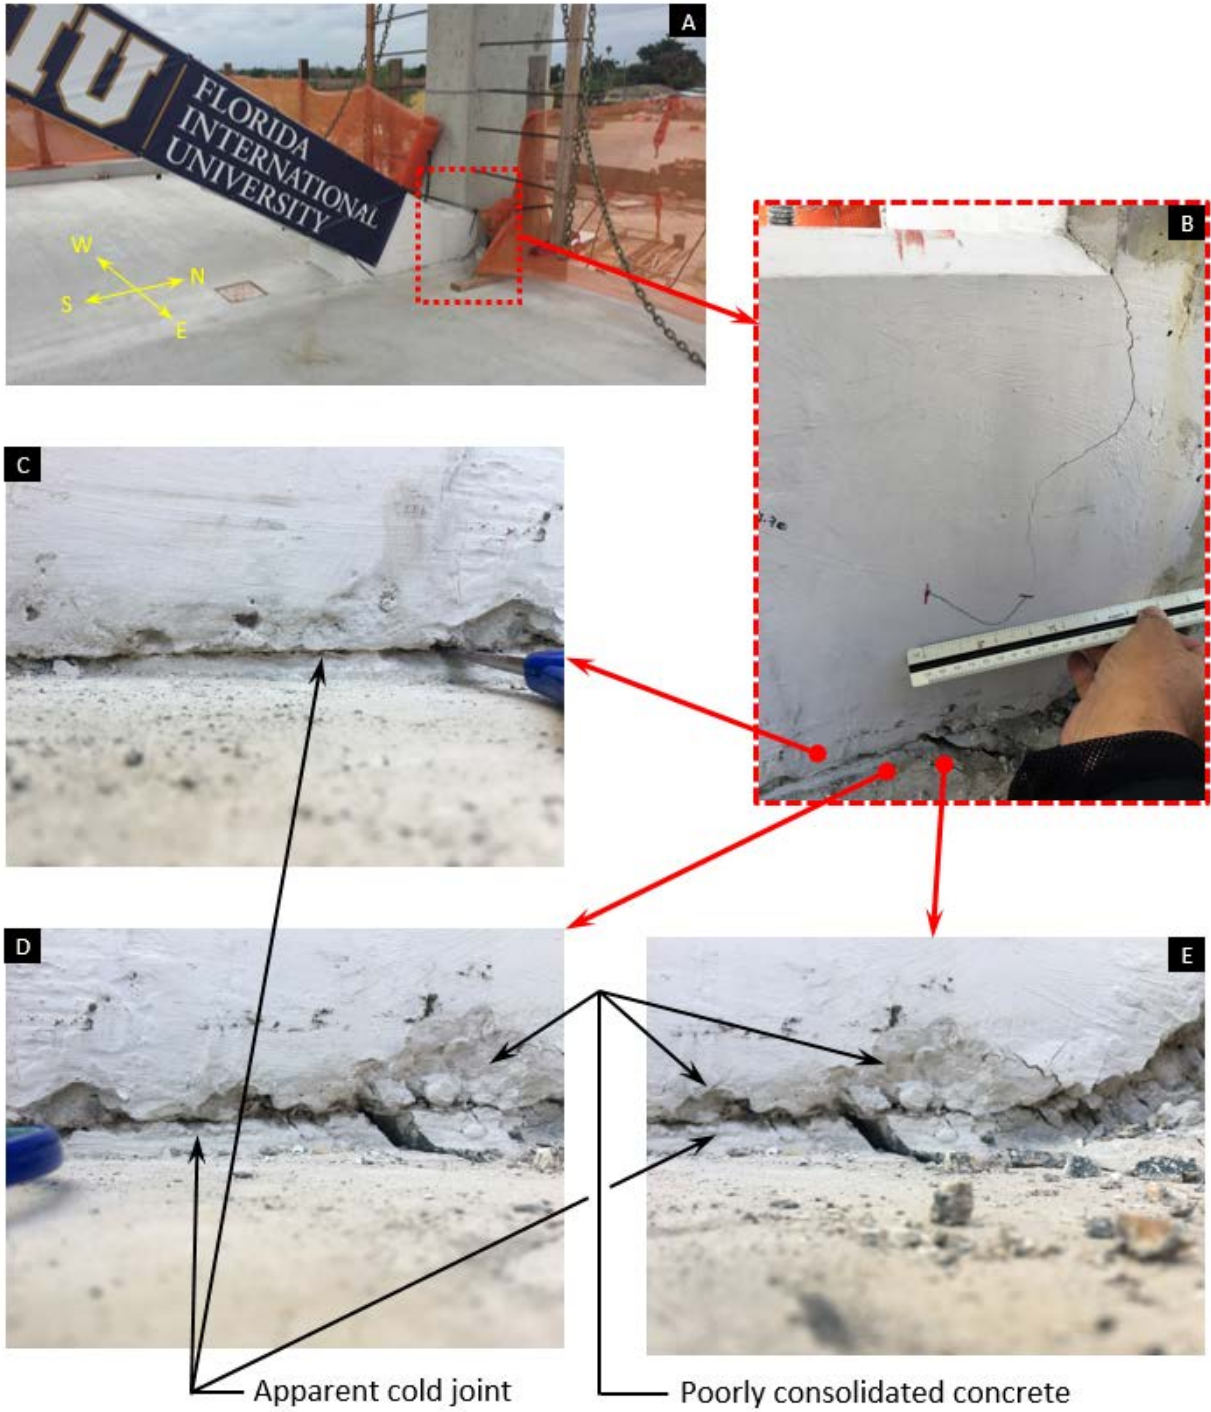
Figure 4. Annotated images demonstrating interface condition on east face of member 11 near member 12.

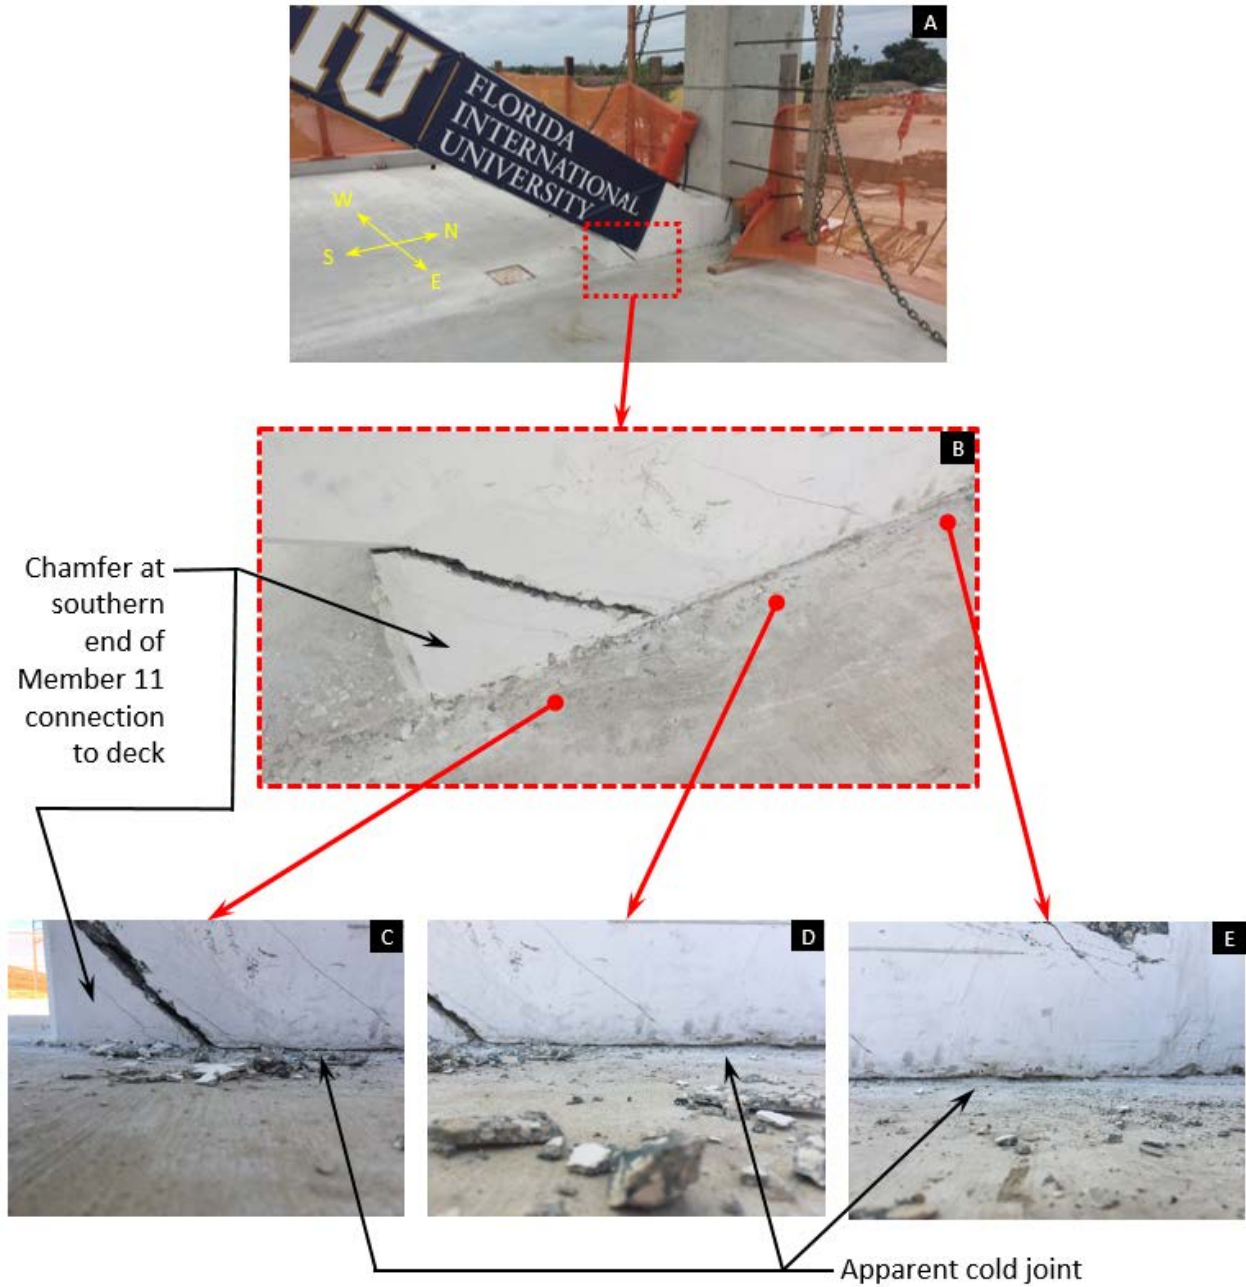
Figure 5. Annotated images demonstrating interface condition near the south end of the east face of Member 11 with the deck.
