PARTY SUBMISSION

TO THE
NATIONAL TRANSPORTATION
SAFETY BOARD

FIU University City Prosperity Pedestrian Bridge
Construction Accident
Miami, Florida | March 15, 2018

Submitted by - Figg Bridge Engineers, Inc.

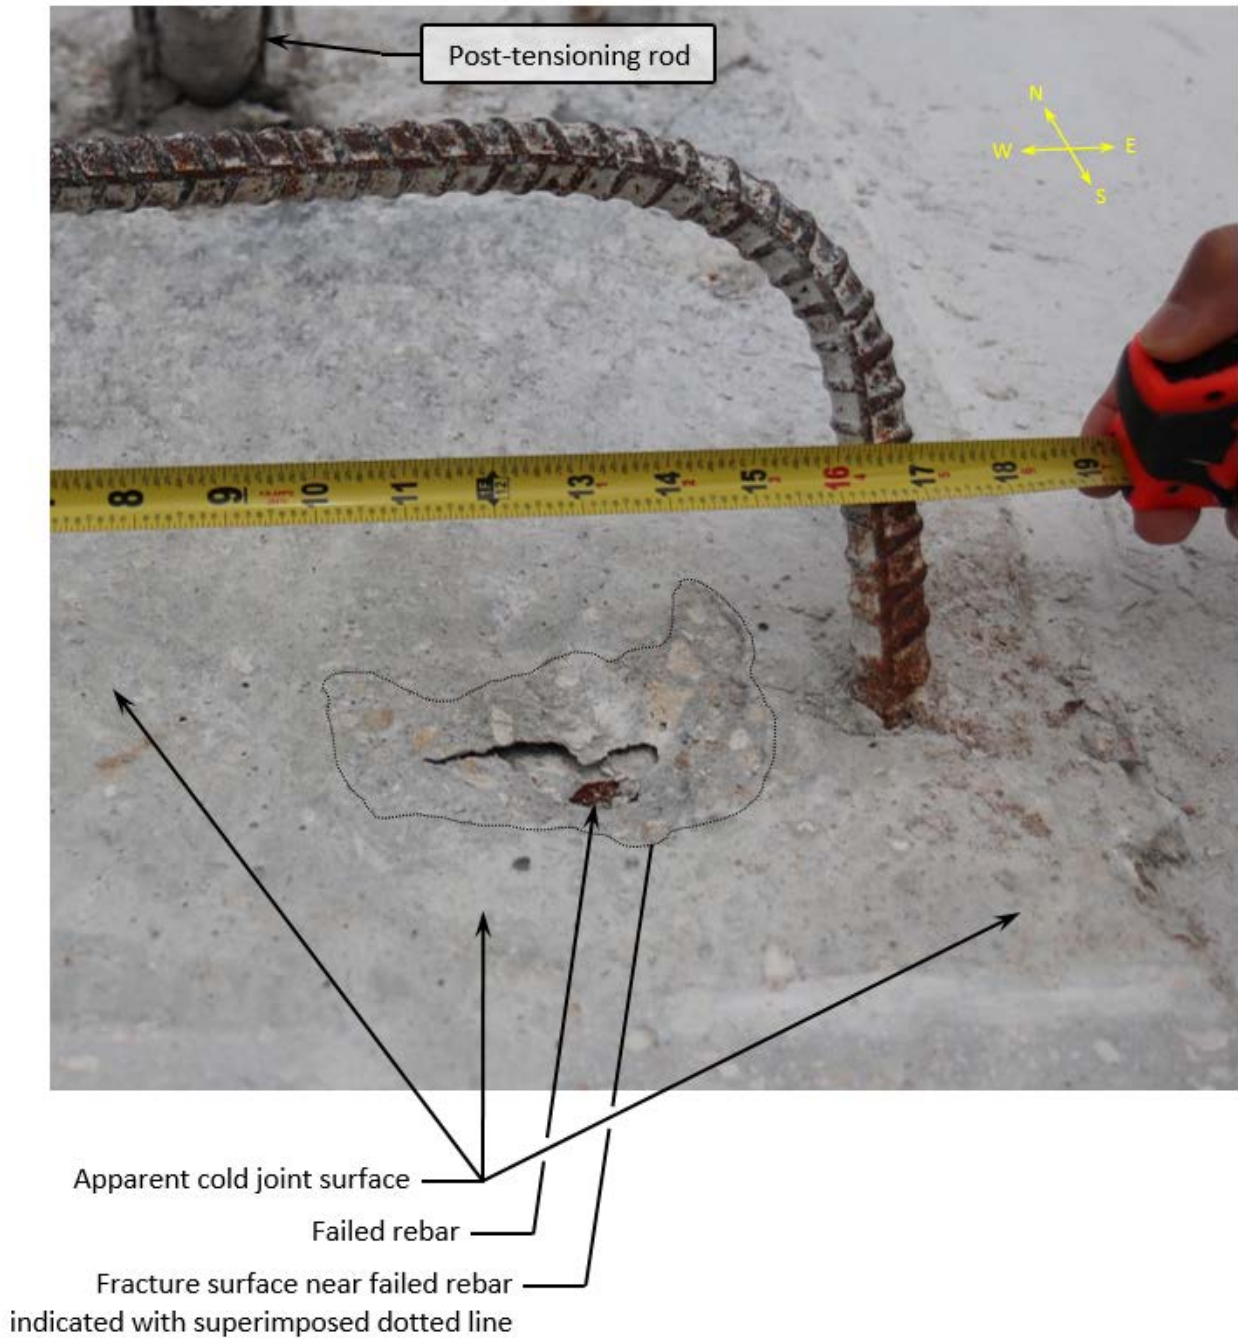
Figure 8. Interface under southeast corner of Member 11 after cleaning.

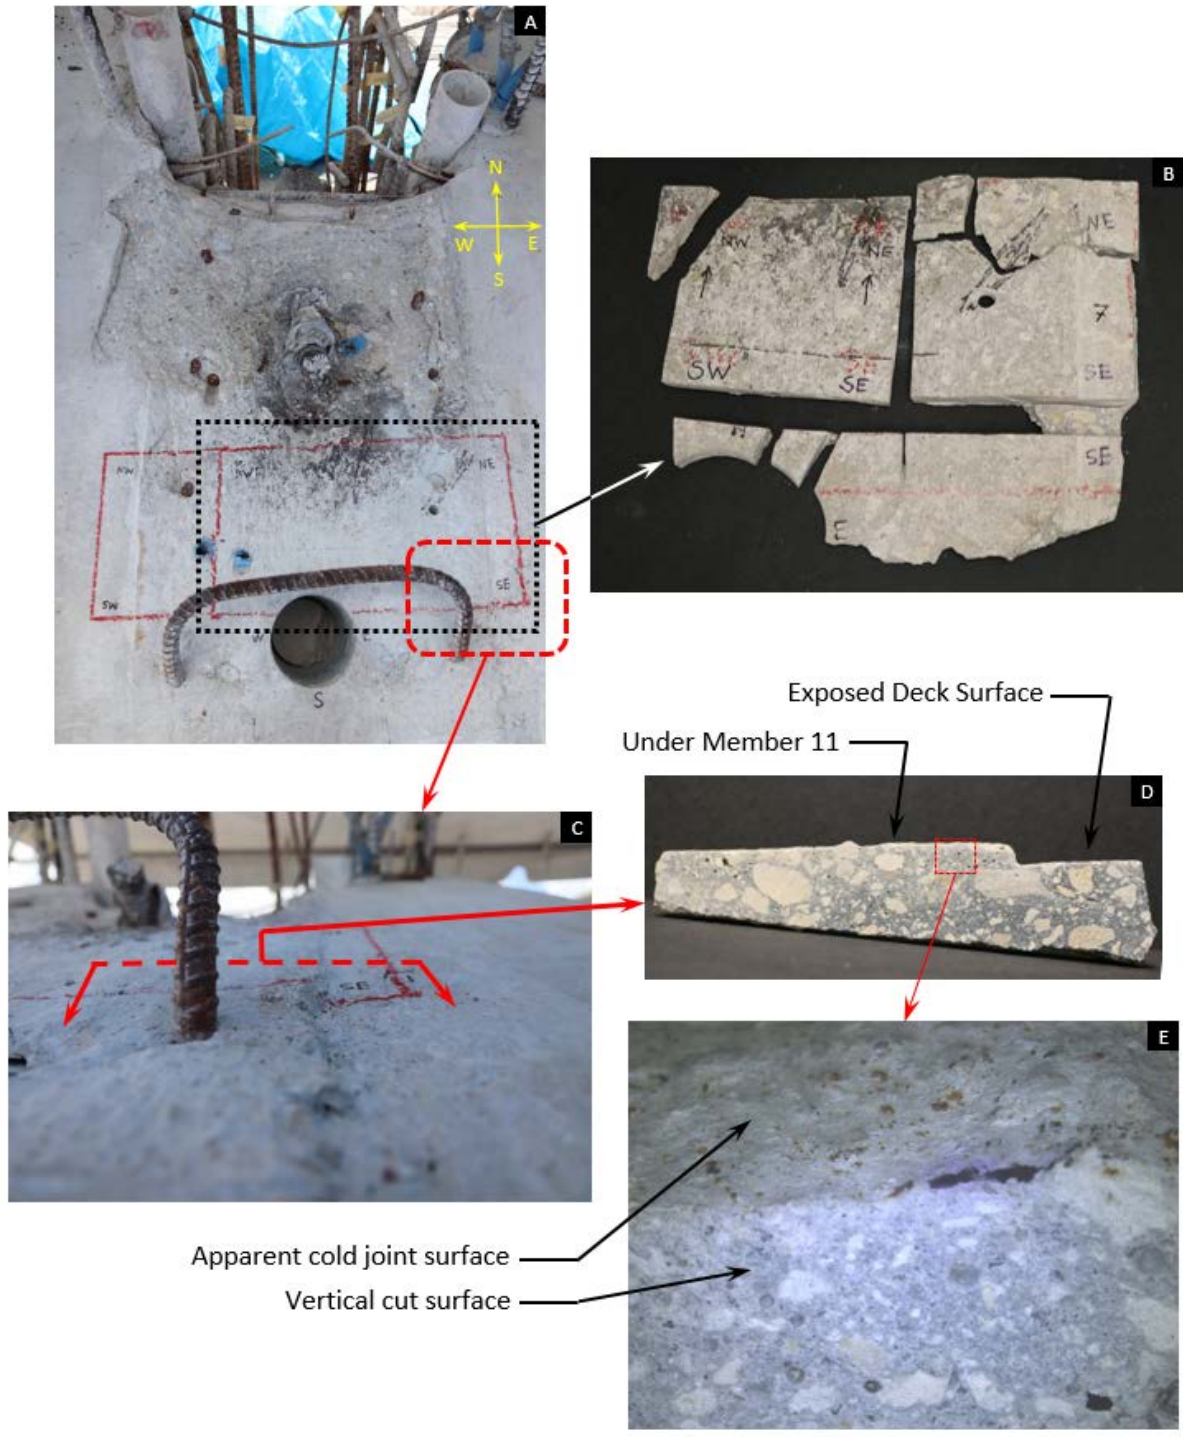
Figure 9. Interface surface under Member 11.

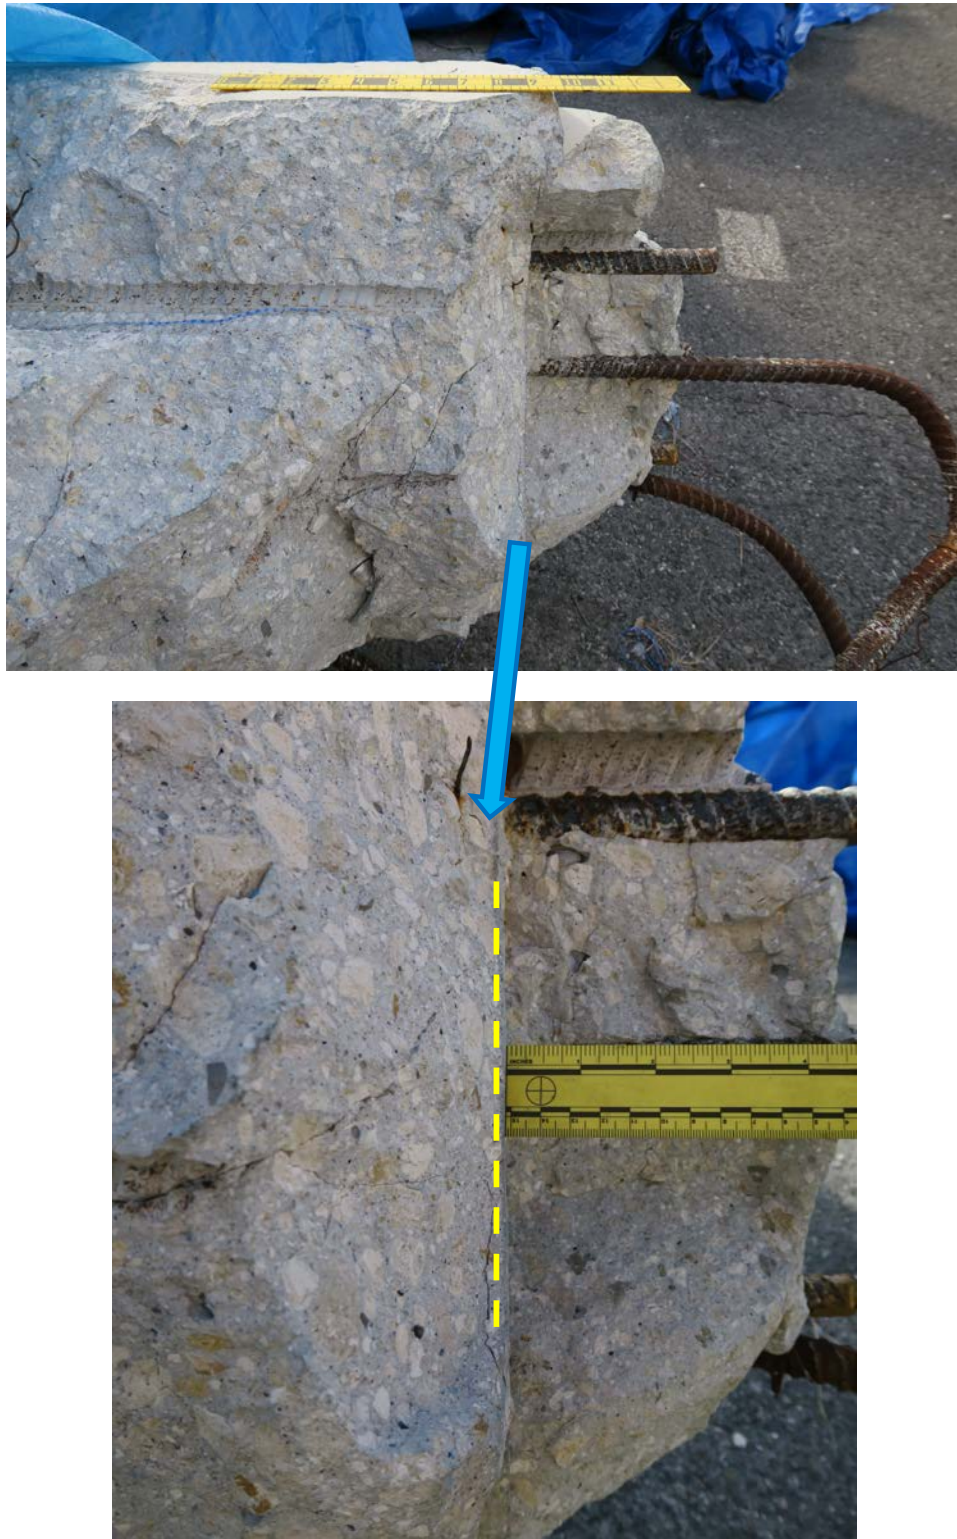
Figure 4: Macro photos of the bottom of Member 12 viewed in profile. The yellow dotted line indicates the straight plane of the flat area observed.

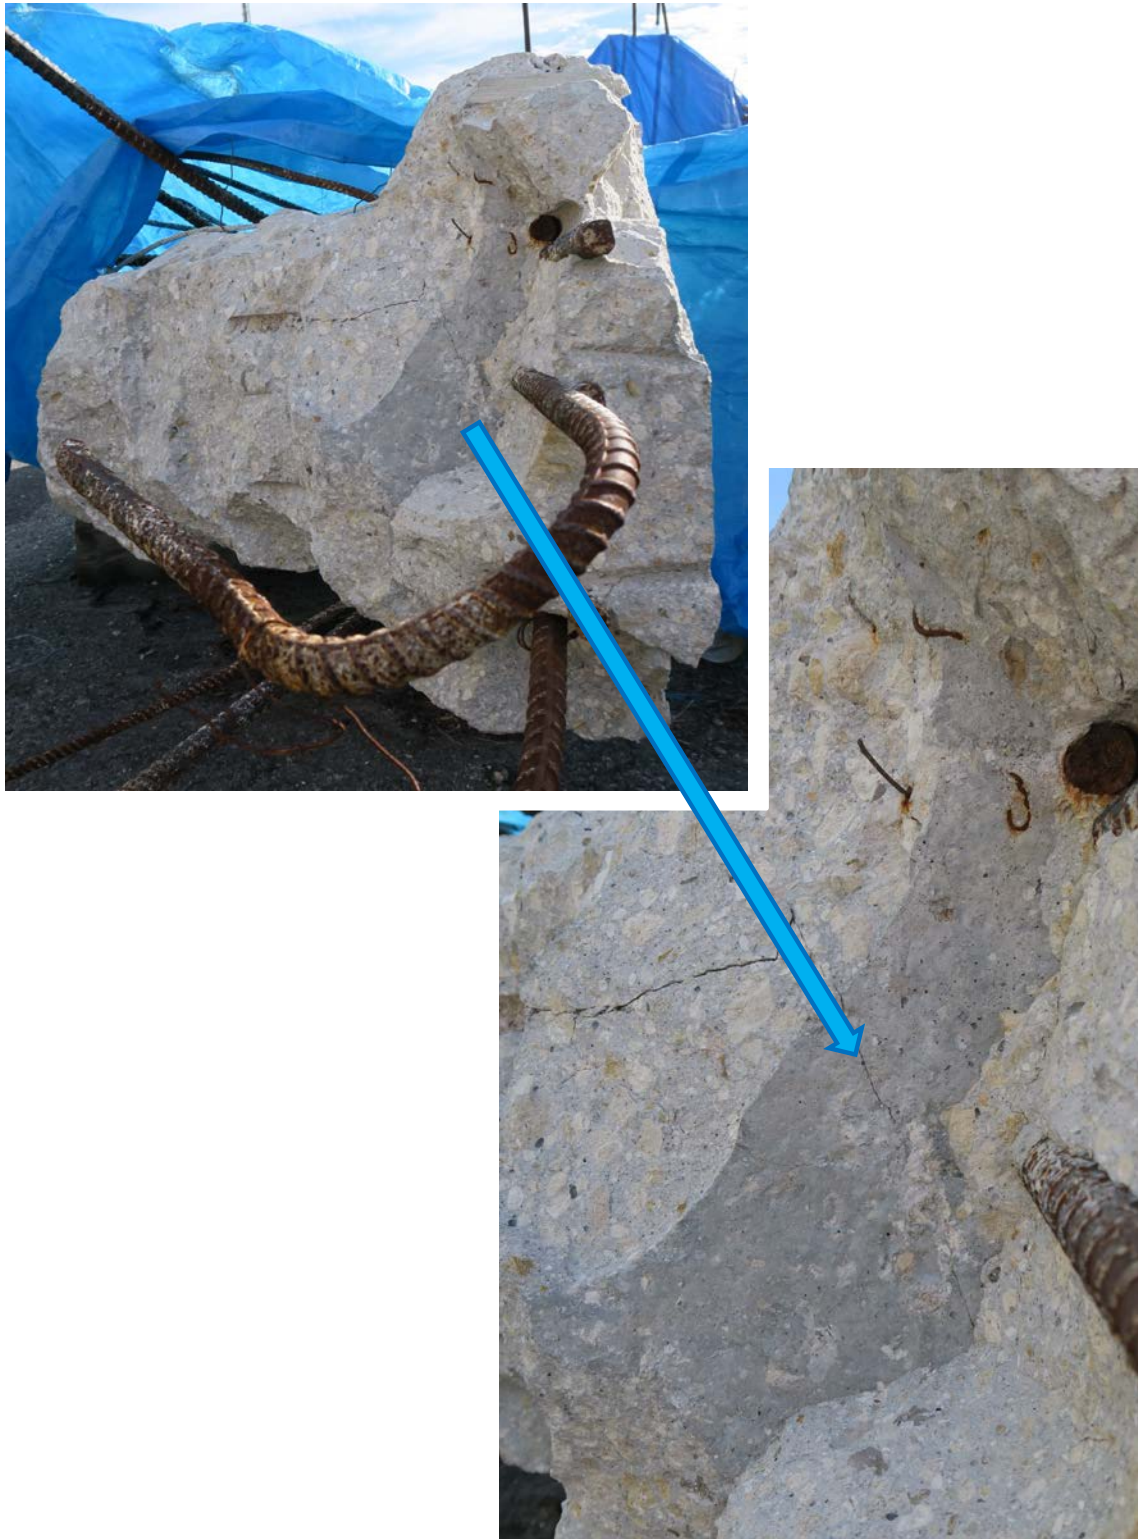
Figure 5: Macro photos of the bottom of Member 12 viewed perpendicular. The flat area observed was irregular in shape.

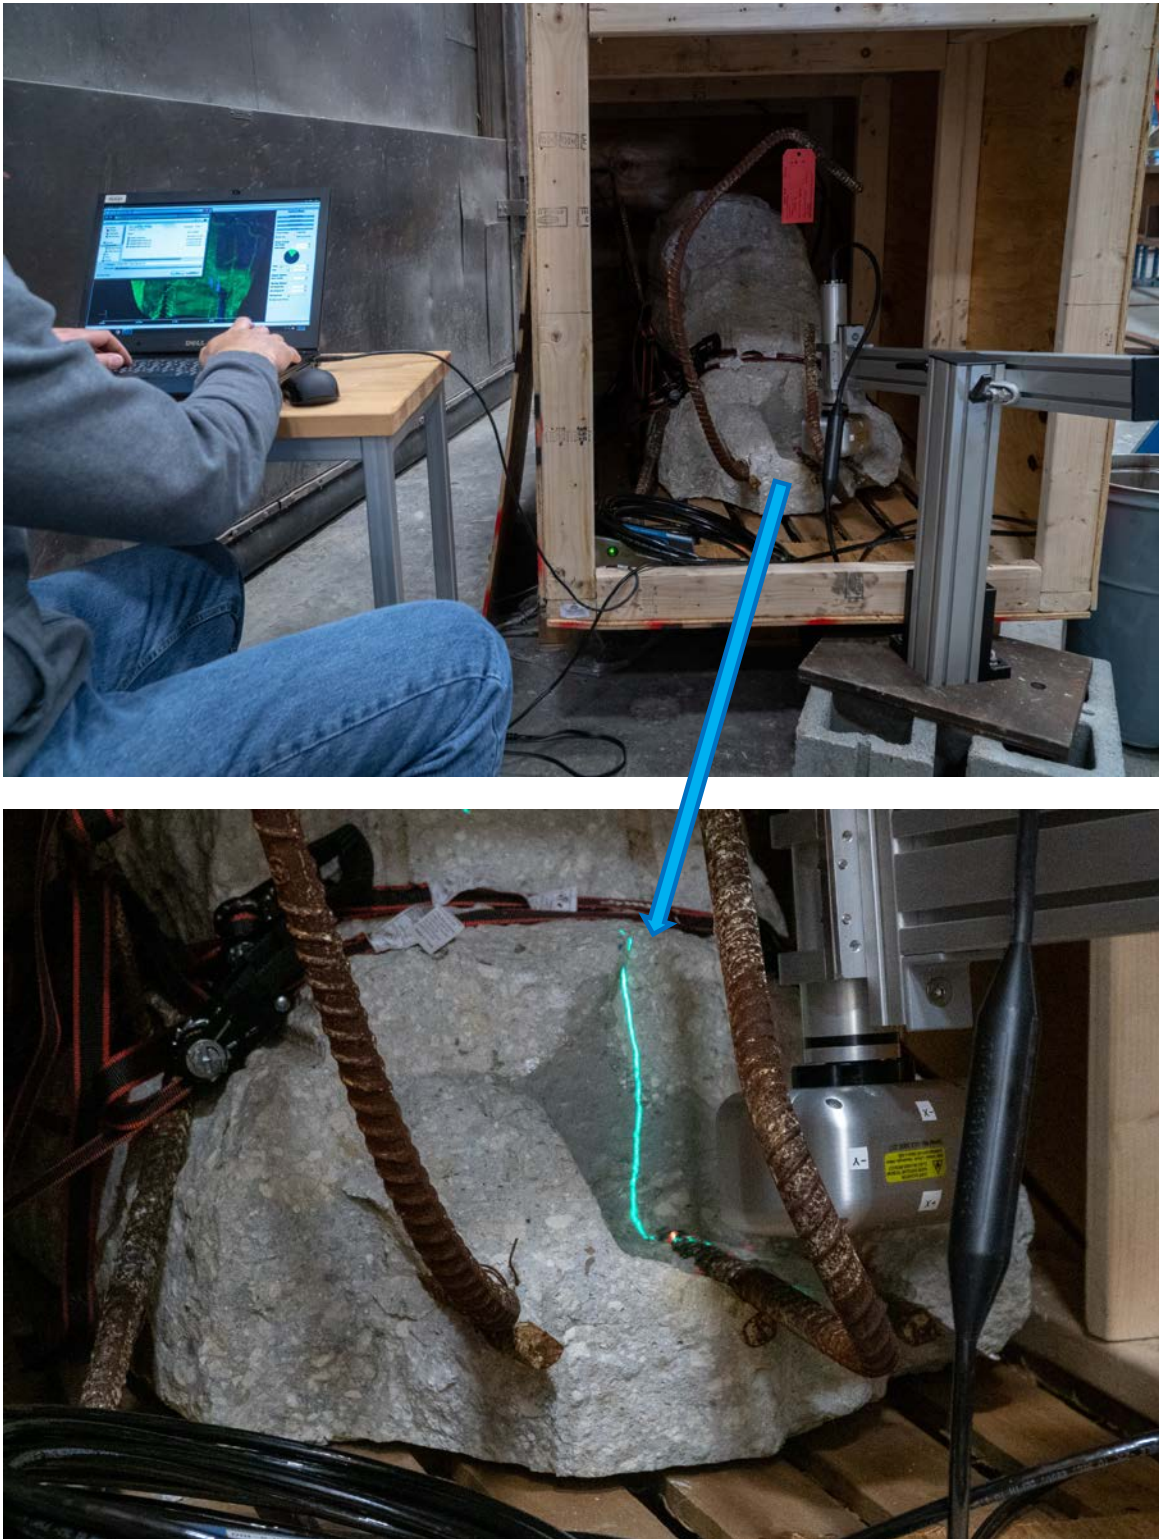
Figure 6: Macro photos of a laser scan of the flat area on the bottom of Member 12. The green line in the bottom image is the laser projected onto the surface.
