NATIONAL TRANSPORTATION SAFETY BOARD

AIRFRAME EXAMINATION

WPR21LA082

Location: Warm Springs, Oregon
Date: January 9, 2021
Aircraft: Cessna 560, N3RB
NTSB IIC: Elliott Simpson

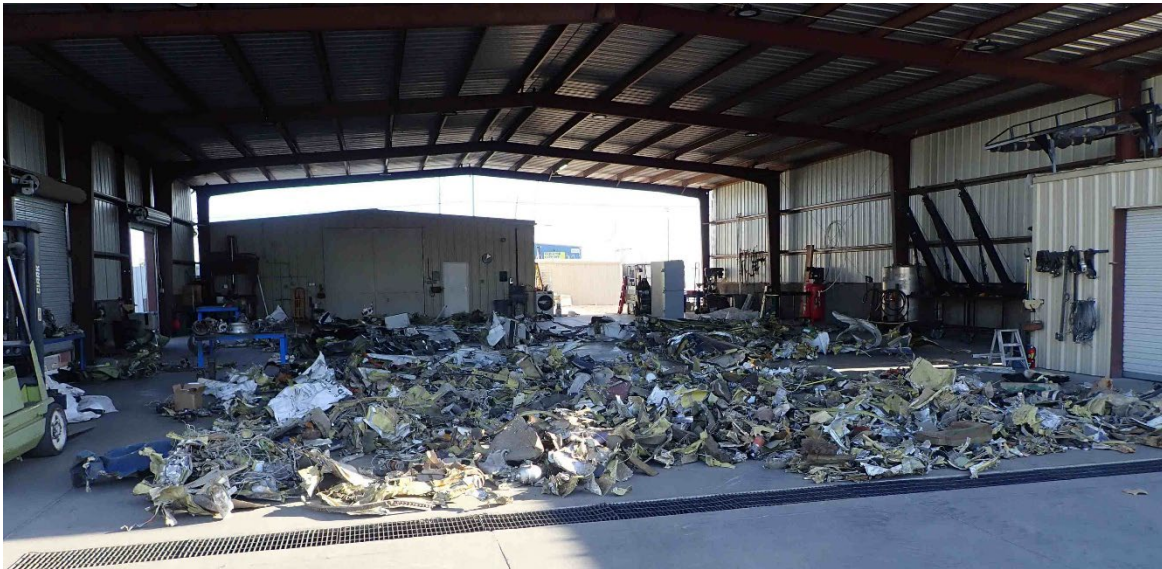
The airplane sustained significant impact damage, and was heavily fragmented (Photo 1). Immediately recognizable within the debris was the primary left wing spar (Photo 2) and associated skins, two 6-ft-long sections of the aft fuselage and empennage (Photo 3,4) and a section of the front left cockpit wall (Photo 5). All “four corners” and sections of primary flight controls were located. Fragmentation of the right wing and the long debris field was consistent with a high speed, right wing down collision with the ground. There was no evidence of bird strike.

Photo 1 - Wreckage

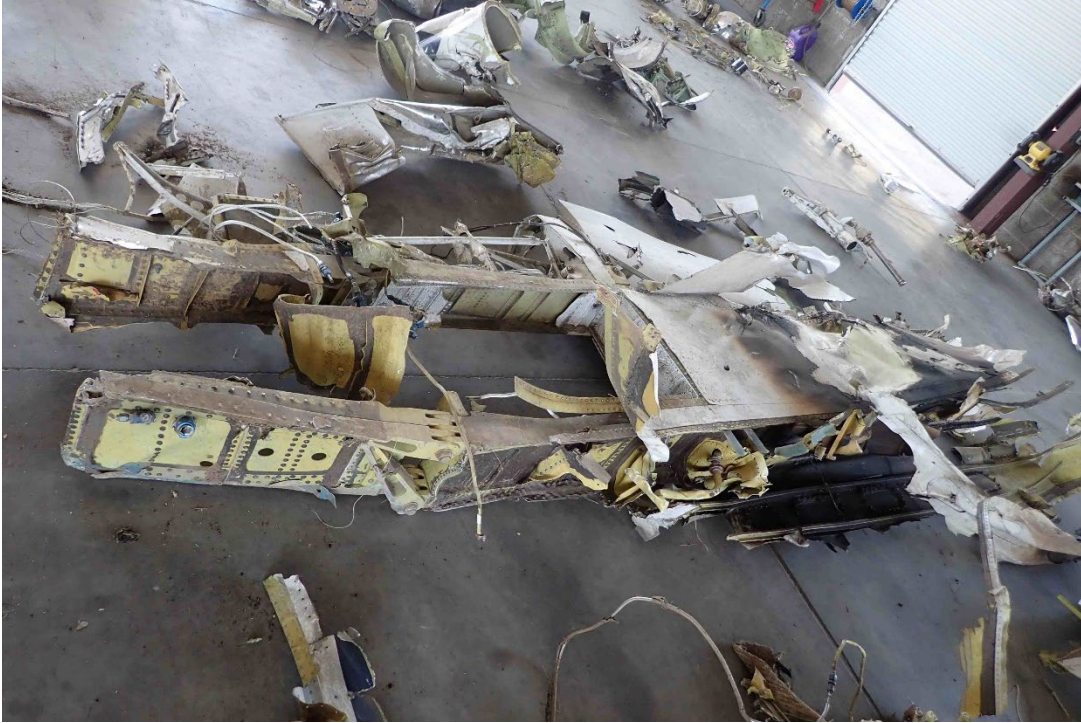
Photo 2 – Left Wing Spar

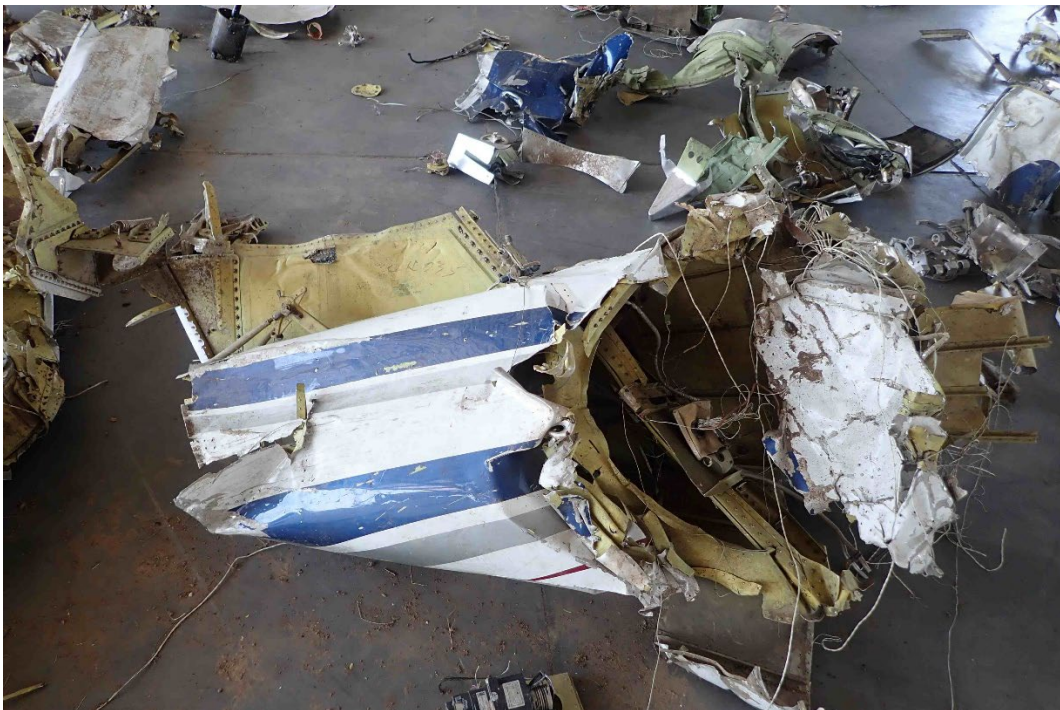
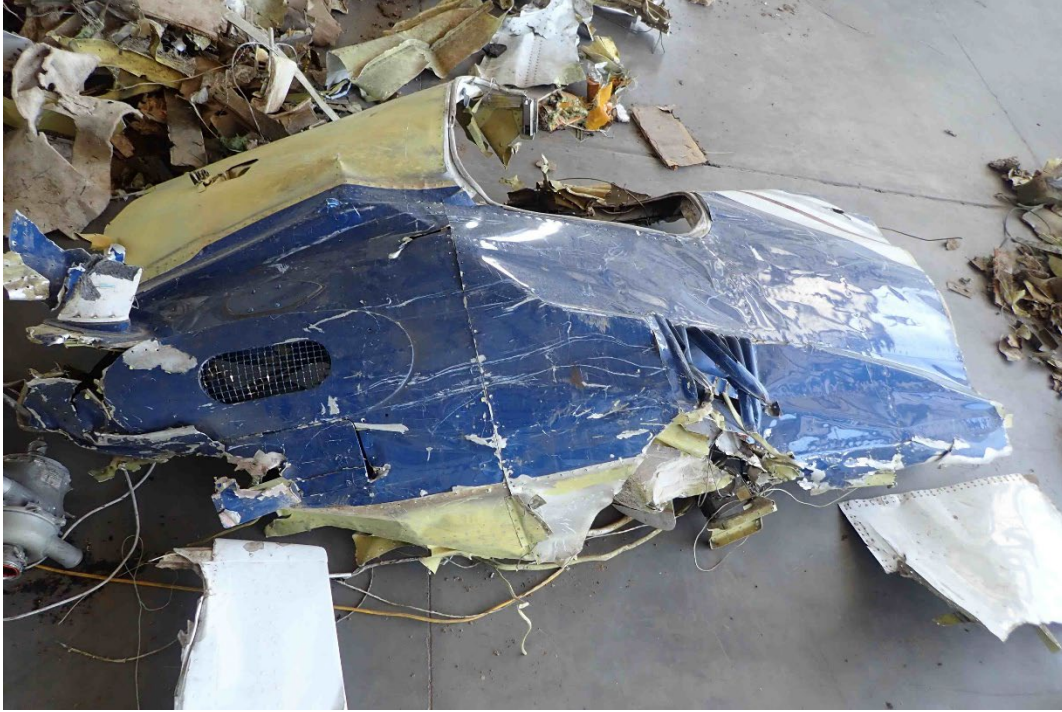
Photo 3 – Aft fuselage

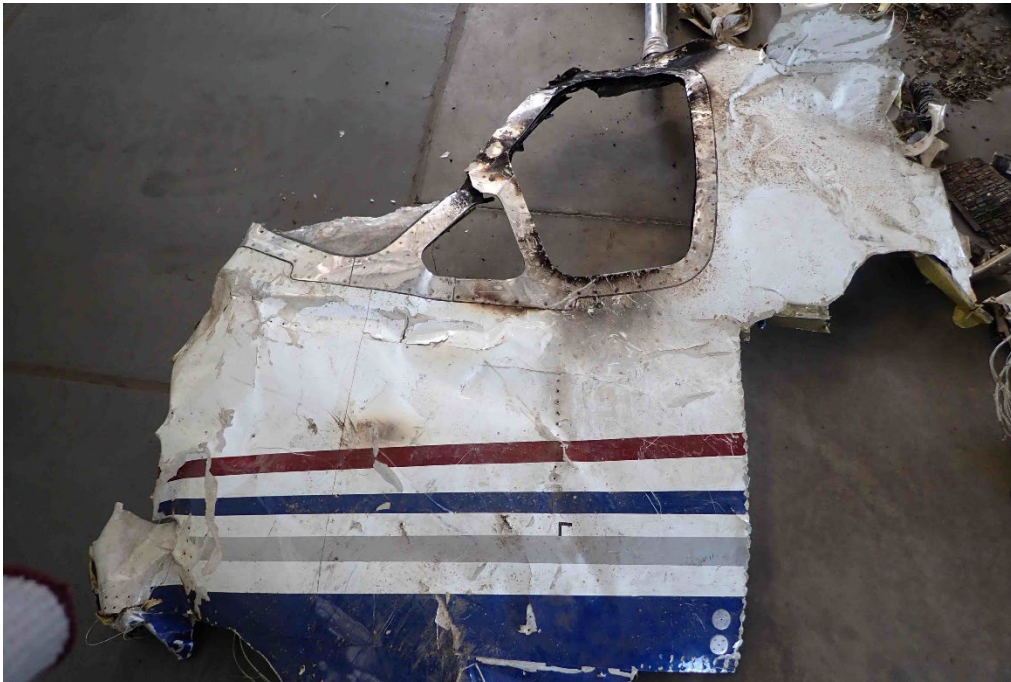
The entire electrical system sustained extensive fragmentation to all electrical instruments (Photo 8). The wire looms were tangled within airframe components. A section of the wire loom adjacent to the front left cockpit circuit breaker panel sustained thermal damage (Photo 9). Examination of the wires did not reveal any indication globular metal or other features consistent with electrical arcing, and the back side of the circuit breaker panel sustained minimal thermal damage (Photo 10). The inner surface of the left cockpit panel sustained thermal damage in the area of the circuit breaker panel and left window (Photo 11). On the outside of the panel, there was smoke damage, but no evidence of smoke trails in the direction of flight airflow, or any other similar indication of in-flight fire (Photo 5).

Photo 5 – Front left cockpit wall

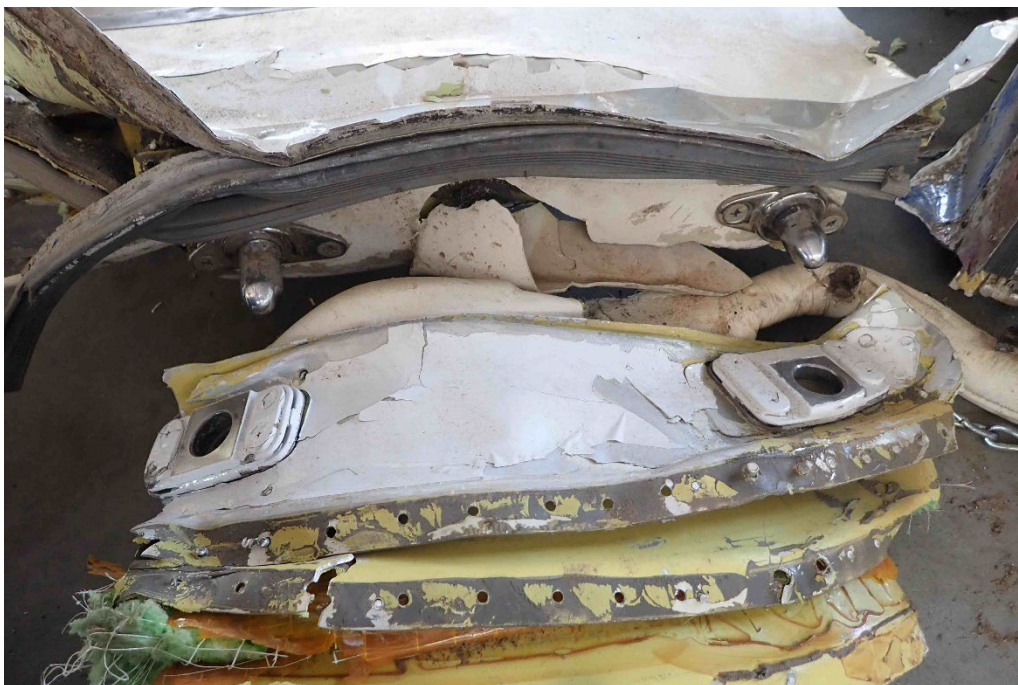
The left main cabin entrance door was fragmented into multiple pieces. Associated sections of the door frame were located and similarly fragmented. The door window was intact. The circular lock pins on the left side of the door were in the extended position, and there was no damage to their corresponding lock holes on the cabin frame (Photo 6). The lower left circular pin sustained damage its associated frame hardware and was noted within the door frame (Photo 7). Two of the four square lock pins (one from the top, one from the bottom) around the door were located and appeared extended and their cabin corresponding lock holes were undamaged.

Photo 6 – Left side door lock pins and holes

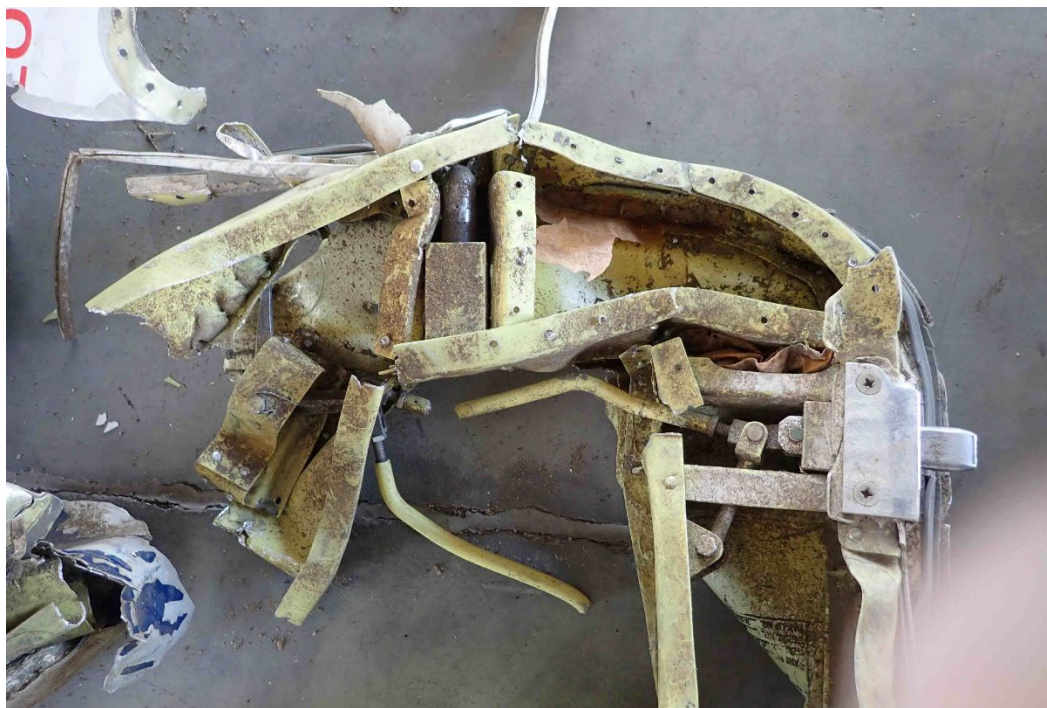
Photo 7 – Square lock pins

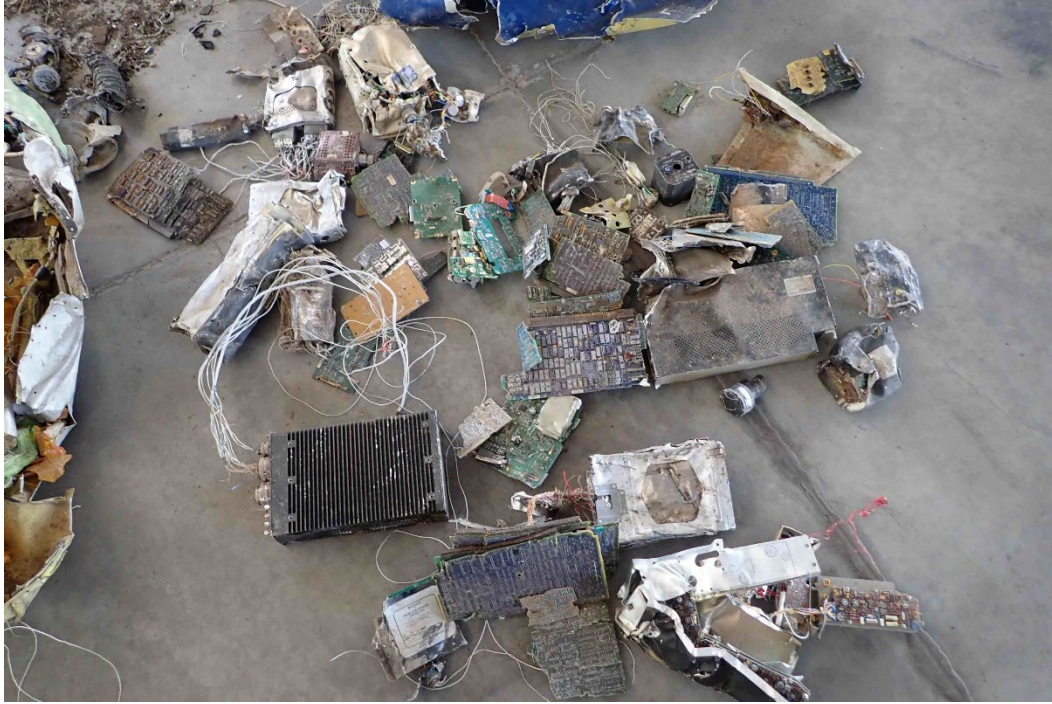
Photo 8 – Assorted electrical and avionics components

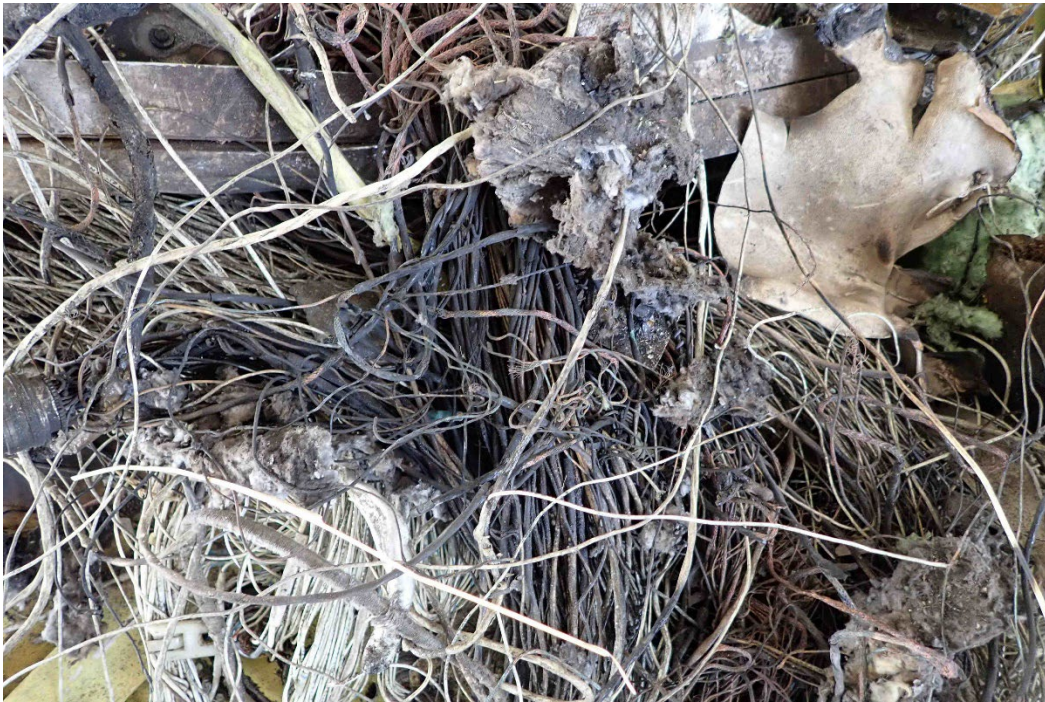
Photo 9 – Thermal damage to electrical loom

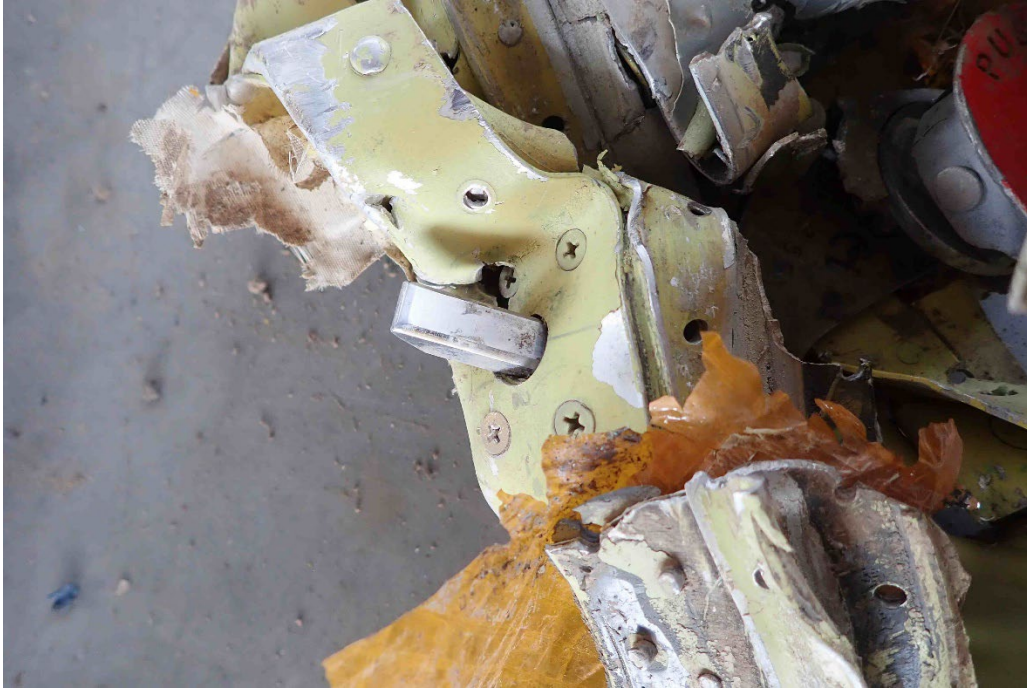
Fragments of the emergency egress door and frame were located (Photo 13). The release handle was in place, and the locking pin was in the extended position. (Photo 12)

Photo 12 – Emergency door lock pin

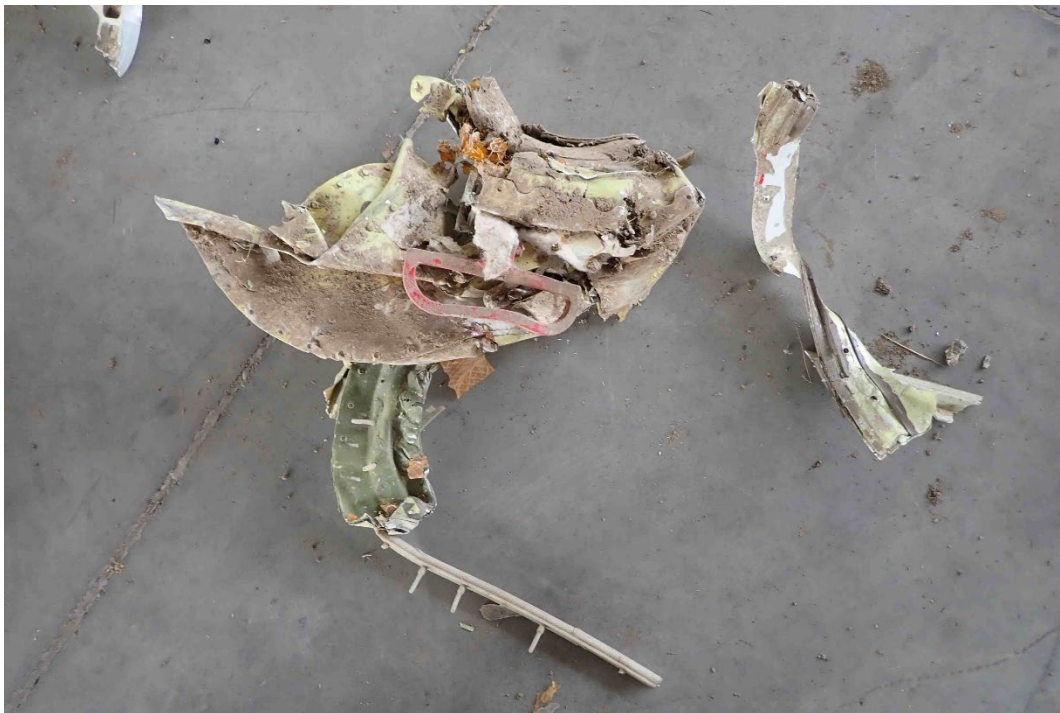
Photo 13 – Emergency door frame

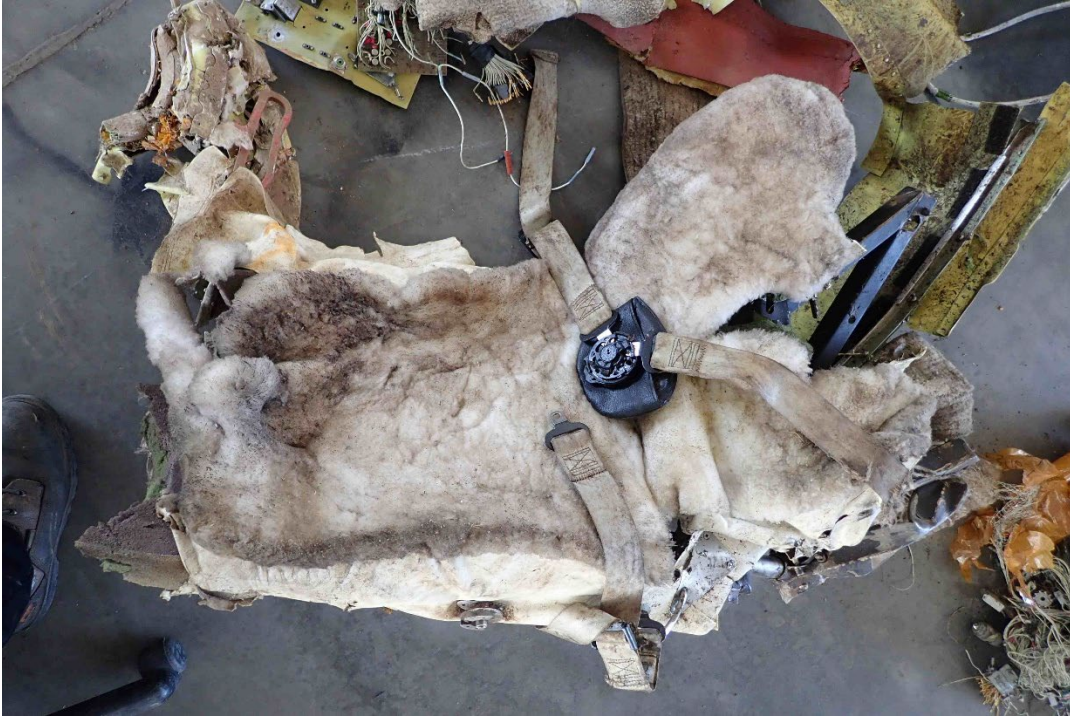
The pilot (left) seat had separated from the airframe. The left and right lower belts remained attached to the seat (Photo 14). The center belt appeared cut about 16 inches from the tongue. The belt locking mechanism sustained damage, and only the left lower and center belt buckles remained attached.

Photo 14 – Pilots seat

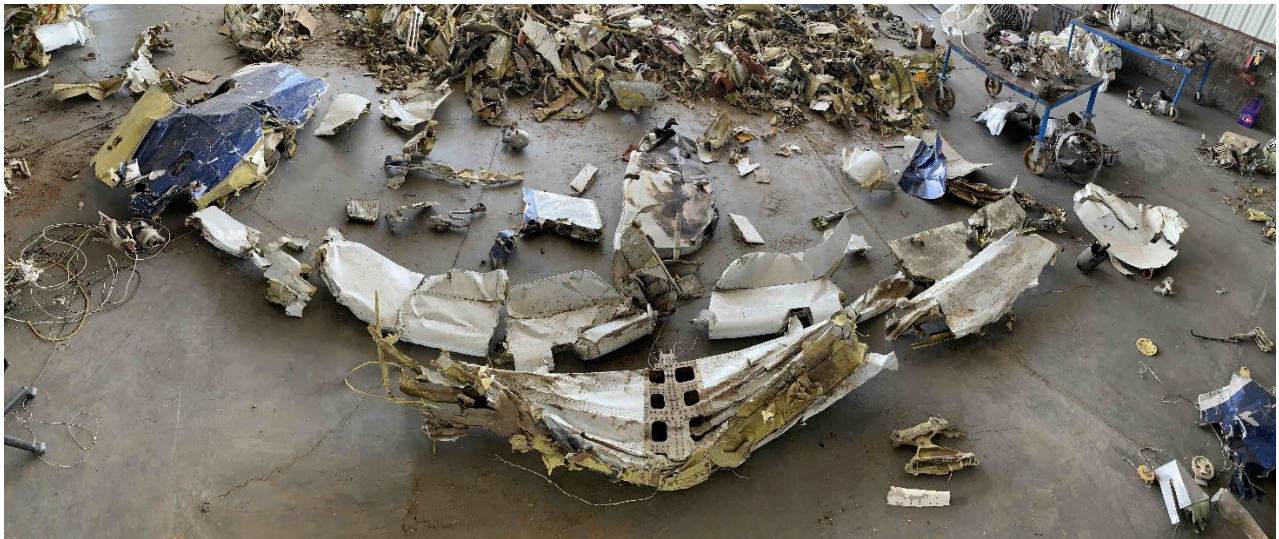
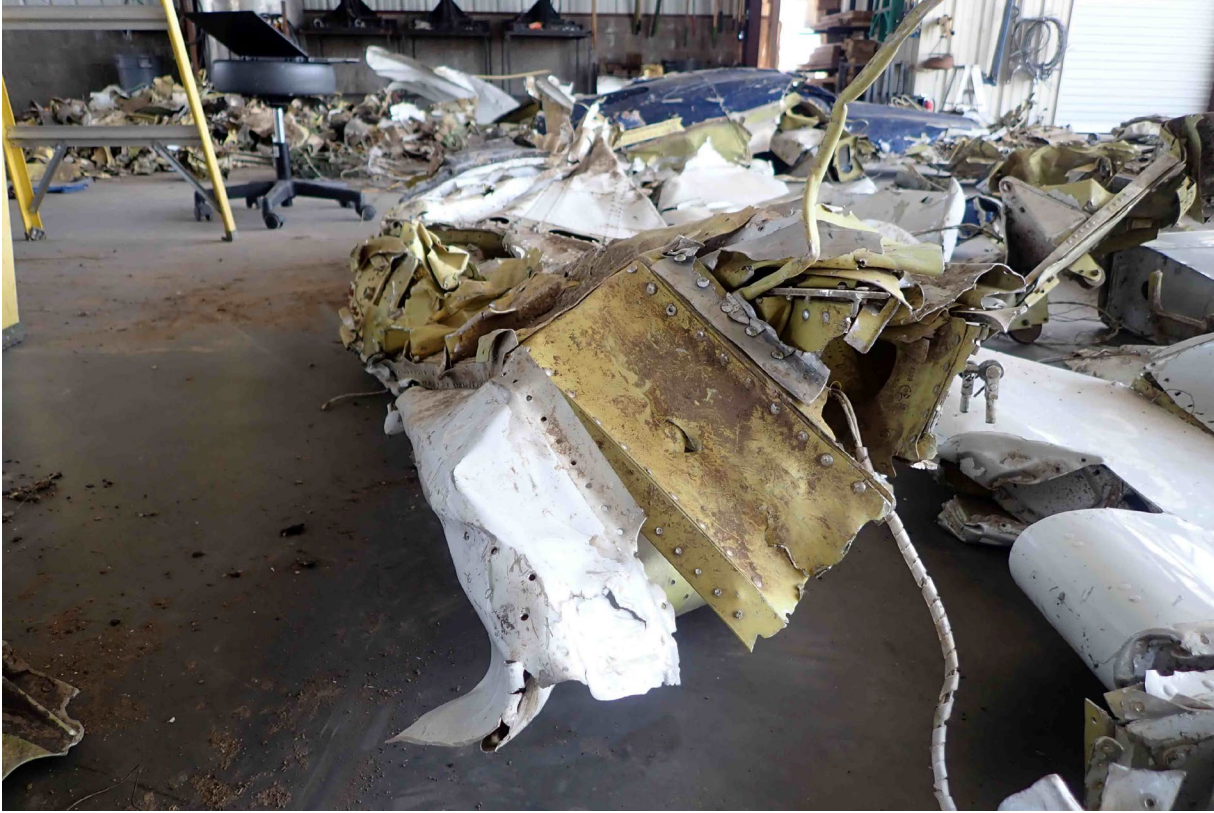
The entire vertical and horizontal stabilizer assembly had detached from the aft fuselage and had fragmented into multiple pieces. The center section of the horizontal stabilizer exhibited leading edge crush damage and aft bending at its tips (Photo 15). The crush damage was about 45 ° in the vertical plane (Photo 16). Most of the fragmented remains of both elevators were recovered, along with one elevator balance weight.

Photo 15 - Empennage

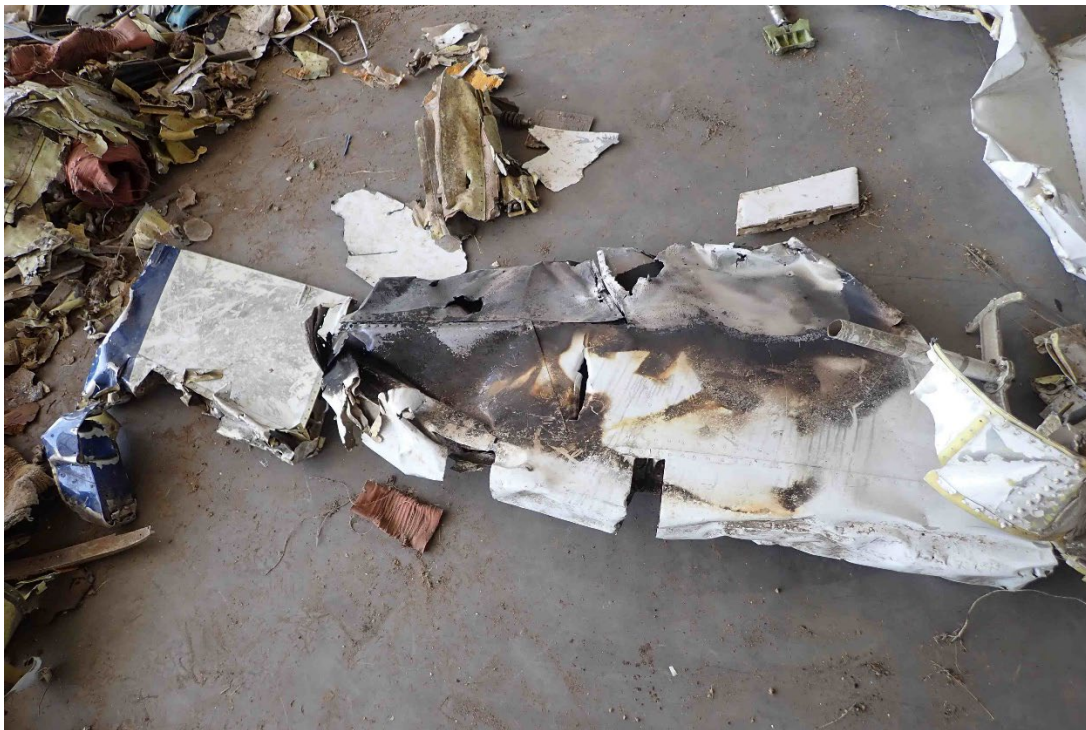
The vertical stabilizer had fragmented into multiple pieces, and the rudder had detached into two pieces, and sustained thermal damage (Photo 17). The rudder balance weight had detached.

Photo 17 – Vertical Stabilizer

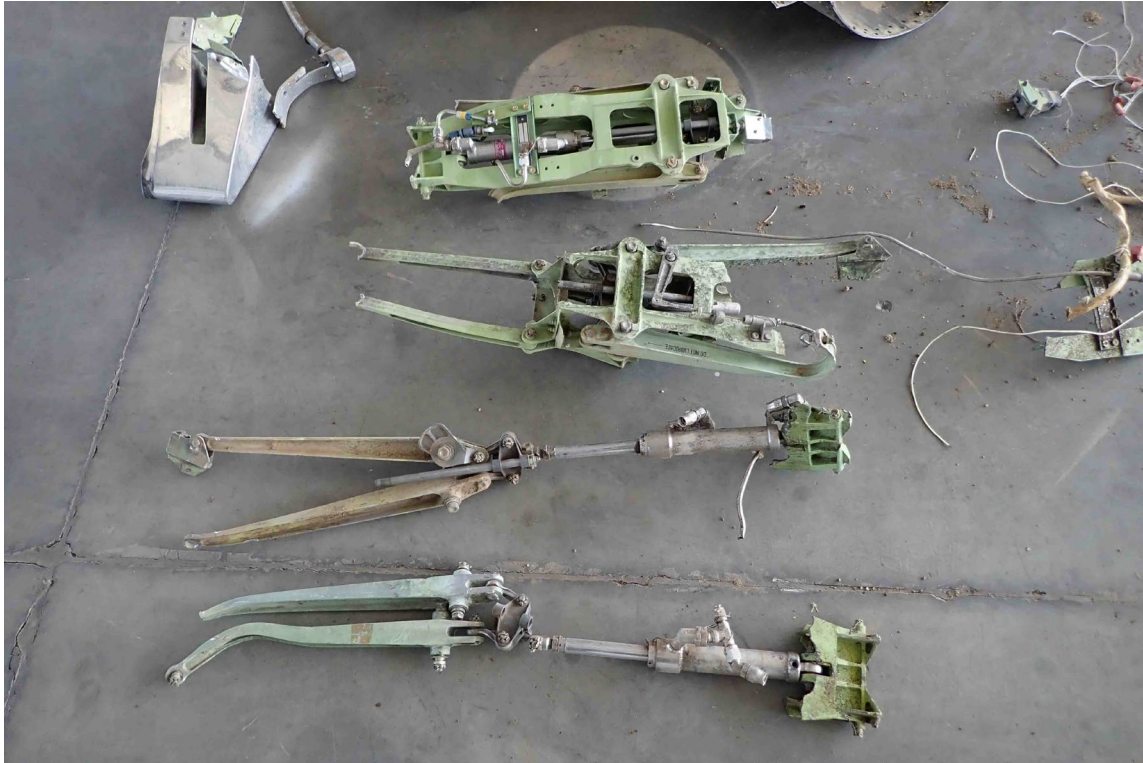
Remnant of all four thrust reverser control assemblies were located. Each of their hydraulic servo actuators were in the extended position, which corresponded with the thrust reverser being in the stowed position (Photo 18).

Photo 18 – Thrust reverser control assemblies

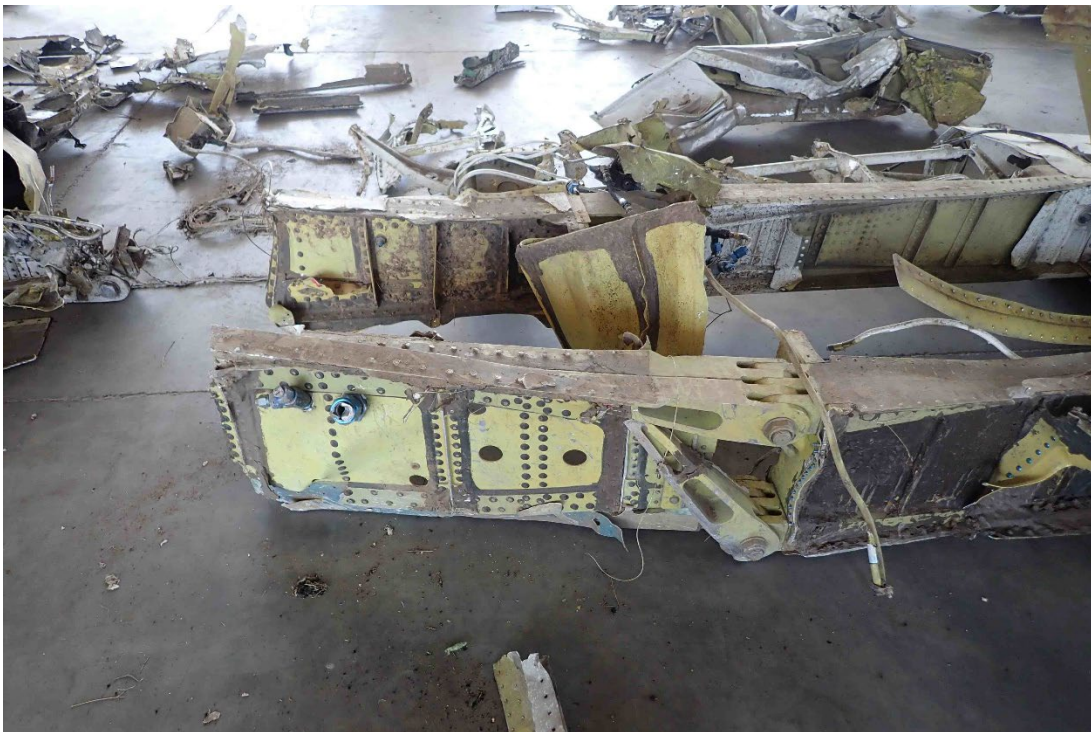
The left side of the wing center box section had detached from the cabin, was coated in mud, and remained attached to the forward and aft spar of the left wing (Photo 19). The left wing was bent about 10 ° aft at the root intersection (Photo 20). The leading edge of the entire wing (fuel tank) was crushed, had detached into long shards, and exhibited intermittent thermal damage (Photo 21). The wing tip and left position light had detached (Photo 22). The aileron and flap surfaces 1 and 2 had detached from the aft spar and were fragmented (Photo 23).

Photo 19 – Left wing box and wing section

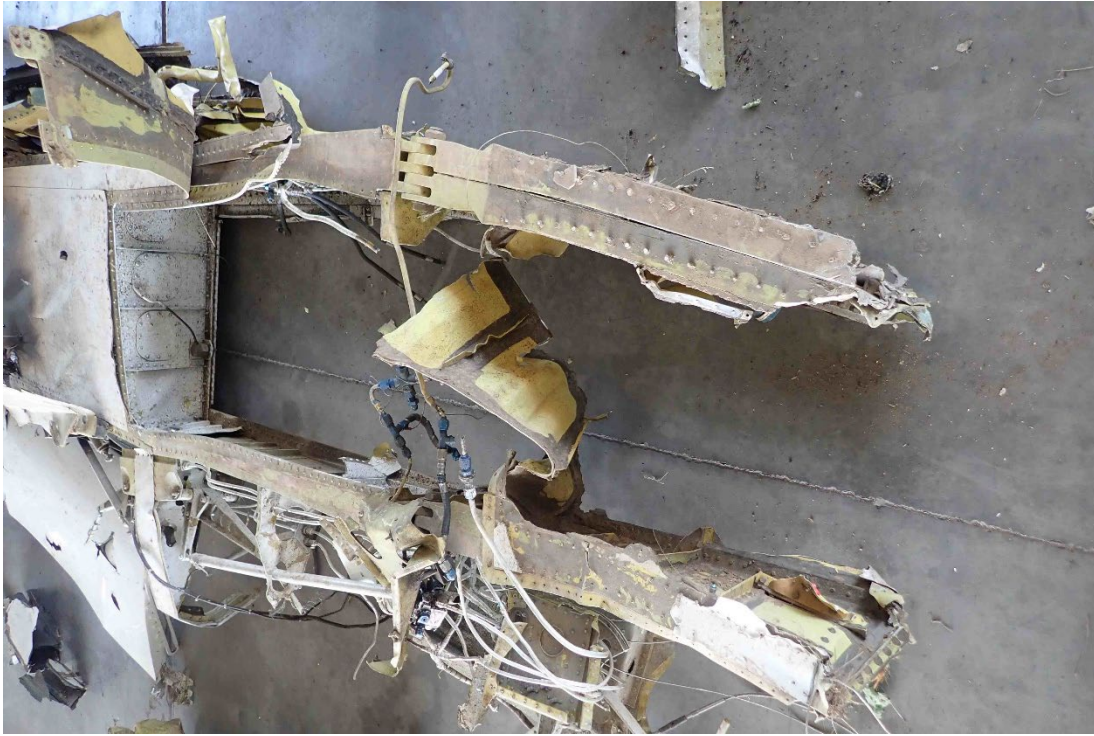
Photo 20 – Left wing aft bend

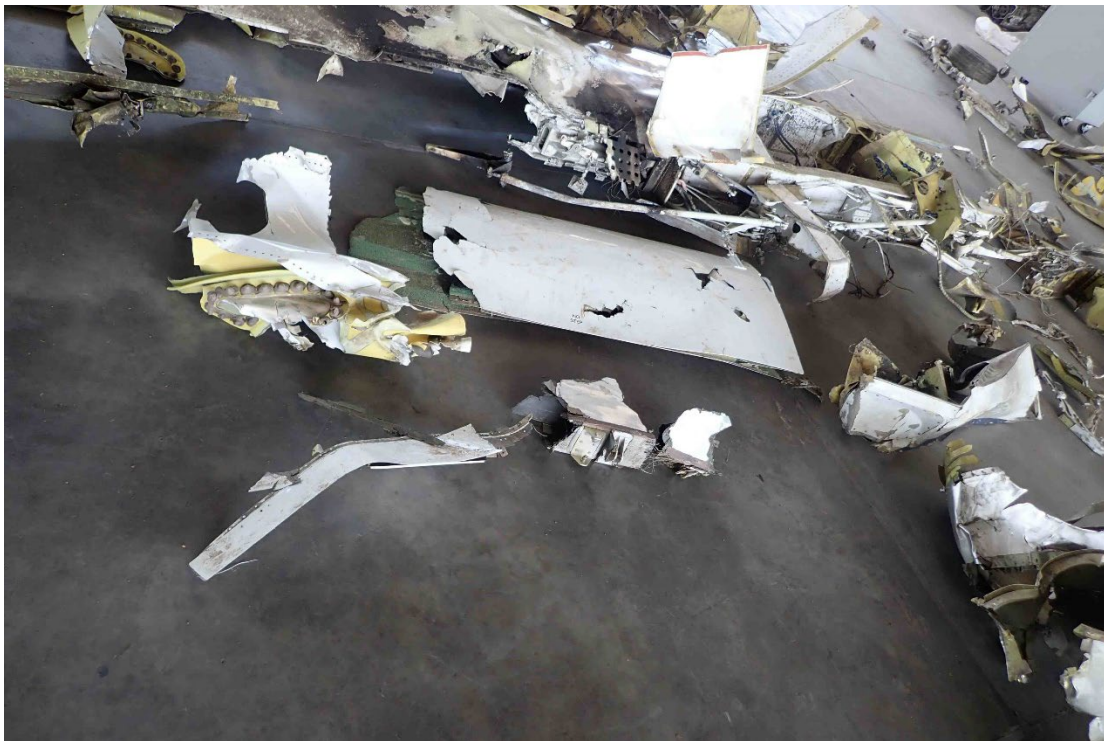
Photo 23 – Left aileron and flap surfaces

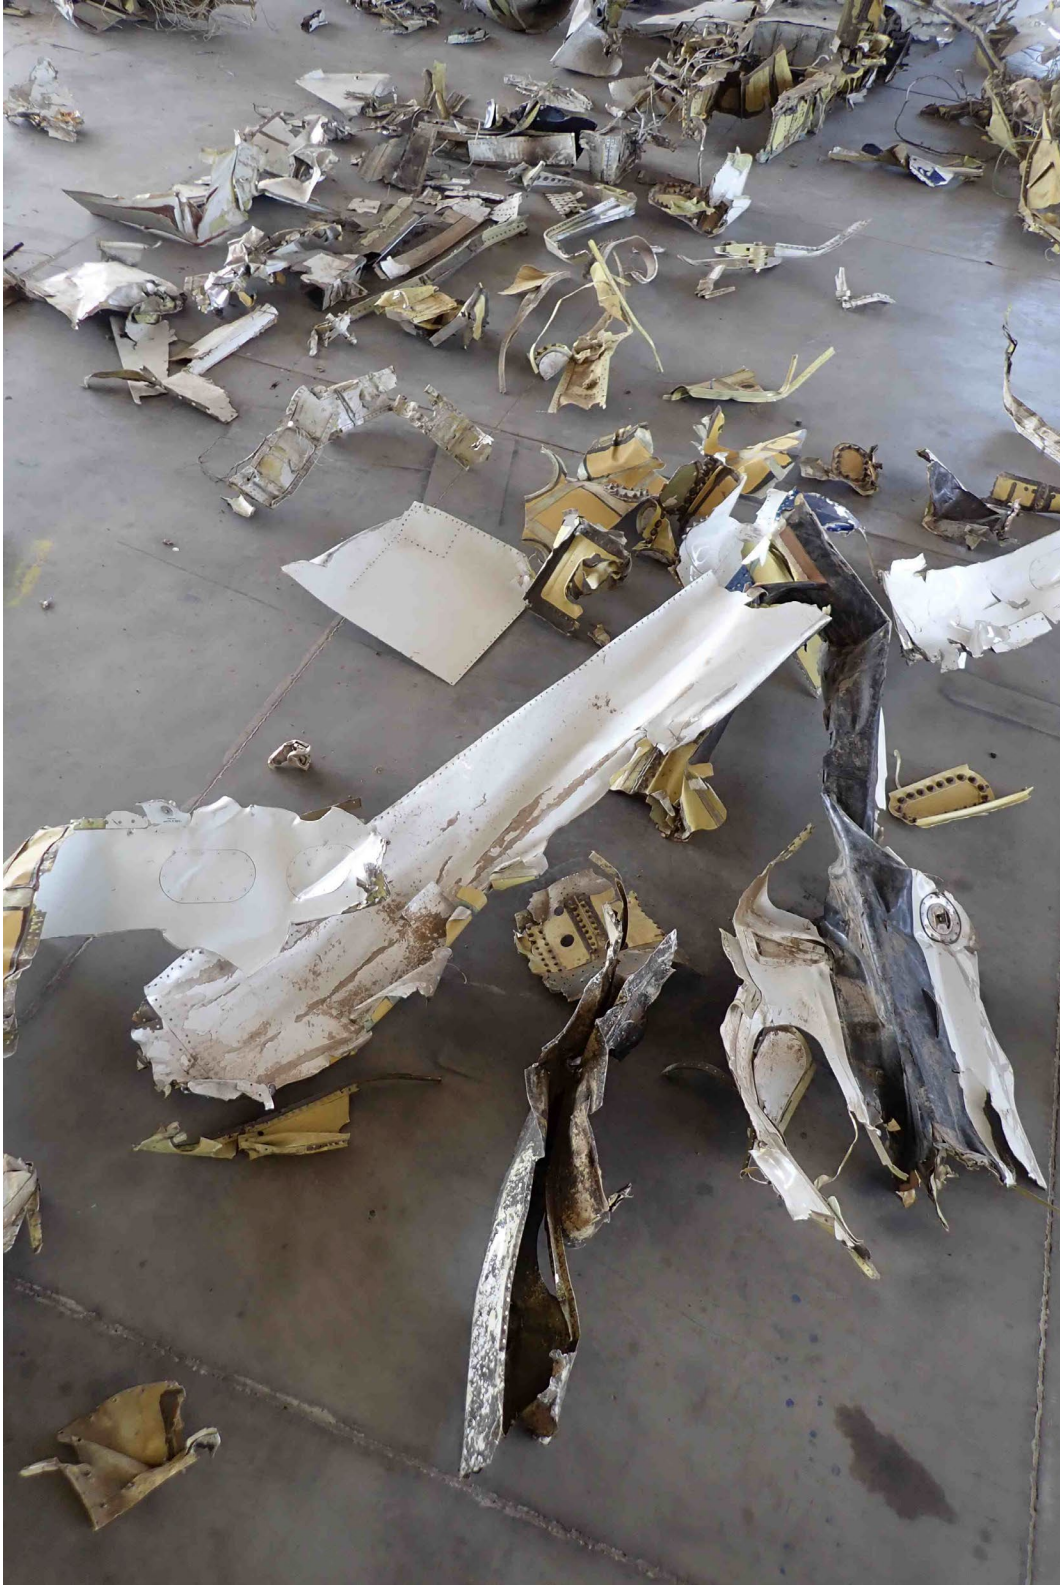
The right wing was completely fragmented along its entire length (Photo 24). Similar fragmentation of the aileron and both flap surfaces were observed (Photo 25). The right wingtip position light assembly sustained crush damage folding it in on itself. (Photo 26).

Photo 24 – Right wing

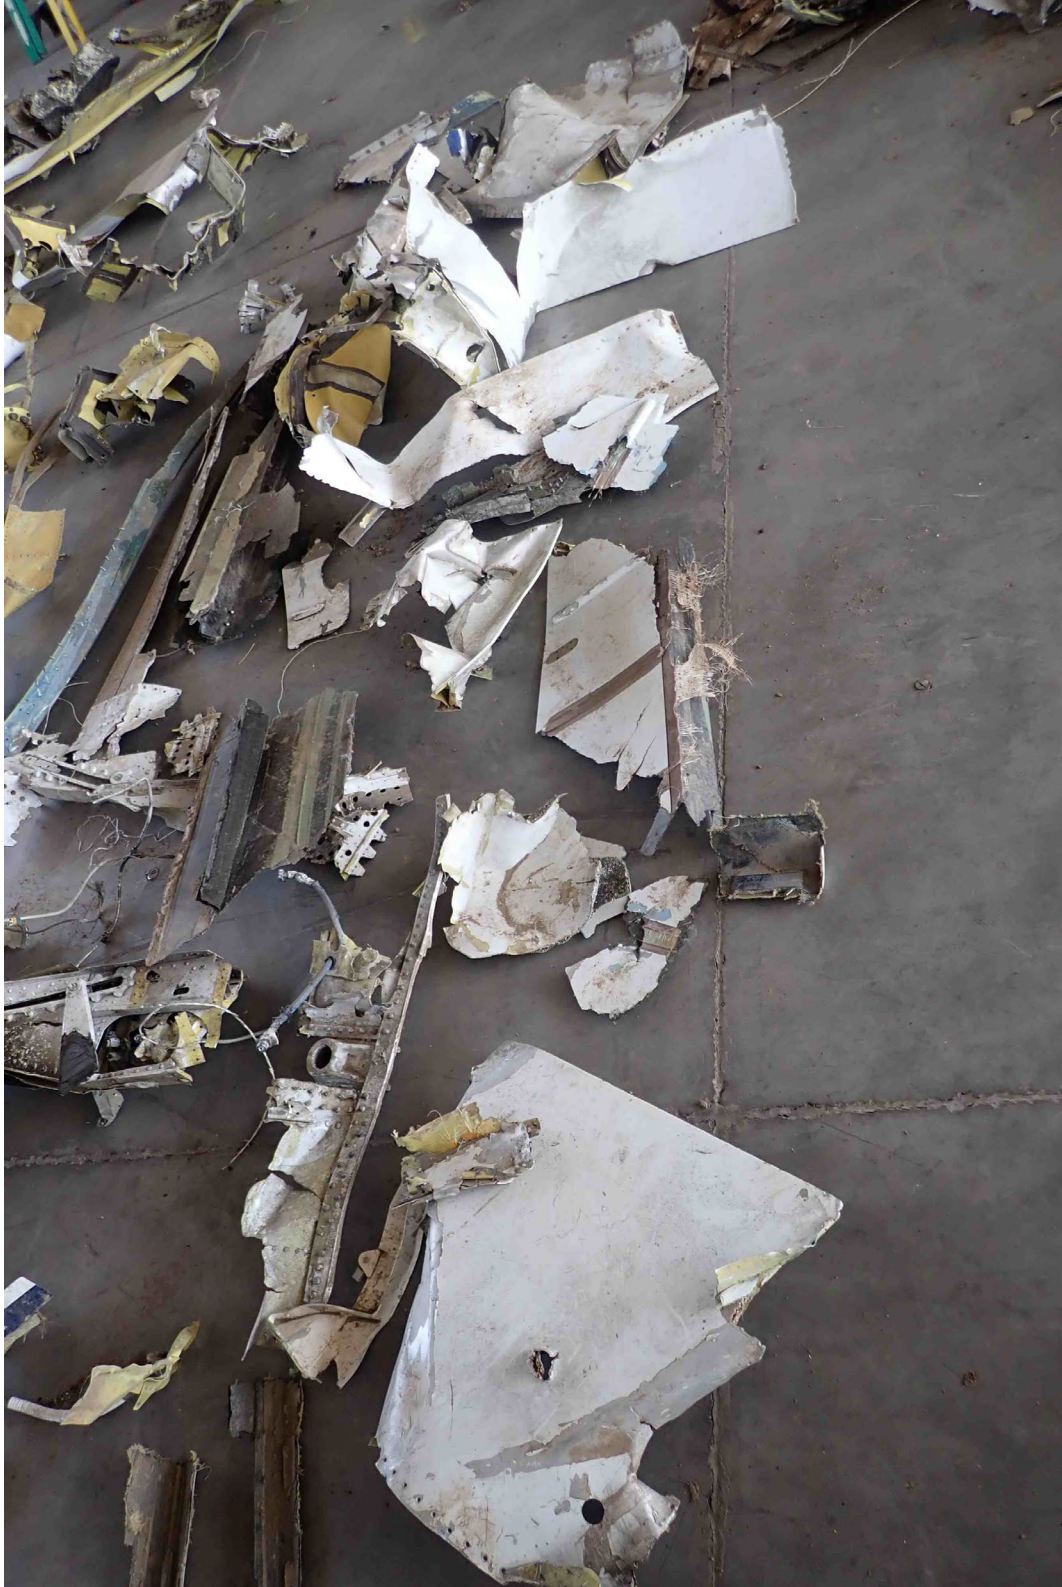
Photo 25 – Right wing aileron and flap surfaces

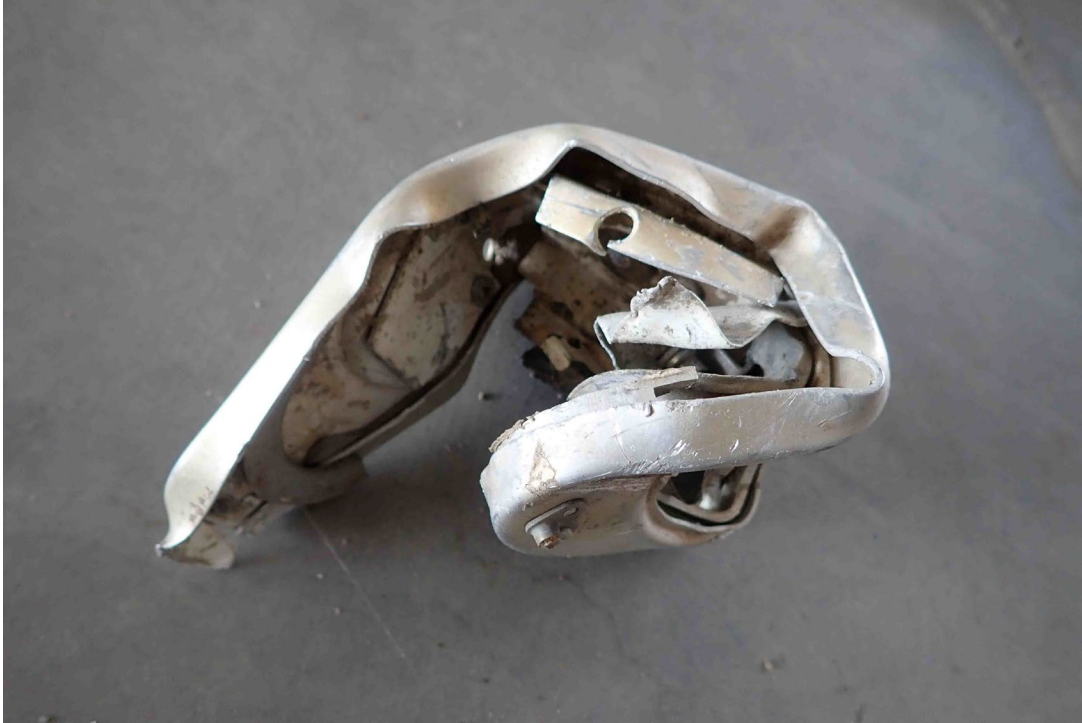
Photo 26 – Right wingtip position light

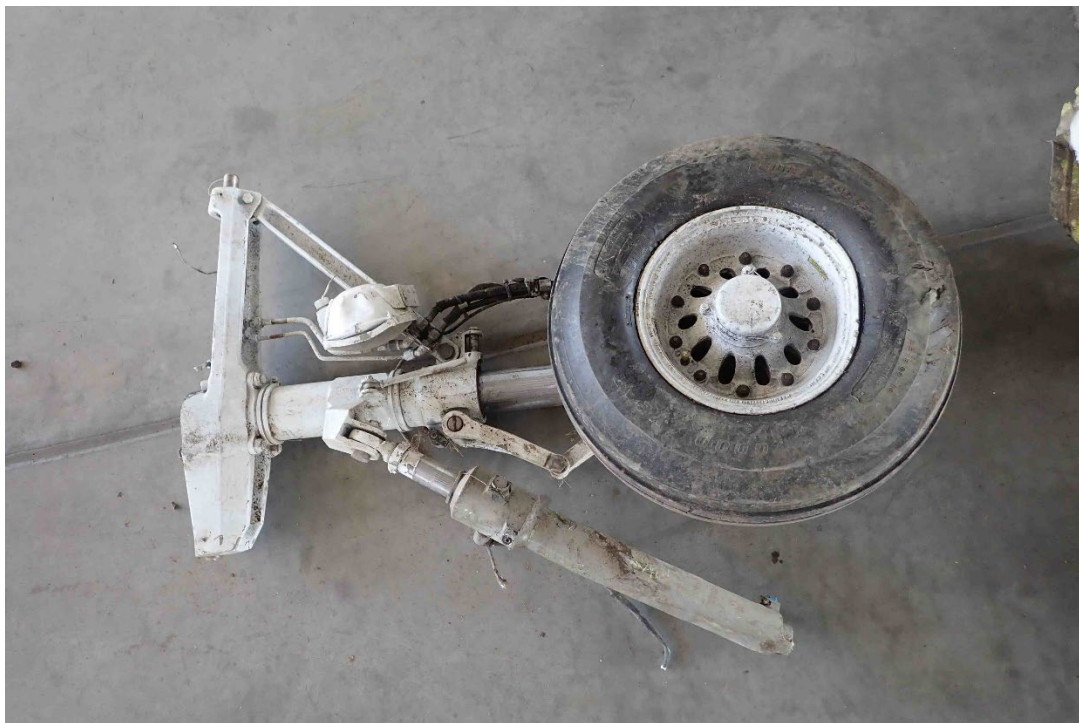
The entire left main landing gear trunnion assembly including the wheel had separated (Photo 27) from the airframe mounting points. The right main landing gear assembly had similarly separated in a similar manner, and the wheel hub and oleo strut had detached (Photo 28). The only section of the nose landing gear located was the oleo strut chamber, which appeared to have burst open, and one side of the landing gear fork. (Photo 29)

Photo 27 – Left main landing gear assembly

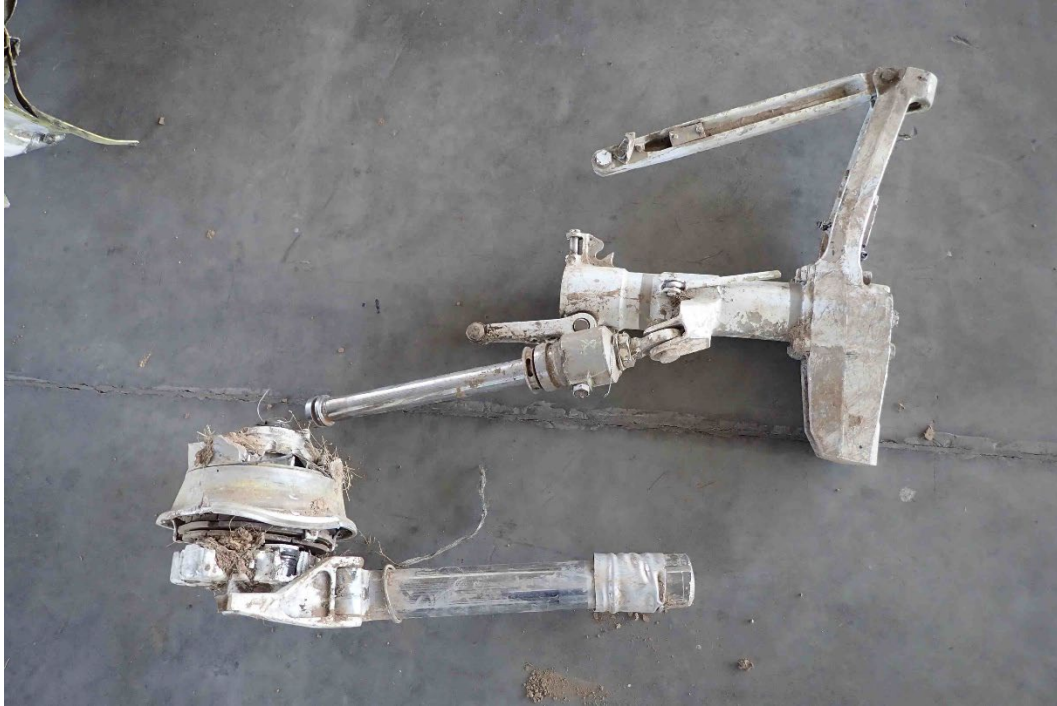
Photo 28 – Right main landing gear assembly

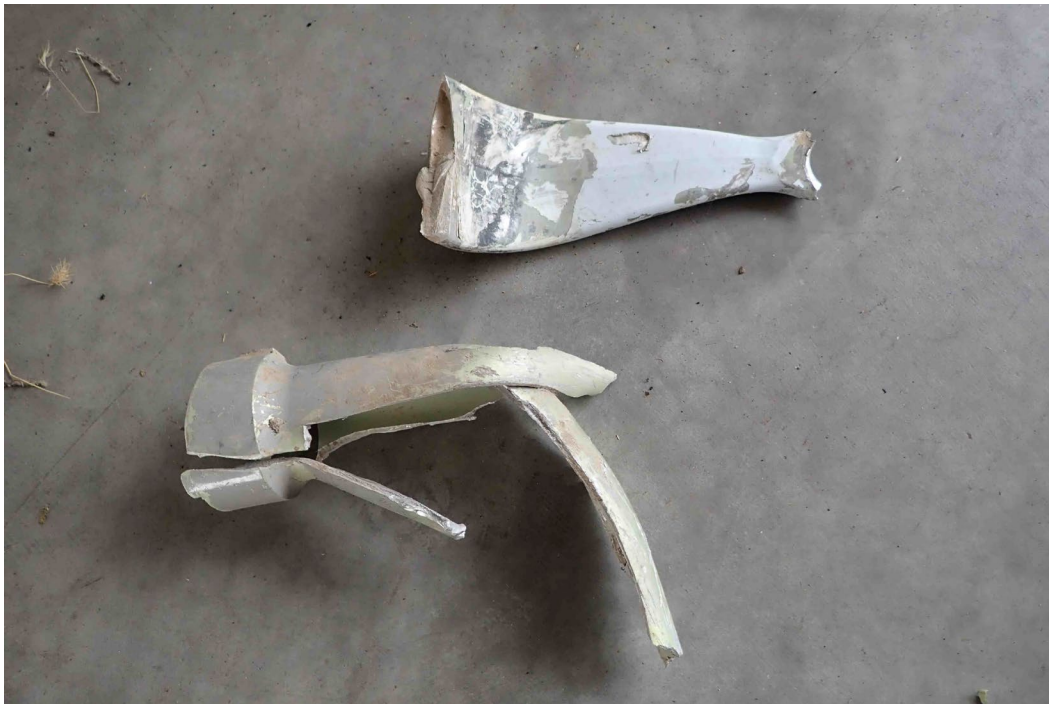
Photo 29 – Nose landing gear fragments
