NATIONAL TRANSPORTATION SAFETY BOARD

AIRFRAME EXAMINATION

WPR21LA082

Location: Warm Springs, Oregon
Date: January 9, 2021
Aircraft: Cessna 560, N3RB
NTSB IIC: Elliott Simpson

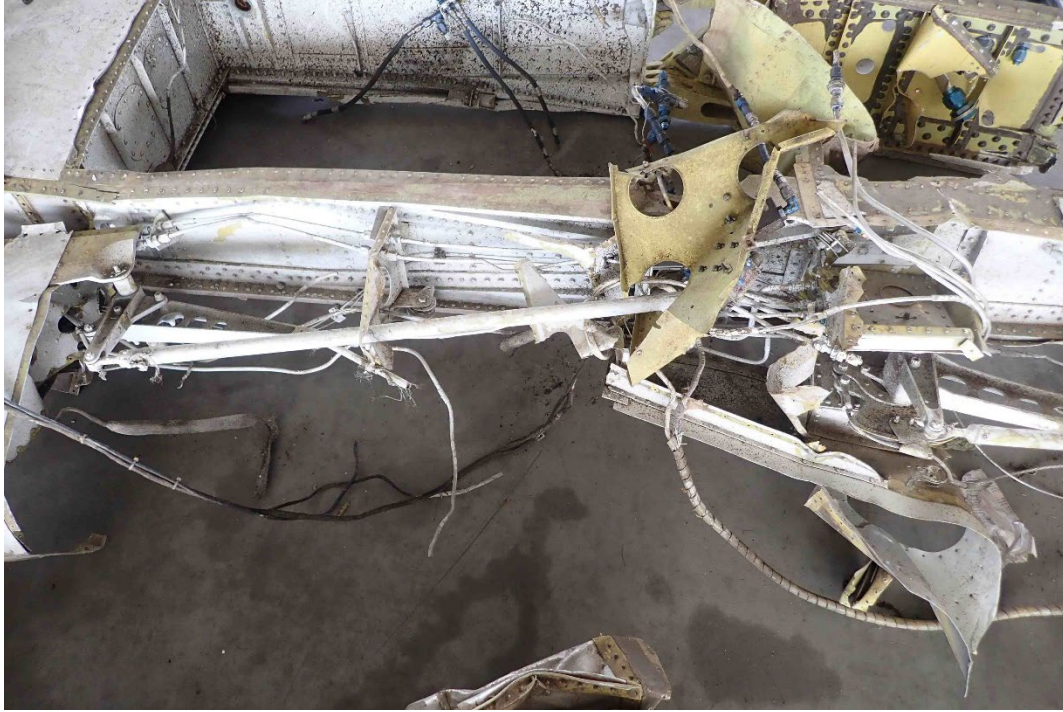
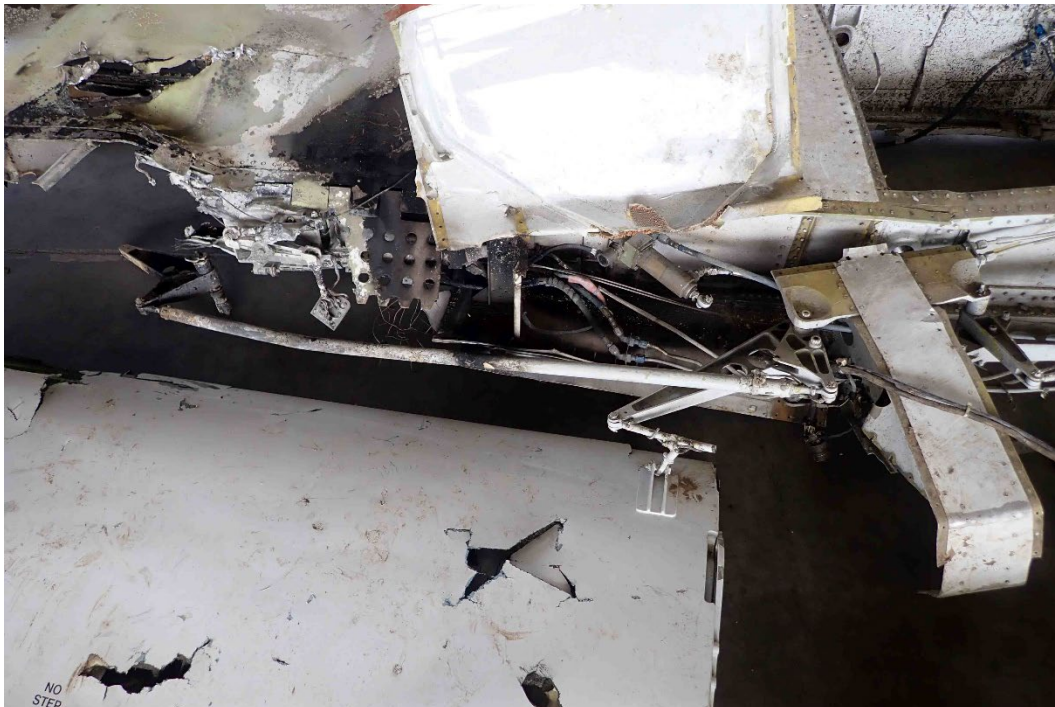
All control cables sustained significant fragmentation damage, and were located throughout the wreckage. All push-pull tubes sustained similar fragmentation, except for those of the left wing flap system, located behind the aft spar, which were largely intact (Photo 30, 31).

Photo 30 – Left wing flap control system

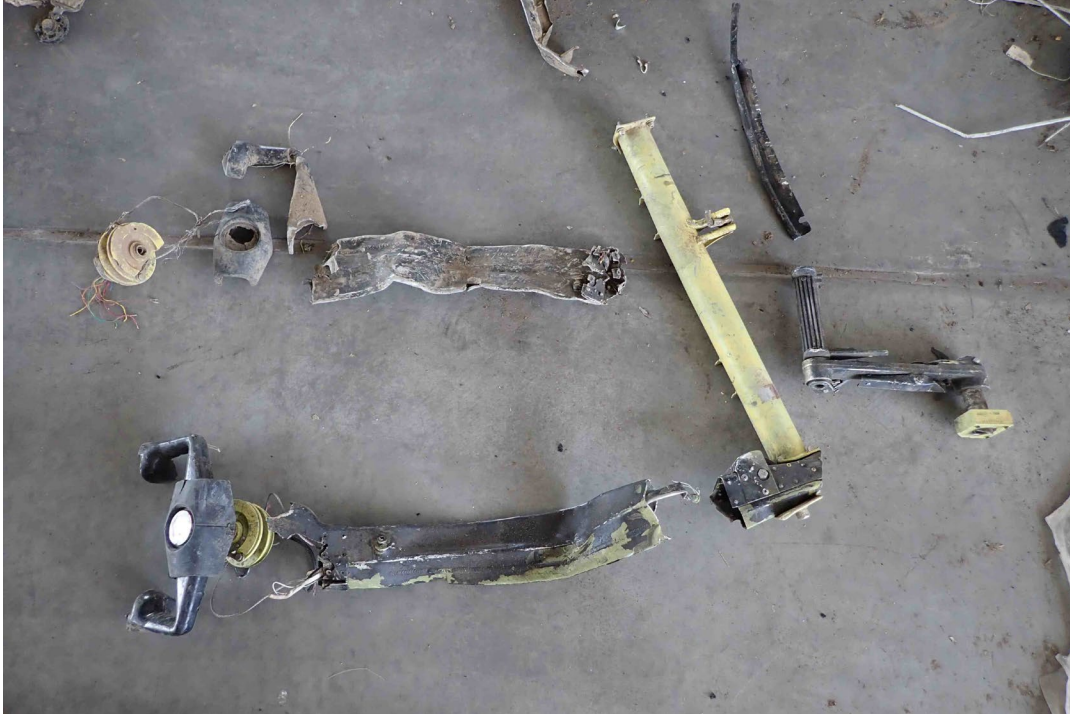
Fragmented remnants of both control columns, and a single rudder pedal were located (Photo 32). The aileron control cables remained attached to both yoke assemblies (Photo 33, 34).

Photo 32 - Fragmented remnants of both control columns

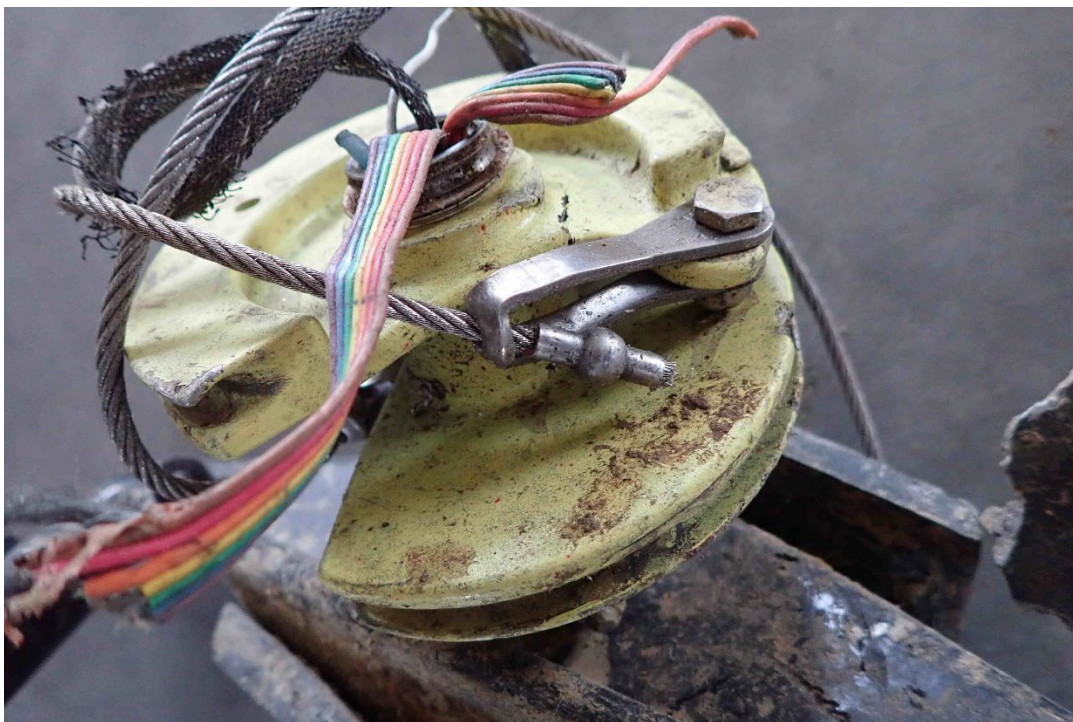
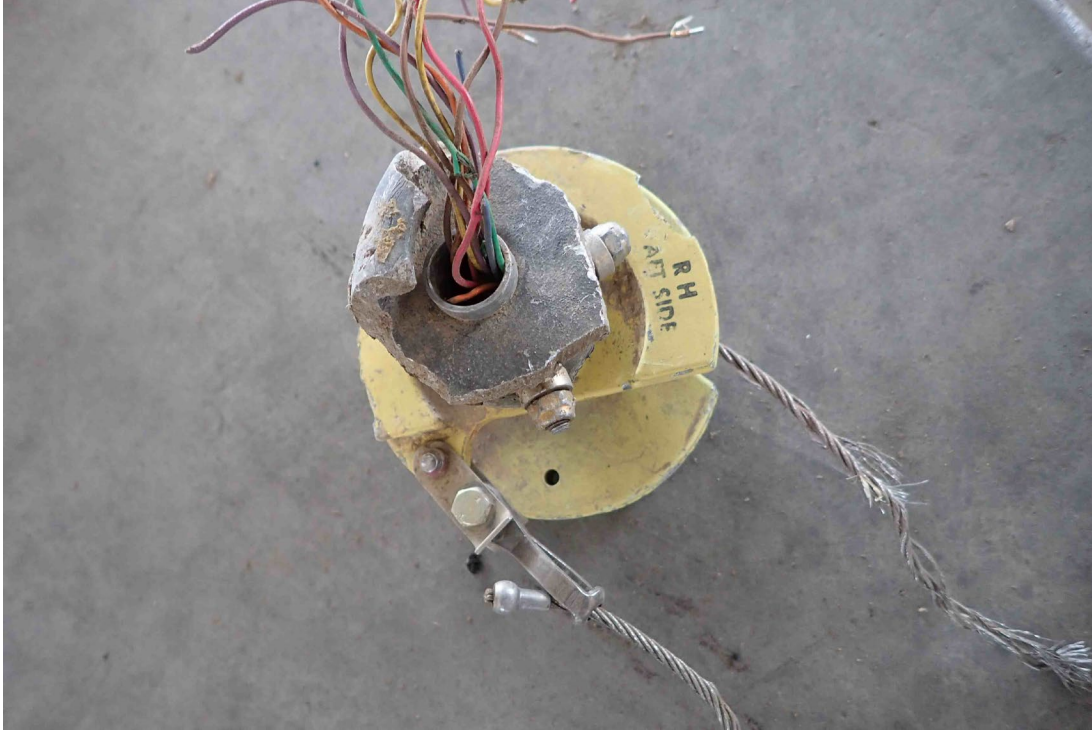
Photo 33 – Aileron control cable at yoke assembly

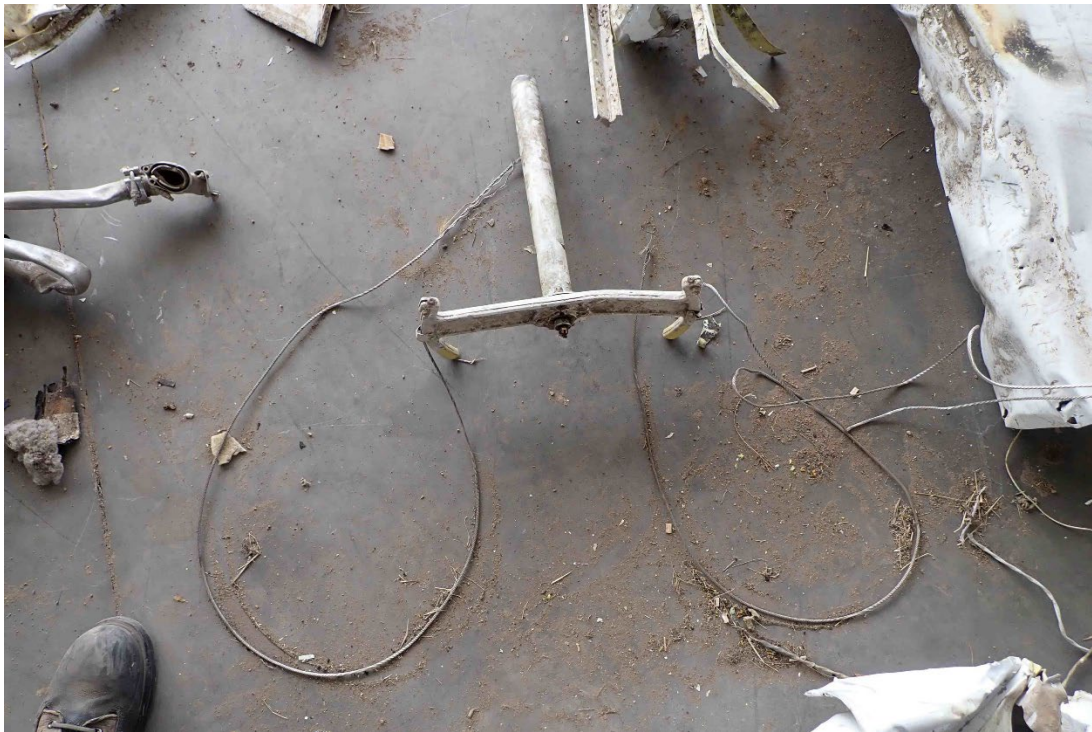
The rudder cable terminations remained attached to the rudder assembly within the cockpit. The rudder horn torque tube assembly had separated from the base of the rudder, but both controls cables remained attached to the bellcrank (Photo 35).

Photo 35 – Rudder torque tube

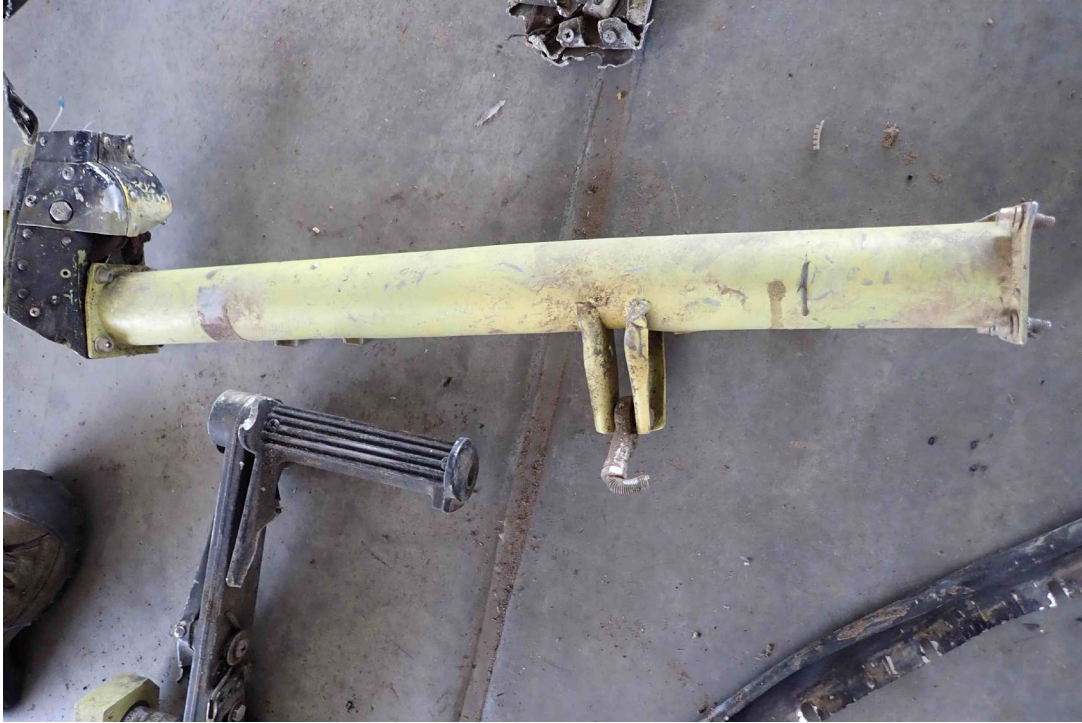
The elevator cable push-pull tube rod bearing remained attached to the elevator control assembly within the cockpit (Photo 36). The corresponding elevator bellcrank remained within the airframe, and both of its elevator cable terminations remained attached. Similarly the cable ends were in place at the aft elevator bellcrank, along with the push-pull tube ends for the control surfaces (Photo 38). The elevator control horns remained attached. The push-pull tube end for the right horn was attached, the left control had broken off (Photo 39, 40).

Photo 36 - Elevator control assembly

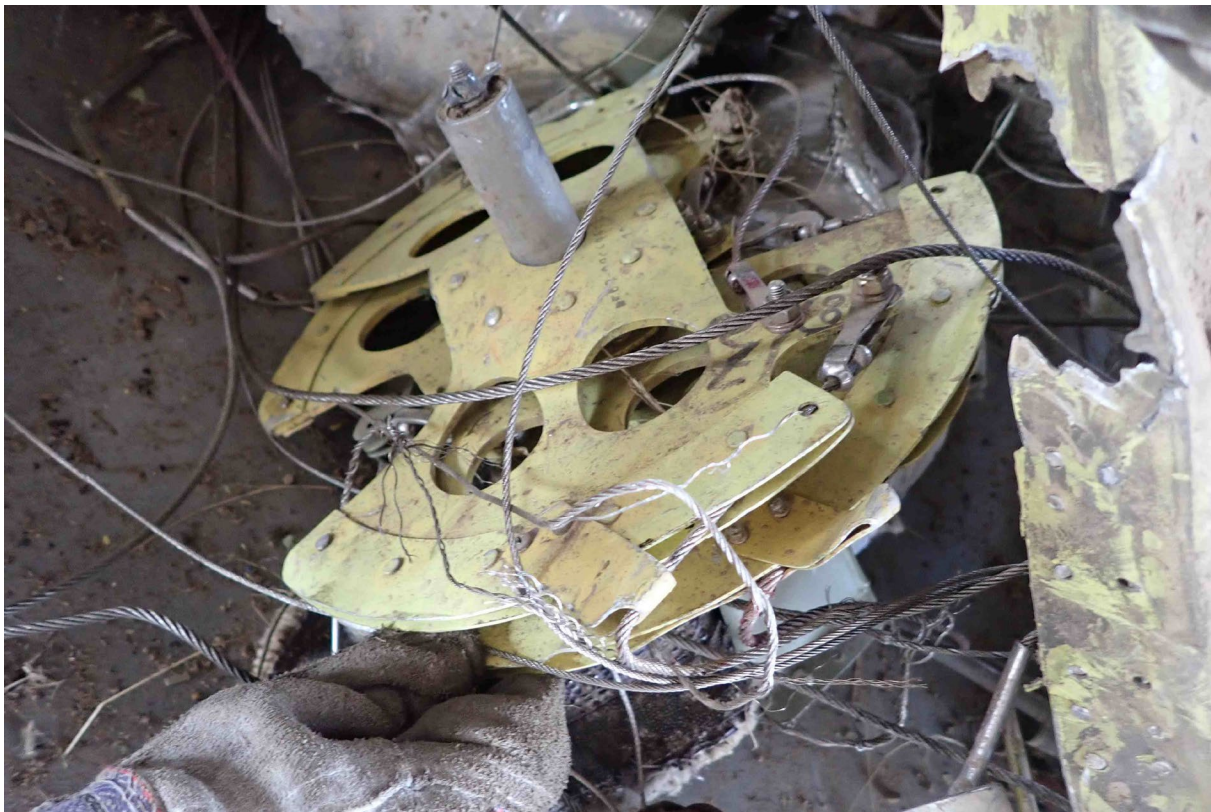
The elevator trim actuators had broken beyond limits. The aileron trim tab actuator (left side) was in a position, which according to Cessna documentation, indicated 5 ° tab down. The rudder actuator was in a position, which according to Cessna documentation, indicated 5 ° tab right. The aileron sector assembly was found in the center fuselage section, all its associated cable ends remained attached. (Photo 37).

Photo 37 - Aileron sector assembly

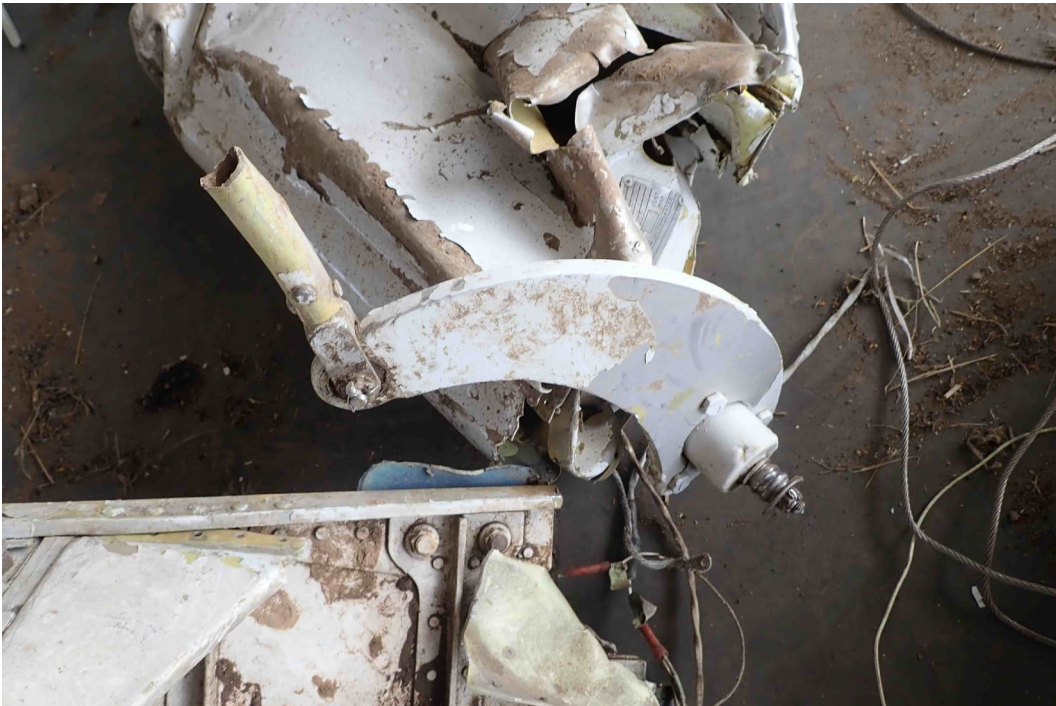
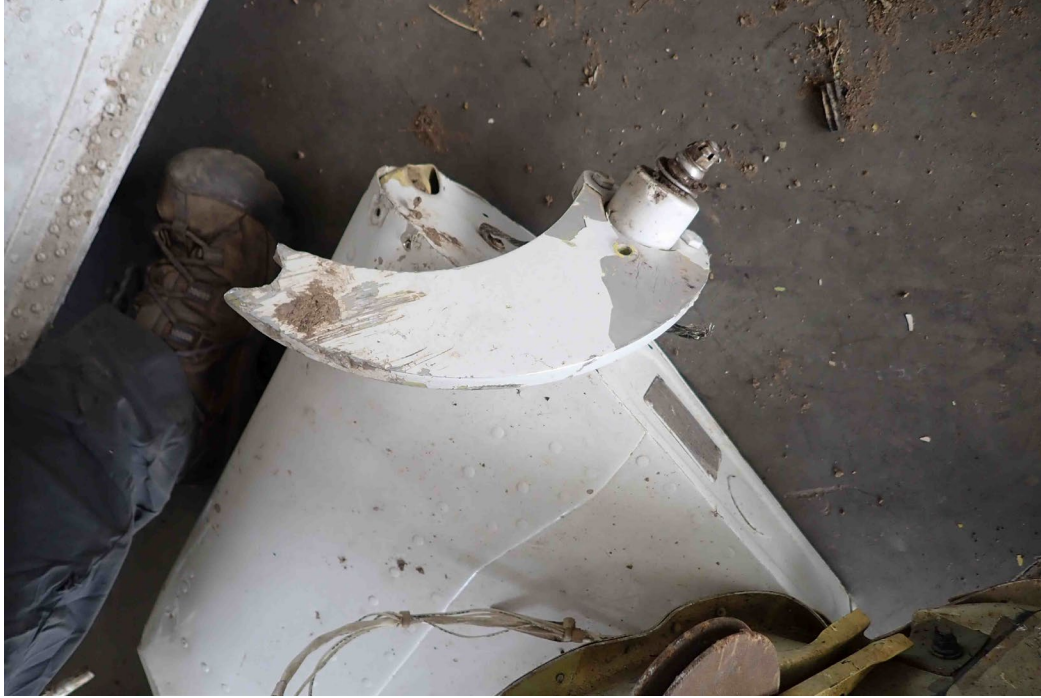
Photo 39 – Elevator control horn

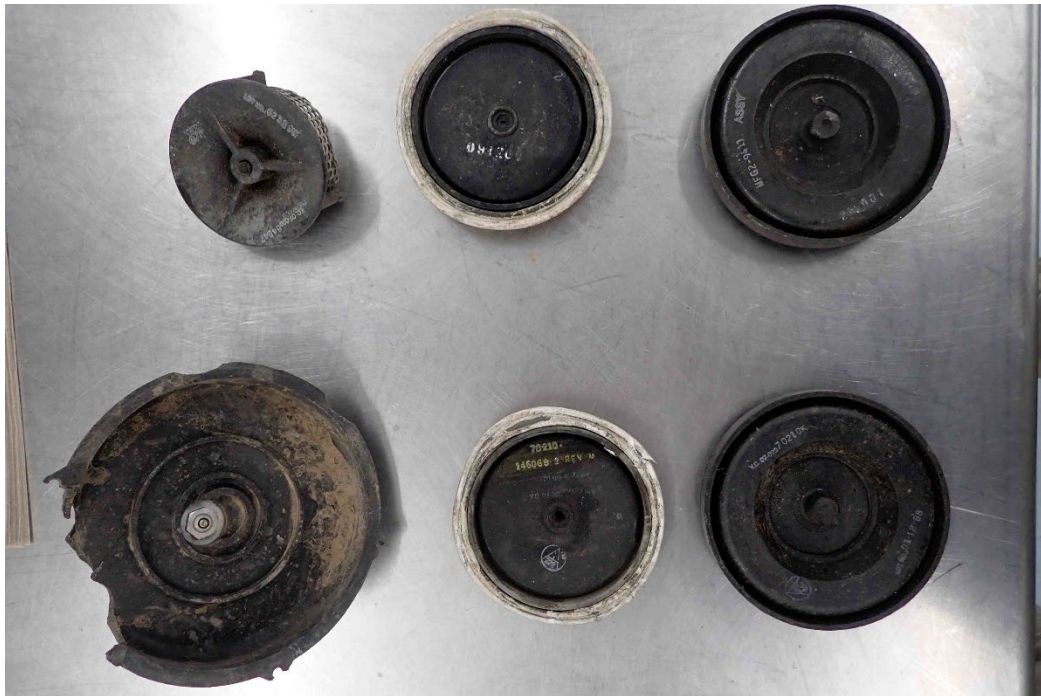
The environmental control panel could not be located. The outflow valve assemblies sustained impact damage, and the only recovered components included one outflow valve head with differential control, two poppet outflow valves, two poppet valve covers and a noise suppression screen. Both valve diaphragms were liberated and sustained multiple tears and cuts. (Photo 41). The cabin rate of climb indicator had been crushed, and its indicating needle was not located.

Photo 41 – Environmental control valve components

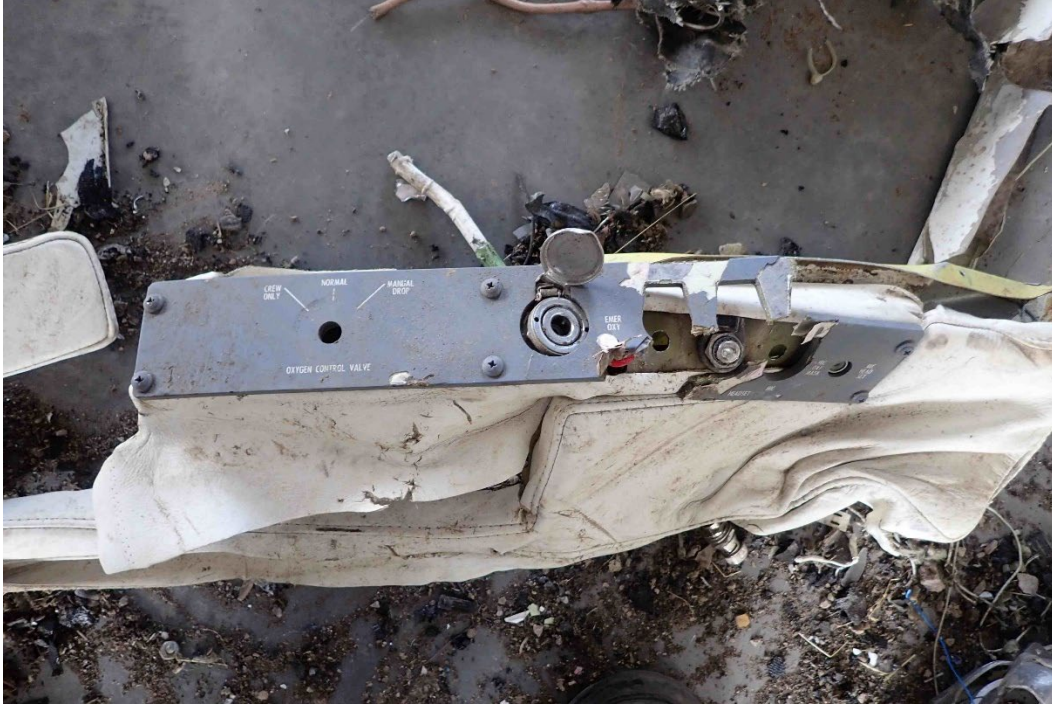
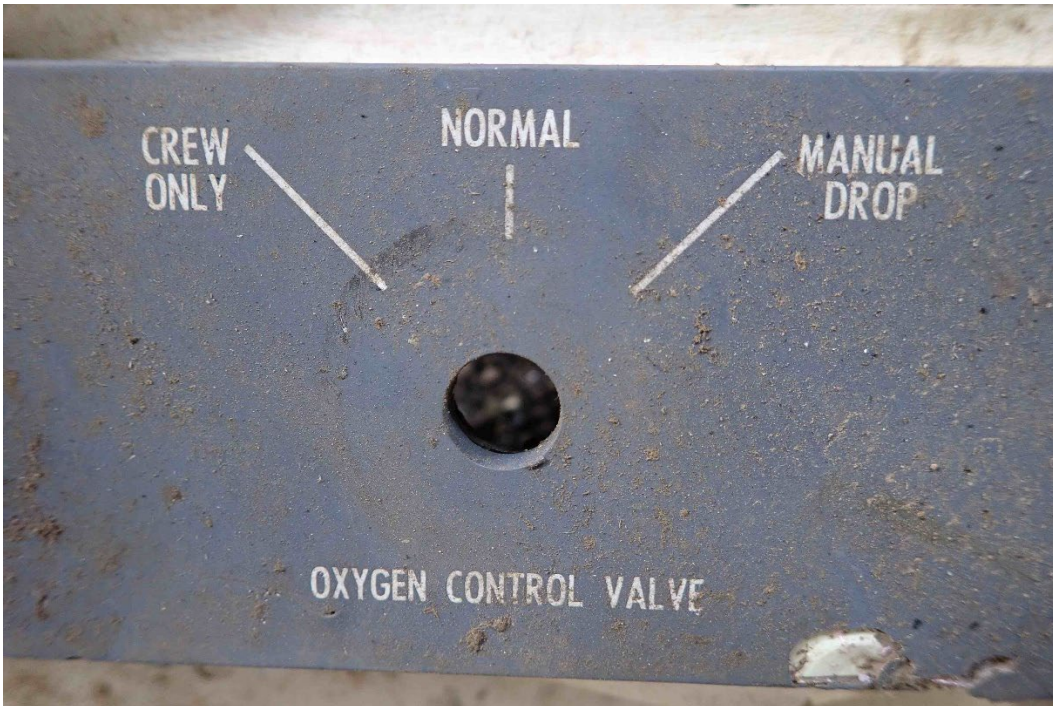
Remnants of three emergency oxygen system mask assemblies were located. The mask for one passenger system remained housed within the assembly, indicating the oxygen system had not deployed. According to the Pilot's Operating Handbook, should the cabin altitude exceed 13,500 +/-600 ft, an altitude sensing switch will electrically actuate the passenger solenoid valve, supplying 70 PSI oxygen pressure to the passenger manifold. This pressure is sufficient to operate the passenger mask actuators, deploy the doors and drop the continuous flow masks at each passenger seat. The oxygen control panel was located, however the control valve switch was detached, as such a determination of its status could not be ascertained (Photo 42,43).

Photo 42 – Oxygen control panel

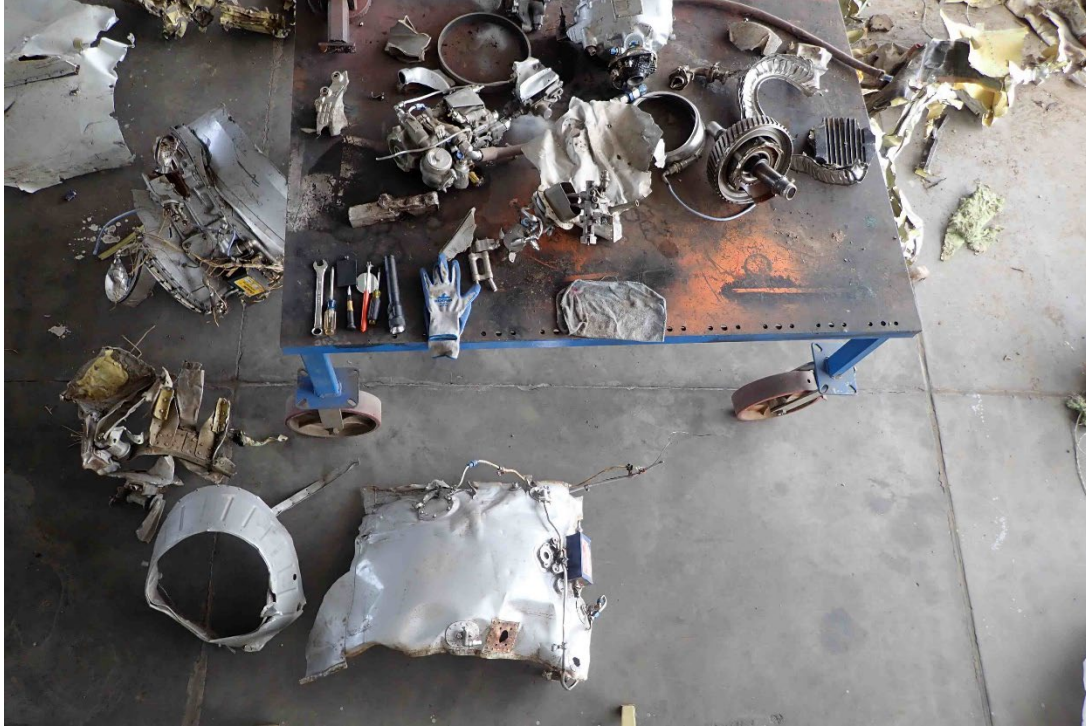
The engine was heavily fragmented, liberating many of its components, not all of which were identified (Photo 44). The accessory gearbox (AGB) had detached (Photo 45), and its case had been breached exposing the internal gears. All gears were wet with oil, and there was no evidence of internal catastrophic failure (Photo 46). Both engine Lord mounts were located and found separated from the engine.

Photo 44 – Number 1 engine remnants

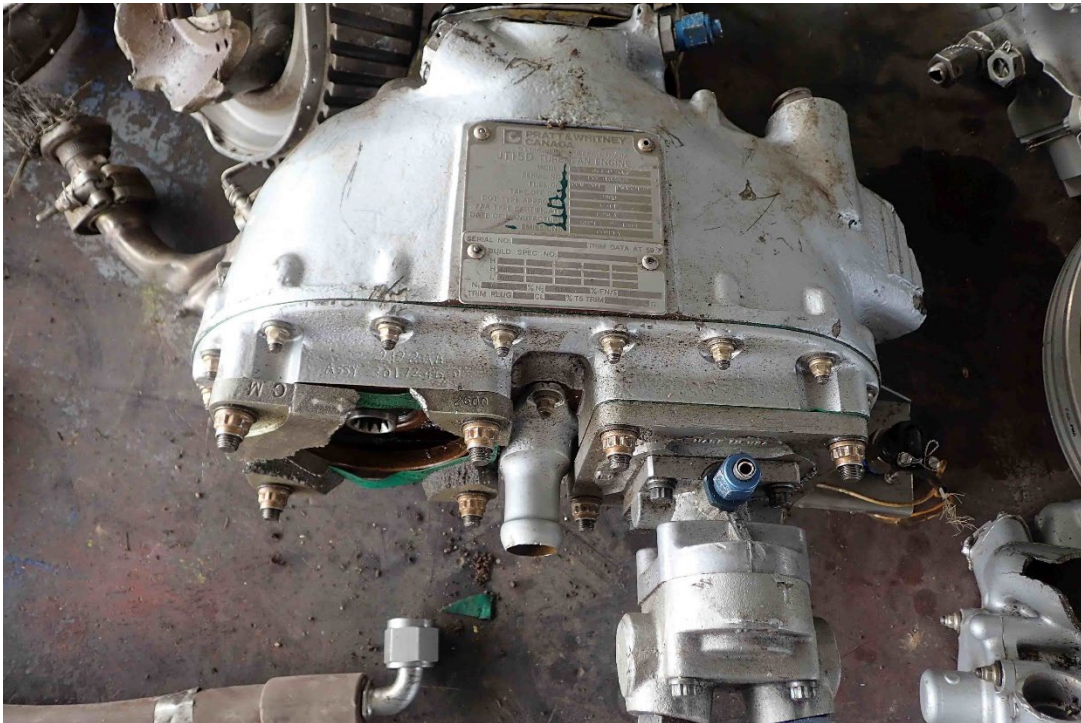
Photo 45 - Number 1 accessory gearbox

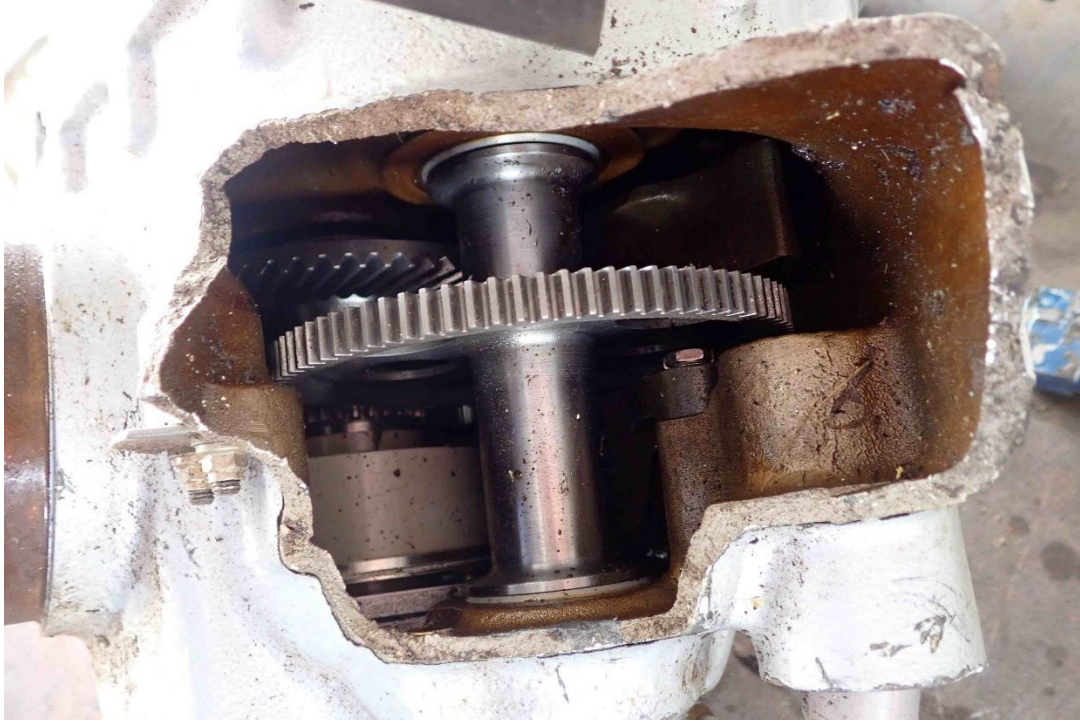
Photo 46 - Number 1 accessory gearbox opening

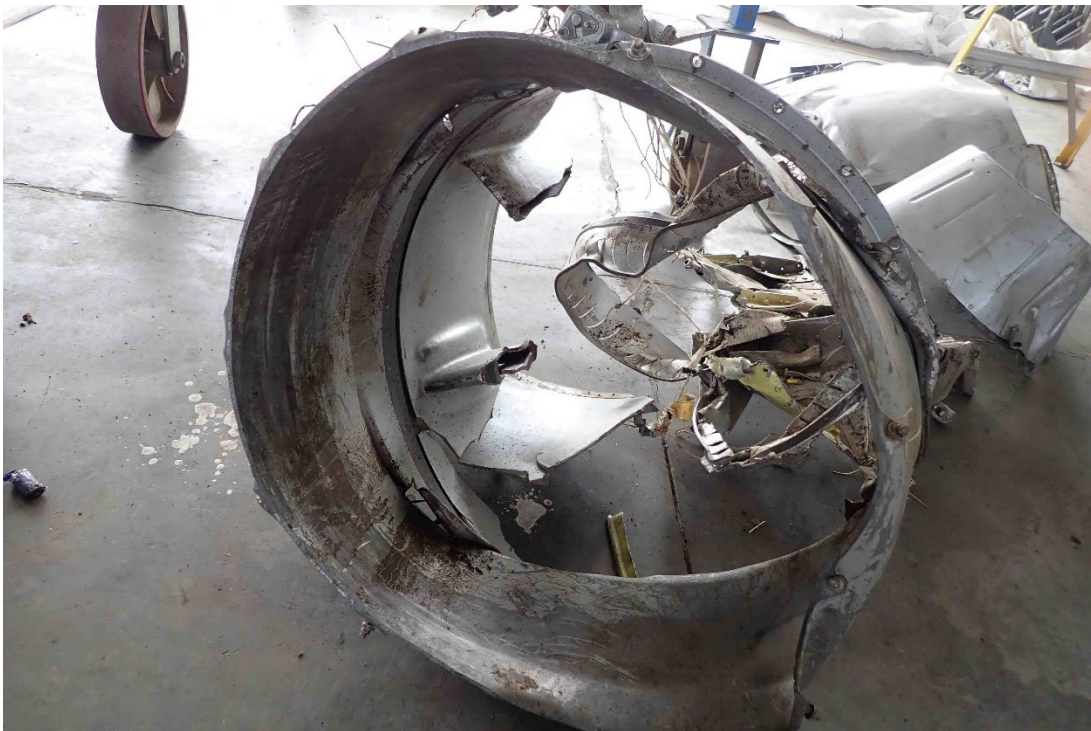
The fuel pump, fuel controller unit, and flow divider had all detached. The low compressor fan shroud had detached, was bent, and exhibit radial scoring signatures in the area of the fan blade tips (Photo 47). Neither the low compressor fan, high pressure compressor, nor any combustion stage components were recovered.

Photo 47 – Number 1 engine low compressor fan shroud

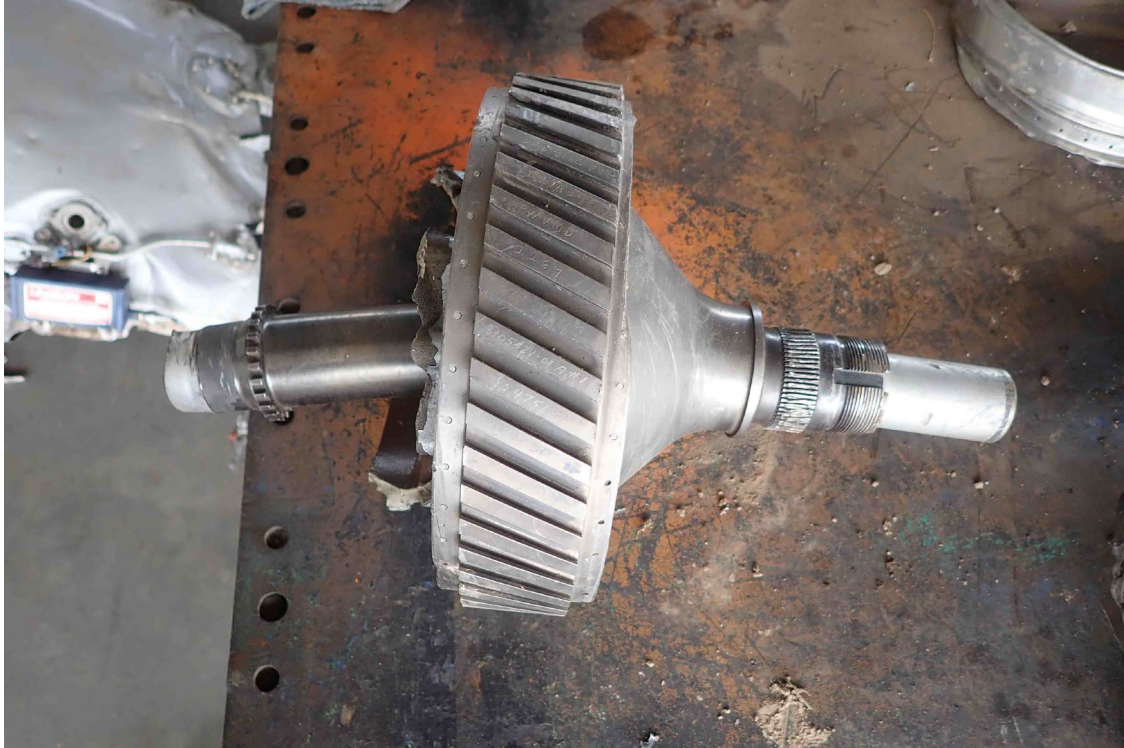
The booster stage was located; however all of its blades were liberated, and none were found (Photo 48). The booster stage shaft was separated about 6 inches aft, and the separation features exhibited rotational scoring and a 30 ° lip at the separation (Photo 49). The booster stage stator was torn, and splayed open. The area adjacent to the booster blades exhibited rotational scoring damage.

Photo 48 – Number 1 engine booster stage

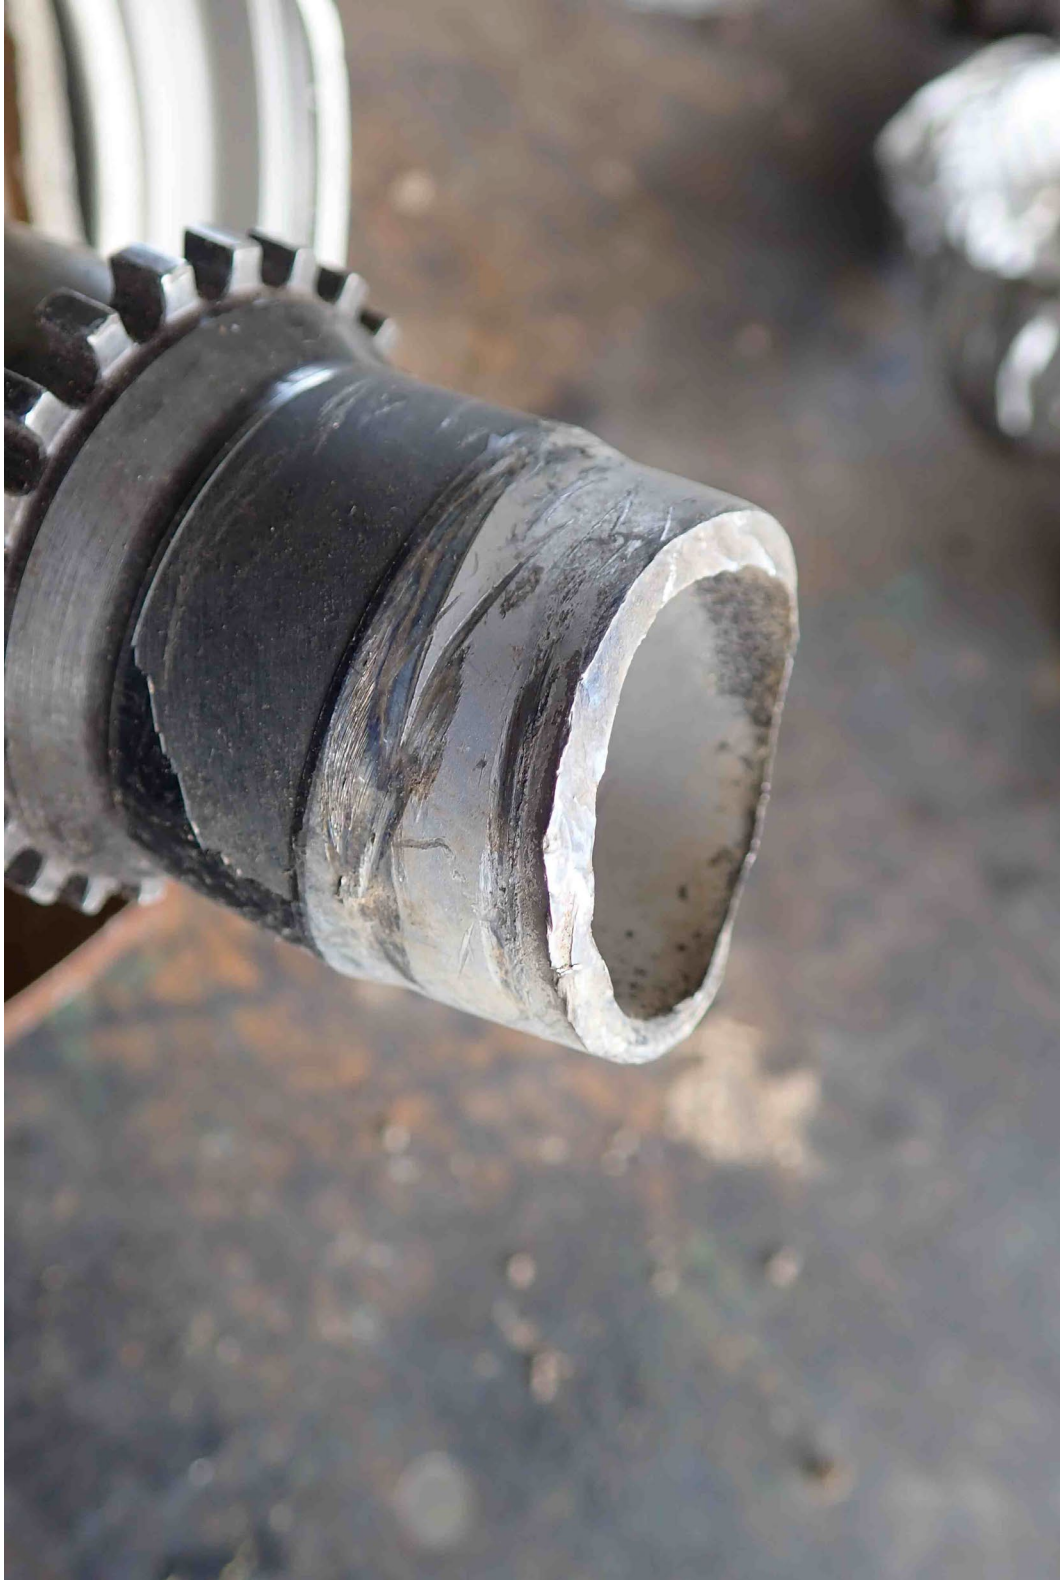
Photo 49 – Number 1 engine booster stage shaft

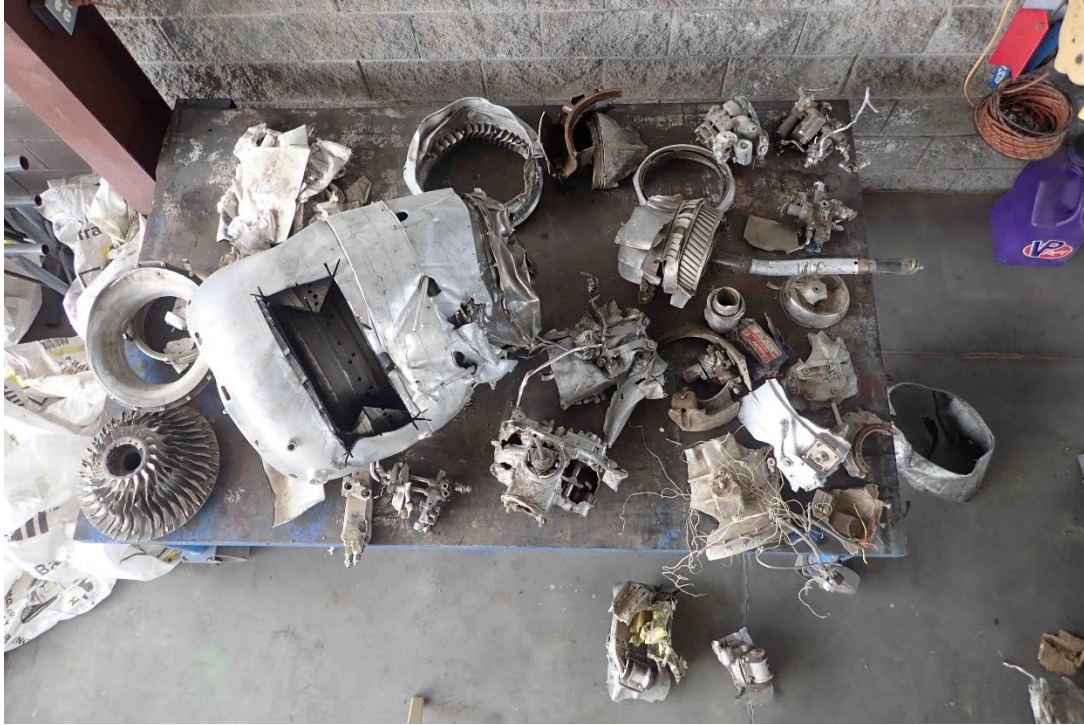
The engine was heavily fragmented, liberating many of its components, not all of which were identified (Photo 50). The accessory gearbox (AGB) had detached, and its case had been breached exposing the internal gears. All gears were wet with oil, and there was no evidence of internal catastrophic failure. Both engine Lord mounts were located, and found separated from the engine. The aft stabilizing mount remained attached to the engine casing. The fuel pump, fuel controller unit, and flow divider had all detached.

Photo 50 – Number 2 engine components

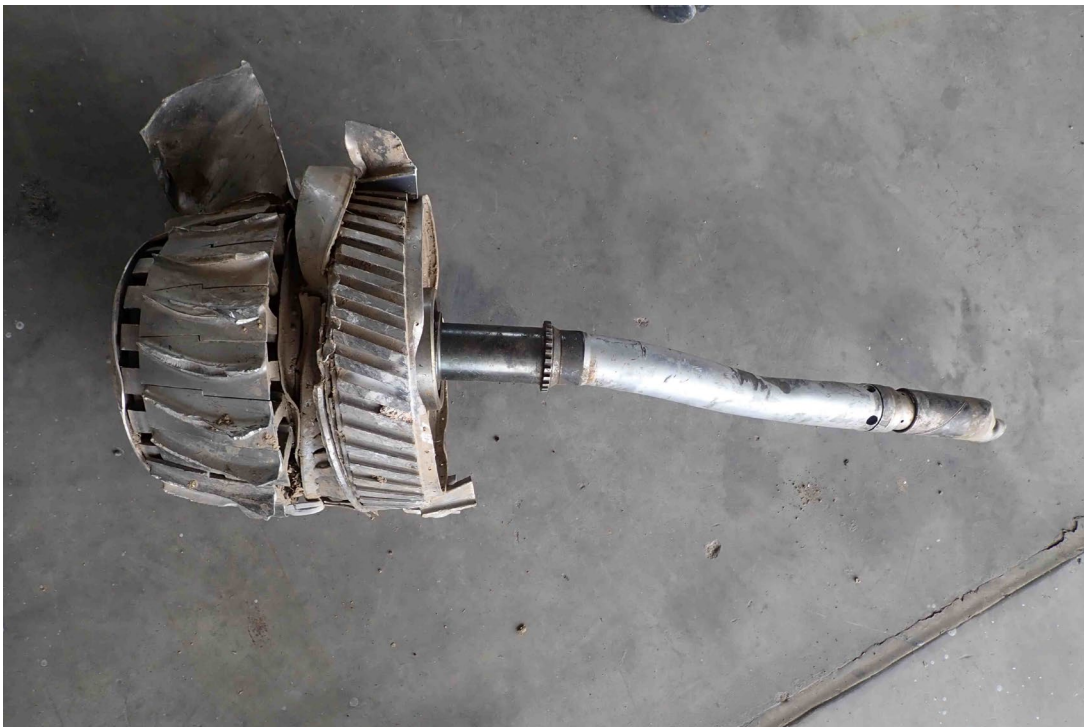
The low compressor fan shroud was not located. The low compressor fan remained attached to the booster stage through the inlet cone shaft (Photo 51). The inlet cone had detached and exhibited crush deformation (Photo 53). All but one of the booster stage blades were liberated, the remaining blade was bent and exhibited leading and trailing edge gouges.

Photo 51 – Number 2 low compressor fan fragments

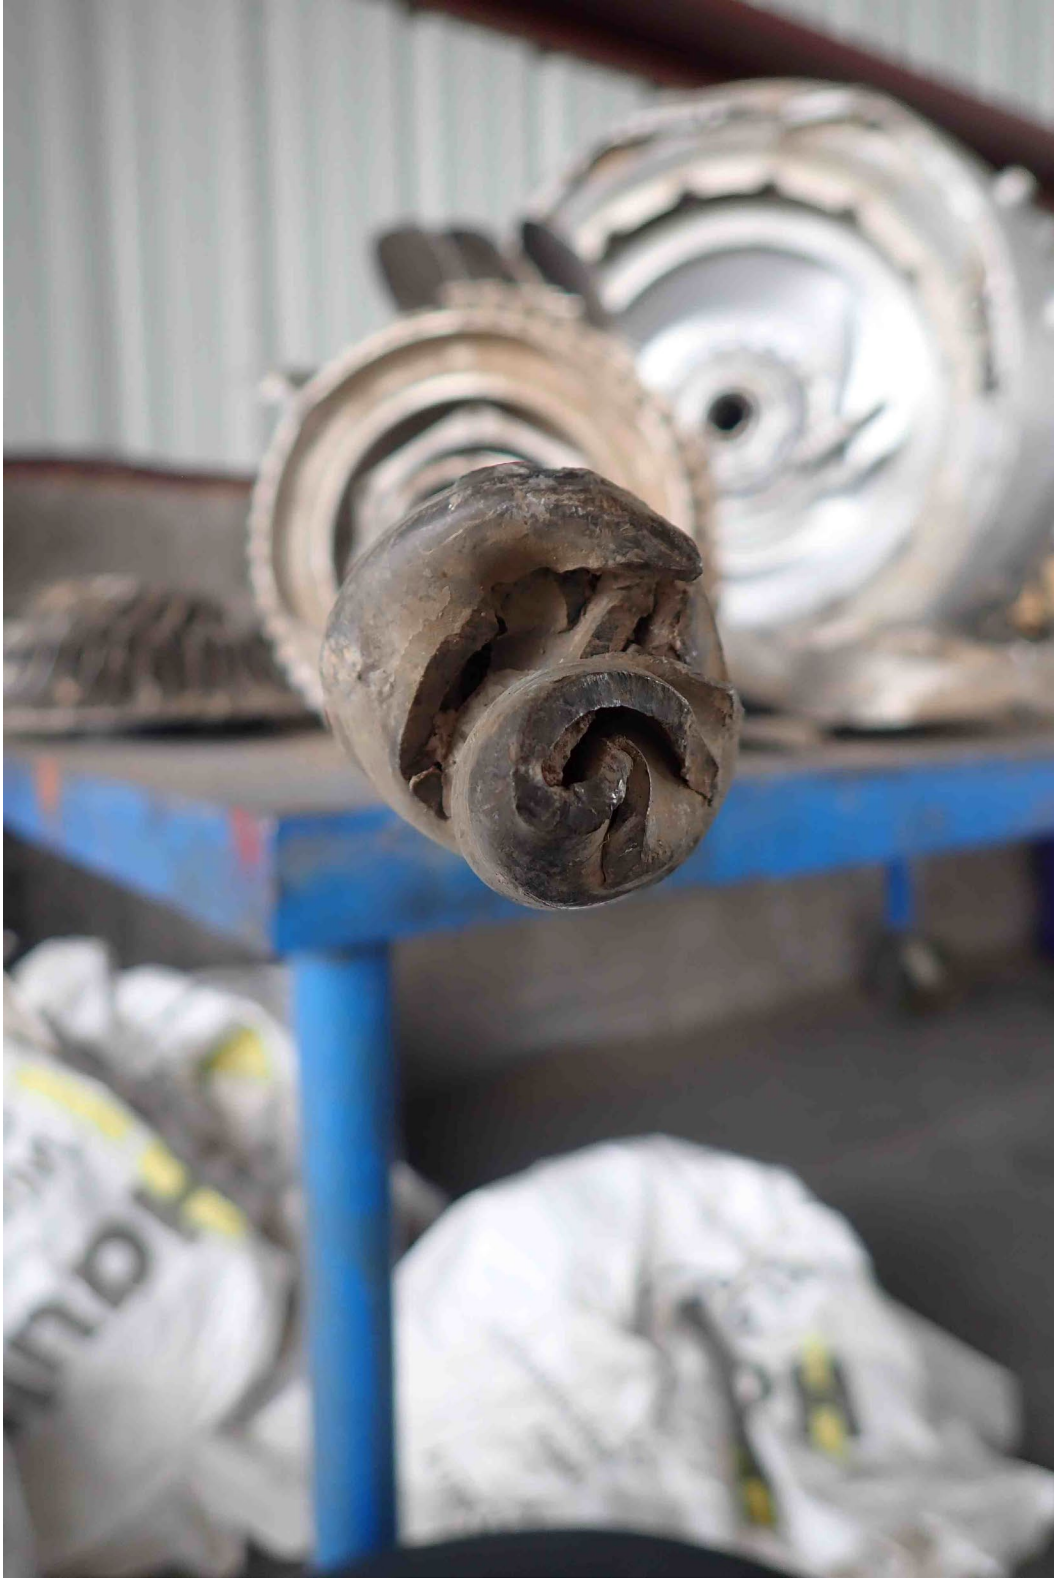
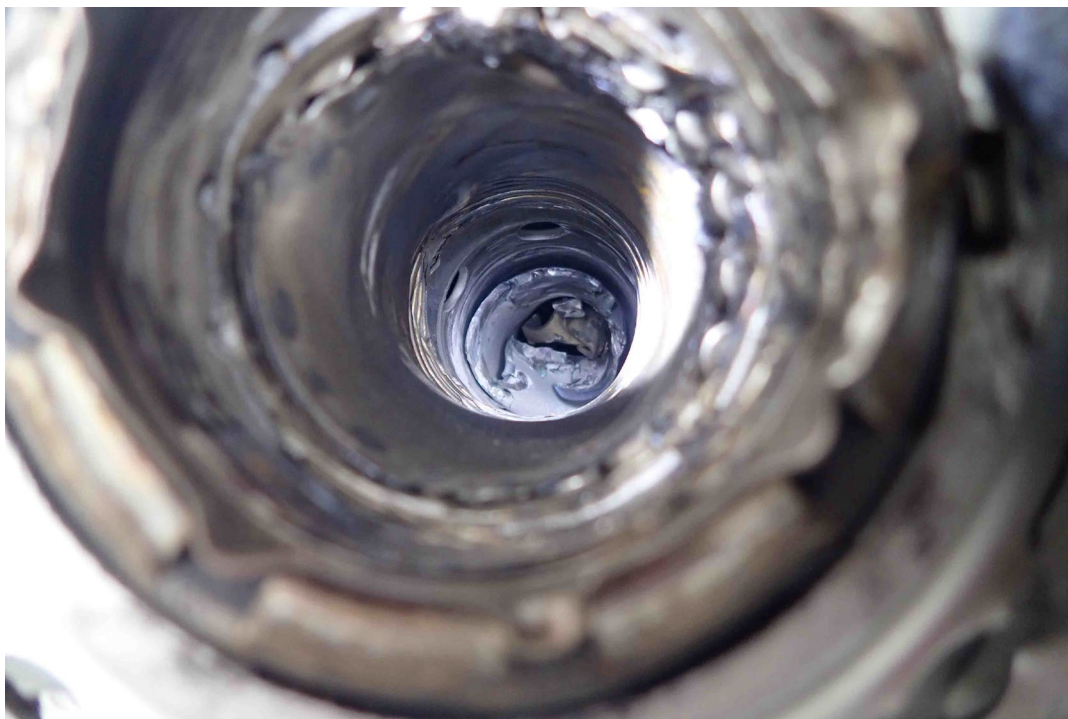
The drive shaft that connected the booster assembly to the low pressure turbine wheels had separated within the engine core. At the separation, the shaft exhibited twisting features and both failure surfaces, along with rotational scoring midspan (Photo 52, 55)

Photo 52 – Number 2 booster assembly driveshaft

Photo 55 – Number 2 drive shaft that connects the booster assembly to the low turbine wheel

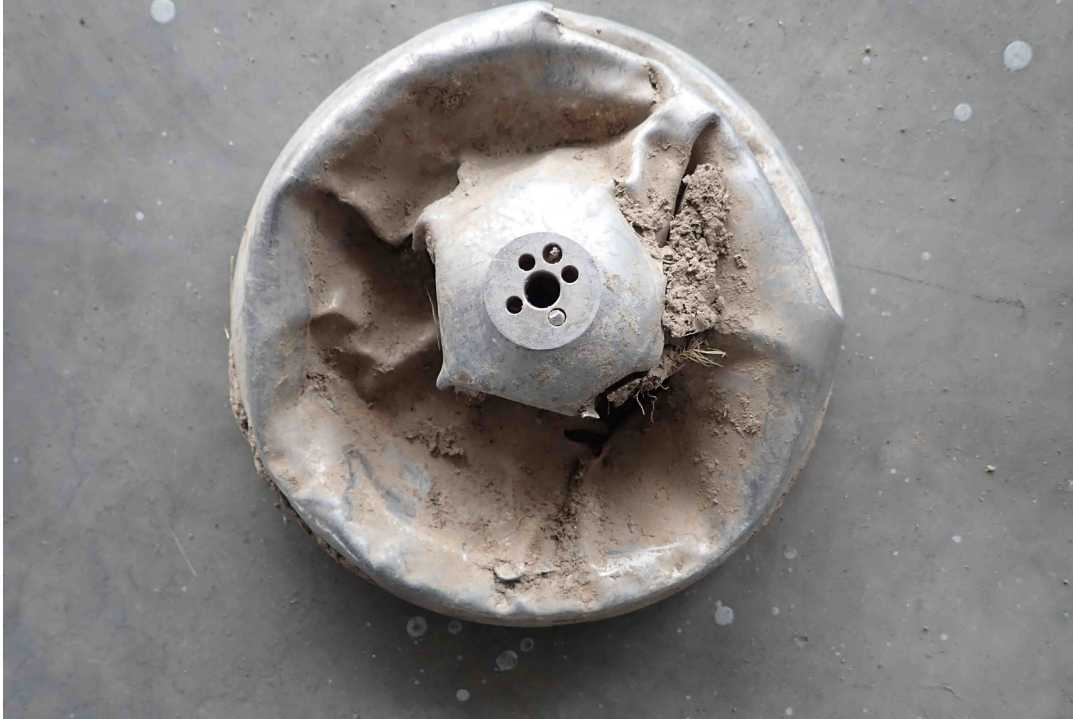
Photo 53 – Number 2 engine inlet cone

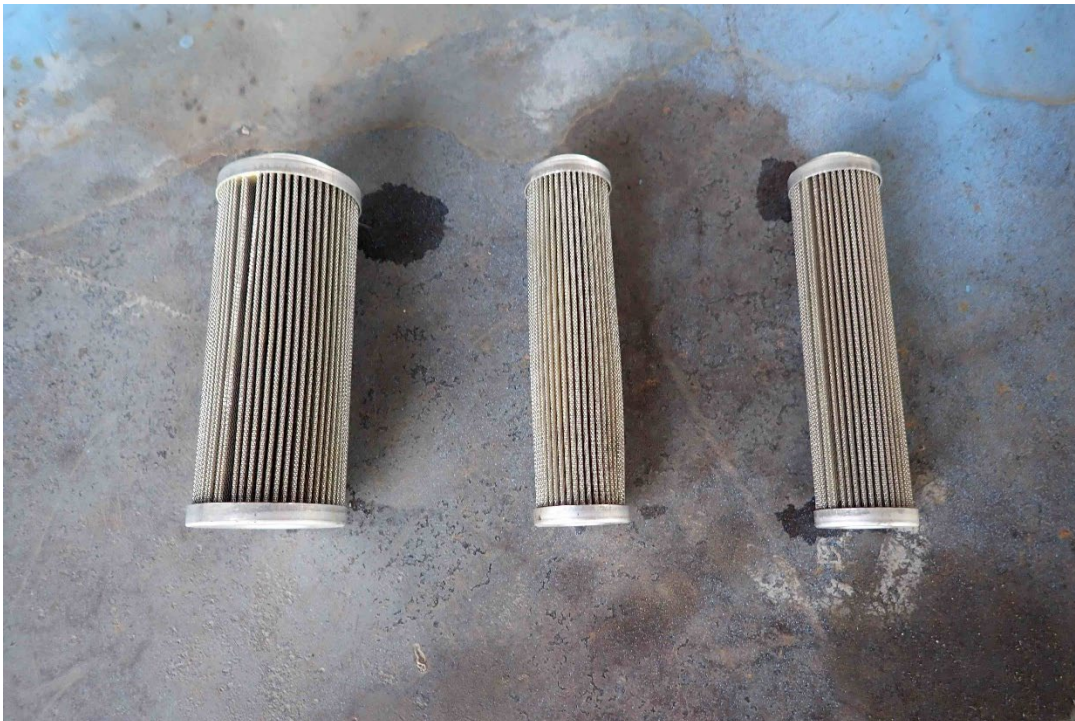
Two pressure line hydraulic filters, and one return line hydraulic filter were located. Disassembly revealed that the screens were free of visible debris. (Photo 54)

Photo 54 – Number 2 pressure and return hydraulic filters
