NATIONAL TRANSPORTATION SAFETY BOARD

AIRFRAME EXAMINATION

WPR21LA082

Location: Warm Springs, Oregon
Date: January 9, 2021
Aircraft: Cessna 560, N3RB
NTSB IIC: Elliott Simpson

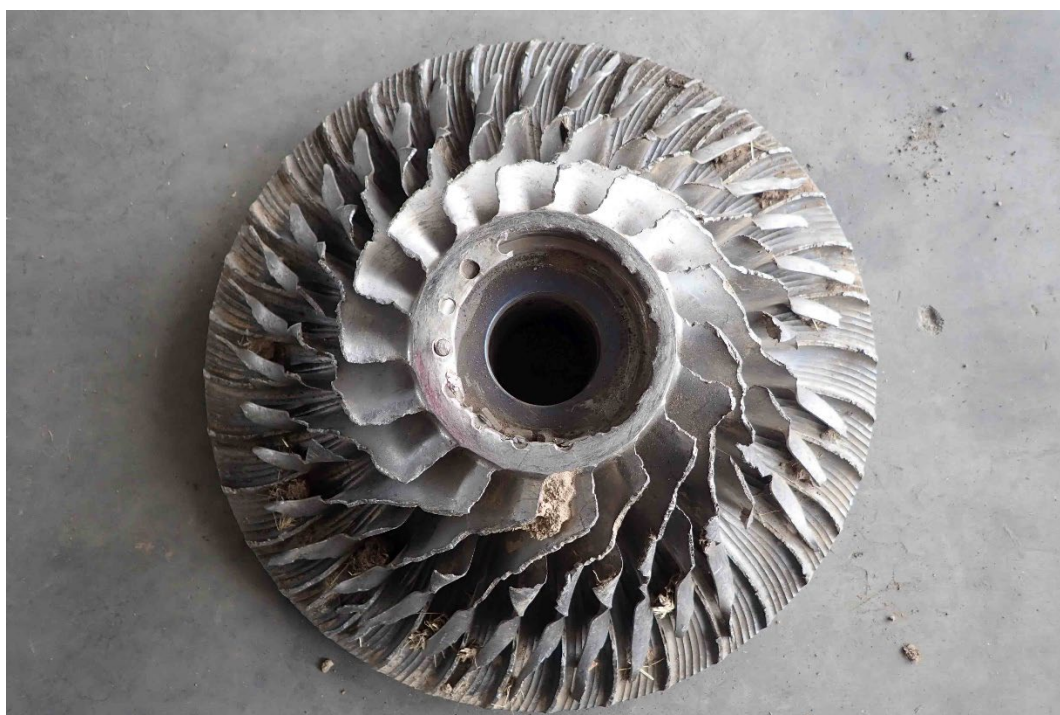
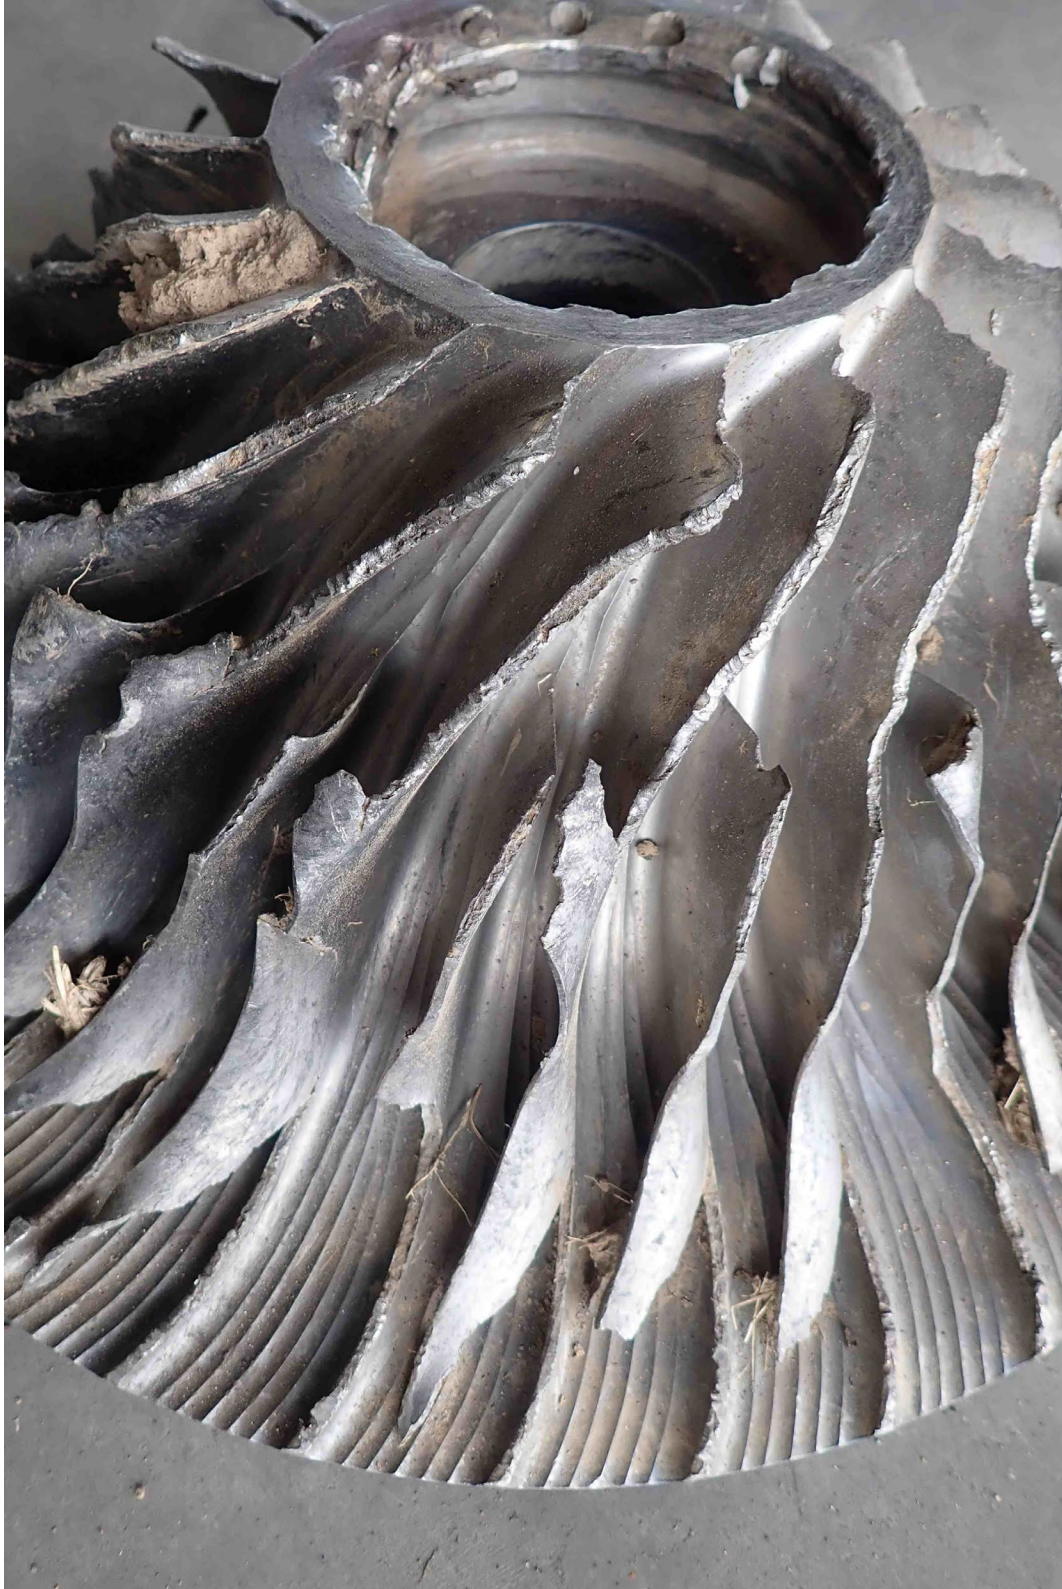
The high pressure compressor sustained extensive damage to its blades, (Photo 56) fragmenting them and rotating them opposite the direction of rotation (Photo 57). Rubbing, discoloration, and breakthrough were present on the corresponding inner surfaces of the compressor shroud (Photo 58, 59)

Photo 56 – Number 2 high pressure compressor

Photo 57- Number 2 high pressure compressor

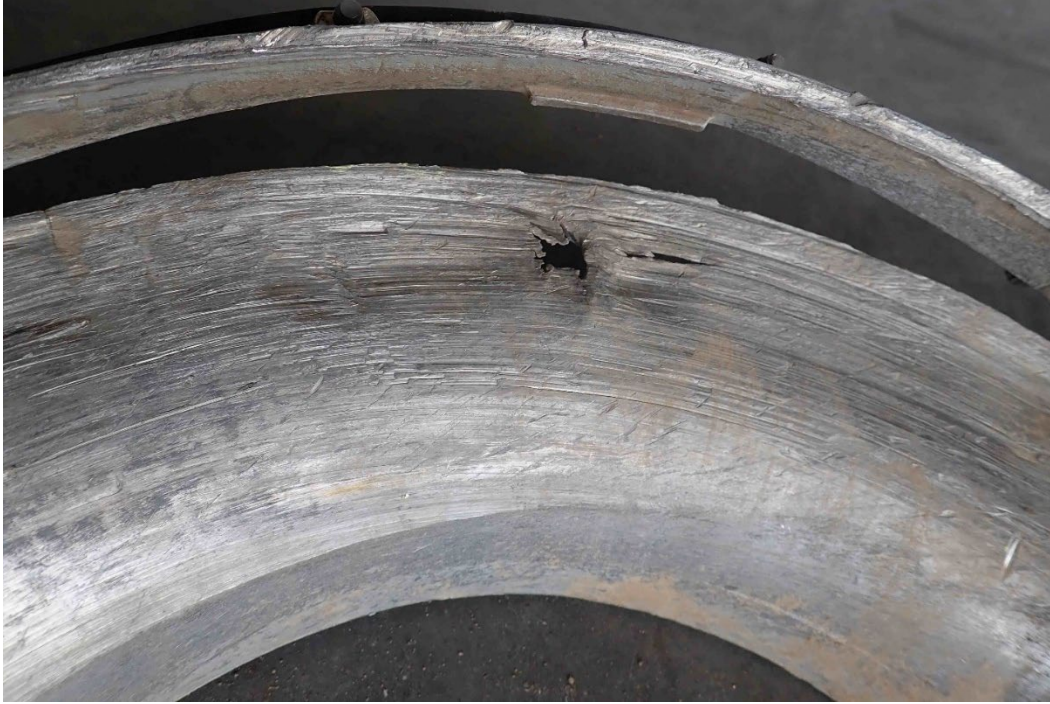
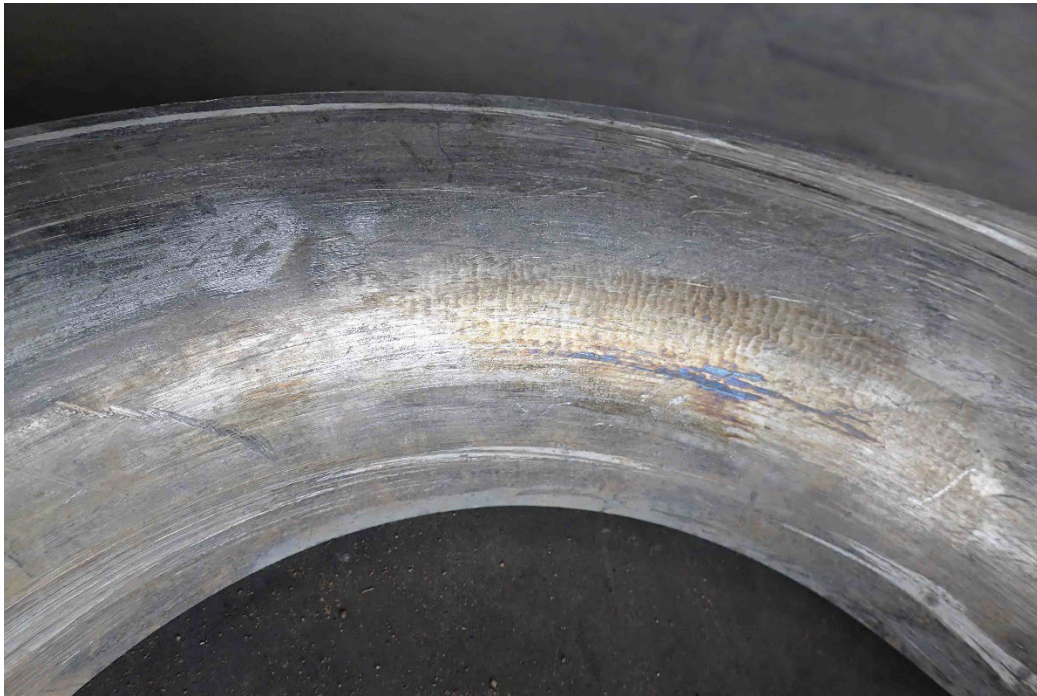
Photo 58 – Number 2 compressor shroud inner surface

Photo 59 - Number 2 compressor shroud inner surface

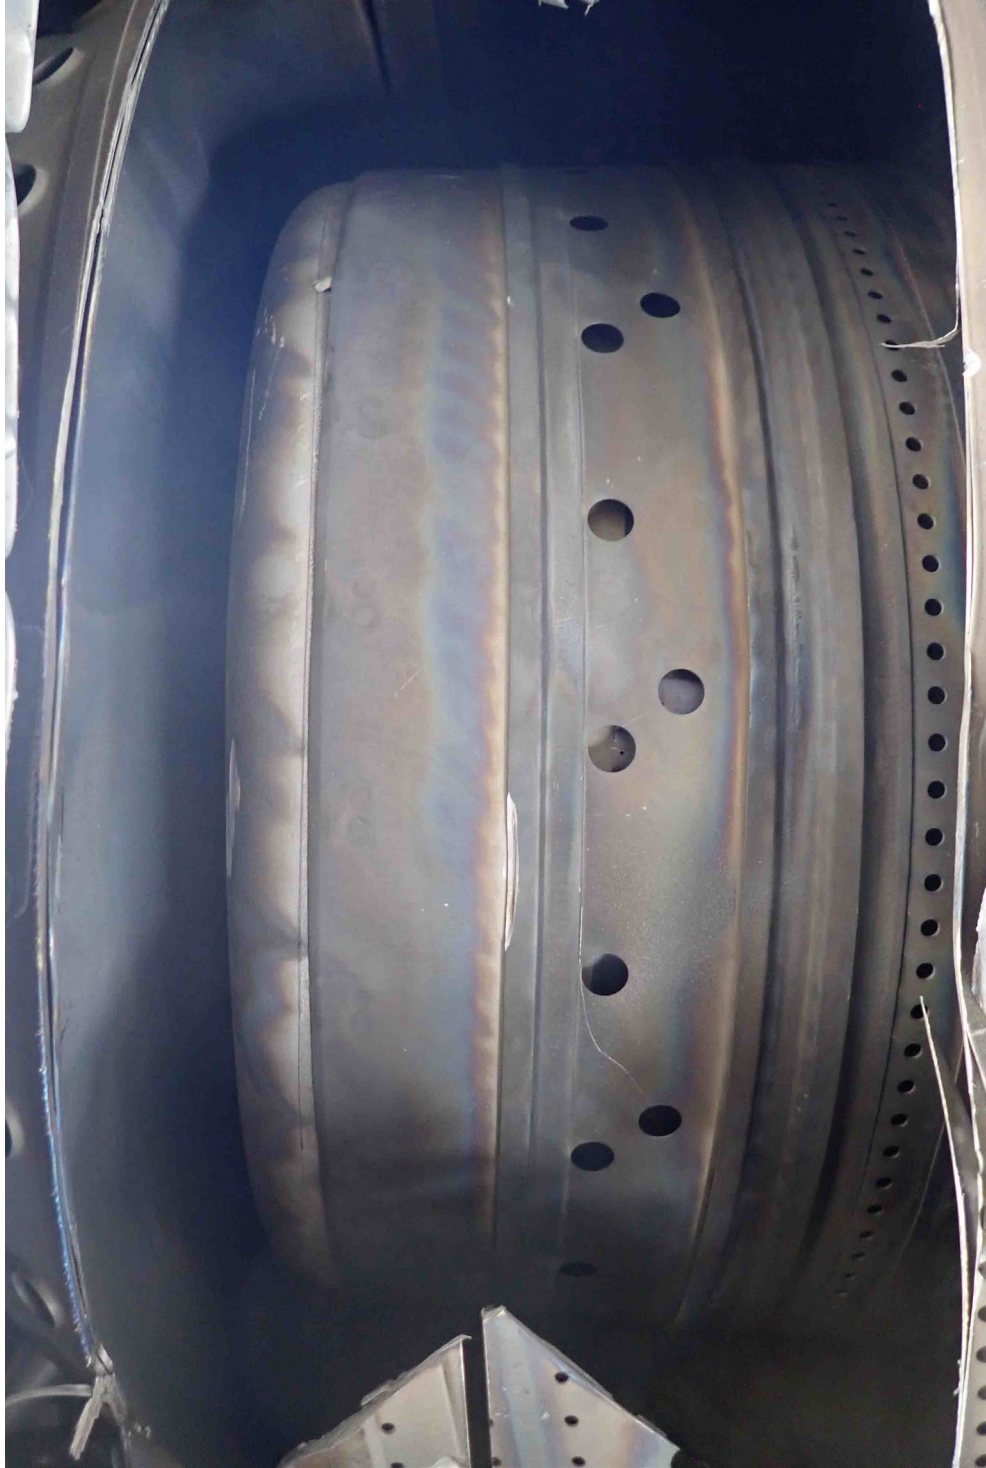
The gas generator stage was largely intact, and the gas generator case was opened revealing blade tip rubbing to the high pressure turbine (Photo 60).

Photo 60 – Number 2 gas generator case
