Hazardous Materials Group Factual Report

Operator: Union Pacific
Accident No.: RRD20LR005
Accident Type: Freight Train Derailment/Release/Fire
Location: Tempe, Arizona
Date of Accident: July 29, 2020

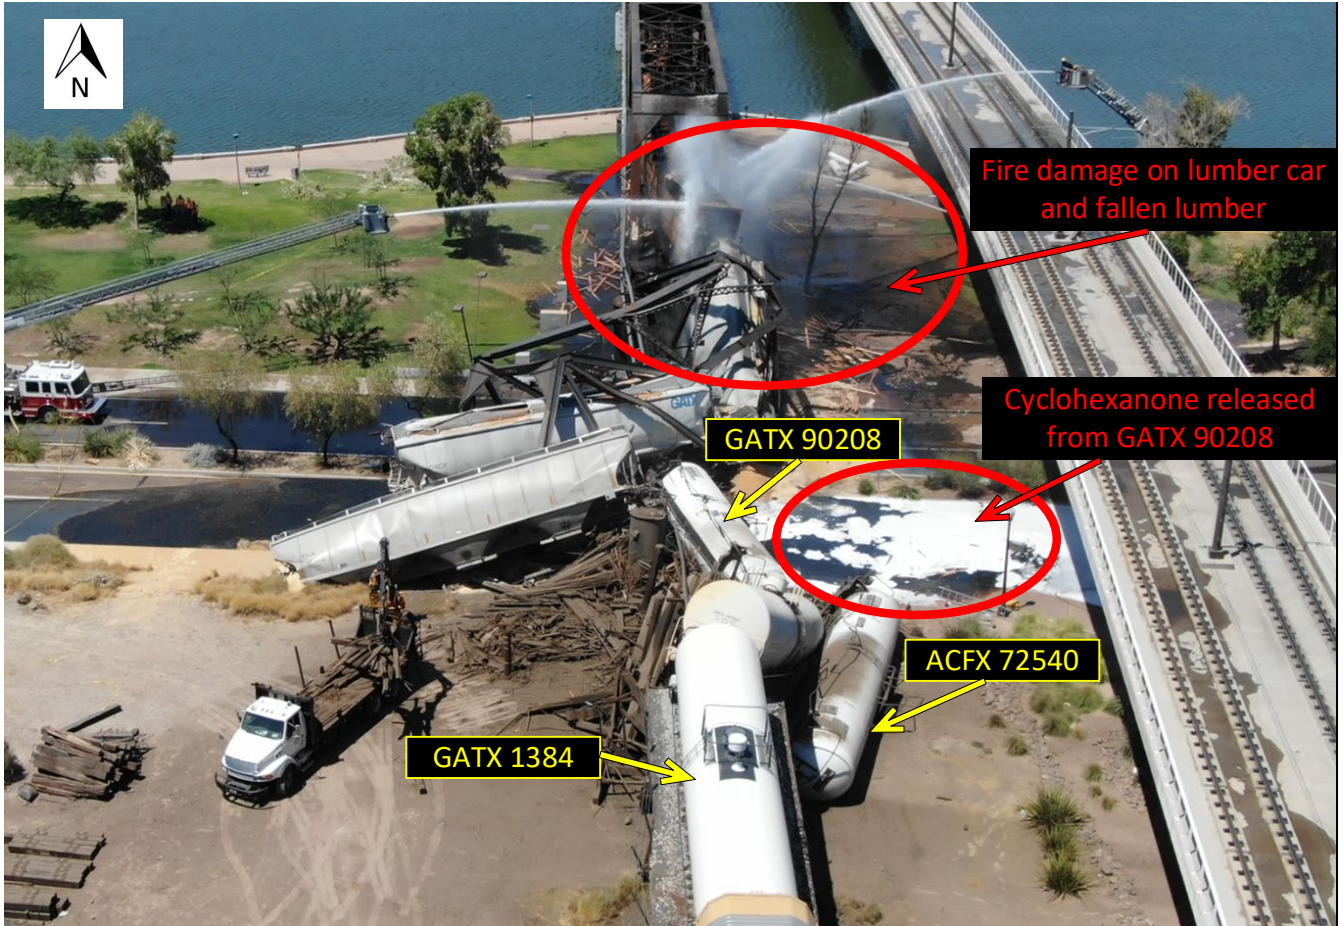
Figure 1: Drone footage of derailed cyclohexanone tank cars and fire damage

At the time of the accident, the three cyclohexanone cars had entered onto the bridge approach but not on the bridge itself. Two of the three cyclohexanone tank cars fell off the elevated track (GATX 90208 and ACFX 72540), and the third (GATX 1384) derailed, however, did not fall off the track. A non-hazmat, tank car loaded with latex liquid rubber was positioned between ACFX 72450 and GATX 1384 (see Figure 1).

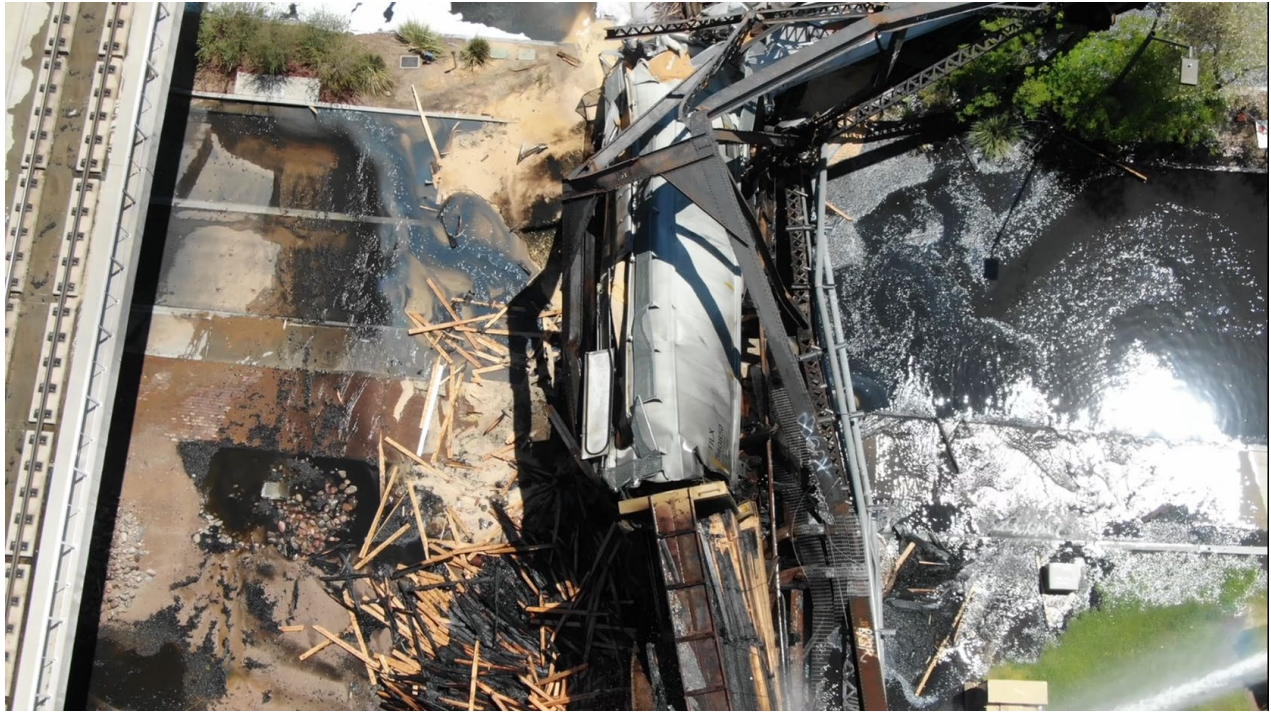
UP reported that 2,201 gallons of cyclohexanone released from GATX 90208. During the tank car examination and load transfers, GATX 90208 was the only car observed to have lost some of its lading that pooled on the ground on a roadway and was contained by the natural contours of the ground; sandbags were added for extra containment. The cyclohexanone was reported to not have impacted the waterway. On the day of the incident, hazardous material response teams stopped the leak at 5:30 p.m., had the tank car upright at 5:50 p.m., and was later staged at 7:30 p.m. The released cyclohexanone did not ignite (Figure 1). UP drone footage showed fire damage on the lumber car TTZX 862290 and its load that fell off the car (Figure 2).

Figure 2: Aerial view of burned lumber car TTZX 862290 in front of soybean car TILX 540850

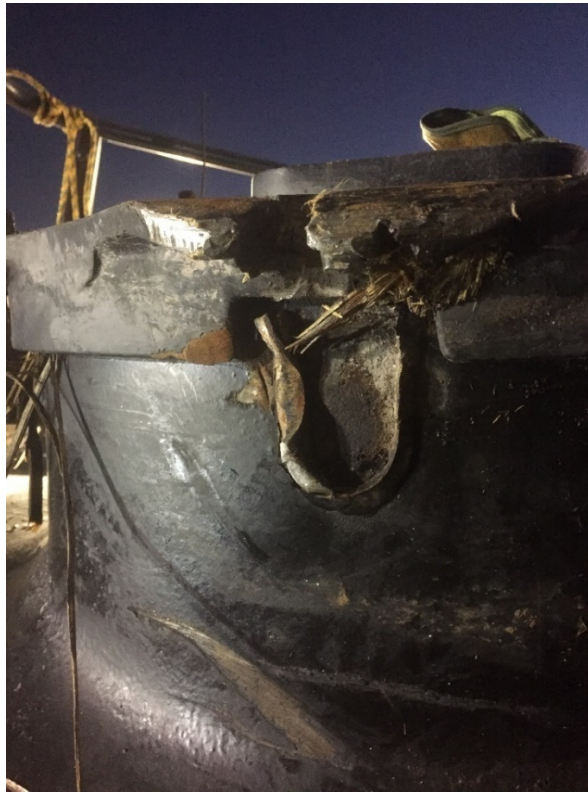
- Lading released 2201 gallons from the manway
- Missing swing bolt (Figure 3 and Figure 4)
- B-end stub sill bent
- BOV nozzle missing
- After derailment, laid to rest on its left side (Figure 1)

Figure 3: GATX 90208: missing swing bolt on manway (photograph courtesy of Union Pacific Railroad)

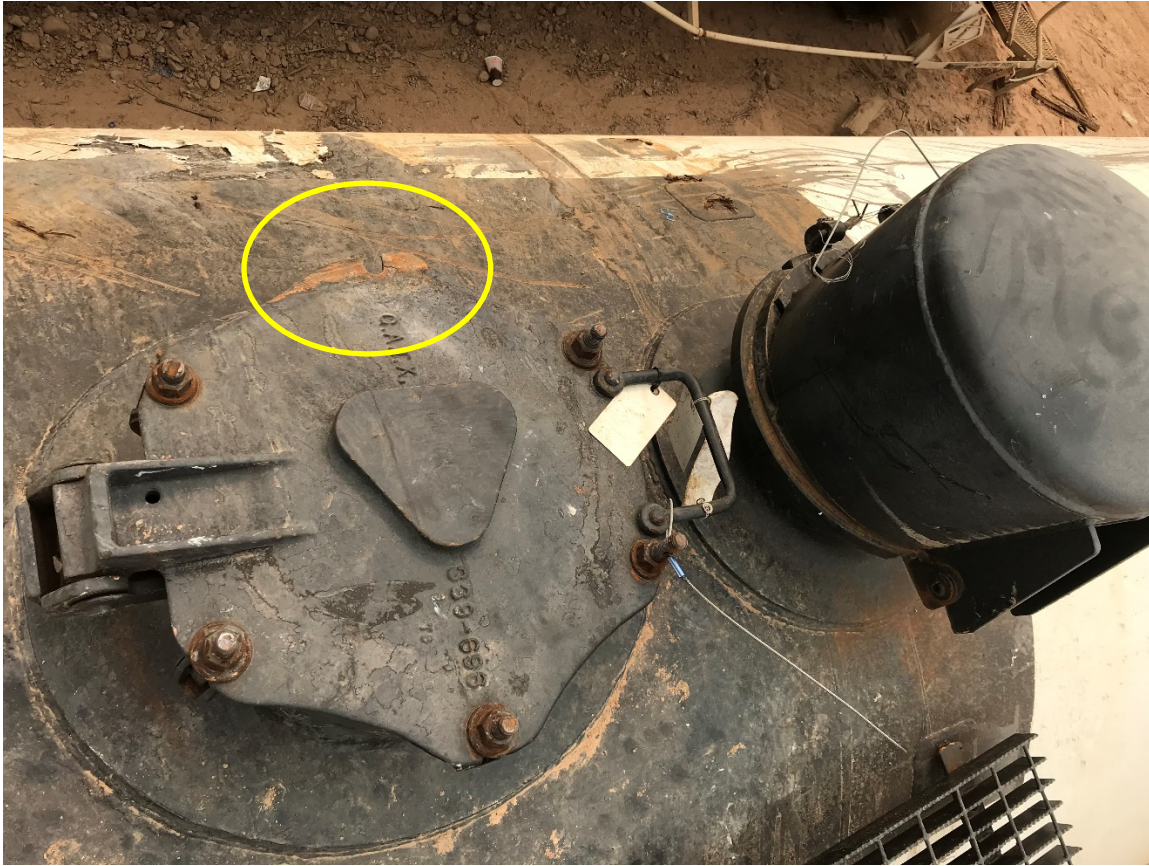
Figure 1: GATX 90208 PRD housing and manway with a missing bolt (circled yellow) (photograph courtesy of FRA)

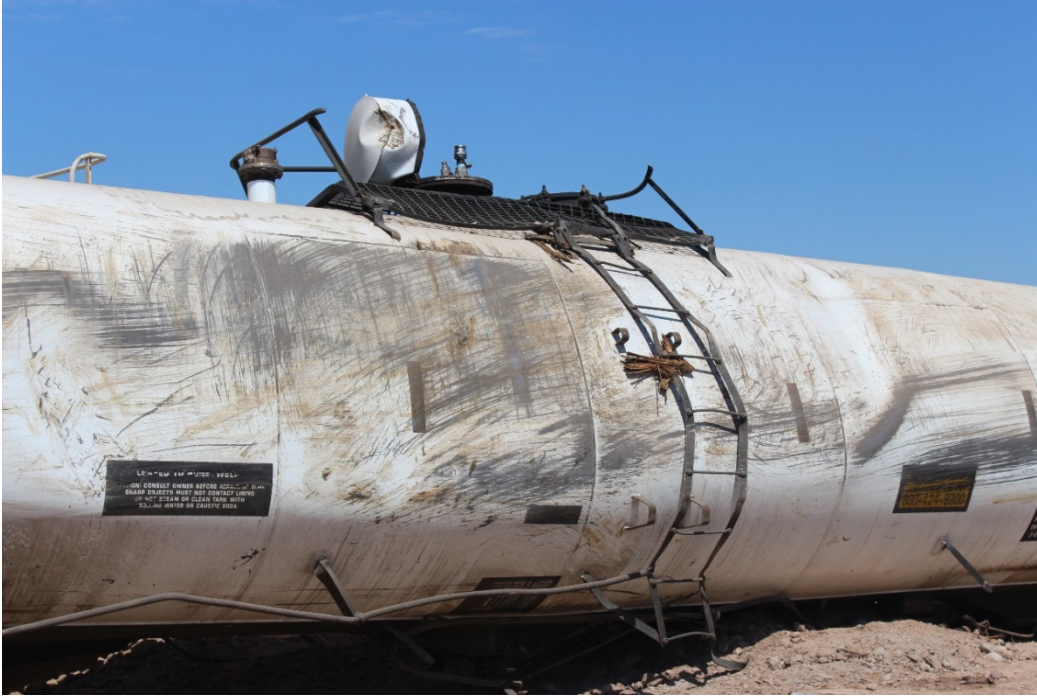
- No lading released
- Several dents on the left side of the tank car shell
 - 64 in (length) x 58 in (height) x 1 ft 2 in (depth)
 - 60 in (length) x 24 in (height) x 2 ft 3/8 in (depth)
 - 16 in (length) x 12 in (height) x 3/16 in (depth)
- Dent on the protective housing, 60 in x 24 in x 2 ft 3/8 (Figure 5)
- After derailment, tank car laid on its left side, B-end leading (Figure 6)

Figure 5: ACFX 72540: Dents on left side and PRD housing (photograph courtesy of PHMSA)

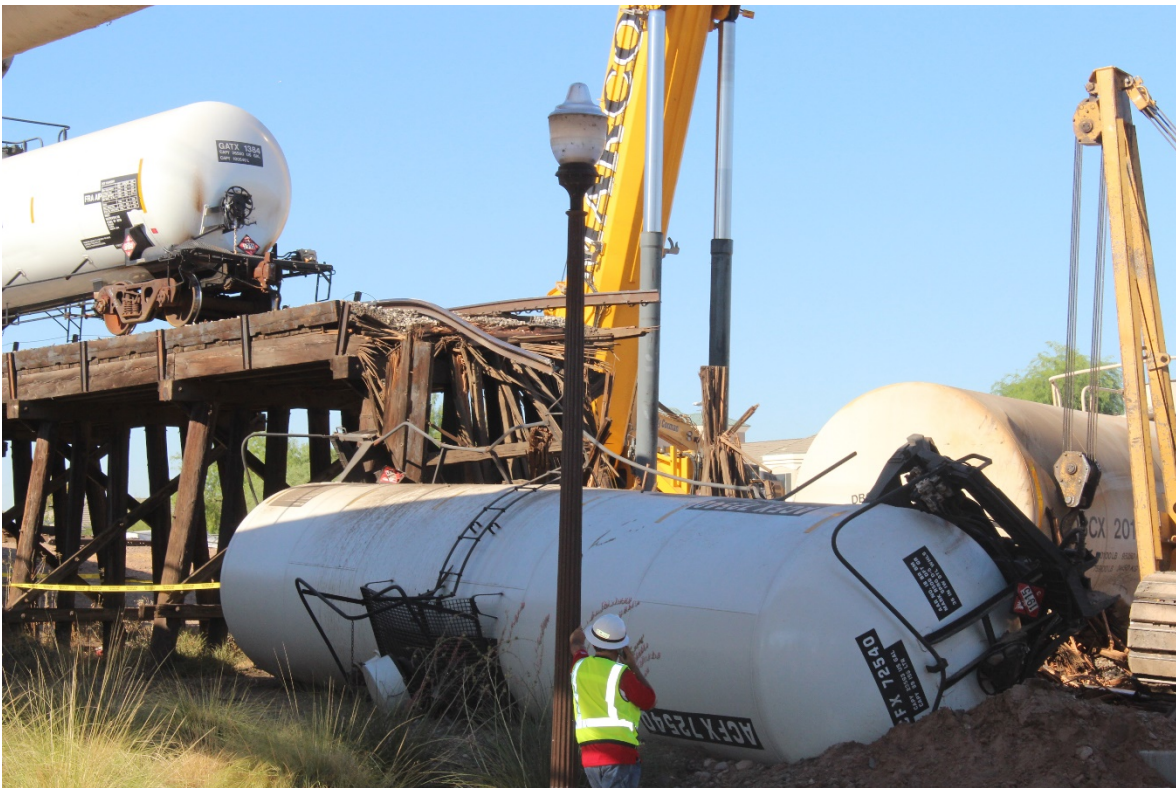
Figure 6: ACFX 72450 post-derailment position before staging (photograph courtesy of PHMSA)

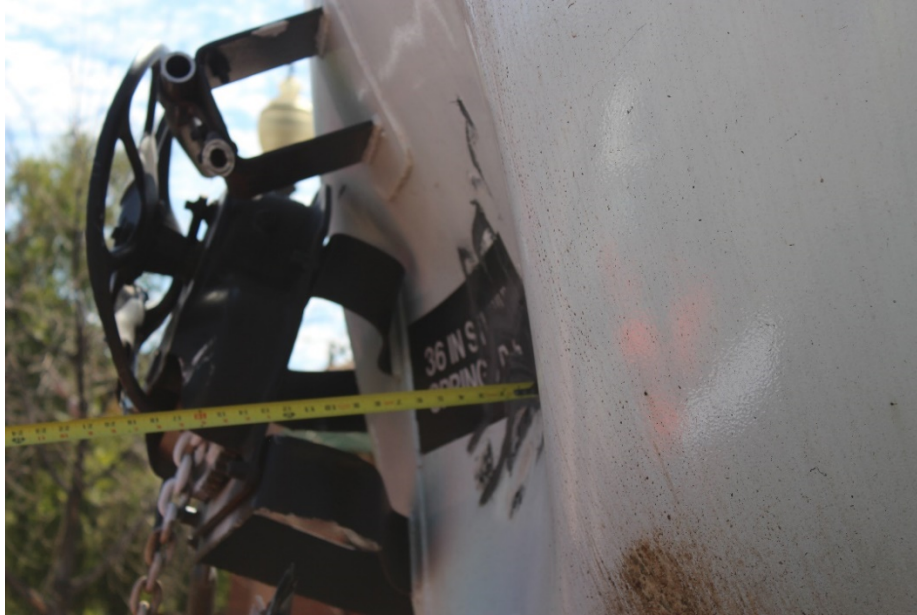
- No lading released
- Dent on the B-end head measured 44 in (length) x 42 in (width) x 7 in (depth) (See Figure 7)

Figure 7: GATX 1384: Dent on the B-end head (photograph courtesy of PHMSA)
