National Transportation Safety Board

ERA23FA033

FUEL SYSTEM EXAMINATION SUMMARY

Location: Keene, New Hampshire
Date: October 21, 2022
Time: 1845 EDT
2245 coordinated universal time (UTC)
Airplane: N8020R, Beech A24R

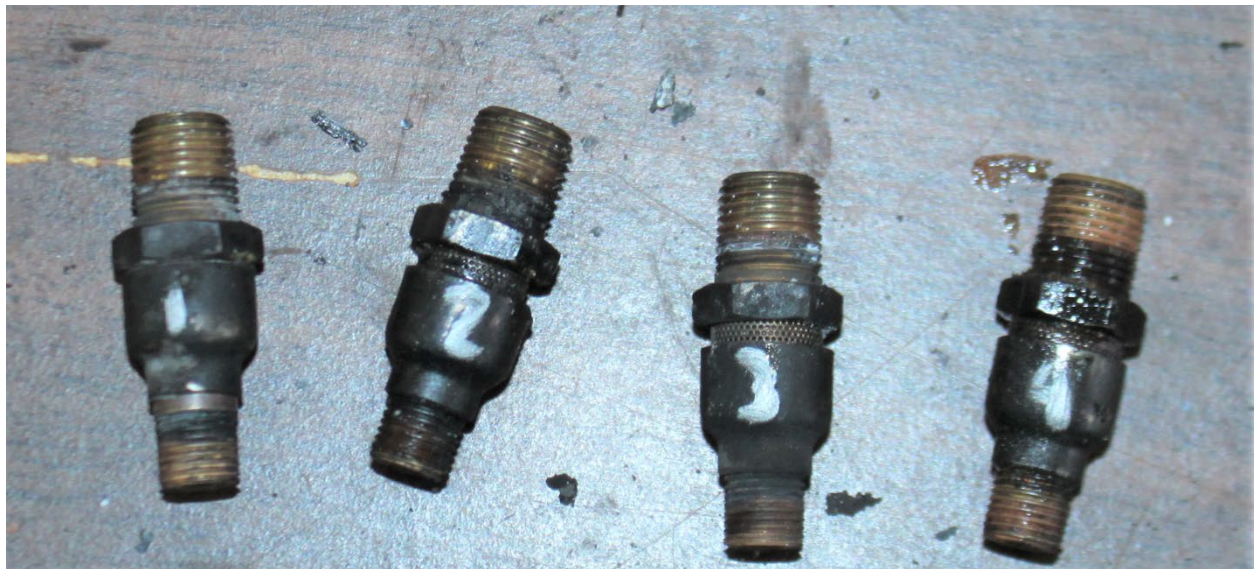
During postaccident examination of the engine, the fuel injector nozzles were removed from each cylinder and none had an insert or restrictor installed.

Figure 1: Close-up Examination of the Fuel Injector Nozzles After Removal from Engine. Note the lack of an insert or restrictor on the lower portion of each nozzle.

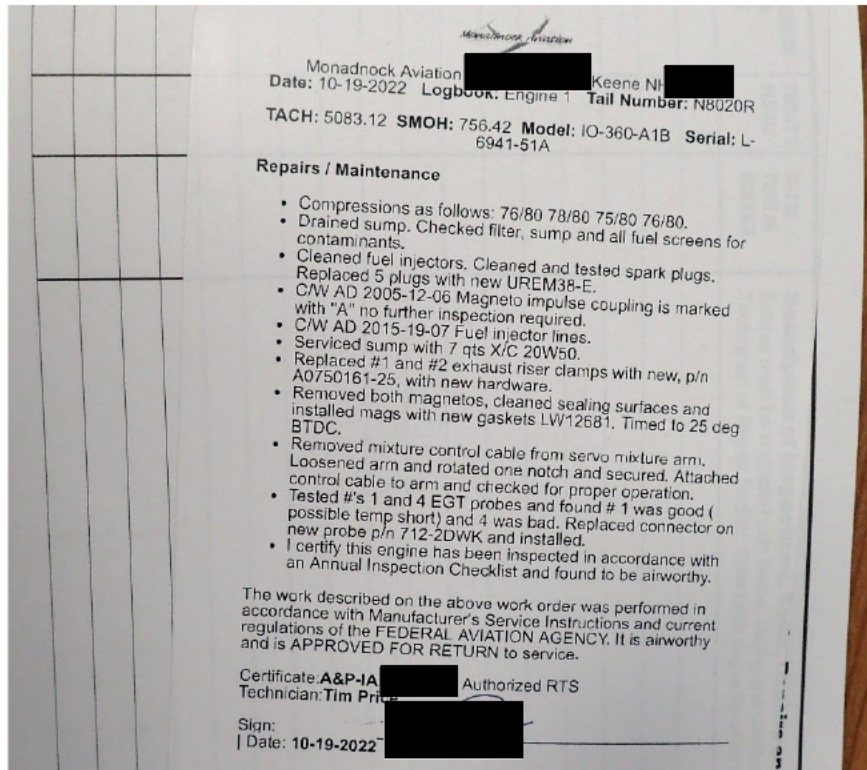
Between July 18, 2016 and June 10, 2022, there was no entry indicating the fuel injection servo was removed, replaced, or repaired. The last entry in the Engine logbook dated October 19, 2022, indicated that the fuel injectors were cleaned. The same entry also indicated that the mixture control cable was removed from the mixture lever at the fuel injection servo, the lever was loosened and rotated one notch, and then the lever was secured, the mixture control cable reattached, and was checked for proper operation.

Figure 5: Entry for Fuel Injector Nozzles Cleaning and Fuel Injection Servo work.

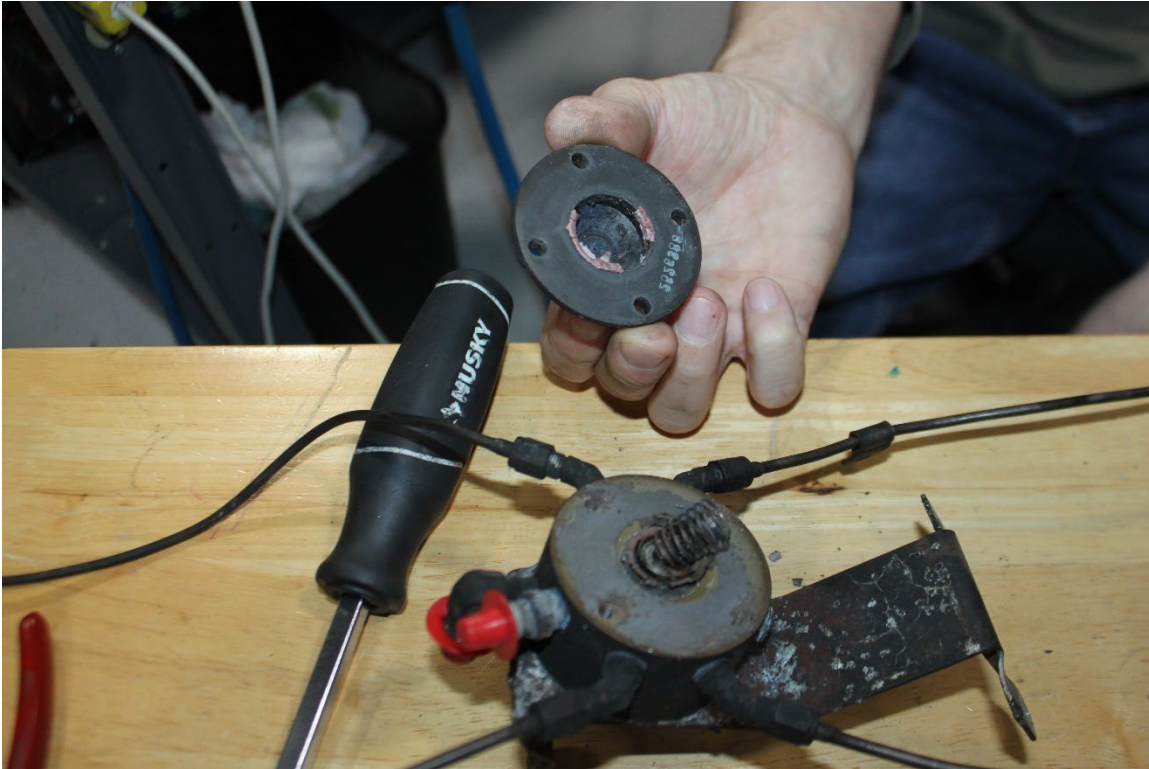
Examination of the manifold valve (P/N) 2524232-2, Lycoming P/N 2524232-2-70, serial number (S/N) ACA²8012, revealed it sustained heat damage that precluded operational testing. The cover screws were in-place and safety wired but there was no lead seal present. During removal of the screws no torque was present. Following removal of the cover the diaphragm was nearly completely destroyed.

Figure 6: View of the Manifold Valve Following Removal of the Cover. Note the Heat Destroyed Diaphragm.

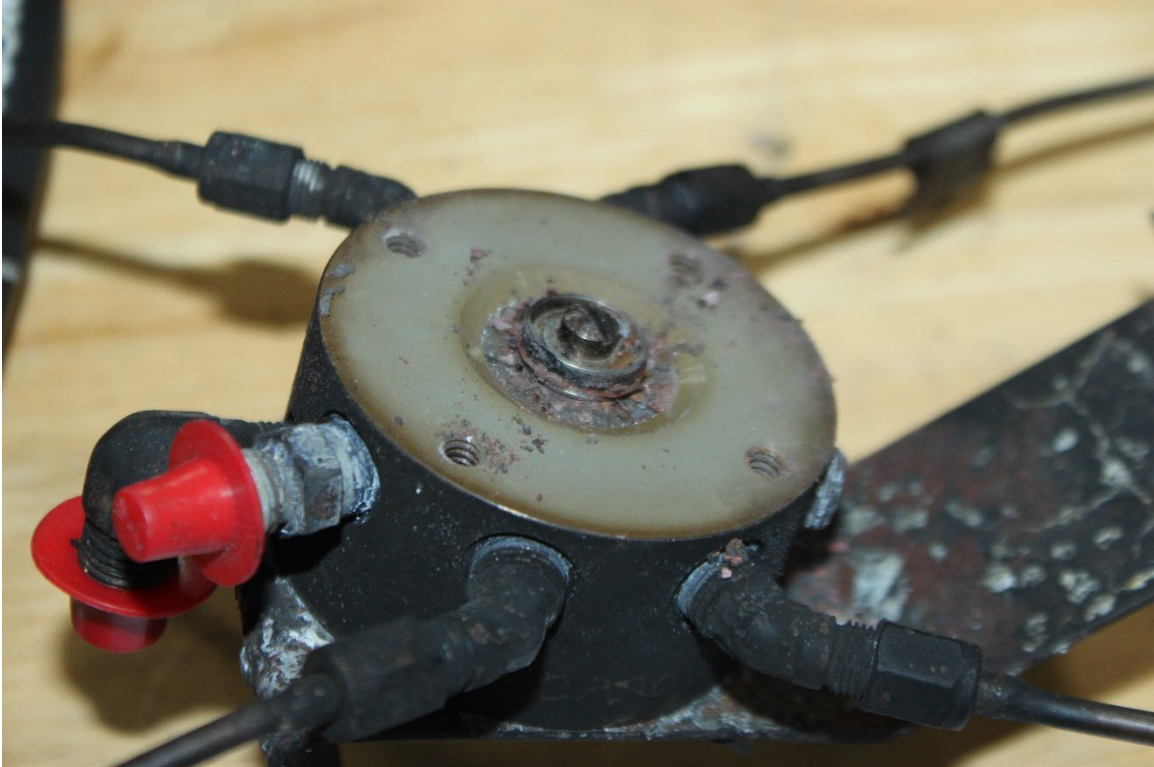
The diaphragm P/N (2526388) was displayed in reverse on the interior of the cover. A 2 psi spring was installed (correct). The spool P/N A1598 was in the fully closed position, and no gouges were noted to it.

Figure 7: View of the Spool in the Fully Closed Position.

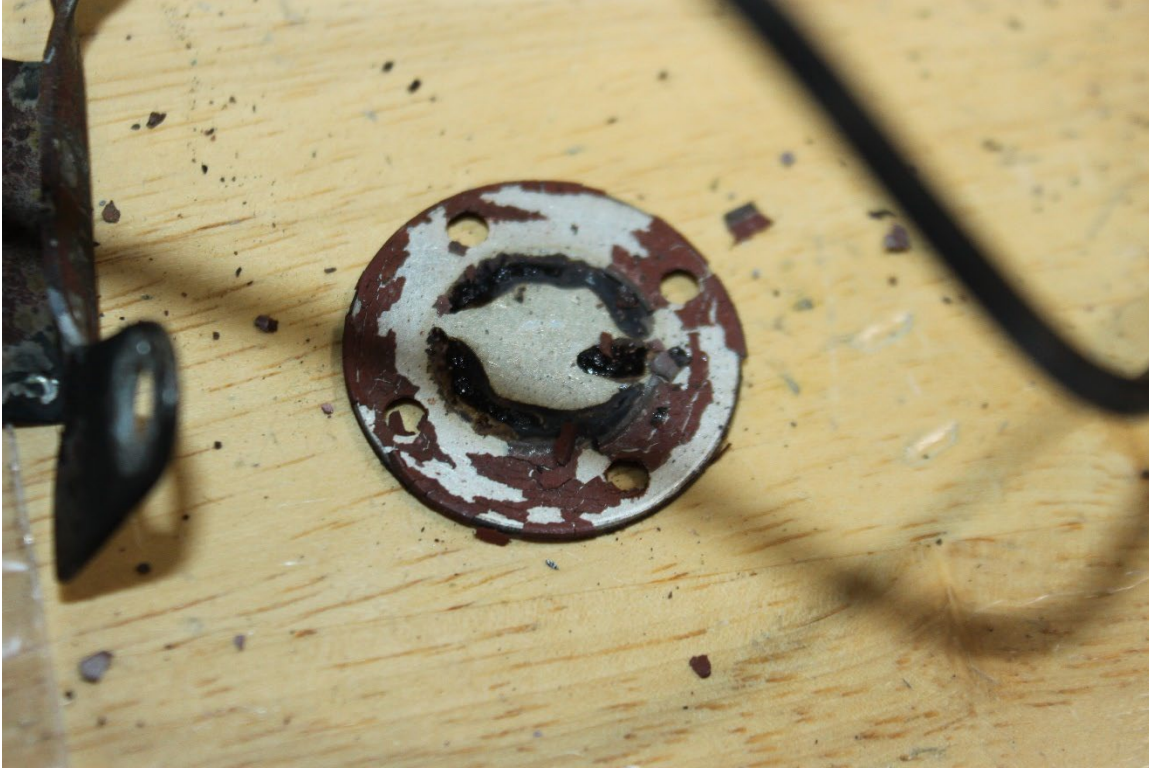
During removal of the cover debris from the heat damaged diaphragm dropped into the bushing area. To facilitate removal of the spool the bracket cover was removed to access the bushing. During removal of the screws, they were noted to be loose (likely due to damage to the gasket).

Figure 8: View of the Heat Damaged Gasket Following Removal Of the Bottom Cover of the Manifold Valve.

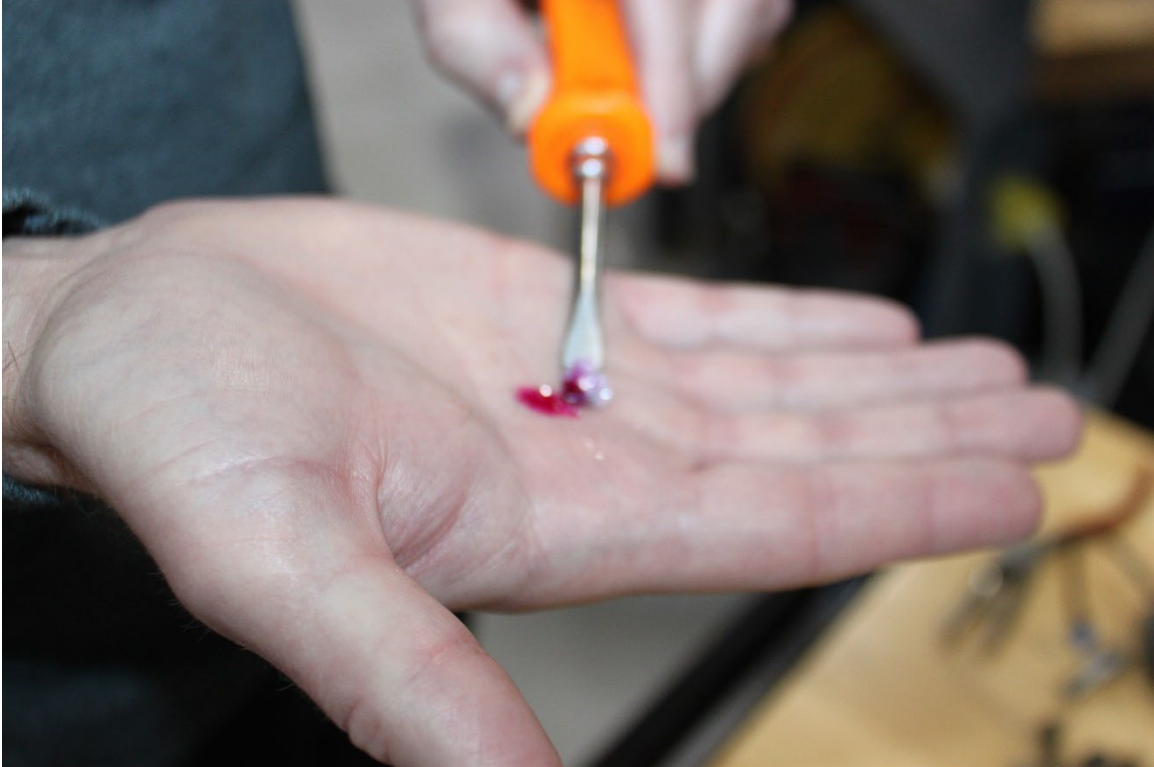
No. 4 - Liquid was ejected from the line onto a bench before sample taken. An additional sample was blown into the palm of a hand and tested to be water using Water Finding Paste. The sample was retained for testing by the NTSB Materials Laboratory for fluoride, though testing was never performed³.

Figure 9: View of the Liquid Drained From the No. 4 Fuel Injector Line and the Positive Results when Tested with Water Finding Paste.

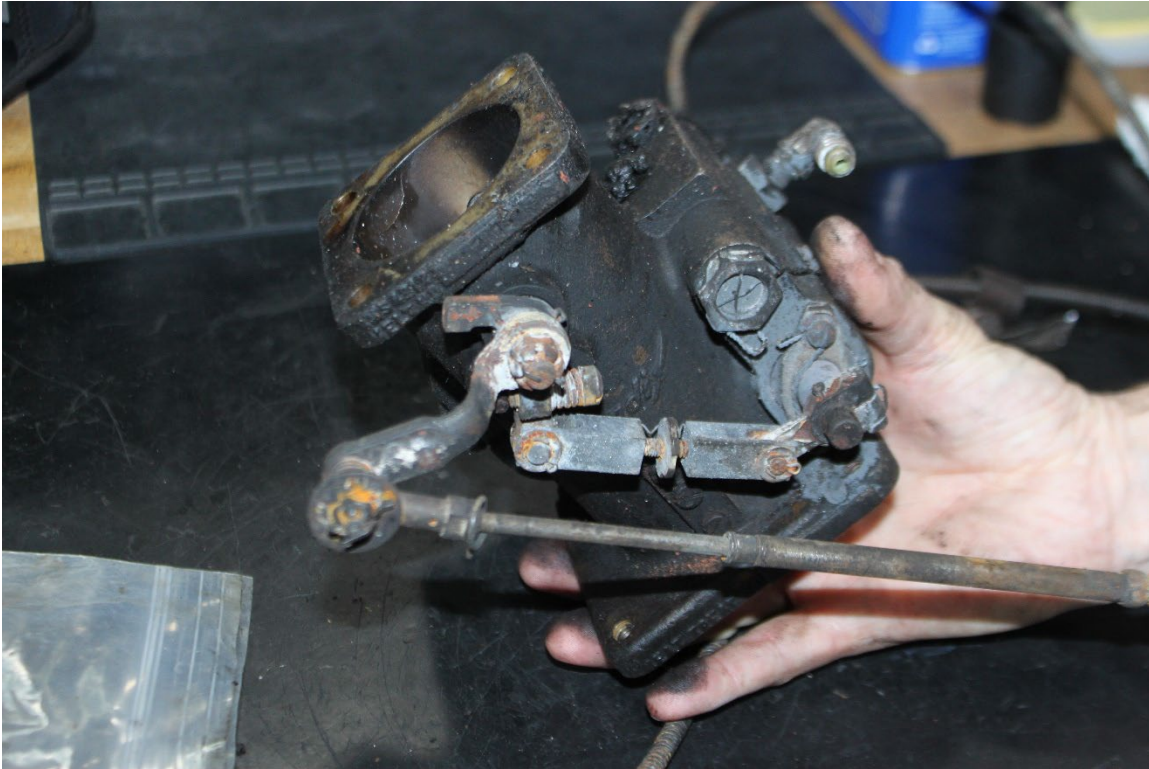
Examination of the servo fuel injector (fuel injector) model RSA-5AD1, parts list 2524054-11, S/N 72GM1907 revealed it sustained heat damage which precluded operational testing.

Figure 10: View of the Heat Damaged Fuel Injector.

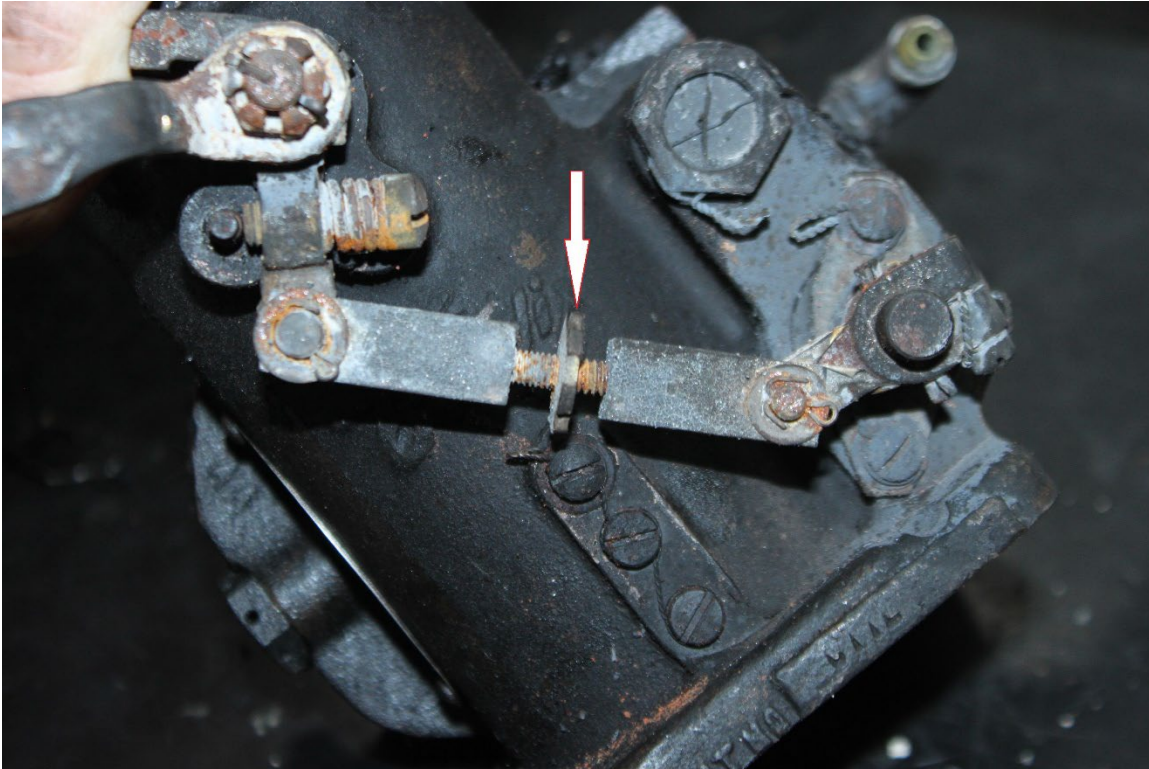
The throttle and mixture controls were tightly attached. The mixture control moved freely but the throttle control was frozen in the idle position. The hex plug was stamped with "G" indicating compliance with Precision Airmotive LLC Service Bulletin PRS-107, dated July 16, 2008, and Federal Aviation Administration (FAA) Emergency Airworthiness Directive (AD) 2008-06-51, issued March 12, 2008. The regulator cover was safety wired with a lead seal present; the lead seal was marked with "PAM" which was consistent with Precision Airmotive. The idle mixture adjustment was towards a slightly lean position. A crack was noted in the bore (likely impact). The venturi was removed and no blue stain was noted. All 3 packings were cracked due to the fire. All impact tubes were clear.

Figure 11: Arrow Points to Idle Mixture Adjustment Towards a Slightly Lean Condition.

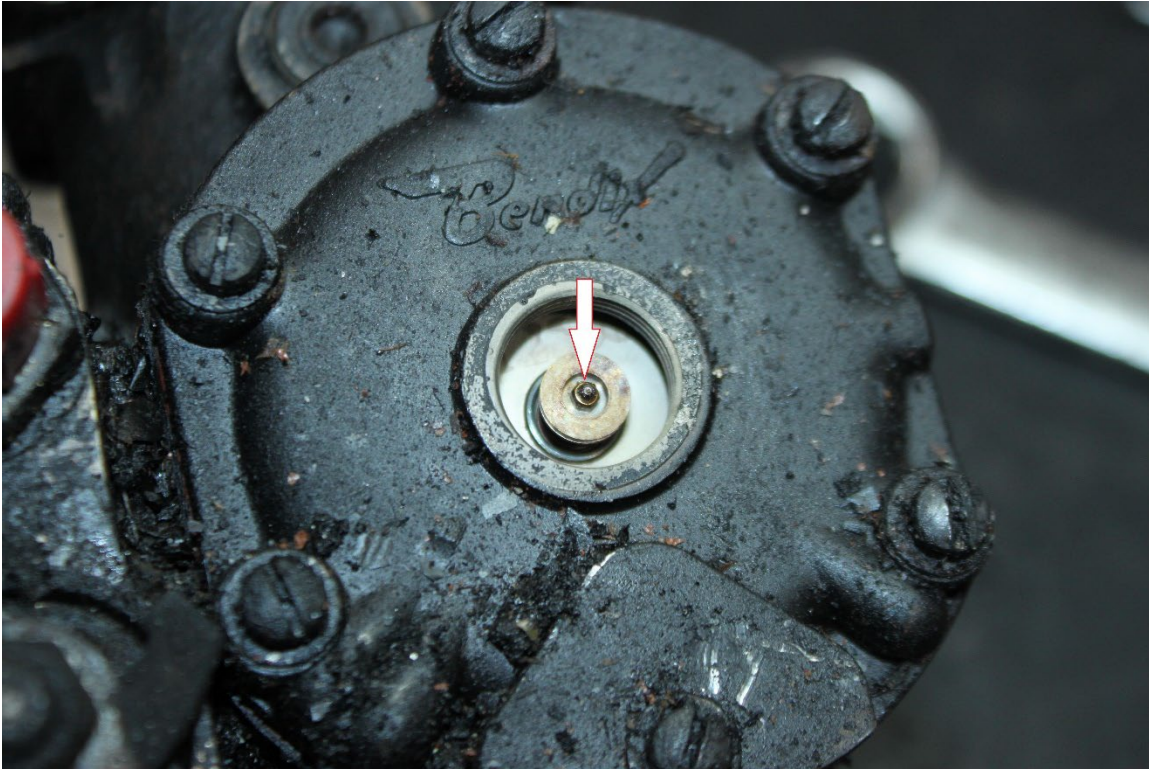
The regulator screws were within limits but the cover was loose. The remains of aluminum from the aluminum coated gasket was found beneath the regulator hex plug. Following removal of the regulator hex plug, the self-locking nut was in place on the fuel diaphragm stem and 2 threads were extended beyond the end of the nut. The nut was torque checked with a calibrated wrench⁴ and the tightening torque check of the nut was within limits. The regulator appeared to be hanging up.

Figure 12: Arrow Points to Self Locking Nut on End of the Fuel Diaphragm Stem. Note 2 threads of the Stem extended Beyond the Nut.

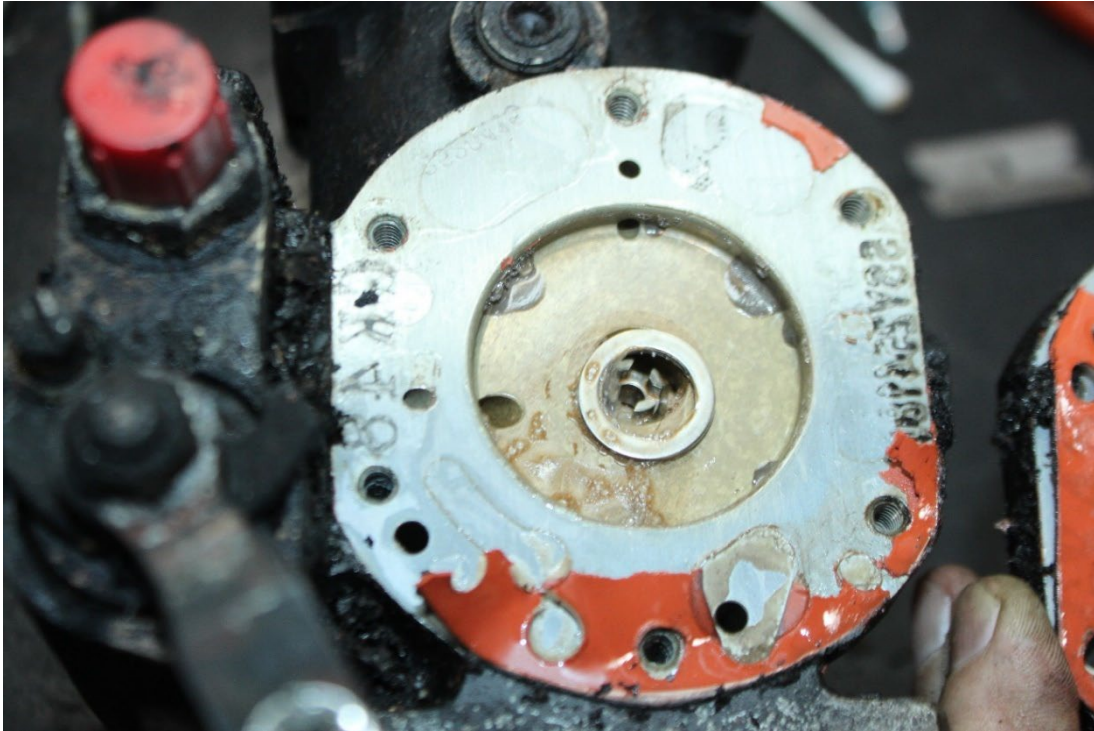
The fuel diaphragm appeared to move freely. The regulator valve seat was destroyed by fire. The unmetered side of the fuel diaphragm had evidence of internal contamination on the bottom side of the regulator section as installed on the engine. The passage connecting the metered and unmetered fuel diaphragm was clear. The path between the fuel regulator section to the outlet fitting was free of obstructions.

Figure 13: Fuel Regulator Area Depicting the Heat Destroyed Regulator Valve Seat.

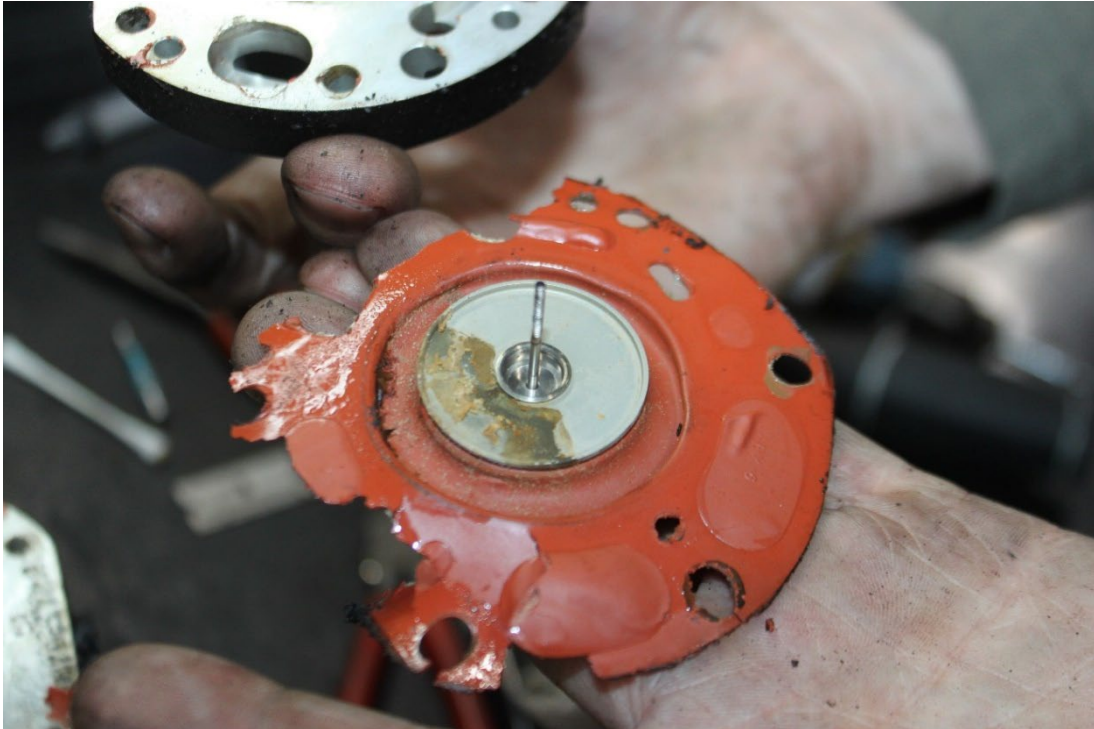
Figure 14: View of the Unmetered side of the Fuel Diaphragm showing Contamination.

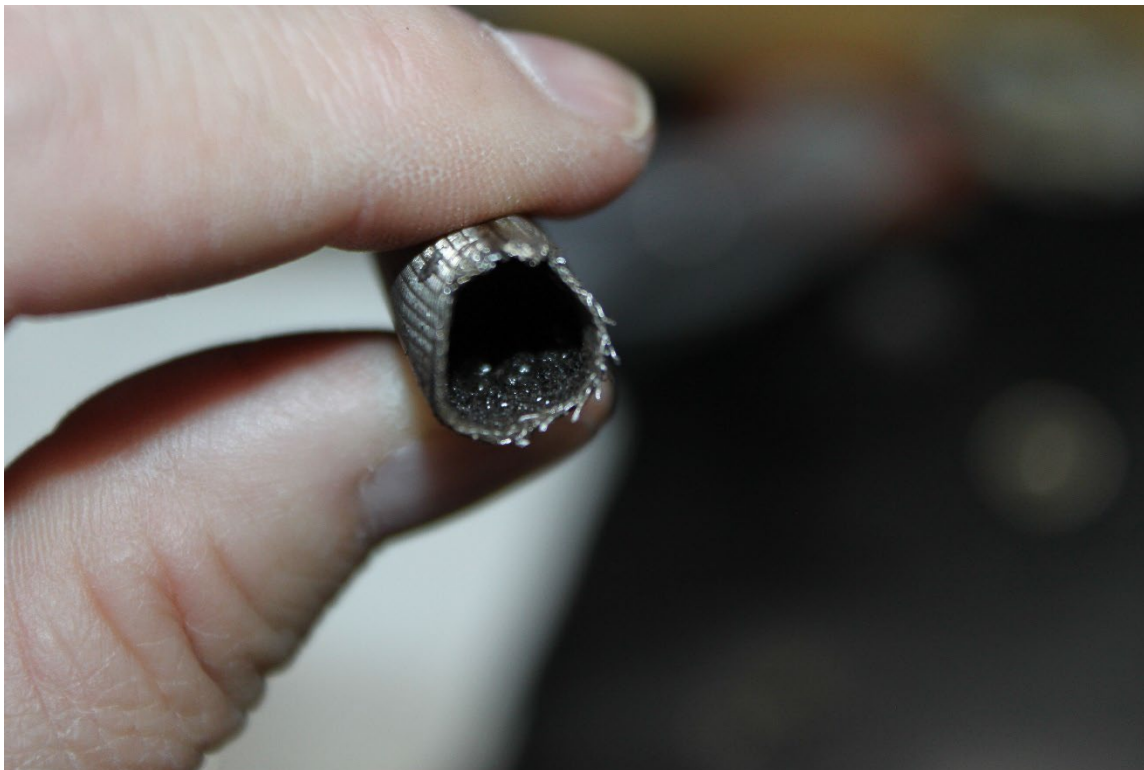
The inlet screen which had been previously removed exhibited slight contamination on inside. The screen was cut open to access the inside.

Figure 15: View of the Inlet Screen After Cutting Showing Slight Contamination.

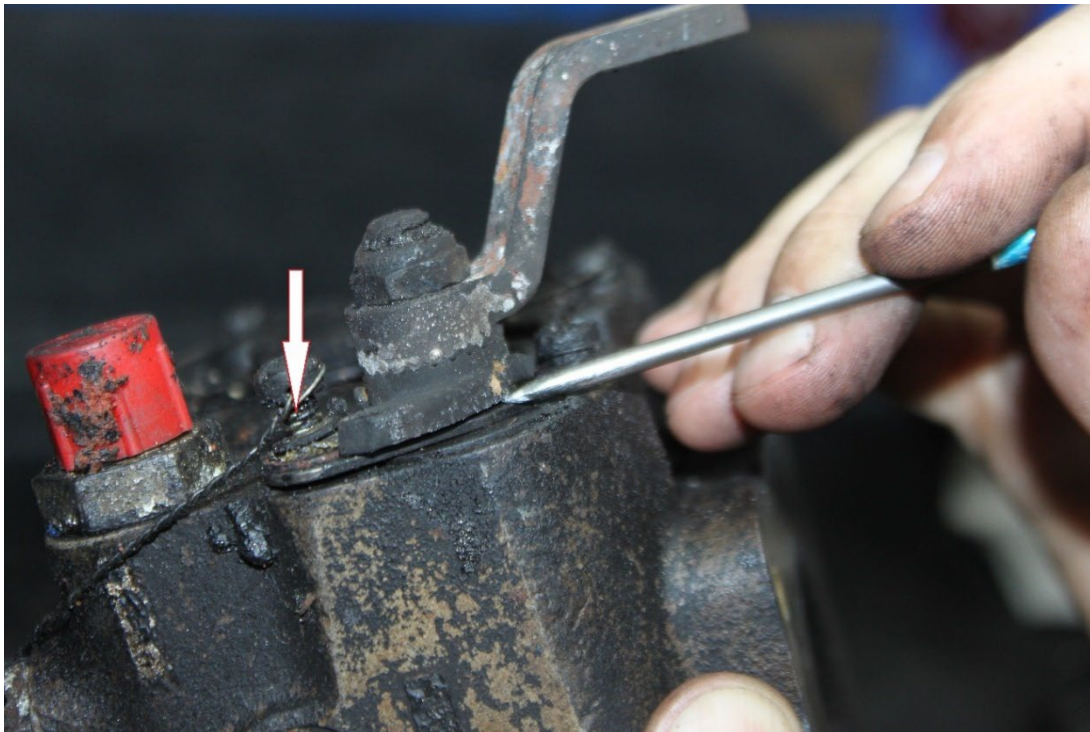
The mixture control nylon stop was missing. Some debris was noted in the mixture control housing consistent with mixture control bushing. Contamination on the mixture control bushing and adjacent area of the mixture control housing was noted. A swab was taken of the contamination of the mixture control housing for examination by the NTSB Materials Laboratory though testing was never performed⁵. A corrosion pit was noted under the contamination after removal of the mixture control valve.

Figure 16: Arrow Points to Where Missing Mixture Control Nylon Stop Would be Installed.

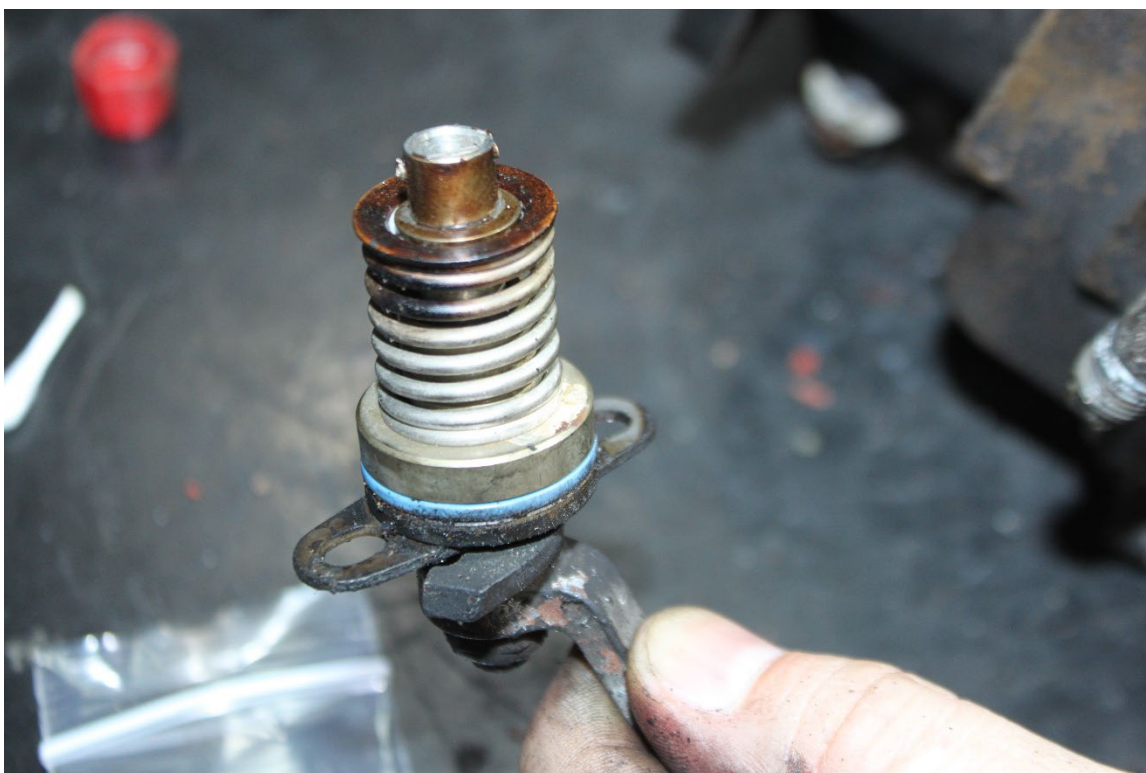
Figure 17: View Showing the Contamination on the Mixture Control Bushing.

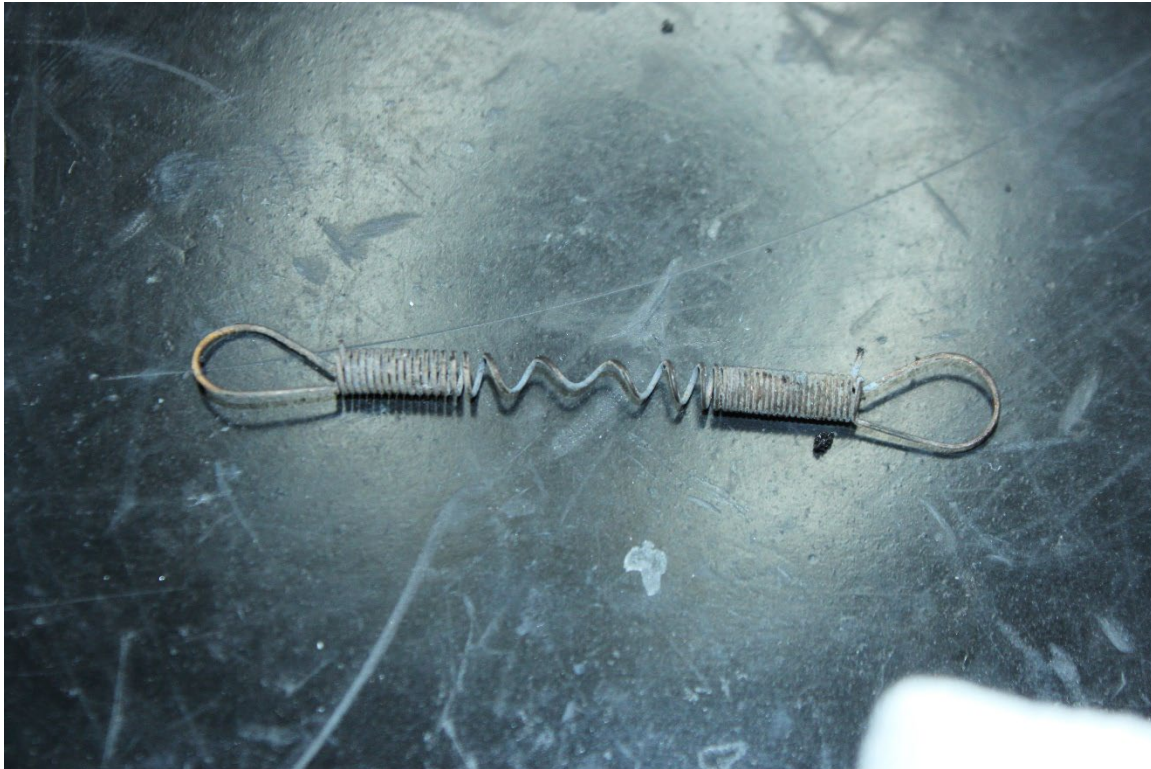
The mixture control clevis spring for idle mixture adjustment was in-place but distorted.

Figure 18: View Showing the Distortion of the Mixture Control Clevis Spring.

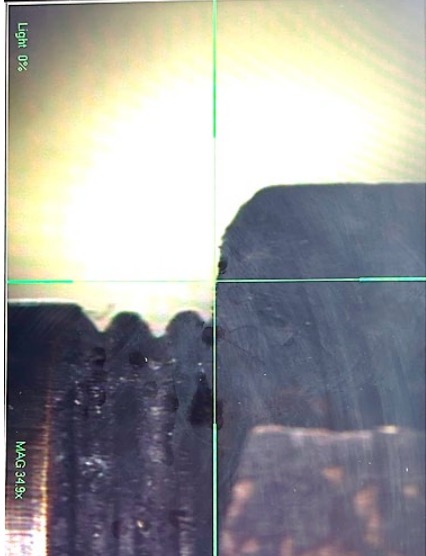
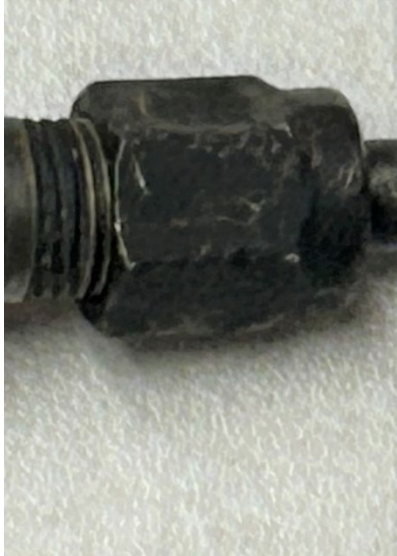
Figures 19a and 19b.

No. 1 Nozzle⁷ - Examination of the nozzle revealed the demarcation line was located 0.17509 inch down from the top of the nozzle. A measurement of 0.26664 inch was between the top of the nozzle to the bottom identified thread of the nozzle. The fuel injector line was installed onto the fuel injector nozzle without an insert and torqued to 37-inch pounds. Visually, in that position only sooty threads of the nozzle were noted and a dimension of 0.07076 inch was measured from the bottom of the union nut to the bottom identified thread of the nozzle.

With an exemplar insert installed into the fuel injector nozzle, the No. 1 fuel injector line was installed onto the nozzle and torqued to 37-inch pounds. Visual inspection of the nozzle revealed the pitch of 1 clear thread was noted beneath the bottom of the union nut. Dimensionally, the soot/clean demarcation line was 0.02813 inch below the bottom of the union nut.

<p>View of The No. 1 Fuel Injector Line and Nozzle. The Line was Torqued to 37-inch pounds onto The No. 1 Fuel injector Nozzle Without an Insert. Note the Threads Between the Union Nut and the Lowest Portion of Nozzle Thread.</p>	<p>View of The No. 1 Fuel Injector Line and Nozzle. The Line was Torqued to 37-inch pounds onto The No. 1 Fuel injector Nozzle With an Exemplar Insert. Note the Clean Threads Between the Union Nut and the Lowest Portion of Nozzle Thread.</p>

A comparison was made of the dimension difference from the bottom of the union nut to the bottom identified thread of the nozzle with the fuel injector line torqued to the fuel injector nozzle with and without an insert installed. With an insert installed, the bottom of the union nut was .03669 inch, or nearly the width of the insert flange higher up the nozzle, and in those conditions, about 1 clean thread of the nozzle was visible.

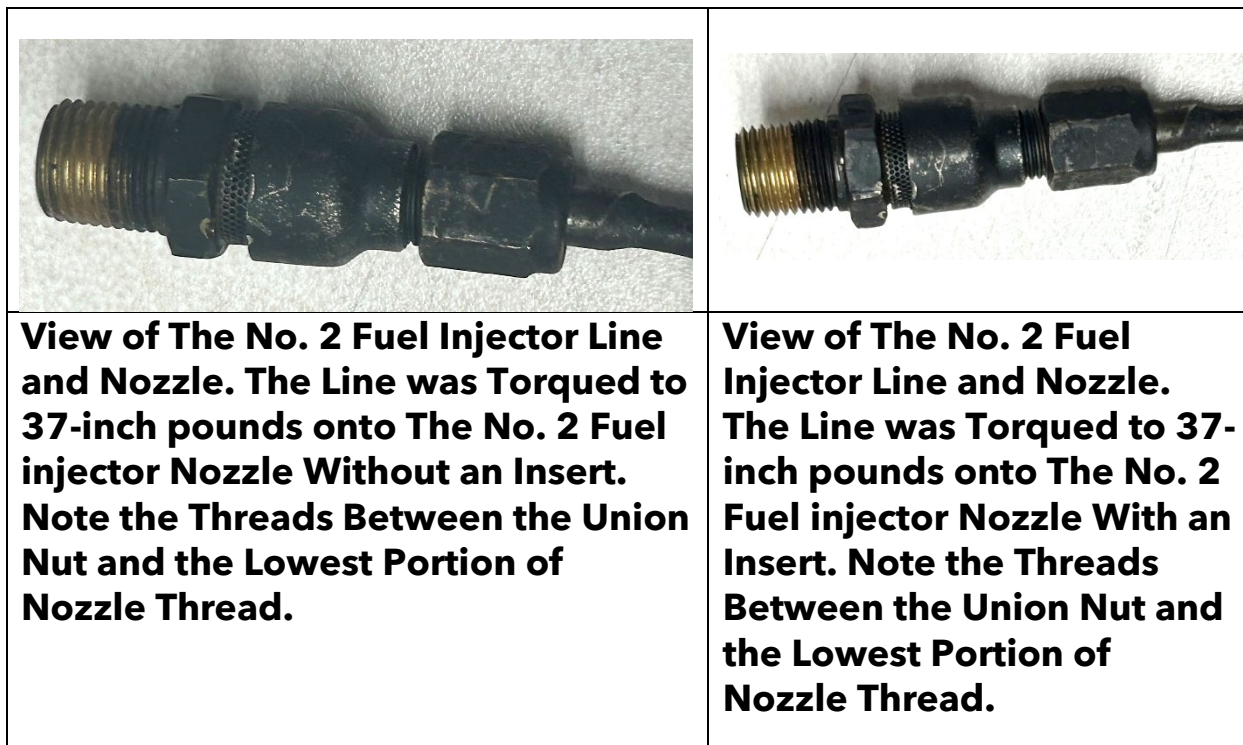
Figures 20a and 20B.

No. 2 Nozzle⁸ - Examination of the nozzle revealed the demarcation line was not as clear as the Nos. 1, 3, and 4 nozzles but a change in color on the threads was noted. The demarcation line was located 0.17598 inch down from the top of the nozzle. A measurement of 0.24990 inch was measured from the top of the nozzle to the top of the screen shield/bottom identified thread of the nozzle. The fuel injector line was installed onto the fuel injector nozzle without an insert and torqued to 37-inch pounds. Visually, in that position, only sooty threads and the pitch of 2 threads were visible and a dimension of 0.04882 inch was measured from the bottom of the union nut to the bottom identified thread of the nozzle.

With an exemplar insert installed into the fuel injector nozzle, the No. 2 fuel injector line was installed onto the nozzle and torqued to 37-inch pounds. Visual inspection of the nozzle revealed the demarcation line was not as clear as the Nos. 1, 3, and 4 nozzles, but it could be determined. Dimensionally, the soot/clean demarcation line was 0.04099 inch below the bottom of the union nut. A dimension of 0.09288 inch was measured from the bottom of the union nut to the bottom identified thread of the nozzle.

A comparison was made of the dimension difference from the bottom of the union nut to the bottom identified thread of the nozzle with the fuel injector line torqued to the fuel injector nozzle with and without an insert installed. With an insert installed, the bottom of the union nut was 0.04406 inch, or nearly the width of the insert flange higher up the nozzle, and in those conditions, about 1 clean thread of the nozzle was visible.

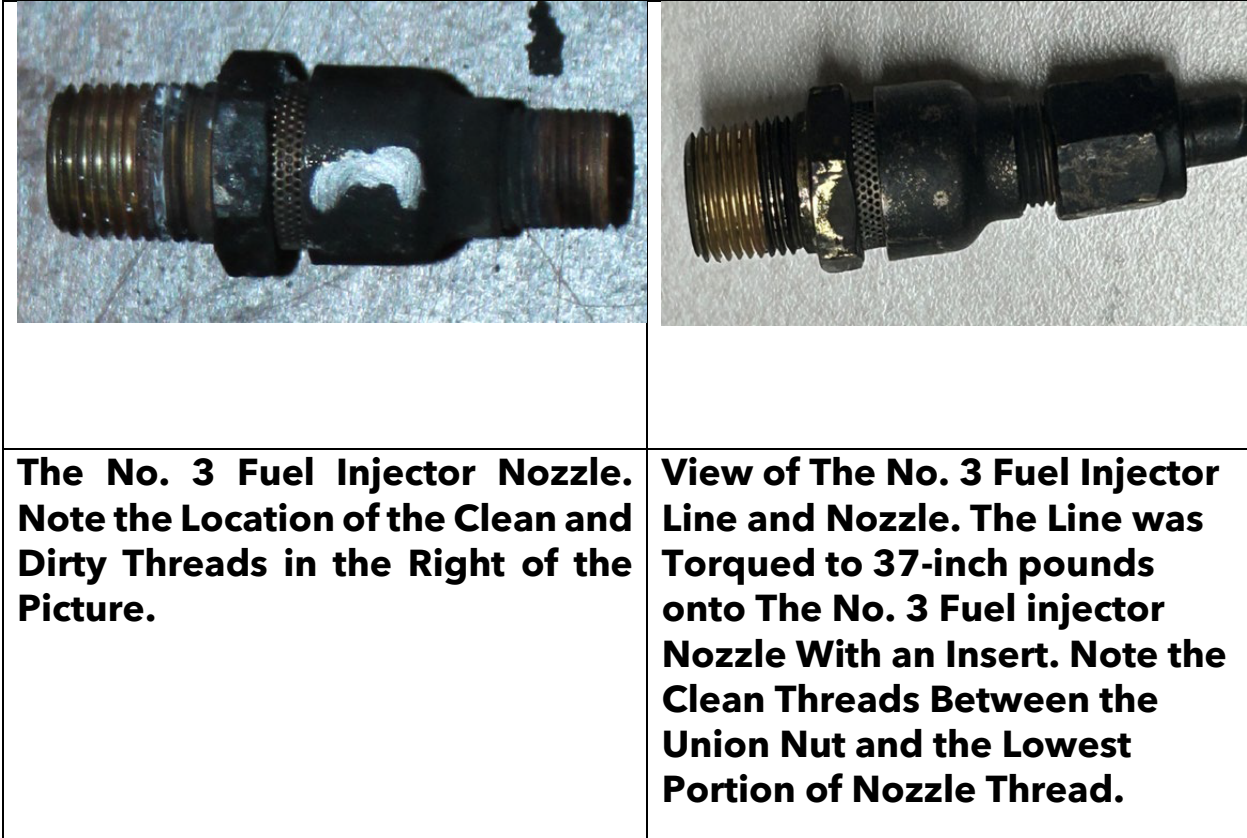
Figures 21a and 21b.

No. 3 Nozzle⁹ -Examination of the nozzle revealed the demarcation line was located 0.17161 inch down from the top of the nozzle. A measurement of 0.26622 inch was between the top of the nozzle to the bottom identified thread of the nozzle. The fuel injector line was installed onto the fuel injector nozzle without an insert and torqued to 37-inch pounds. Visually, in that position only sooty threads of the nozzle were noted and a dimension of 0.06351 inch was noted from the bottom of the union nut to the bottom identified thread of the nozzle.

With an exemplar insert installed into the fuel injector nozzle, the No. 3 fuel injector line was installed onto the nozzle and torqued to 37-inch pounds. Visual inspection of the nozzle revealed about 1 clean thread was noted. Dimensionally, the soot/clean demarcation line was 0.0256 inch below the bottom of the union nut. A dimension of 0.09659 inch was noted from the bottom of the union nut to the bottom identified thread of the nozzle.

A comparison was made of the dimension difference from the bottom of the union nut to the bottom identified thread of the nozzle with the fuel injector line torqued to the fuel injector nozzle with and without an insert installed. With an insert installed, the bottom of the union nut was 0.03308 inch, or nearly the width of the insert flange higher up the nozzle, and in those conditions, about 1 clean thread of the nozzle was visible.

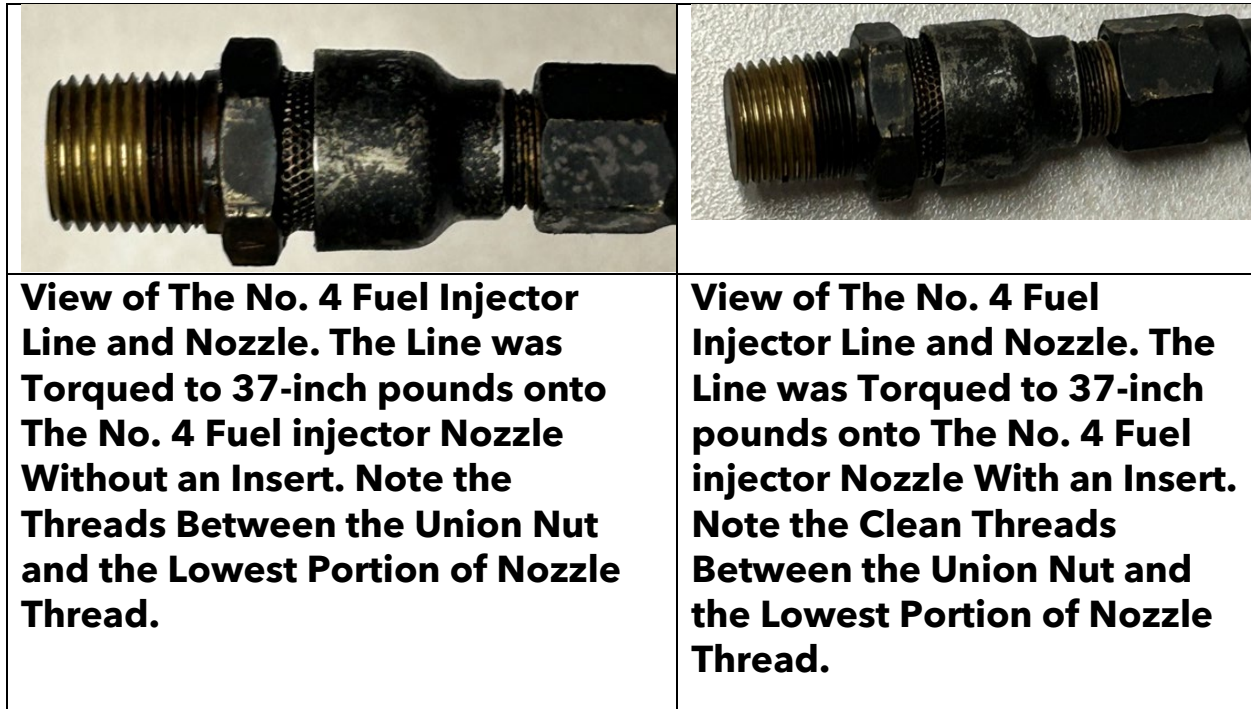
Figures 22a and 22b.

No. 4 Nozzle¹⁰ - Examination of the nozzle revealed the demarcation line was located 0.20250 inch down from the top of the nozzle. A measurement of 0.27504 inch was between the top of the nozzle to the bottom identified thread of the nozzle. The fuel injector line was installed onto the fuel injector nozzle without an insert and torqued to 37-inch pounds. Visually, in that position only sooty threads of the nozzle were noted and a dimension of 0.08265 inch was noted from the bottom of the union nut to the bottom identified thread of the nozzle.

With an exemplar insert installed into the fuel injector nozzle, the No. 4 fuel injector line was installed onto the nozzle and torqued to 37-inch pounds. Visual inspection of the nozzle revealed the pitch of two clean threads were noted. Dimensionally, the soot/clean demarcation line was 0.4065 inch below the bottom of the union nut. The

distance from the bottom of the union nut to the bottom identified thread of the nozzle was 0.11869.

A comparison was made of the dimension difference from the bottom of the union nut to the bottom identified thread of the nozzle with the fuel injector line torqued to the fuel injector nozzle with and without an insert installed. With an insert installed, the bottom of the union nut was .03604 inch, or nearly the width of the insert flange higher up the nozzle, and in those conditions, about 1 clean thread of the nozzle was visible.
