Memorandum For Record

Date: 7/31/2023
NTSB Accident Number: ERA23FA033

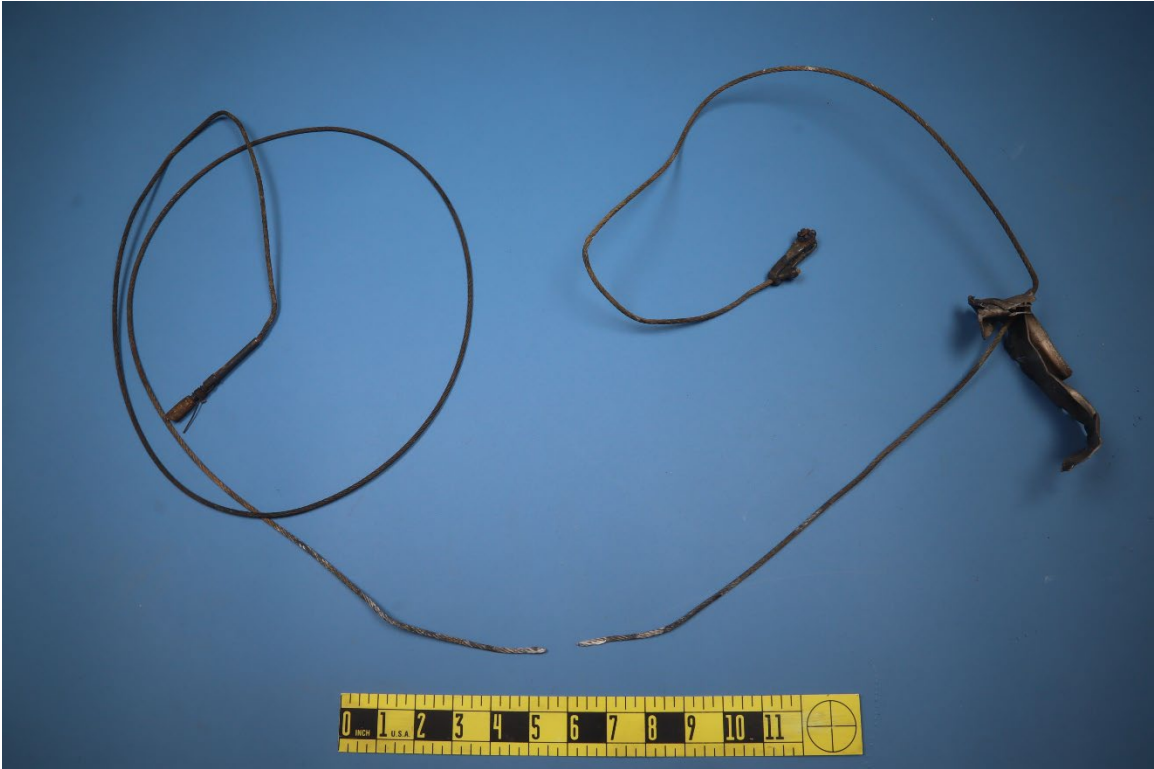
As part of the investigation thermally fractured sections of aileron control cable (Figures 1 and 2) were sent on December 15, 2022 by UPS Ground 1ZA3978T0393235578 to the NTSB Materials Laboratory for examination. It was received on December 22, 2022.

Figure 1: NTSB Materials Laboratory Photograph of Aileron Cable Assembly Received. The Fractured Section is Seen in the Lower portion of the Photograph adjacent to the ruler.

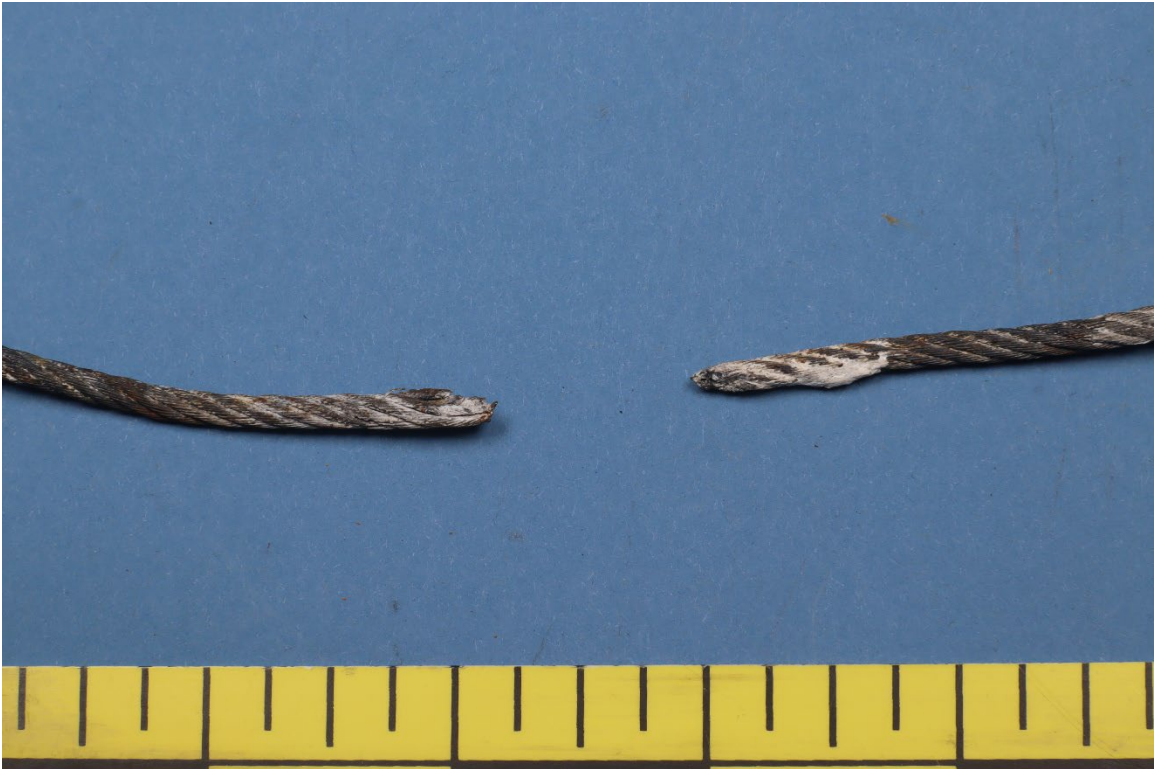
Figure 2: NTSB Materials Laboratory Photograph of Aileron Cable Assembly Received Showing the Fractured Section in Question.

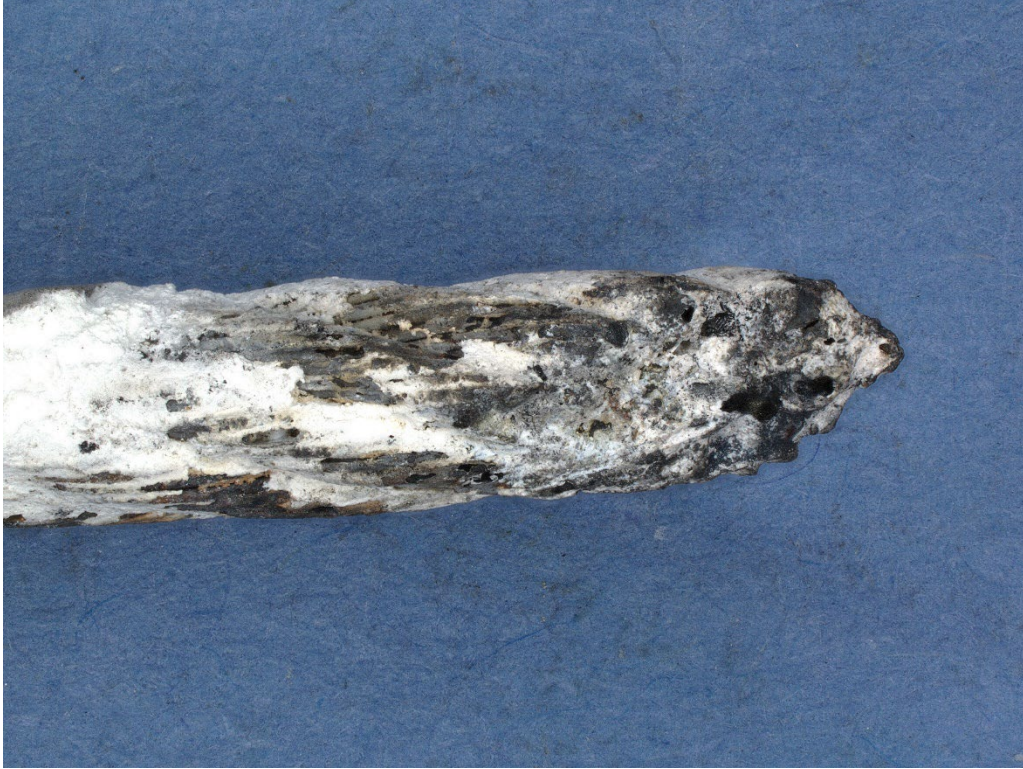
According to the NTSB Materials Engineer, “The macro profile of the cable was consistent with separation due to tensile overstress. Melted debris was observed on the separated ends of the cable (Figure 3). One end of the cable was sectioned and then cleaned using sodium hydroxide. After cleaning, the separated cable end showed the strands remained bundled (Figure 4), but the wires within each strand had melted together. The fracture surfaces of the individual wires had melt damage that obscured any finer features. The still bundled strands indicated the tensile overstress of the cable likely occurred due to the presence of the melted debris, which resulted in localized heating and subsequent weakening of the strength of the cable.”

Figure 3: NTSB Materials Laboratory Photograph of One End of the “Debris End” of The Fractured Aileron Cable Assembly with the Profile Rotated 90°. View at 20X magnification.

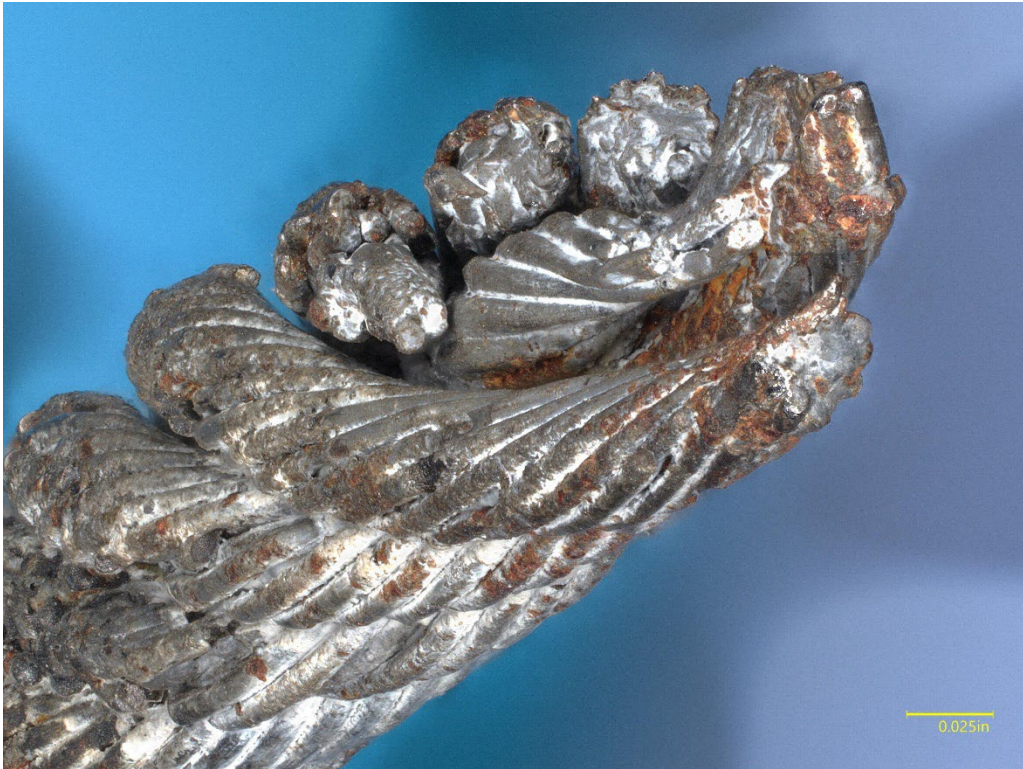
Figure 4: NTSB Materials Laboratory Photograph of the Fitting End of the Fractured Aileron Cable Assembly After Cleaning. View at 40X magnification.
