# National Transportation Safety Board

ERA23FA033

## **PROPELLER GOVERNOR EXAMINATION SUMMARY**

Location: Keene, New Hampshire  
Date: October 21, 2022  
Time: 1845 EDT  
2245 coordinated universal time (UTC)  
Airplane: N8020R, Beech A24R

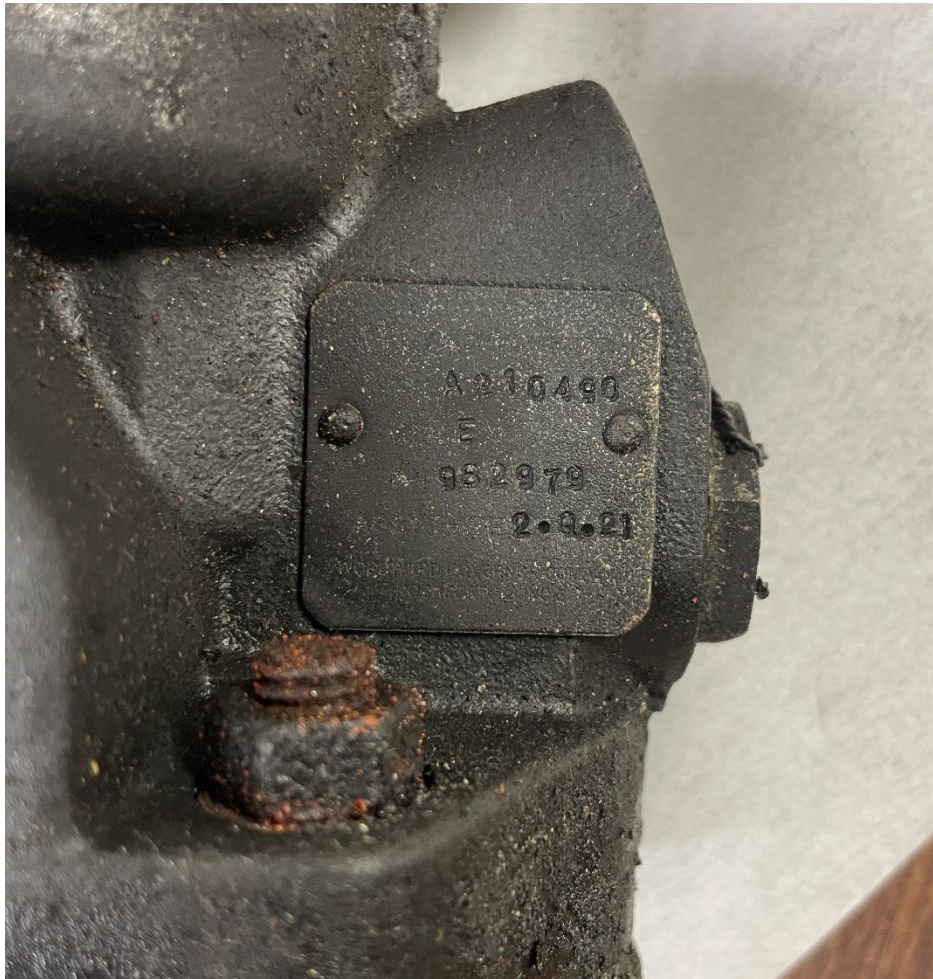
**Figure 1: View of Governor DataPlate.**

The dataplate was marked in part with the part number, serial number, and with "2.Q.21".

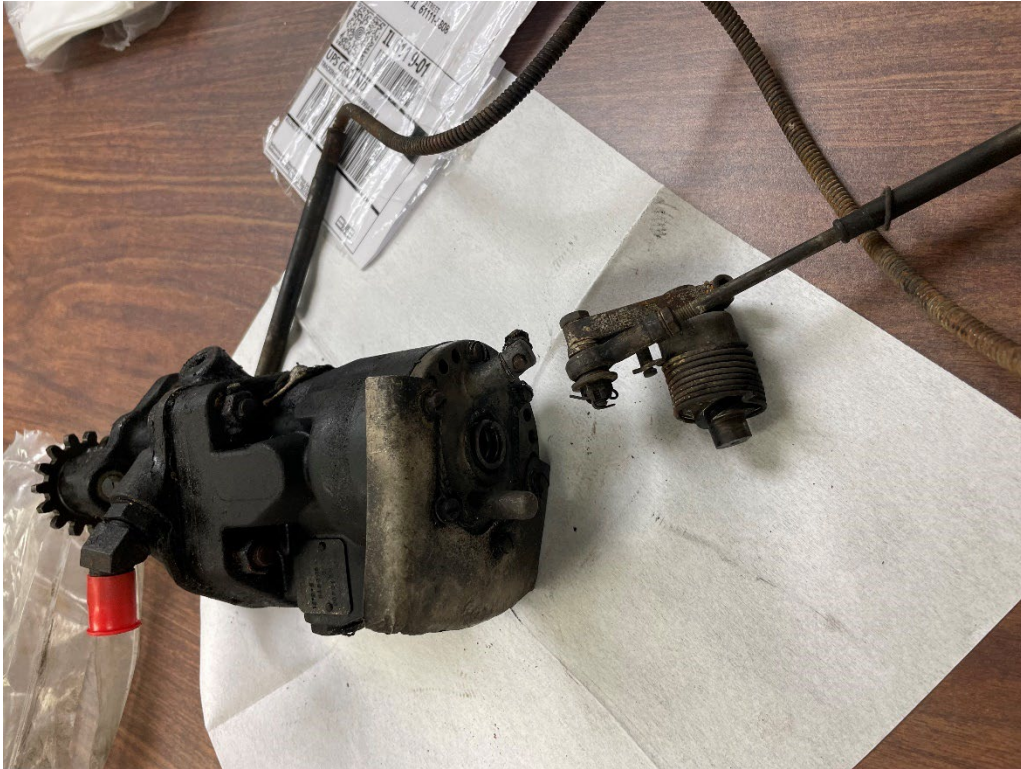
Examination of the propeller governor revealed heat damage and the Assembly Cover was fractured. Attached to the separated section of cover was a speed adjusting lever, control lever spring, control shaft, and length of actuating cable. The Speeder Spring was visible due to the fracture separated section of the cover. Due to impact damage to the cover and heat damage the governor could not be operationally tested as received.

**Figure 3: Propeller Governor as Received. Note the Overall Heat Damage and Impact Damage to the Cover.**

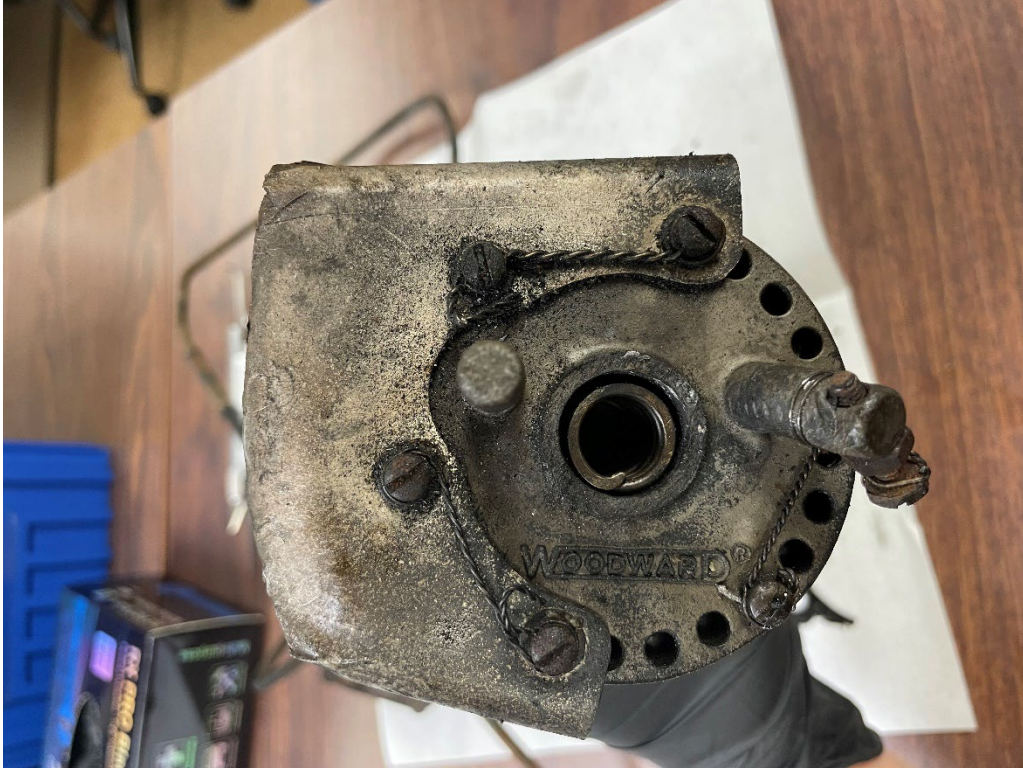
**Figure 4: View of the Top of the Governor Showing The Fractured Governor Assembly Cover.**

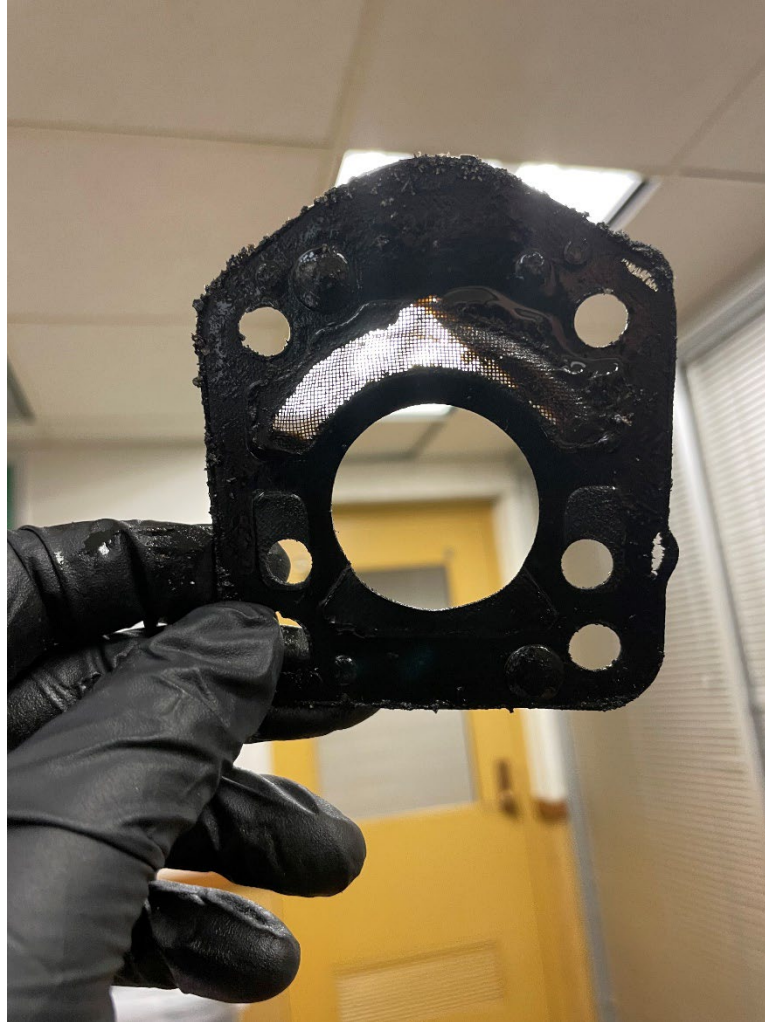
The customer hardware consisting of the governor driven gear was removed. The governor was equipped with a screen which when inspected had evidence of coked oil, but there was no abnormal particles.

**Figure 5: View of the Governor Base Gasket. Note the Coked Oil.**

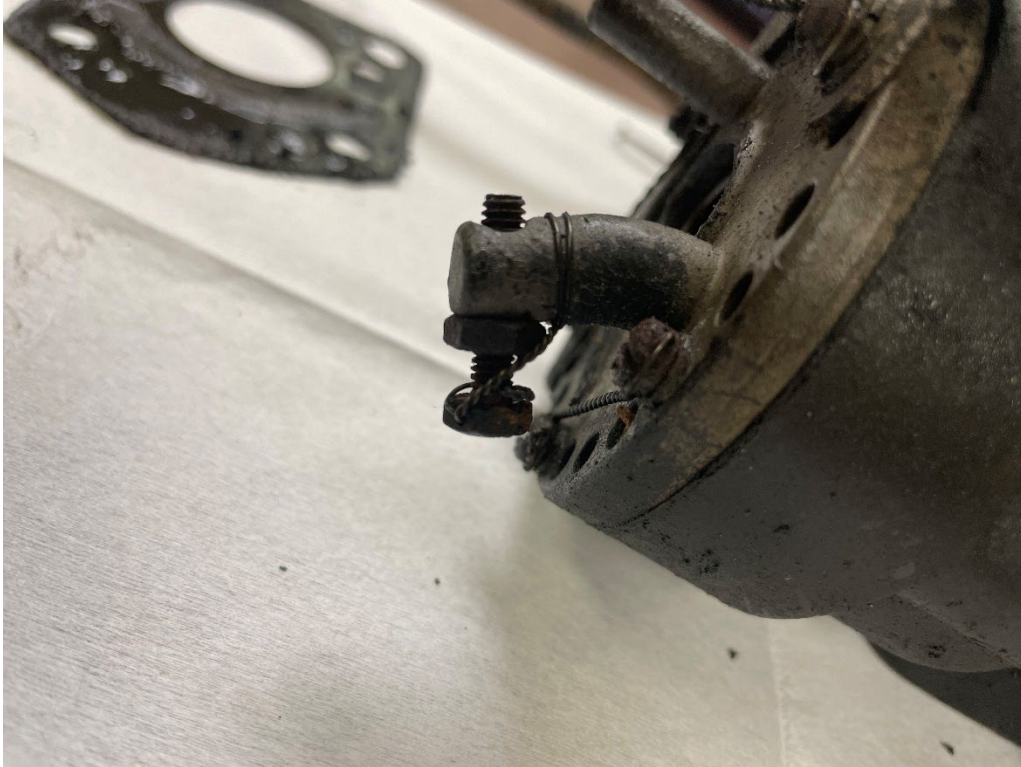
The remaining portion of the cover was examined, and the maximum speed adjustment post was bent and the maximum adjustment speed screw had 3 threads showing.

**Figure 6: View Showing the bent maximum speed adjustment post the maximum adjustment speed screw had 3 threads showing.**

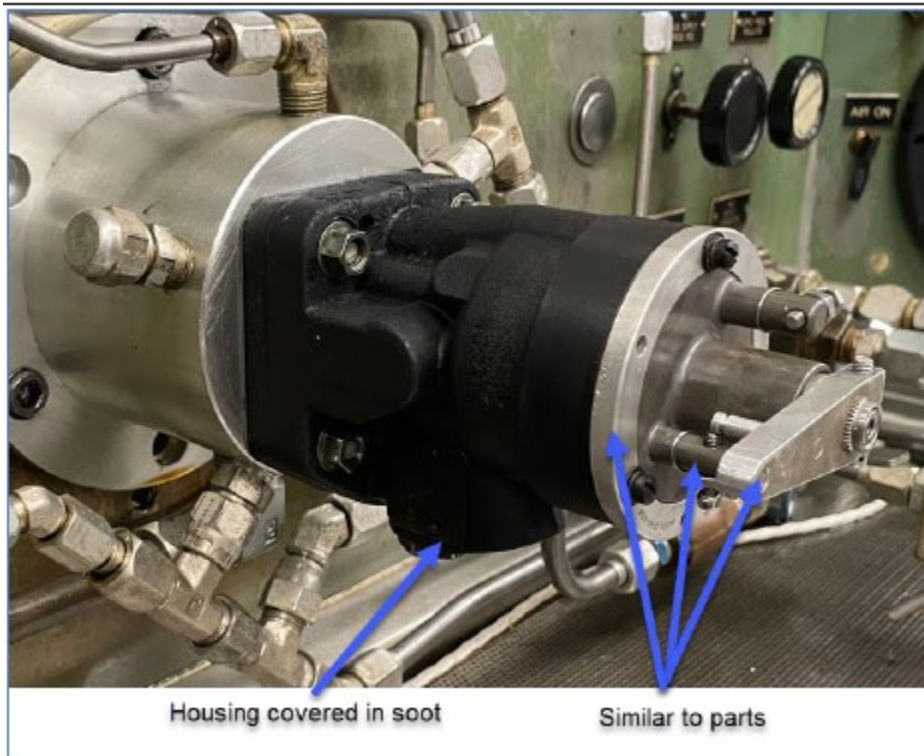
**Figure 7: Governor Installed on Test Stand. Arrows Pointing to “similar to parts” reflect the exemplar parts installed for operational testing.**

The governor was placed on a test bench and during operation a slow drip from the exemplar cover was noted because a gasket could not be installed with the exemplar cover. Because the original cover was not used for testing, calibration of the minimum and maximum speed points as well as any field adjustments were lost. The speed adjusting lever was re-indexed to set maximum rpm setting of 2,340 at 150 psi, and minimum rpm setting of 1,200 rpm at 150 psig. The pump capacity was 1.1 quarts-per-minute less than the minimum specified value, and the internal leakage was 5.0 quarts-per-hour greater than the maximum value for an overhauled governor. The governor responded to control input and the Pilot Valve Plunger was moving.

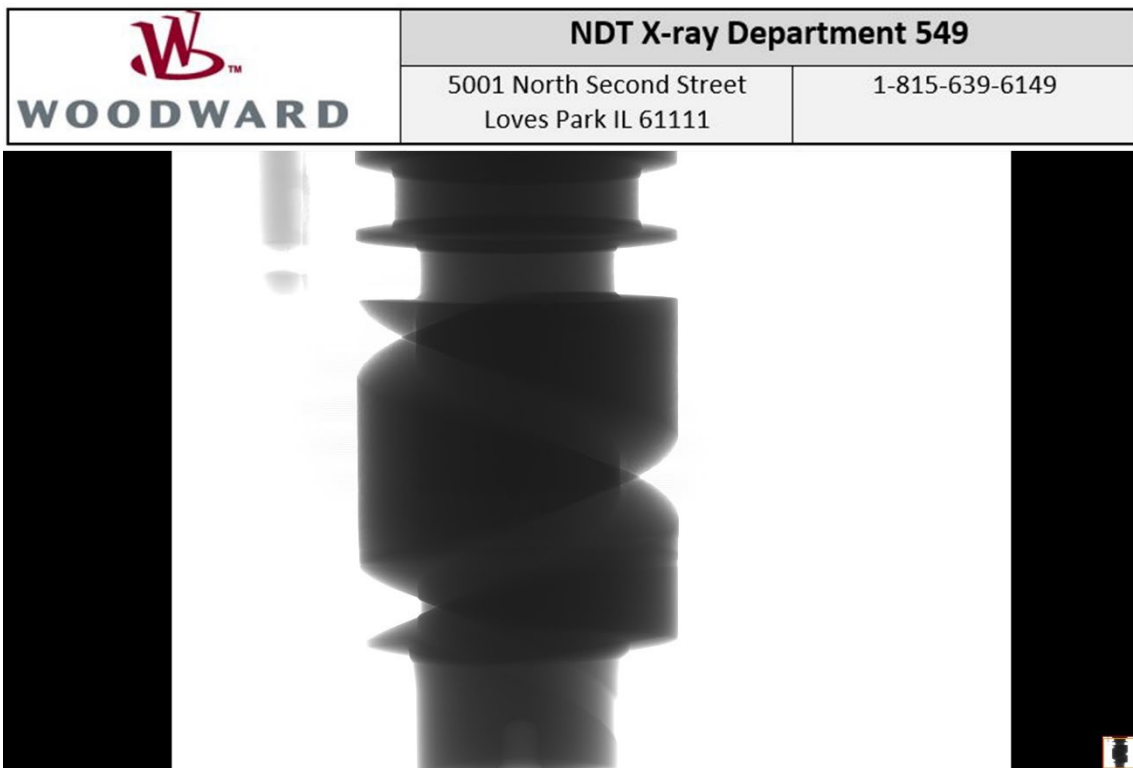
cover with control shaft were performed. The control shaft or worm gear appeared normal.

**Figure 8: X-ray Image of control shaft or "worm gear".**
