NATIONAL TRANSPORTATION SAFETY BOARD

RESTRAINT SYSTEM FACTUAL REPORT

WPR19MA177

Location: Mokuleia, Hawaii
Date: June 21, 2019
Aircraft: Beech 65-A90, N256TA, S/N LJ-256
NTSB IIC: Elliott Simpson

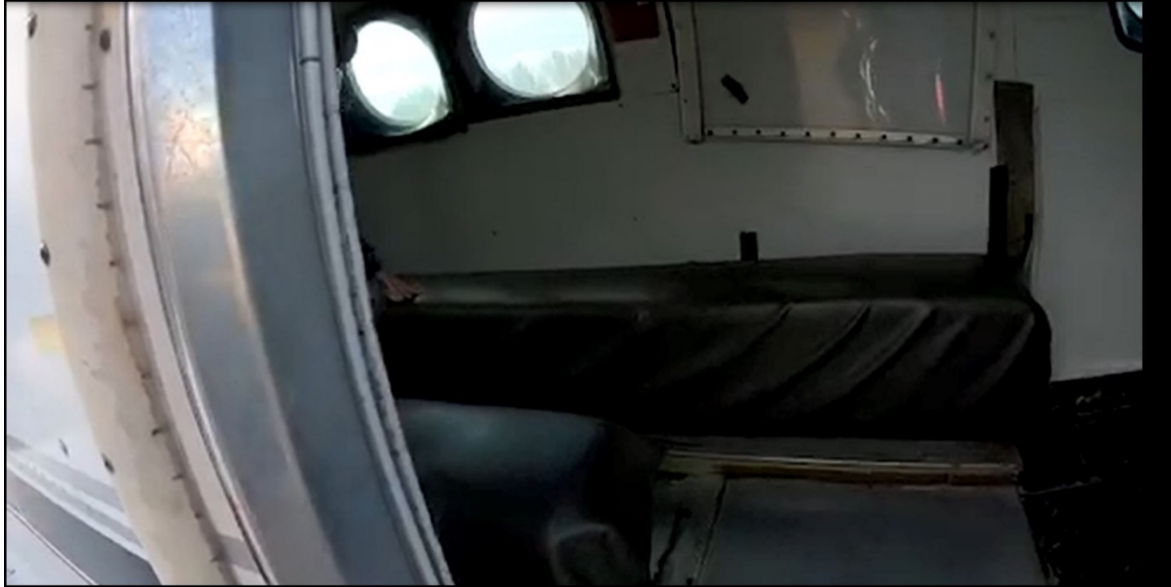
The airplane was equipped with two vinyl-covered longitudinal straddle-bench seats mounted about 6 inches inboard from the cabin walls. The left bench extended from the back of the pilot's seat through to the forward edge of the cabin door opening. The right bench extended from the copilot's seat through to the aft edge of the cabin door opening (Photos 1,2,3).

Photo 1: Photo of Bench Seats Viewed from the Cabin Door.¹

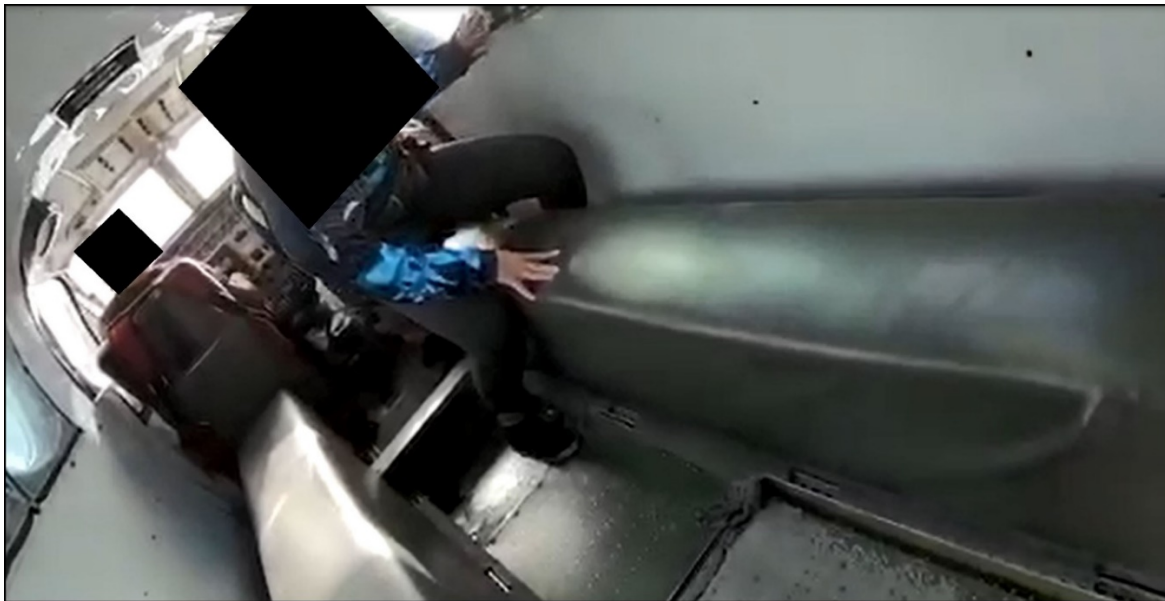
Photo 2: Photo of Bench Seats Viewed from the Rear of the Airplane.

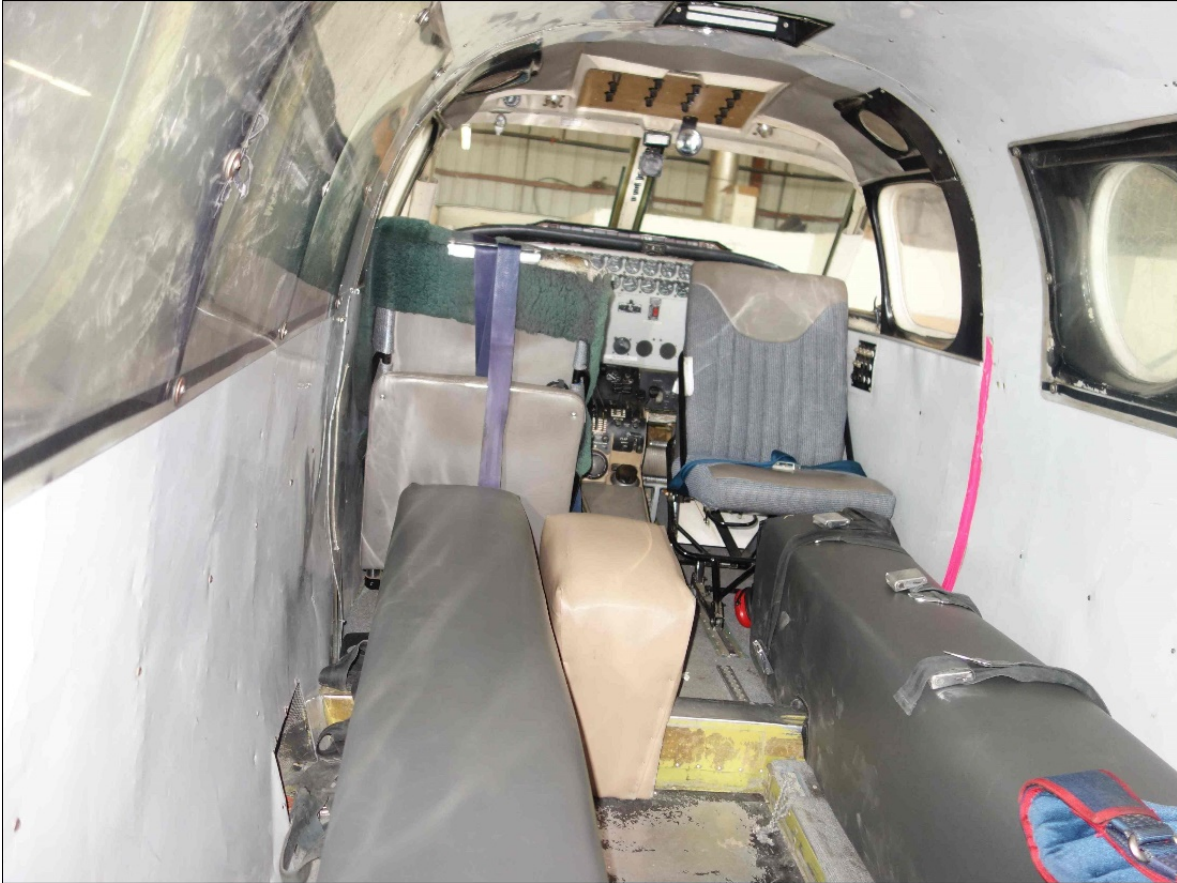
Photo 3: Photo of Copilot Seat Facing Aft (the cream colored center bench was not installed at the time of accident)

The copilot's seat had been installed facing backwards², and was used to carry one jumper³ (Photo 3).

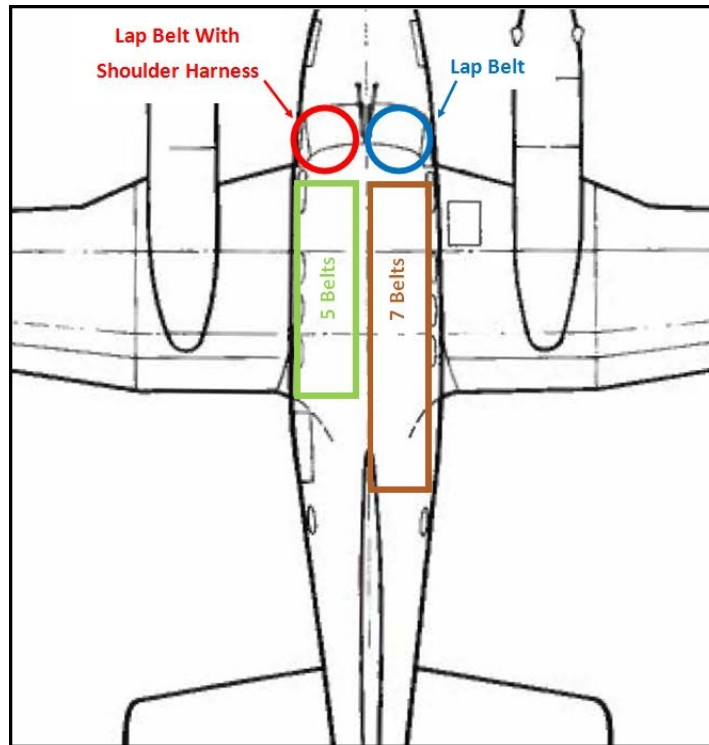
The right bench had a seat belt capacity for seven jumpers, and the left bench for five⁴ (Figure 1).

Figure 1: Seating Locations at the Time of the Accident

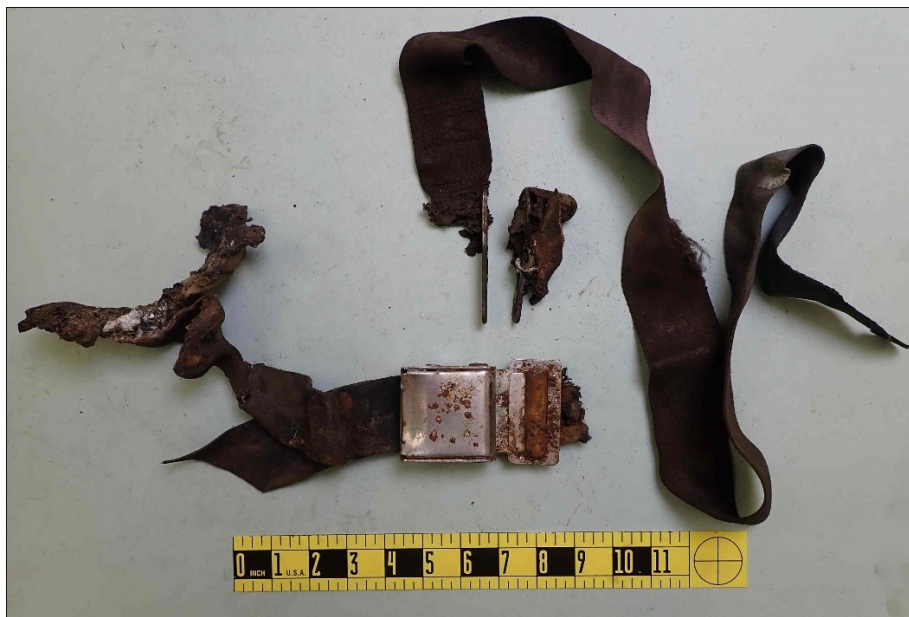
The pilot’s lift-latch lap belt was found in the latched position, and had melted into the seat cushion. The two shoulder strap locking tabs were free and unsecured, consistent with the pilot not using the shoulder harness⁶ (Photo 4). No buckles were located that could be definitively attributed to the copilot seat.

Photo 4: Pilot Seatbelt Assembly

⁶ Review of multiple onboard videos revealed that the accident pilot did not utilize the shoulder harness.

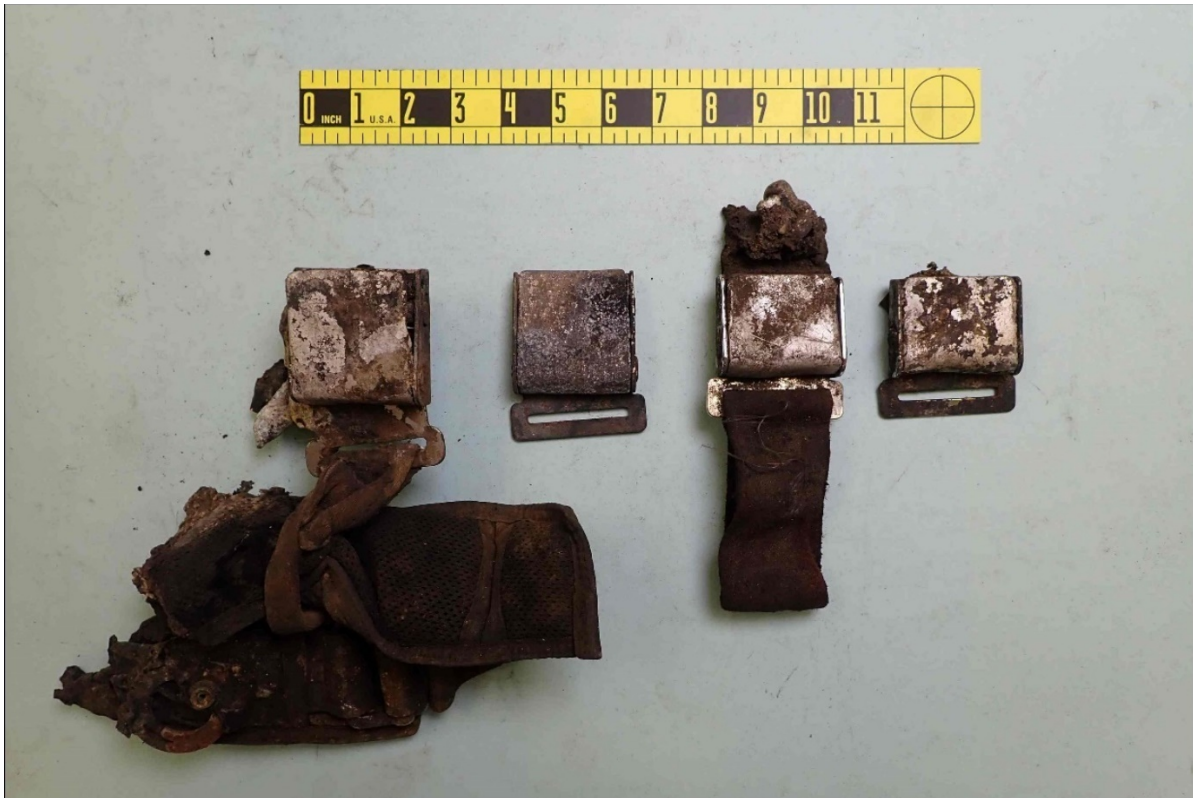
Twelve lift-latch buckle assemblies for the parachute jumpers were located. Four were in the latched position (Photo 5), with the remaining eight unlatched (Photo 6). One of the unlatched buckles sustained downward bending damage to its lifting tab, and a section of its associated latch assembly base appeared to have been thermally consumed. The latch assembly of the remaining buckles were undamaged, and their locking pins remained squarely recessed within each latch base. One of the latched buckle assemblies was still wrapped around the lower parachute harness of a solo jumper (Photo 5), the remaining buckle assemblies were distributed within the wreckage, and an accurate assessment of their location could not be determined.

Photo 5: Latched Bench Seat Buckles, with a Parachute Harness Still Attached to the Left Buckle

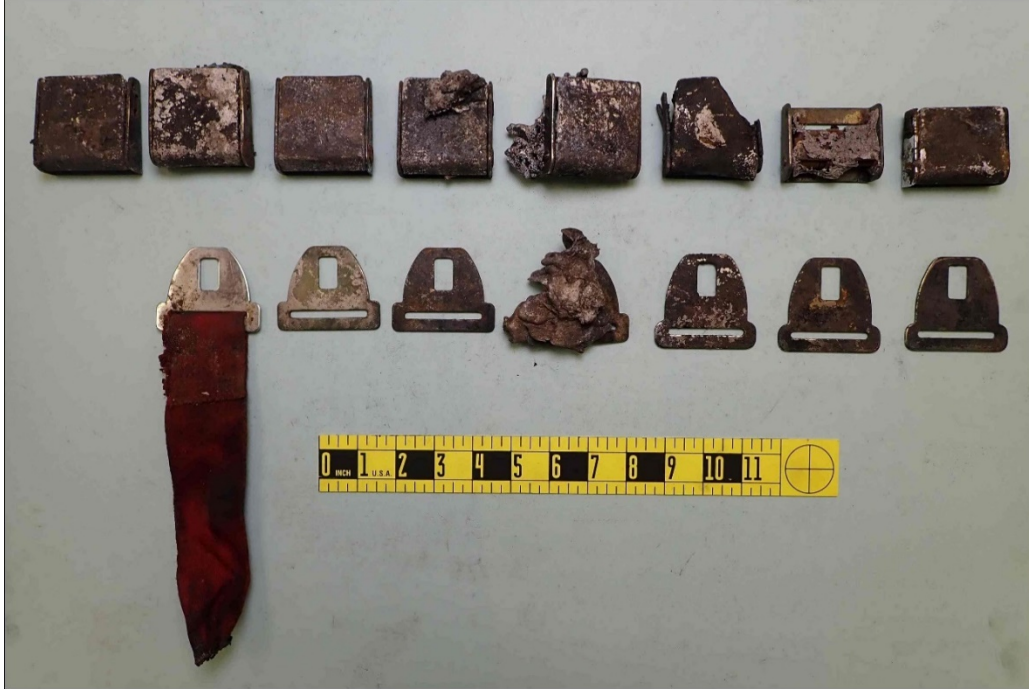
Photo 6: Unlatched Bench Seat Buckles

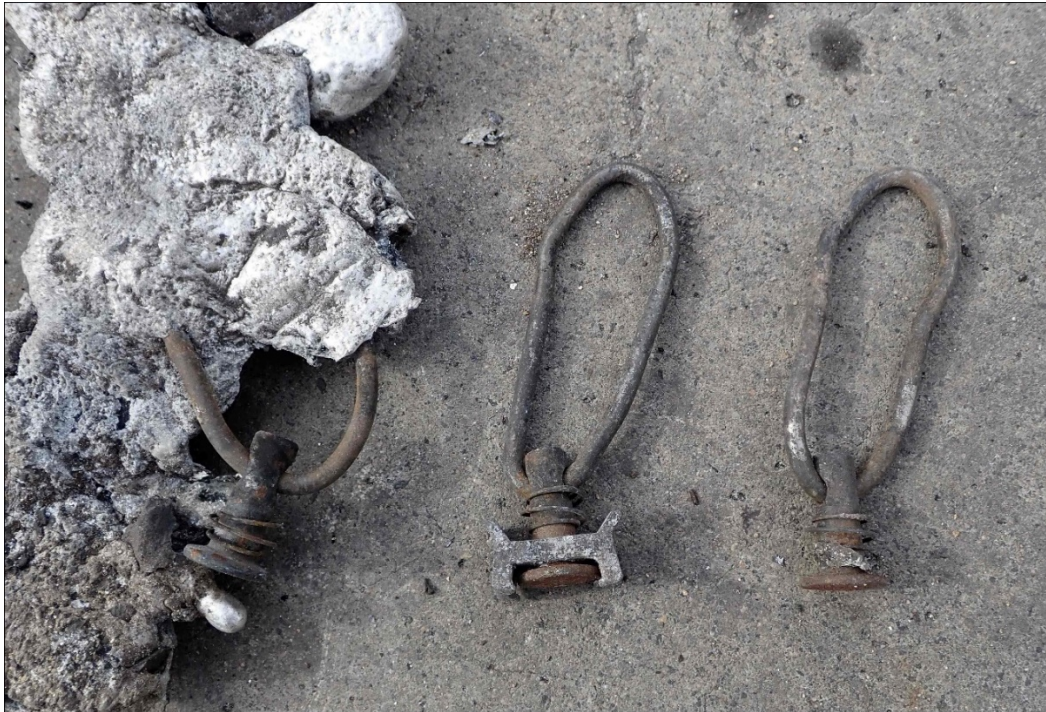
Fragments of the floor rail, along with nine floor tethering ring assemblies were located. Three of the rings had deformed and exhibited stretch damage (Photo 7). The remaining rings were intact (Photo 8).

Photo 7: Deformed/Stretched Floor Tethering Rings

Nine total floor-mounted tethering rings utilized to secure the parachute jumper buckle assemblies to the airframe were located. Six appeared undamaged and had retained their shape, and three exhibited stretch deformation.

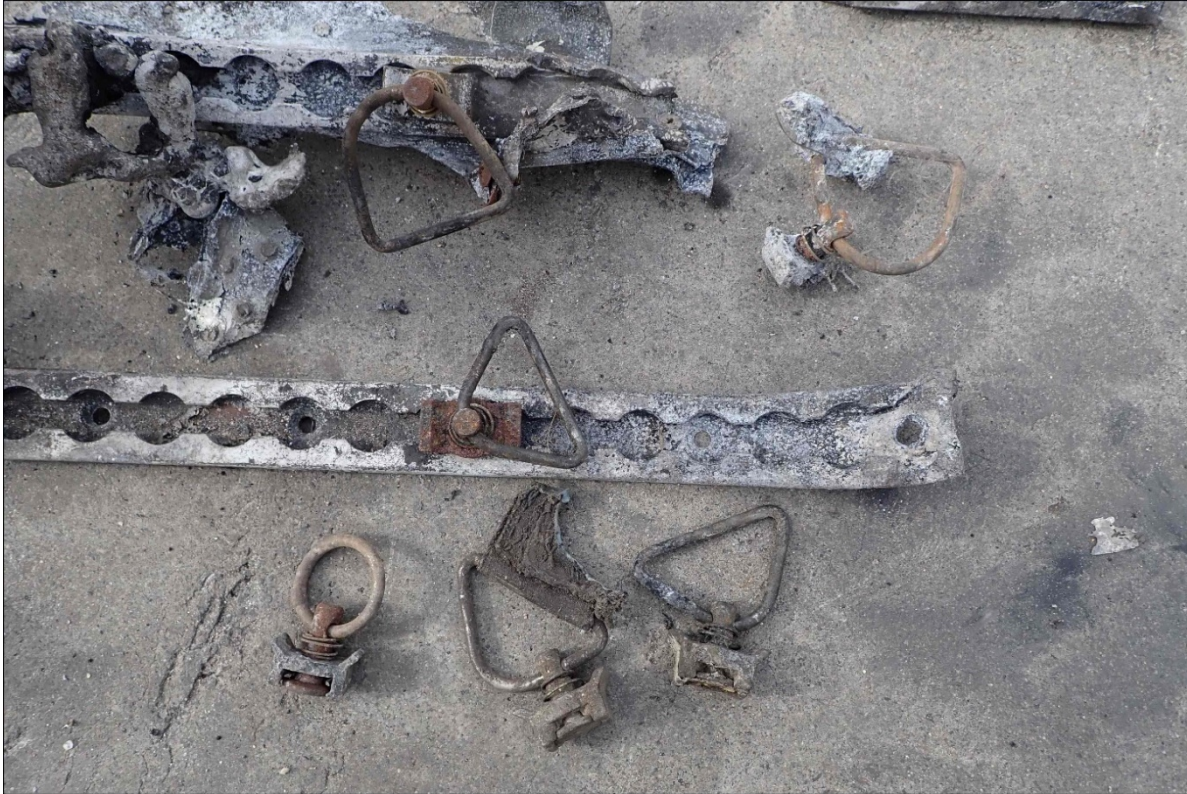
Photo 8: Undamaged Tethering Rings
