National Transportation Safety Board

ERA21FA135

WRECKAGE EXAMINATION SUMMARY

Location: Mayfield, Kentucky
Date: February 22, 2021
Time: 1756 CST
Airplane: Henry D Babenco / Vans RV-7A, N383DB

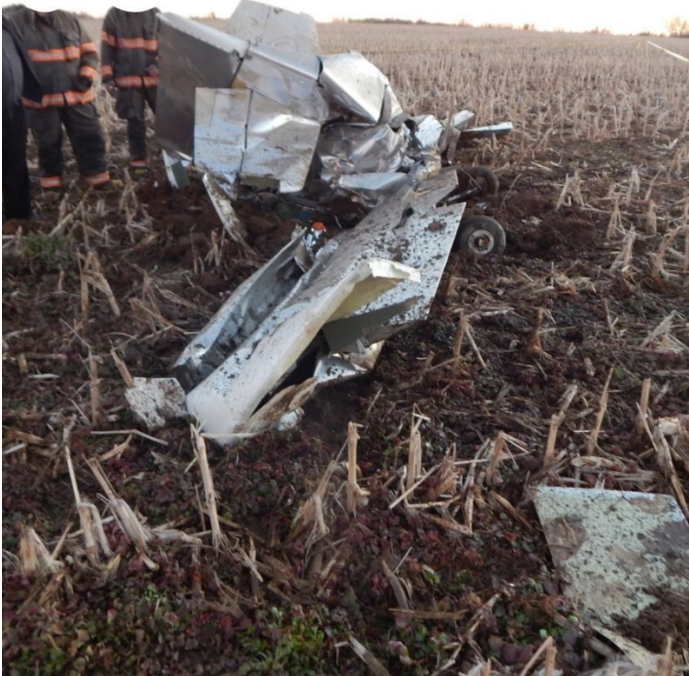
The airplane came to rest north of the airport about 1011 ft in an open field. All major components of the airplane were located in the vicinity of the main wreckage.

Figure 2- View of airplane at accident location

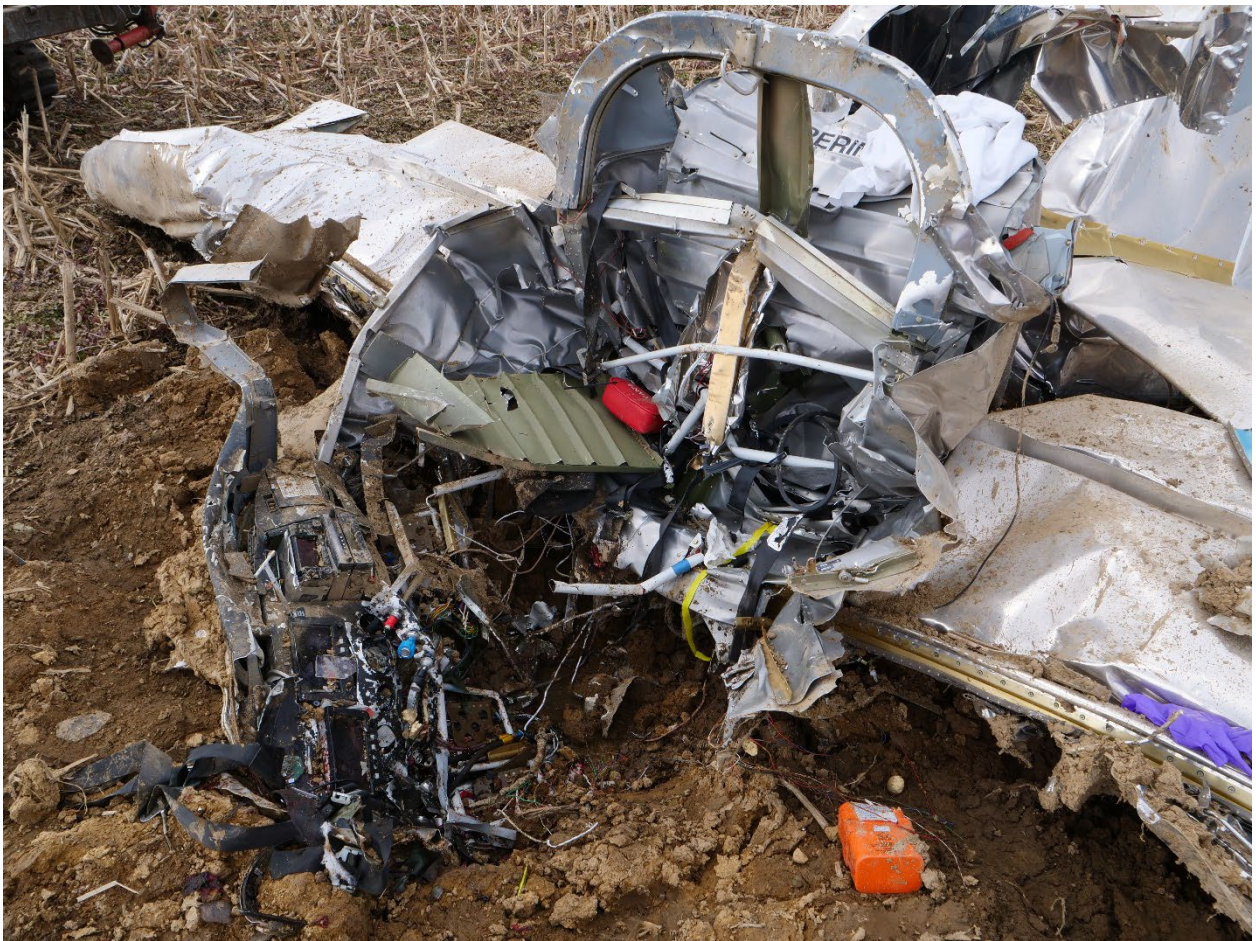
The forward cabin was impact crushed. The instrument panel and throttle quadrants were damaged but intact. The nose section, consisting of the powerplant, engine mount, and other accessories, separated from the fuselage.

The fuselage was compressed and torn - recognizable portions included a rear structural frame, sections of airplane skin, and tail cone pieces with registration markings.

Figure 4- Forward cabin and fuselage

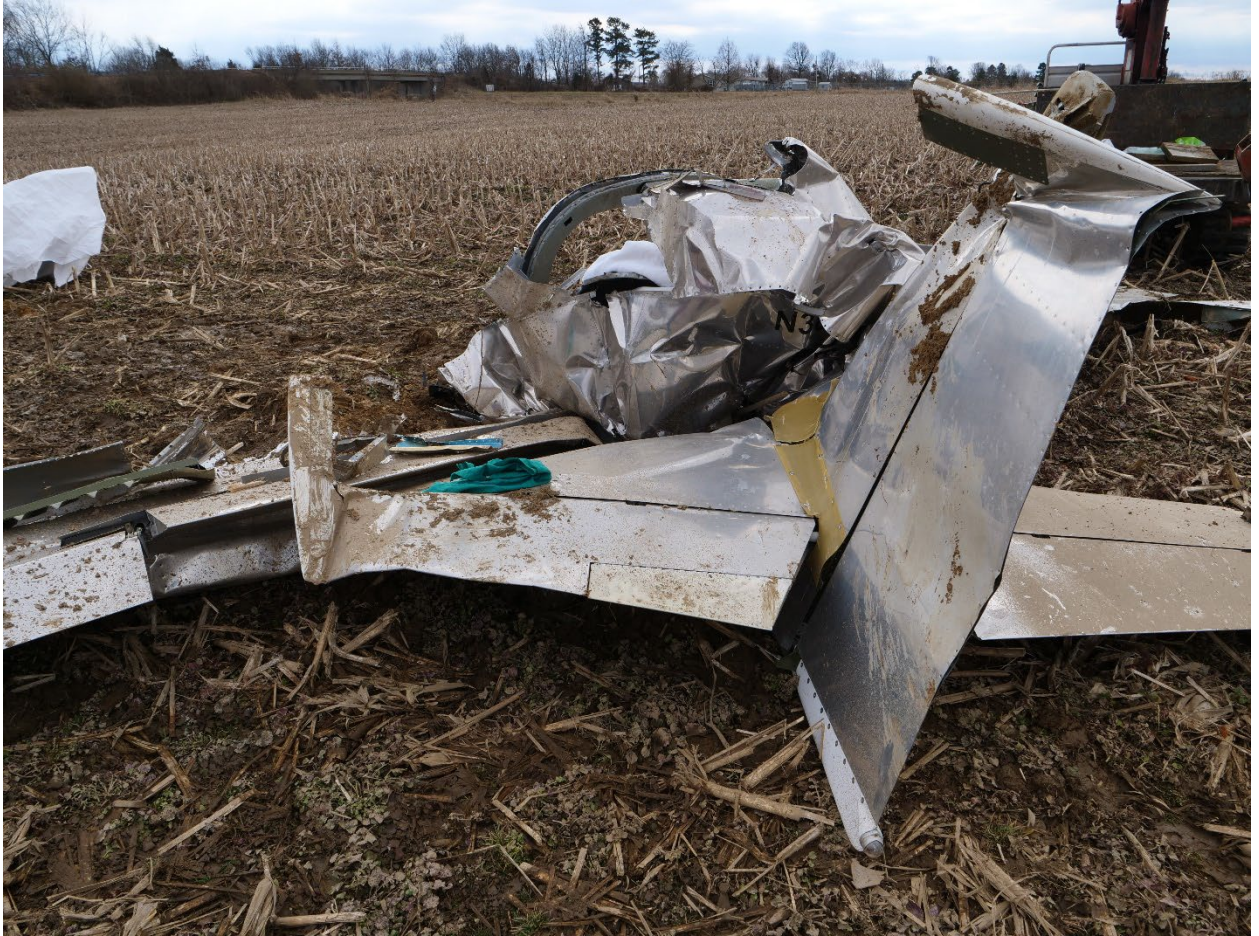
The empennage was attached to the fuselage. The vertical stabilizer and rudder remained attached. The leading edge of the vertical stabilizer and the topmost portion of the rudder were impacted damaged.

The left horizontal stabilizer and left elevator remained attached. The outboard portion of the left horizontal stabilizer was impact damaged.

The right horizontal stabilizer and right elevator remained attached. The right horizontal stabilizer was impact damaged at leading edge and connection to the fuselage.

The elevator trim tab remained attached to the inboard portion of the attached left elevator. The elevator trim tab push/pull rod remained attached to the actuator and to the trim tab.

Figure 5 - Empennage

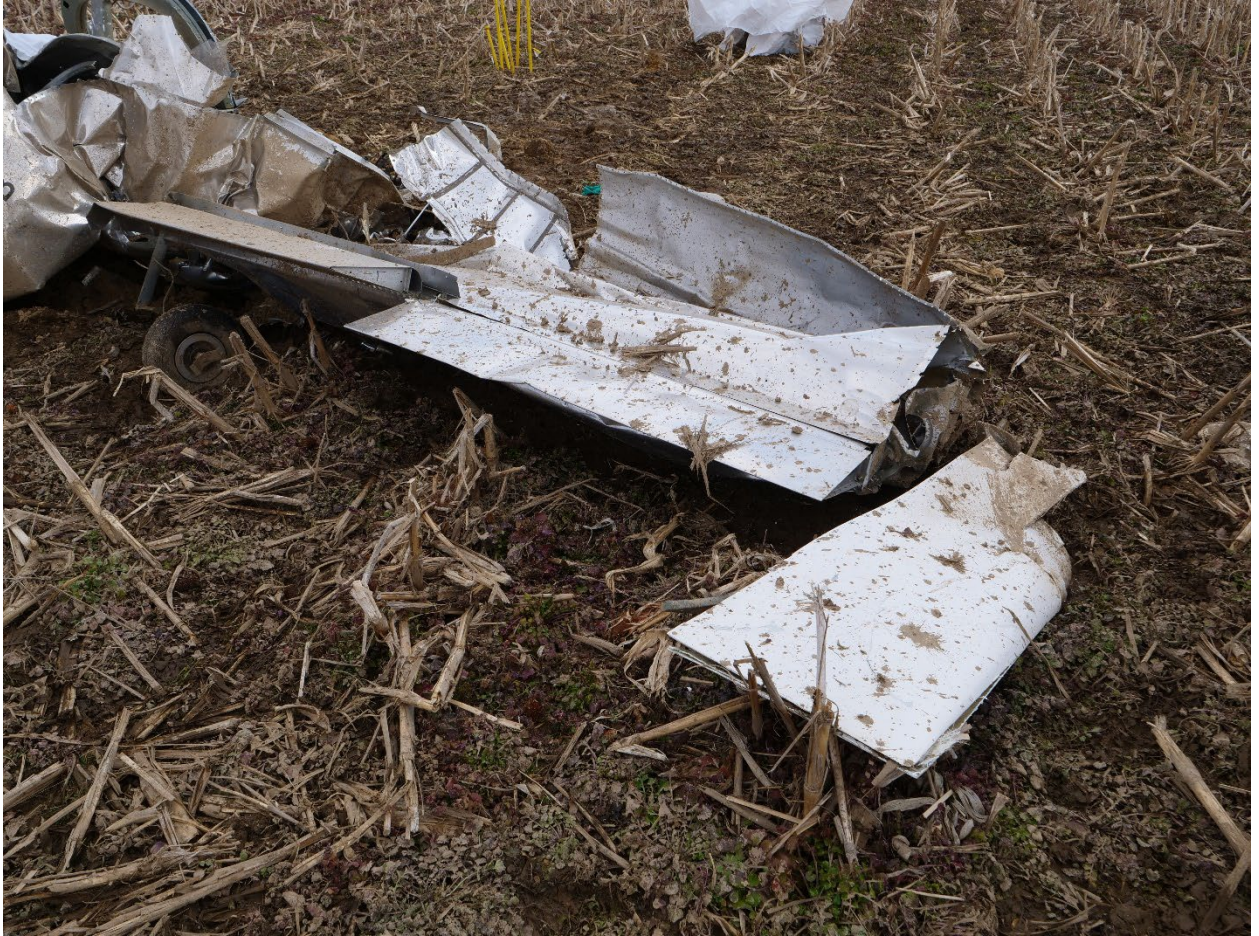
The right wing remained attached to the airplane, was torn by impact forces, and exhibited accordion-like crushing. The right aileron remained attached and intact. The right flap remained attached and intact. The right wingtip was separated from the wing.

Figure 6 - Right Wing.

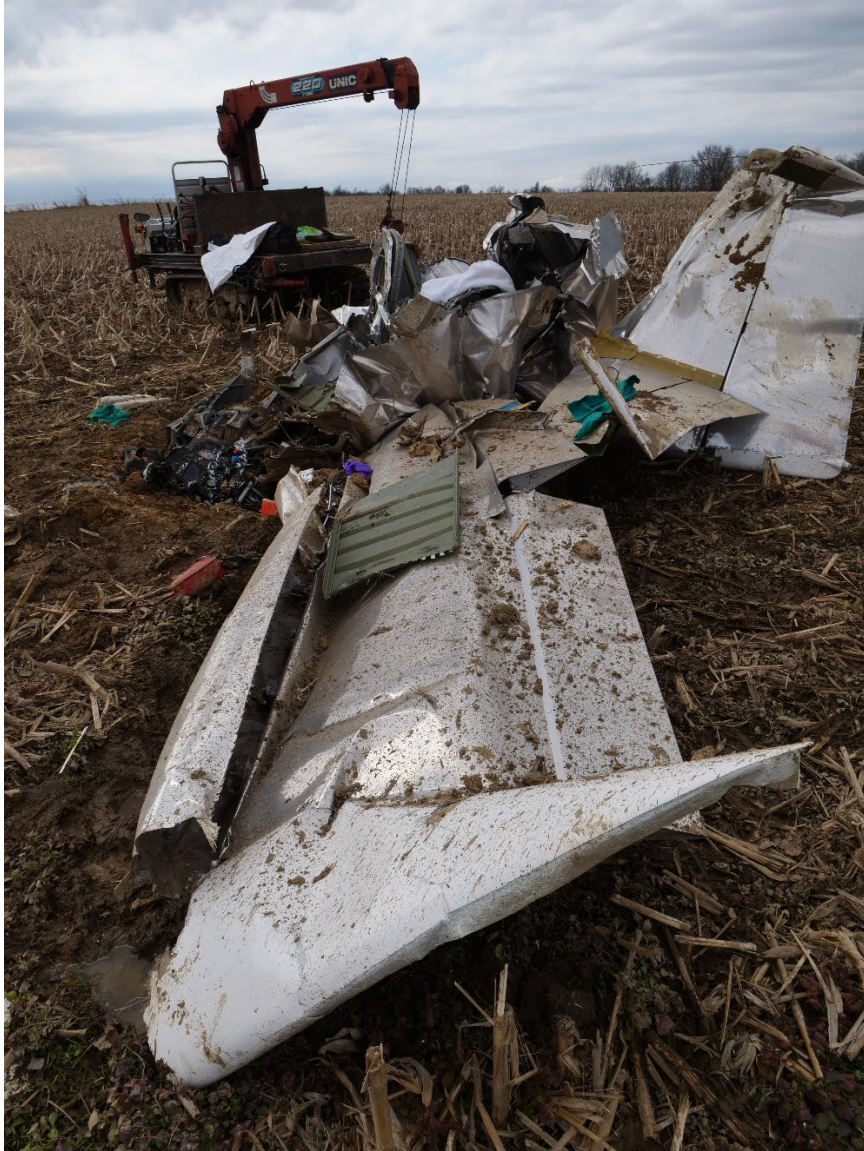
The left wing remained attached to the airplane and exhibited accordion-like crushing by impact forces. The left aileron remained attached and intact. The left flap remained attached and intact. The left-wing tip remained attached to the left wing.

Figure 7 - Left wing.

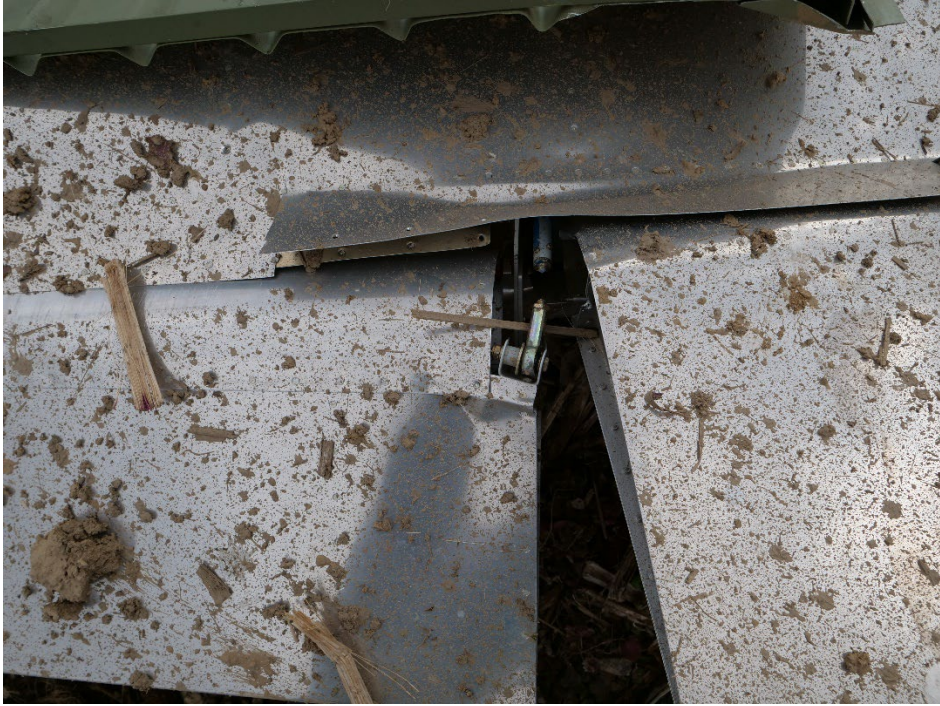
Flap position was undetermined. The left flap push/pull rod was fractured due to impact forces.

Figure 8- Right flap push/pull rod, broken.

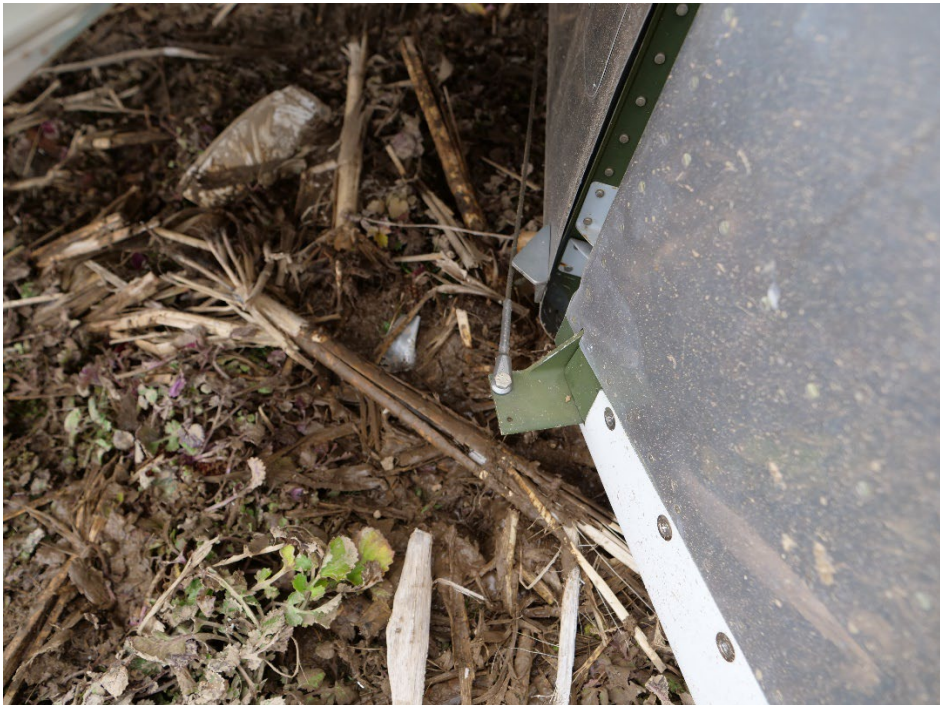
Both the right and left sides of the rudder had cables attached.

Figure 9 - Lower right side of rudder, cable attachment point

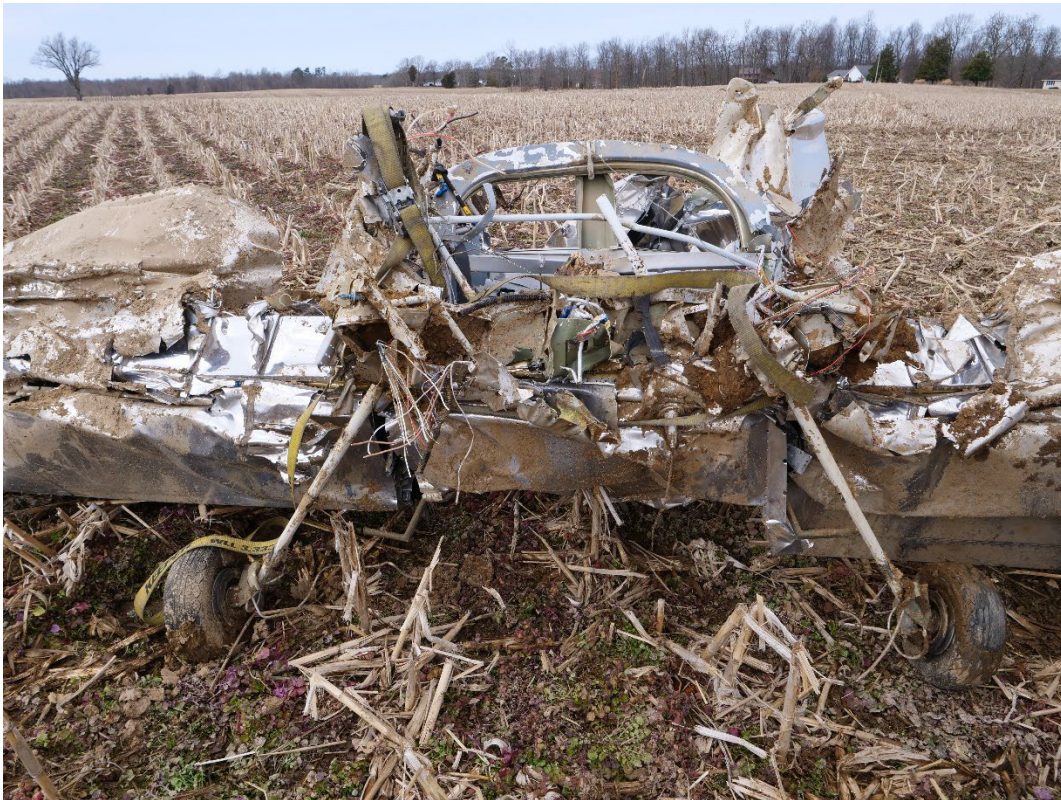
The main landing gear remained attached to the fuselage. The nose landing gear separated from the aircraft on impact.

Figure 10- Main landing gear

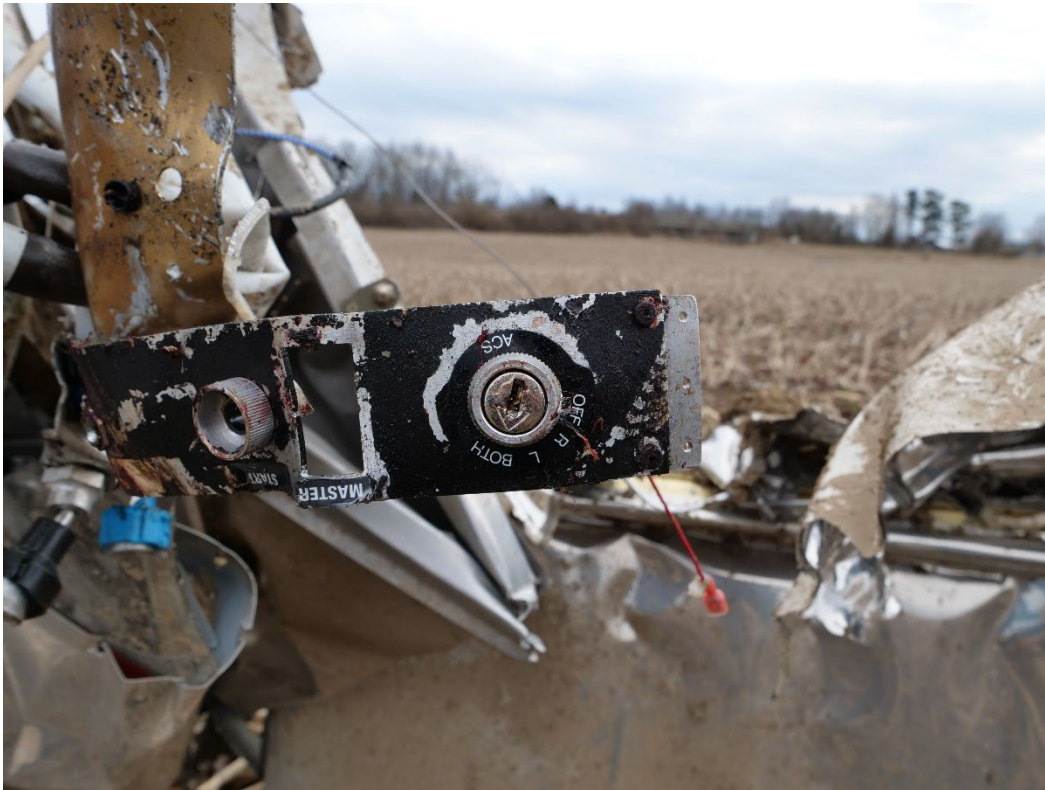
The magnetos switch was in the "Both" position.

Figure 11 - Magneto switch position

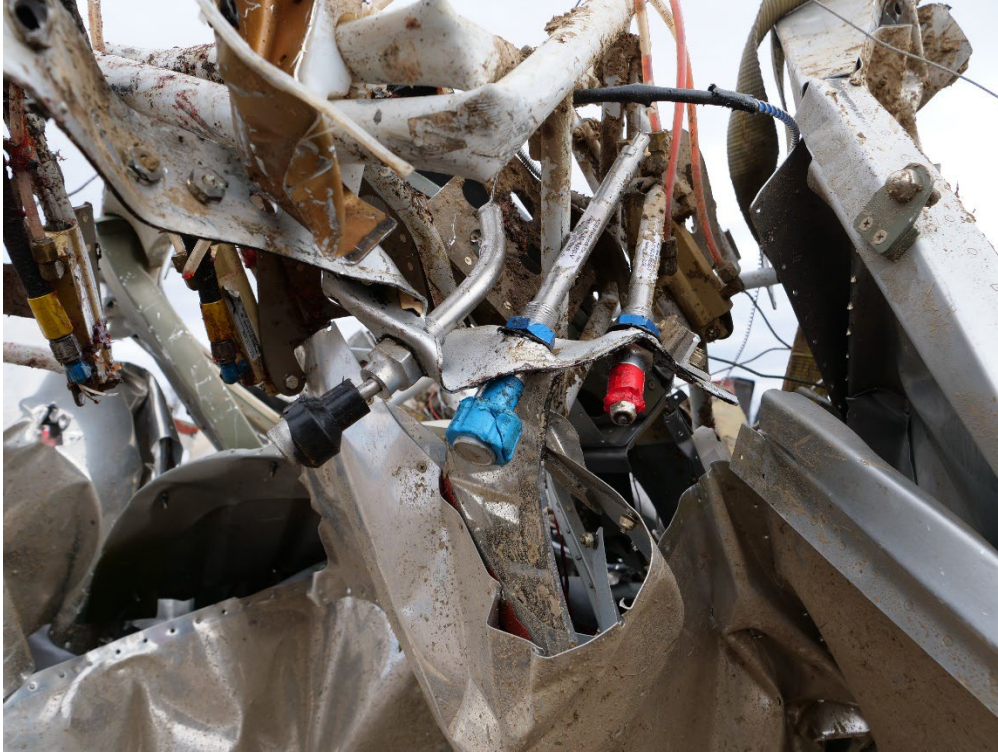
The control quadrant was impact crushed. Engine control levers indicated: Throttle, near full forward; propeller, full; mixture, full rich.

Figure 12 - Throttle quadrant controls

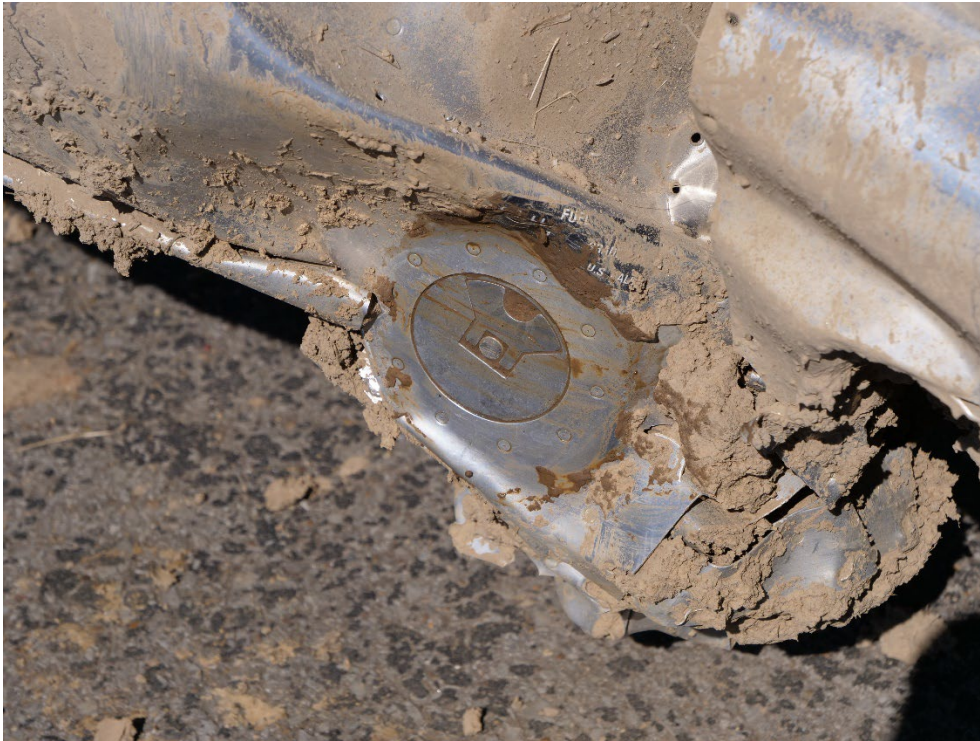
The left and right fuel tank caps were both in place and intact.

Figure 13 - Left wing fuel tank cap (in place)

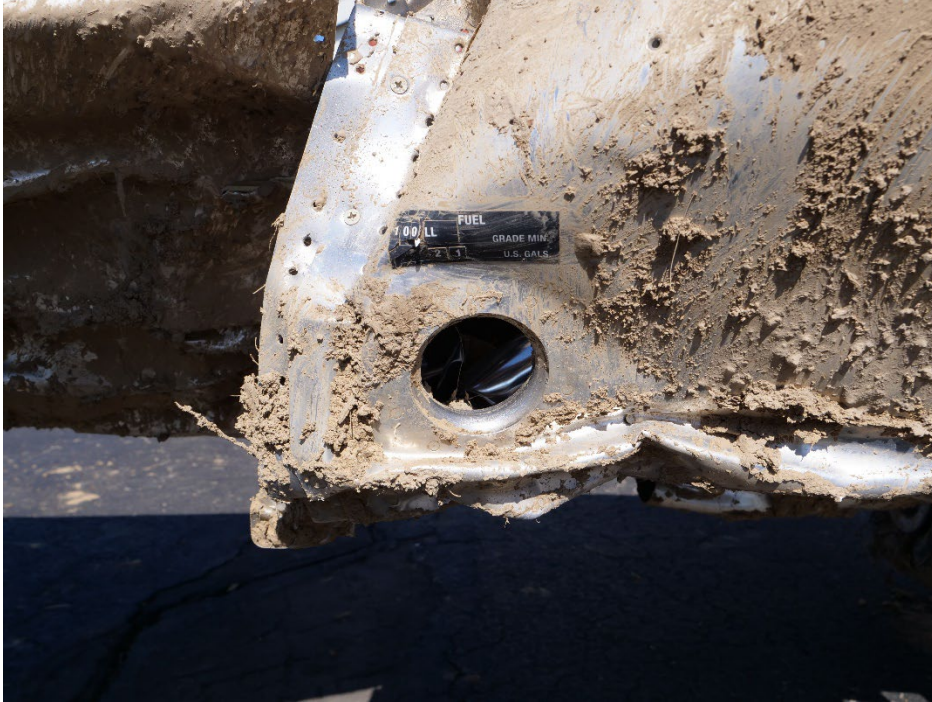
Both the left and right wing fuel tanks were breached due to impact. The smell of 100LL aviation fuel was noted at the accident site, but no fuel was observed in either tank.

Figure 14 - Left fuel tank filler hole (cap removed for exam).

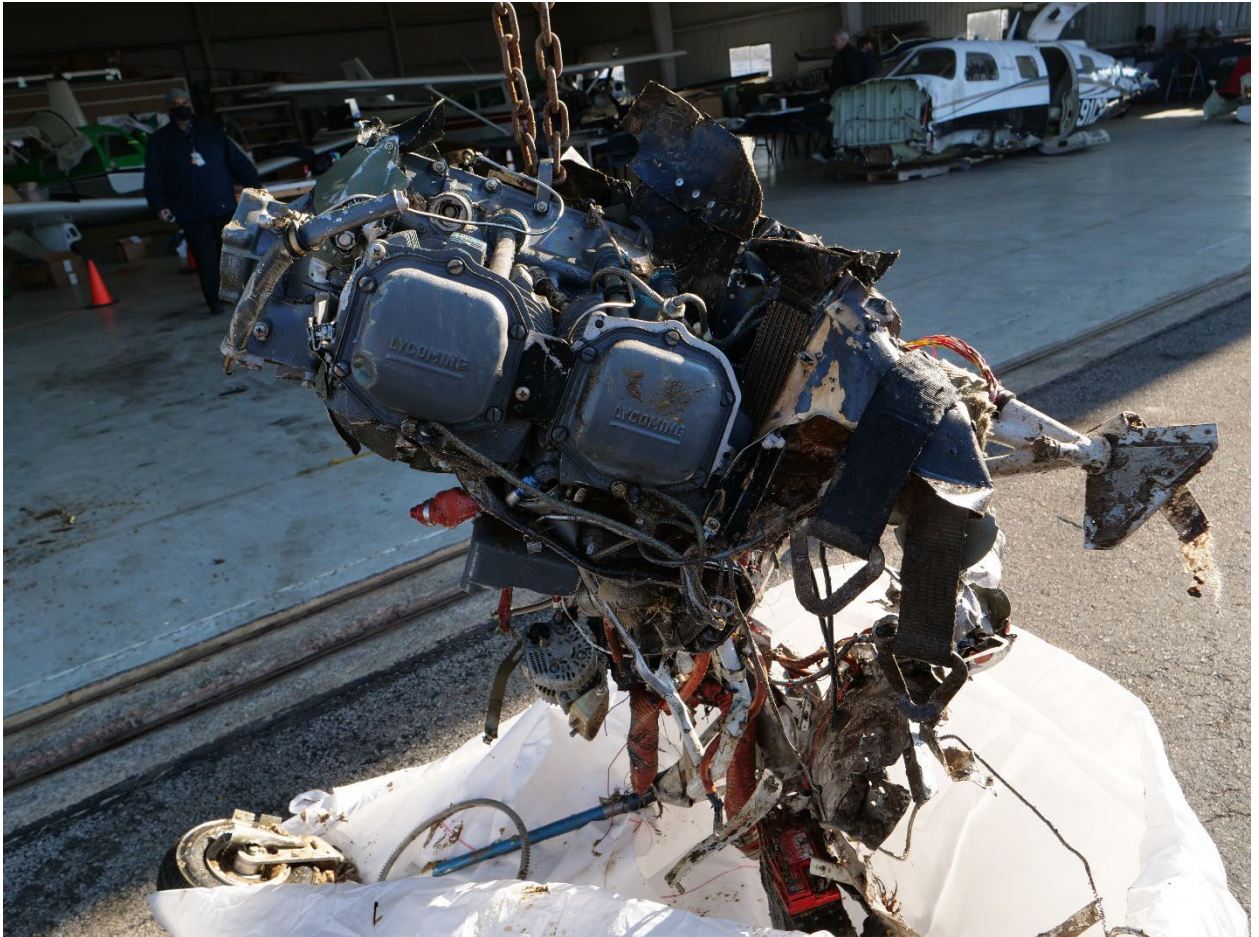
Figure 16 - View of engine after airplane was recovered.

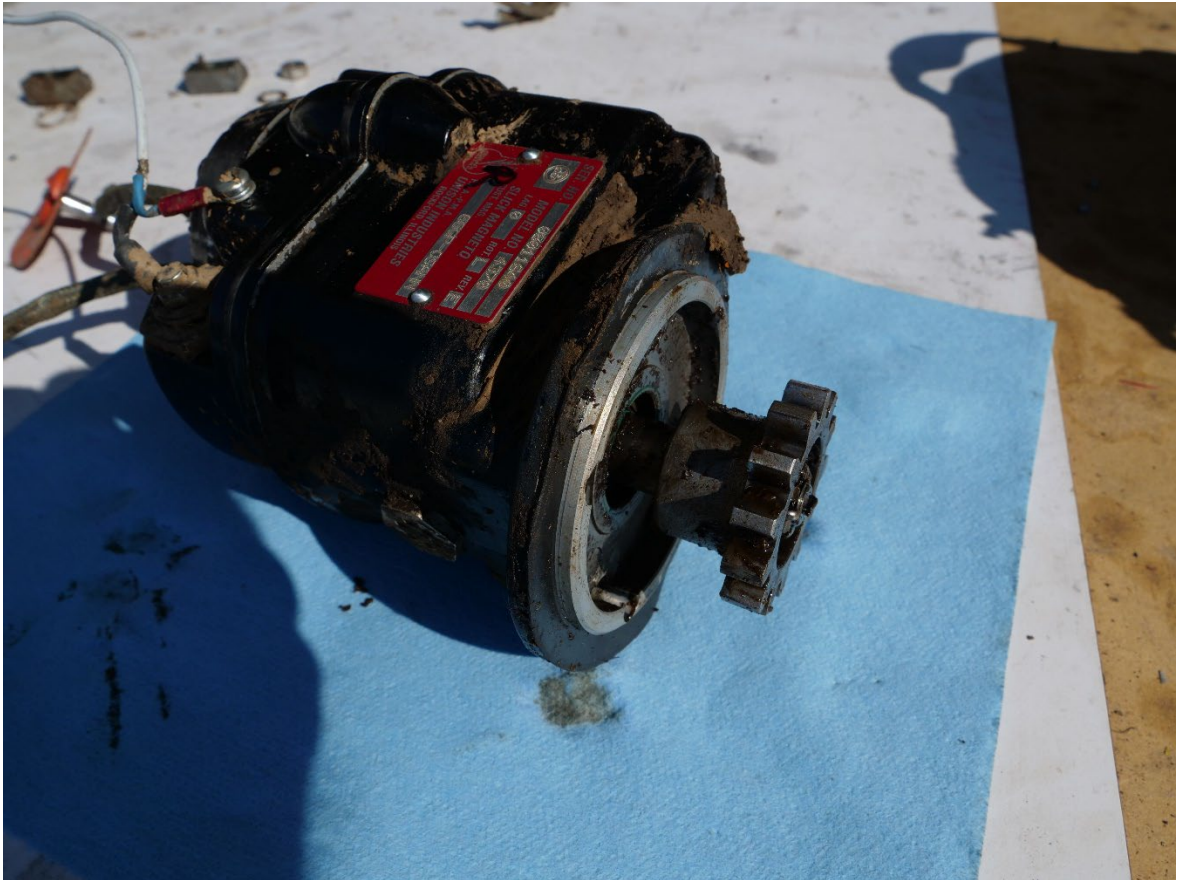
The right magneto - manufactured by Slick, model 4370 and serial no. 08011640, had a broken flange and was freely rotated by hand, producing a spark at each lead.

Figure 17 - Right magneto, moved from engine.

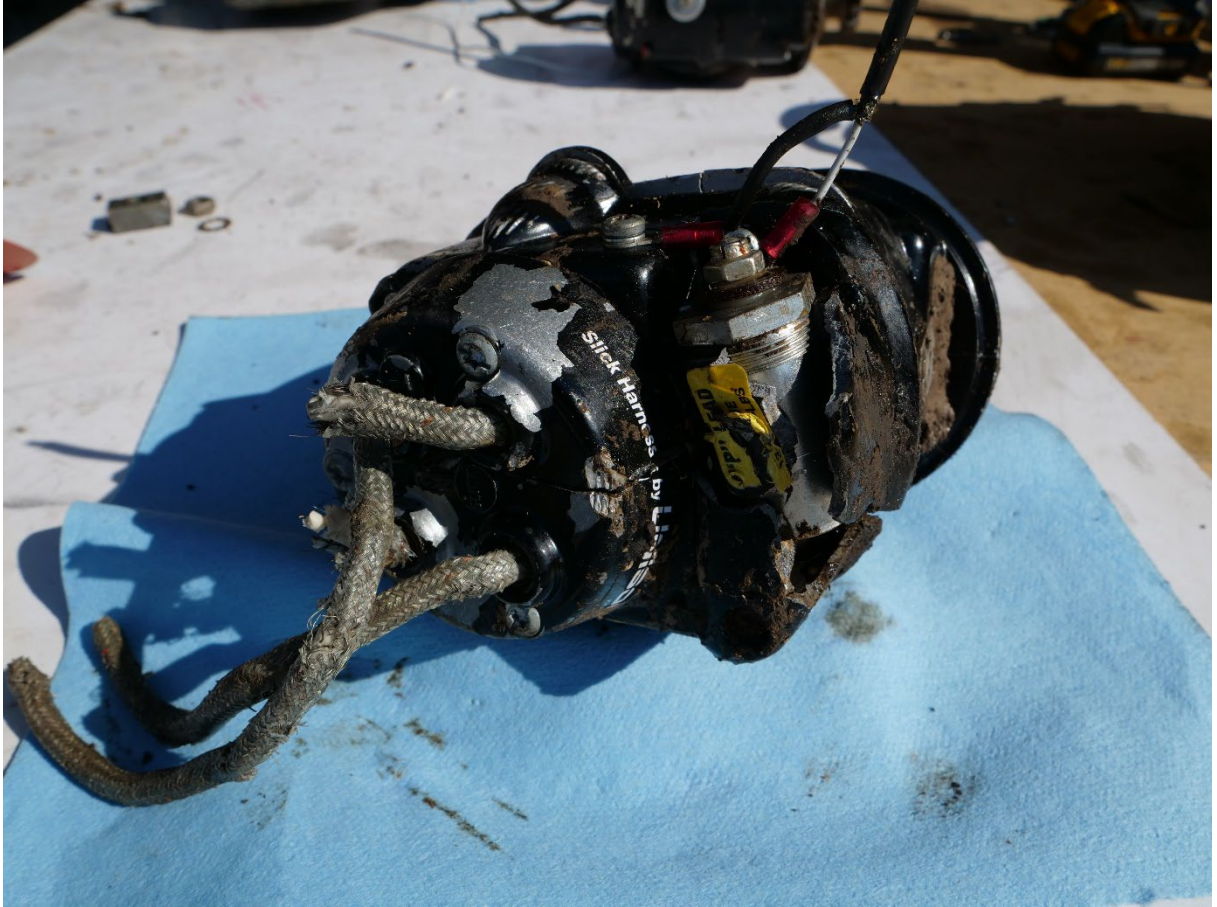
The left magneto - manufactured as model 4373 and serial no. 08011874 - was impact damaged (cracked case) and the area around the capacitor was found crushed. The magneto was not rotatable.

Figure 18 - Left magneto, removed from engine.

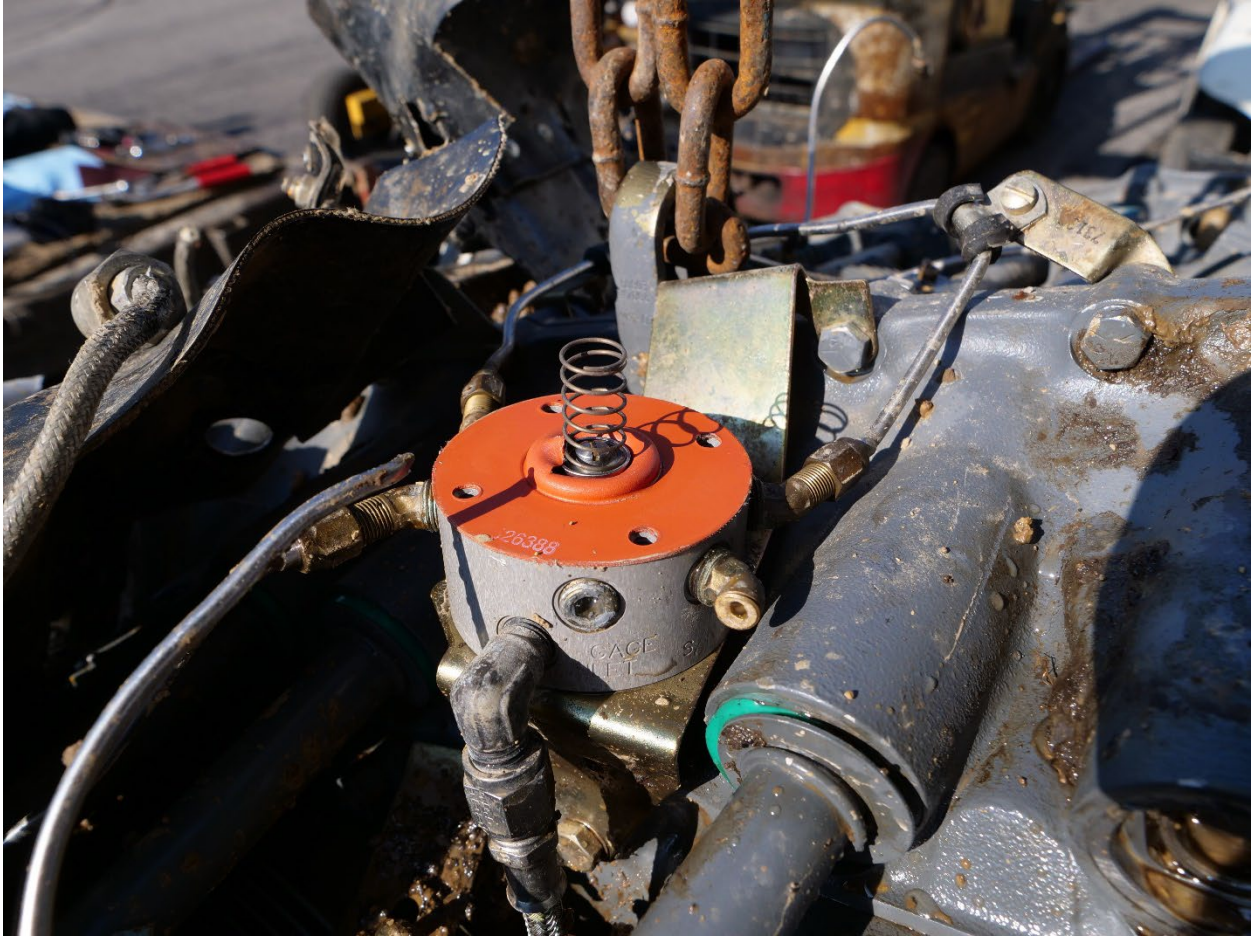
The fuel system was manufactured by Precision as model EX-5VA1 with setting 30150002. The fuel flow divider was disassembled, and a tear was observed in the diaphragm near the spring.

Figure 19 - Fuel flow divider diaphragm, note tear on left side of spring.

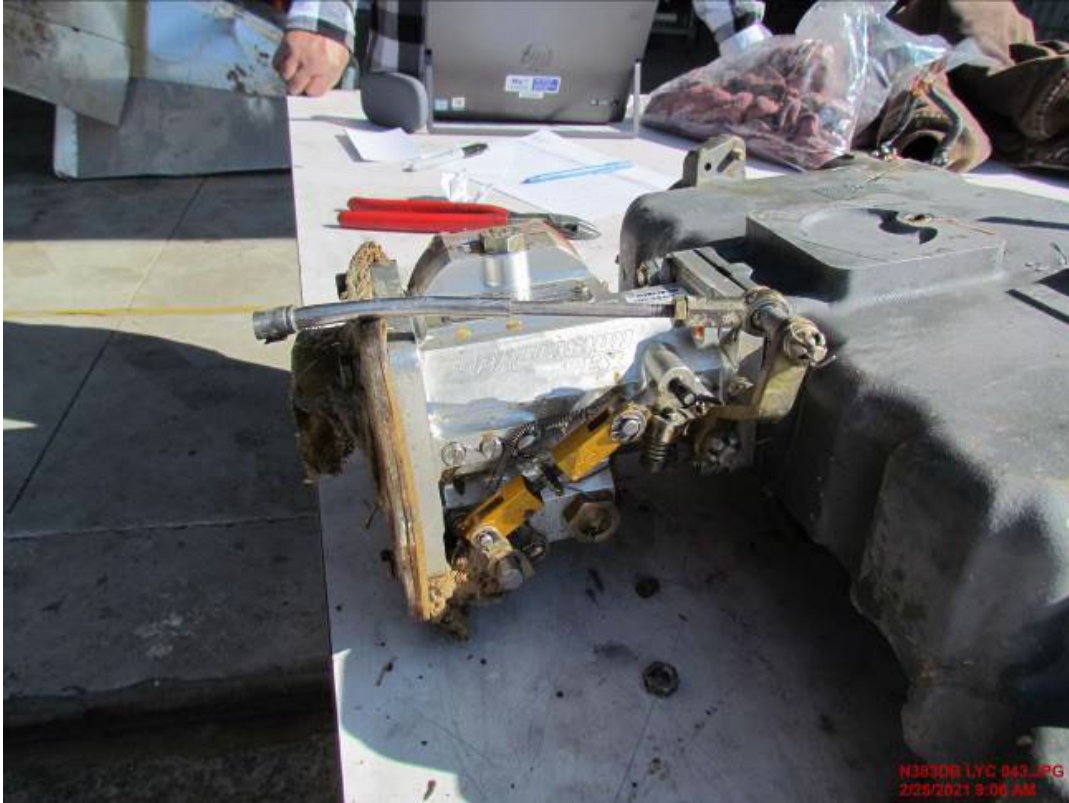
The fuel servo remained attached to the oil sump, with its brass plug tight and safety wired. Fuel was observed coming the servo.

The mixture arm was found separated from the servo. The throttle arm and rod end remained attached to the fuel servo. The throttle cable was separated at the rod portion of the cable.

Figure 20- Fuel servo, removed from engine (Courtesy of Lycoming)

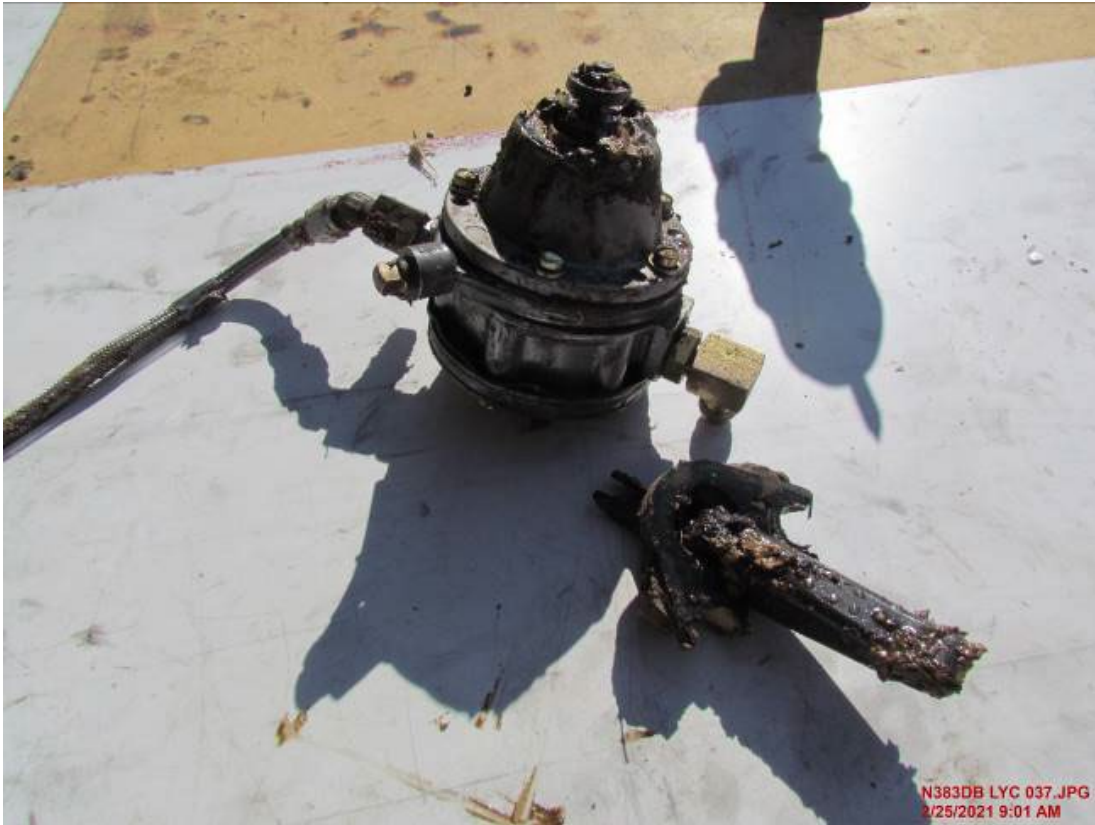
The engine driven fuel pump was removed and showed signs of impact damage. The pump lever was fractured from the main pump body.

Figure 22 - Engine-driven fuel pump, removed from engine (Courtesy of Lycoming)

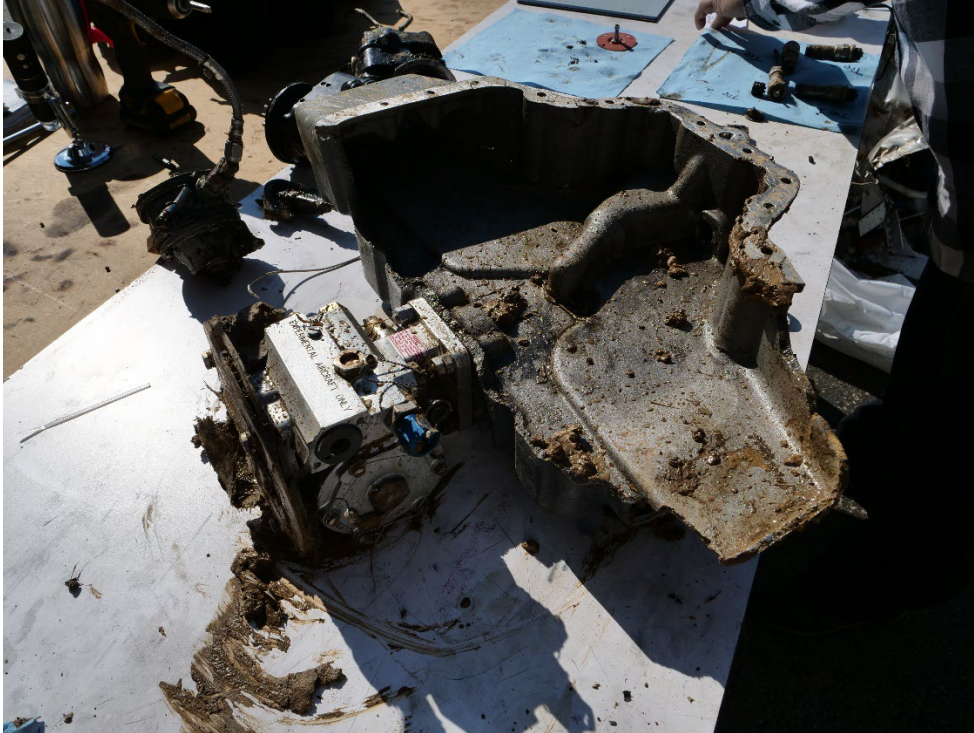
The oil sump was fractured from the engine and no oil was present as a result of impact damage.

Figure 23- Oil sump, fractured.

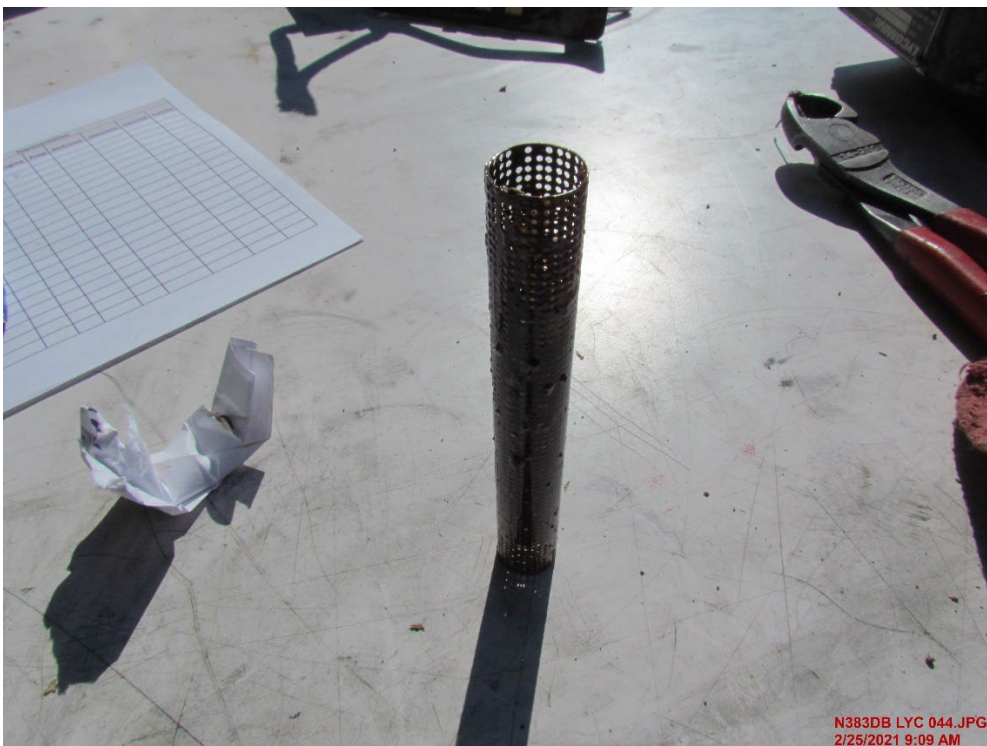
The oil suction screen was removed and observed to be clean. The oil cooler was found partially crushed with its lines still attached. The oil filter was crushed.

Figure 24- Oil suction screen (Courtesy of Lycoming).

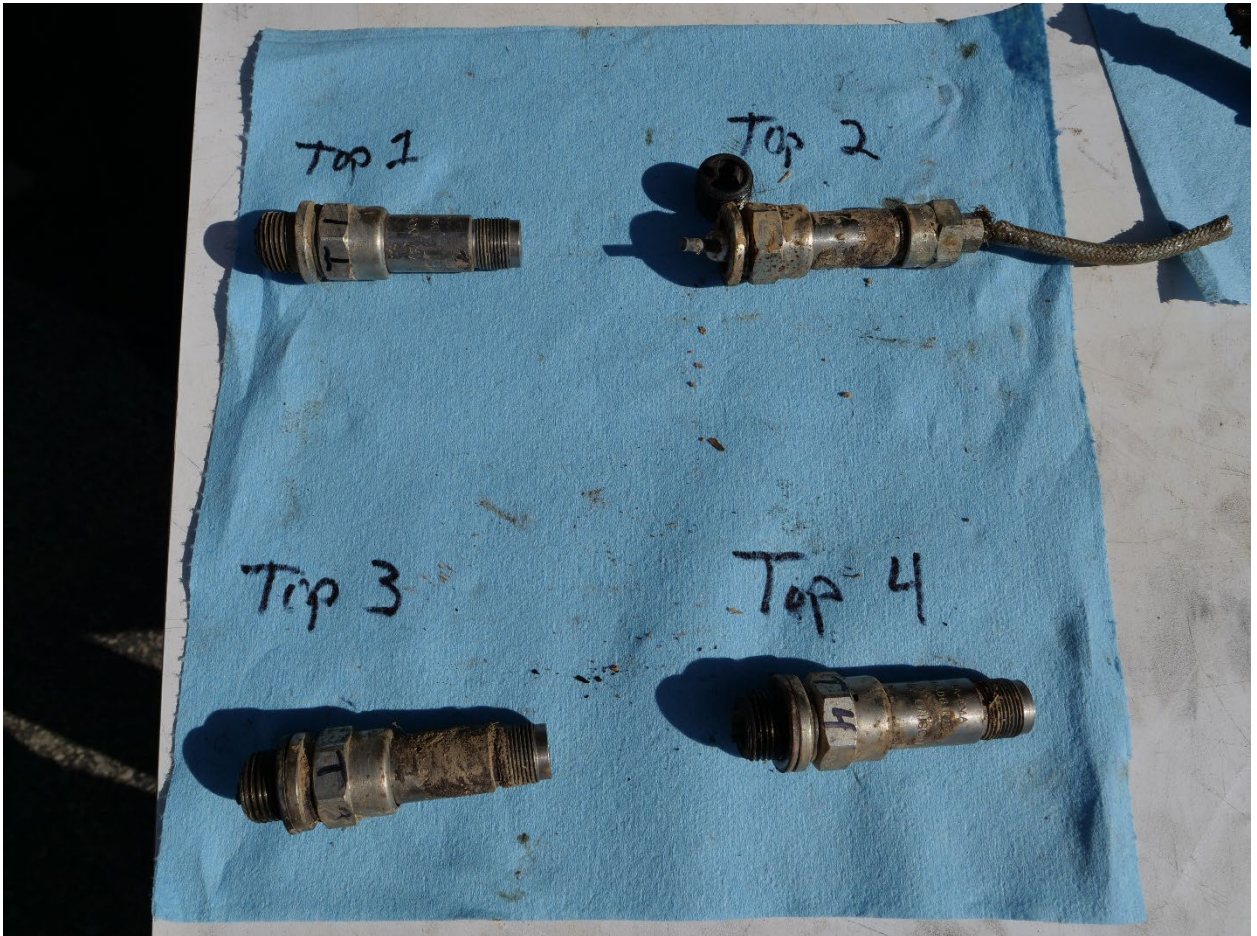
The top spark plugs - manufactured by Autolite, type UREM38E and SI 1042 Approved - were removed from cylinders Nos. 1, 3 and 4 and noted as having an undamaged electrode / normal per the Champion Aviation Check-A-Plug Card AV-27. The spark plug from cylinder no. 2 was fractured at the cylinder.

Figure 25- View of top spark plugs removed from engine.

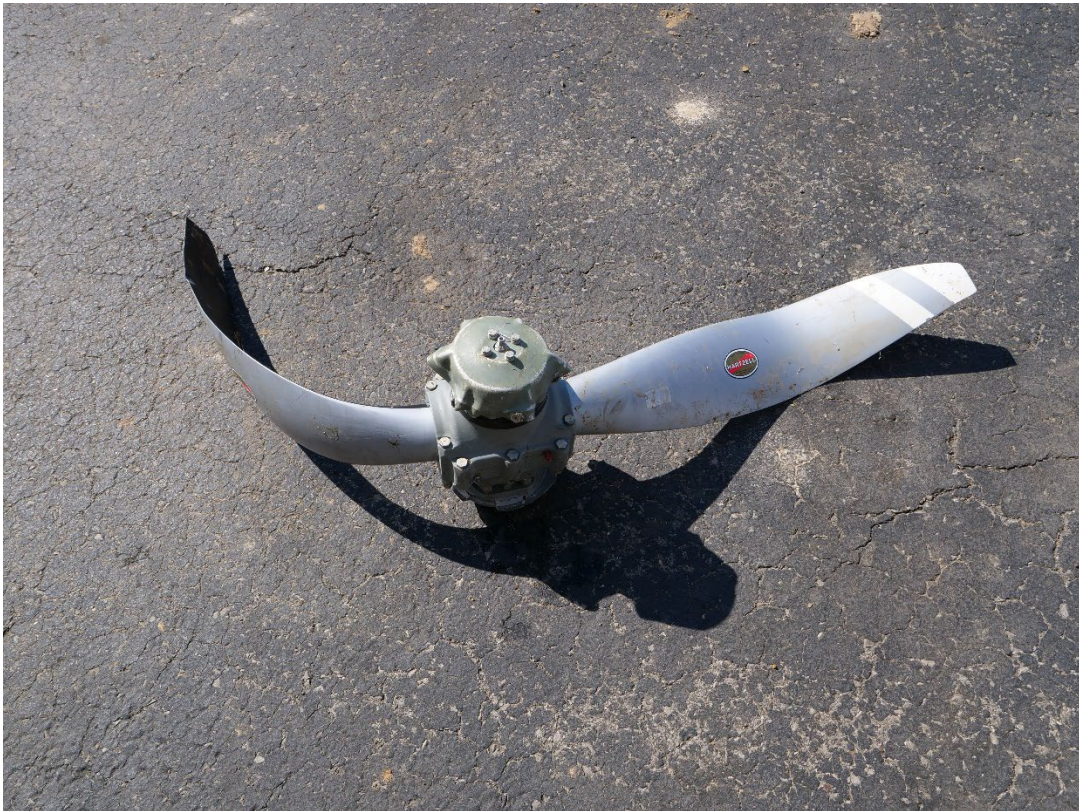
The propeller was a two blade, controllable pitch, Hartzell model HC-C2YR-1BFP s/n CH43370B. The propeller was found fractured from the engine. It was recovered from about 4 ft under the engine. The propeller and crankshaft flange had broken off just aft of flange due to impact forces.

One propeller blade was bent aft and exhibited leading edge damage. The second blade was bent back and then forward about halfway (S-bending).

Figure 27- Propeller

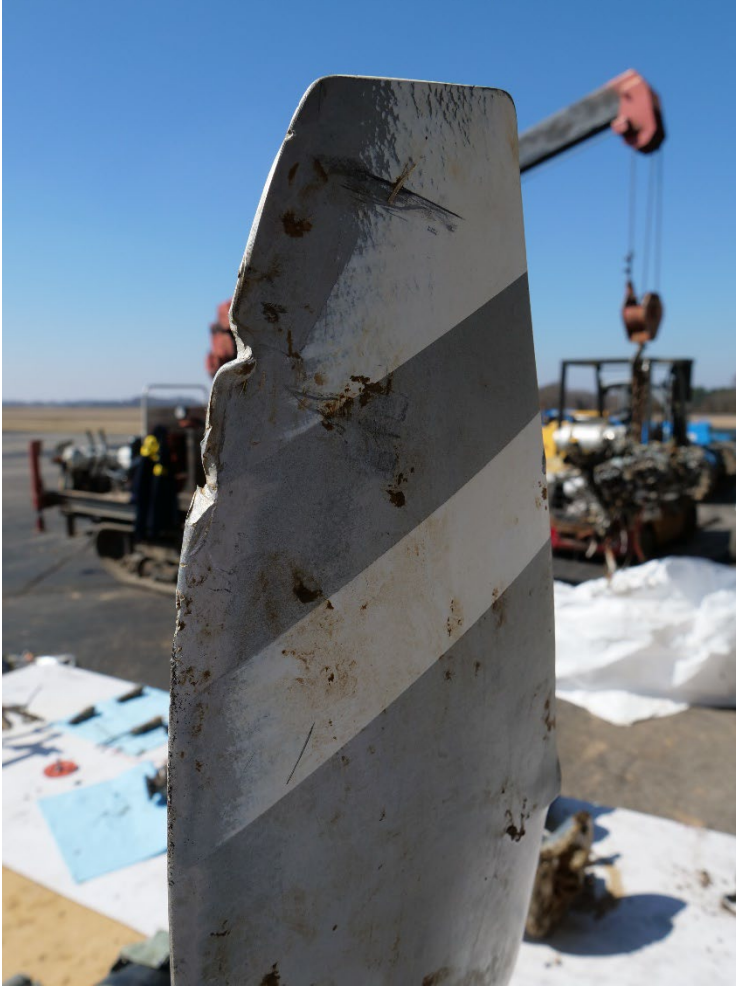
Figure 28-Leading edge damage to propeller blade
