National Transportation Safety Board

ERA21FA135

WRECKAGE EXAMINATION SUMMARY

Location: Mayfield, Kentucky
Date: February 22, 2021
Time: 1756 CST
Airplane: Henry D Babenco / Vans RV-7A, N383DB

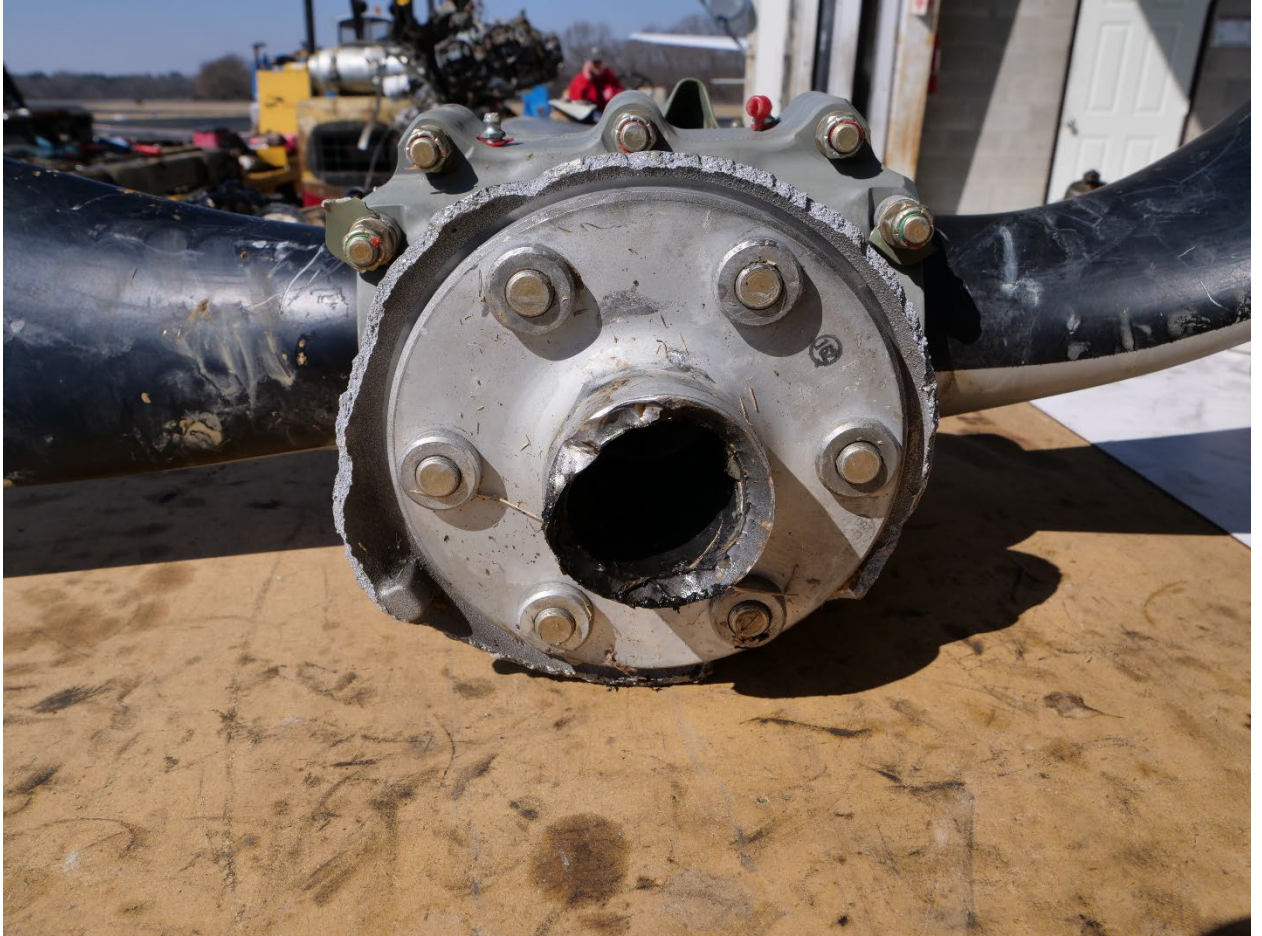
The propeller was a two blade, controllable pitch, Hartzell model HC-C2YR-1BFP s/n CH43370B. The propeller was found fractured from the engine. It was recovered from about 4 ft under the engine. The propeller and crankshaft flange had broken off just aft of flange due to impact forces.

Figure 29-Propeller flange.
