**NATIONAL TRANSPORTATION SAFETY BOARD
Office of Research and Engineering
Vehicle Recorder Division
Washington, D.C.**

SPECIALIST'S FACTUAL REPORT OF INVESTIGATION

ERA21LA036

Cockpit Voice Recorder

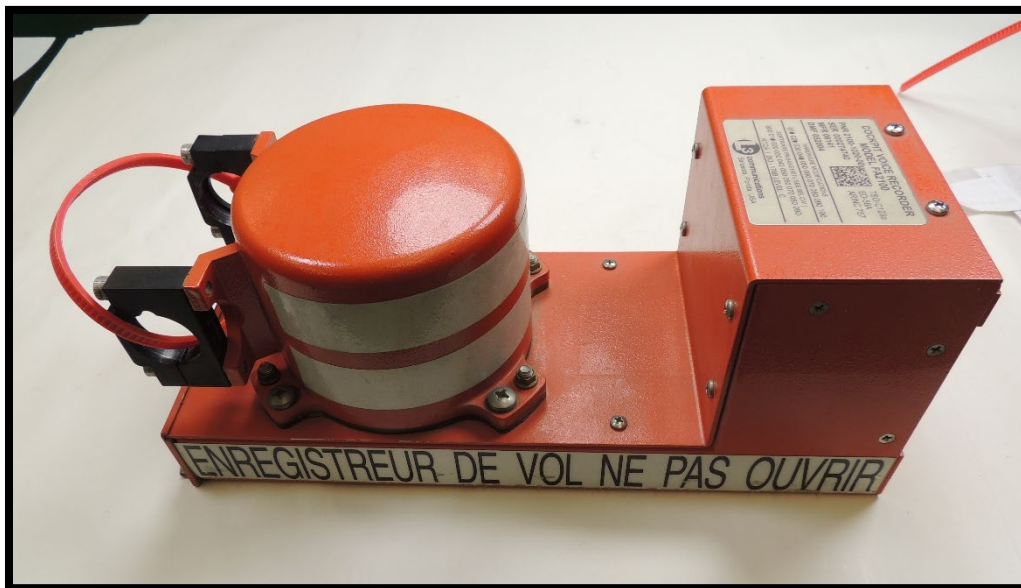
Figure 2. Event CVR, as received.

Upon arrival at the laboratory, it was evident that the CVR had not sustained any heat or structural damage, and the audio information was extracted from the recorder normally, without difficulty. The CVR, as received, is shown in Figure 2.
